**NATIONAL TRANSPORTATION SAFETY BOARD  
Office of Aviation Safety  
Washington, DC 20594**

**SUMMARY OF ENGINES AND PROPELLERS EXAMINATION**

**CEN22FA145**

Location: Pond Creek, Oklahoma  
Date: March 17, 2022  
Time: 4:38 pm Central Daylight Time  
Aircraft: Piper PA-30 (S/N 30-1504) N8357Y

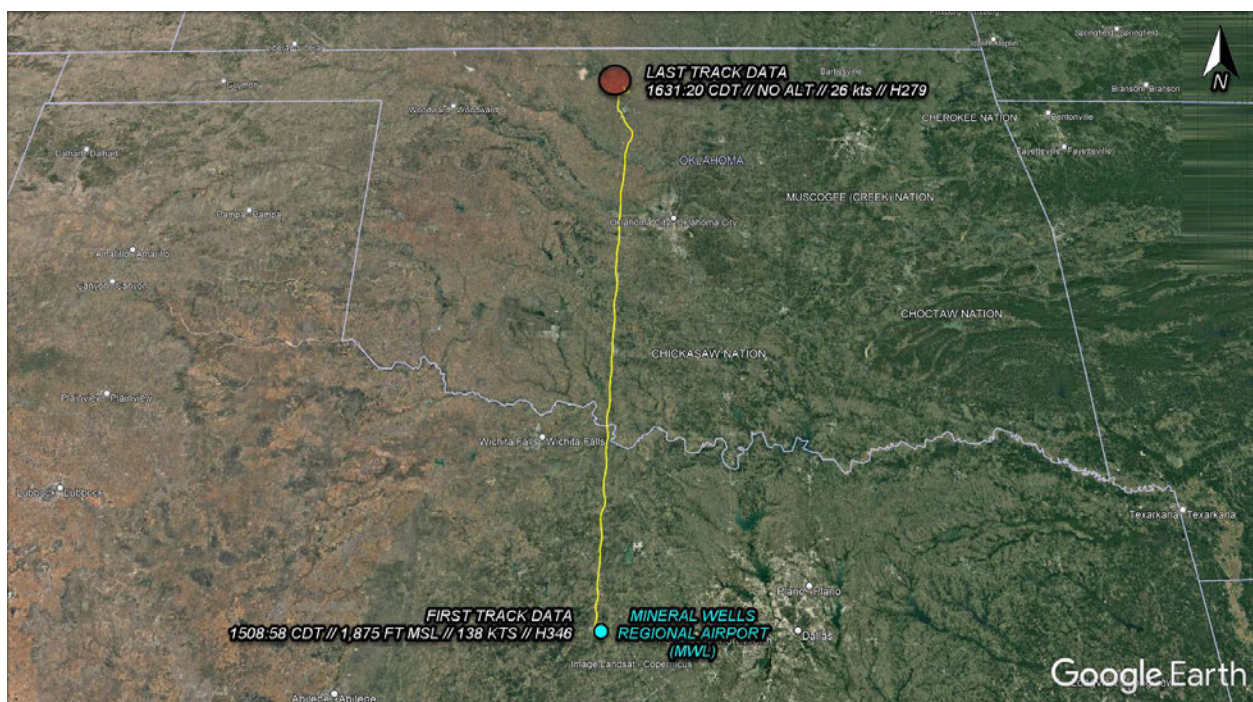
Figure 1. ADS-B Flight Track.

Preliminary radar and Automatic Dependent Surveillance-Broadcast (ADS-B) data indicated the airplane first appeared at 1509 about 1.5 nautical miles west of the Mineral Wells Regional Airport (MWL), Mineral Wells, Texas. The airplane tracked north climbing initially to a cruise altitude of 8,500 ft and then later climbing to 16,500 ft. The airplane began descending after passing over Vance Air force Base (END), Enid, Oklahoma and turned momentarily eastbound. The airplane then turned westbound and back to the north while descending and decreasing in ground speed from over 200 knots to under 100 knots. Mode C position reporting data was lost followed by the loss of all track data about 1631. The airplane was about 5 nautical miles southwest of Pond Creek, when track data was lost.

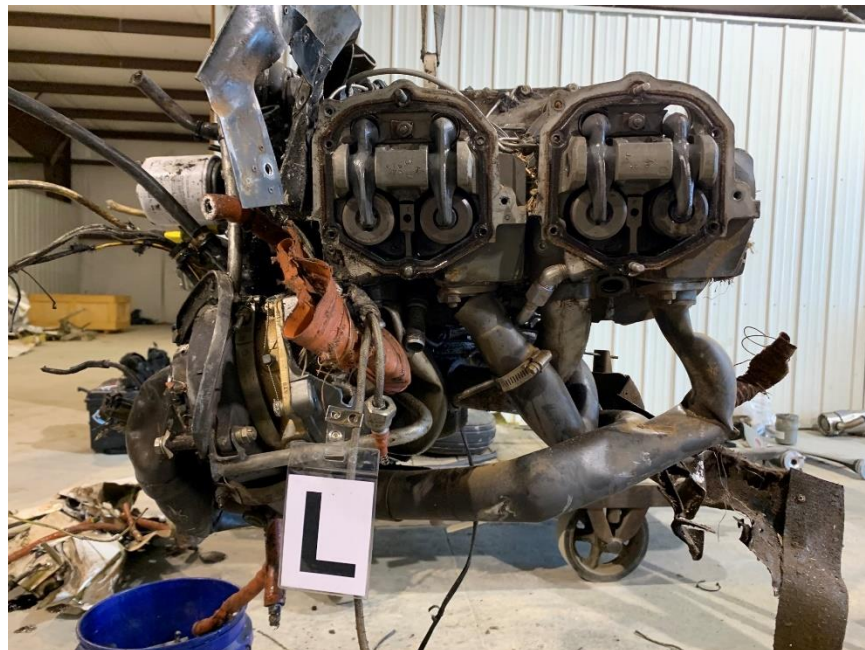
Figure 3. Left Engine, Right Side, Cylinders 1 and 3

The left engine was attached to the airframe. The remaining cowling was removed, and the engine was removed from the airframe and lifted for the examination. The front of the engine case was broken around the crankshaft fracture. The crankshaft was fractured about 3 inches aft of the flange. The fracture was consistent with torsional and sideload tearing. The front of the crankcase

was cracked and broken around the crankshaft fracture. The top and front cylinders of the engine showed crush damage. Several of the push rods and tubes were bent inward and aft. The engine was pushed aft into the firewall, concaving the firewall and crushing the engine mounts and accessory section.

The rocker box covers were removed, and the rockers examined. All rockers and springs for the intake and exhaust valves were intact. The bent push rods were removed, and the top spark plugs were removed and examined. The electrode on plug 2 was bent. Plug 3 was broken. Plugs 1 and 4 showed extended wear but were within operational tolerances when compared with a spark plug wear chart. All of the bottom spark plugs showed normal wear.

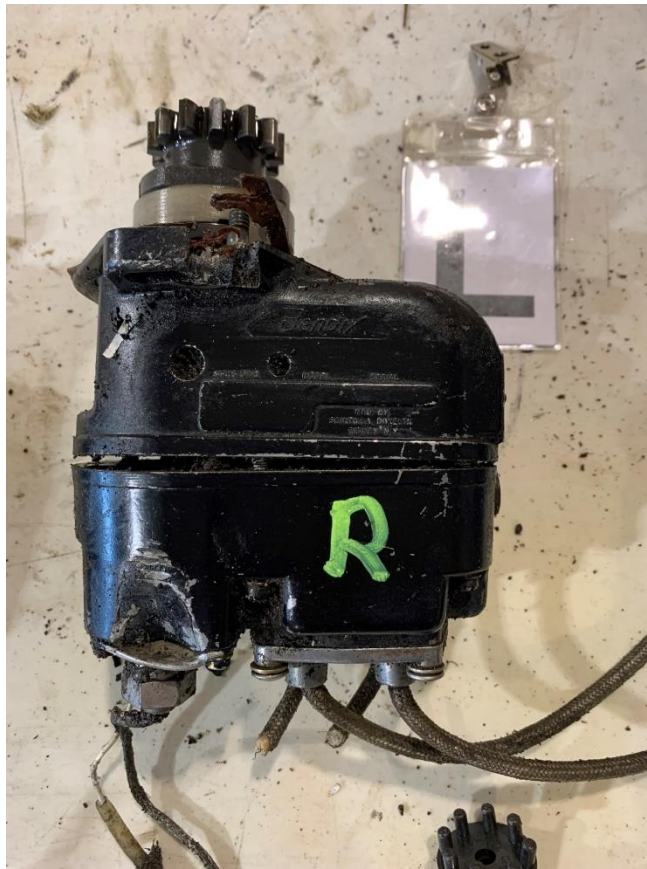
Figure 5. Right Magneto

The right magneto showed impact damage. The leads were cut, and the impulse coupling was rotated. The coupling rotated but the leads showed no spark.

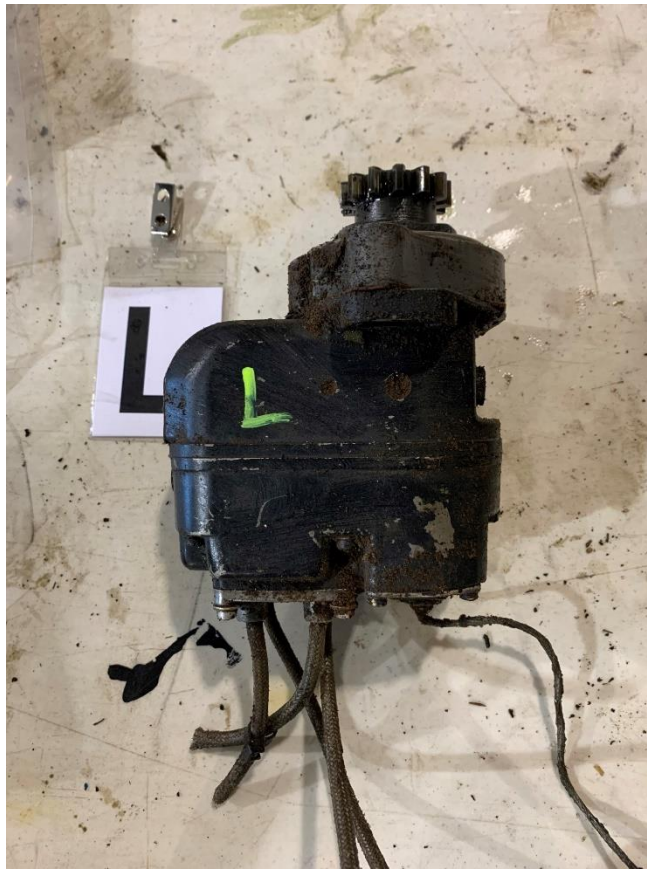
Figure 6. Left Magneto

The left magneto was intact. The leads were cut, and the impulse coupling was rotated. Spark was observed at all four leads.

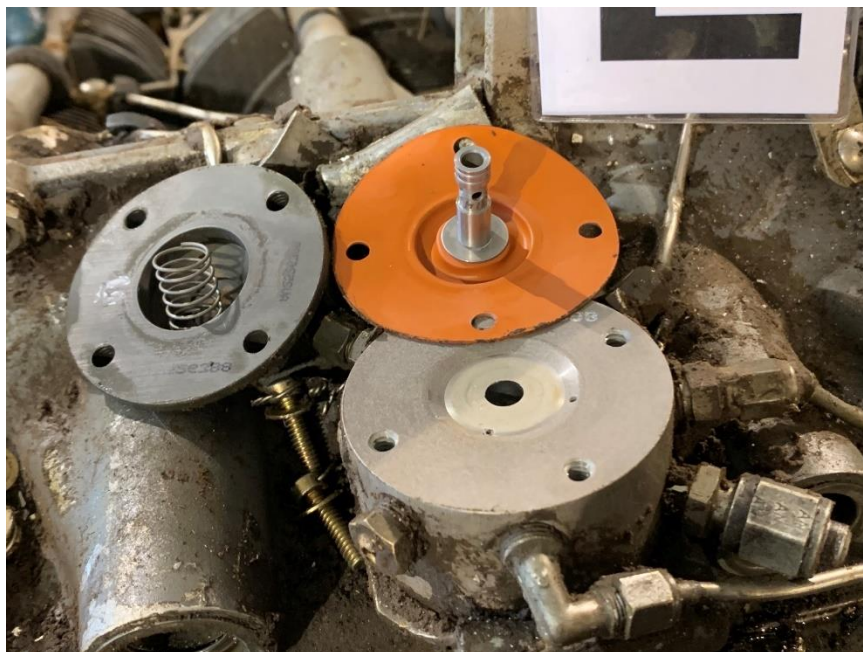
Figure 7, Disassembled Fuel Distribution Manifold

The fuel distribution manifold was opened. The diaphragm was removed and examined. The diaphragm showed no damage and was clean. No debris was observed in the manifold housing or the ports to the lines leading to the cylinders.

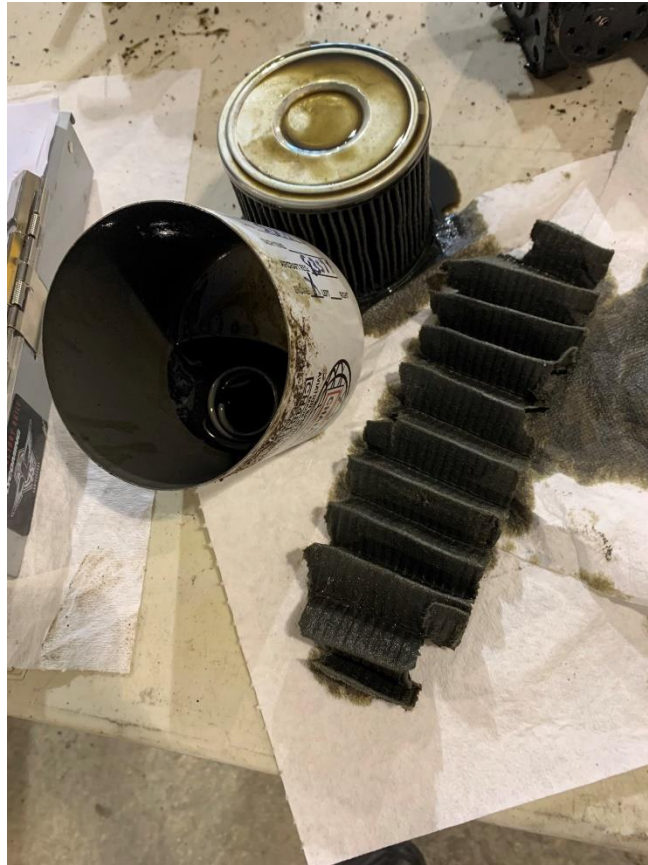
Figure 8. Disassembled Oil Filter

The oil filter was intact and showed minor top crushing. The filter was removed and disassembled. Little oil was in the filter, but what oil observed was clean. The filter was opened and examined. No debris was noted. Information written on the filter showed it had been installed in May 2021.

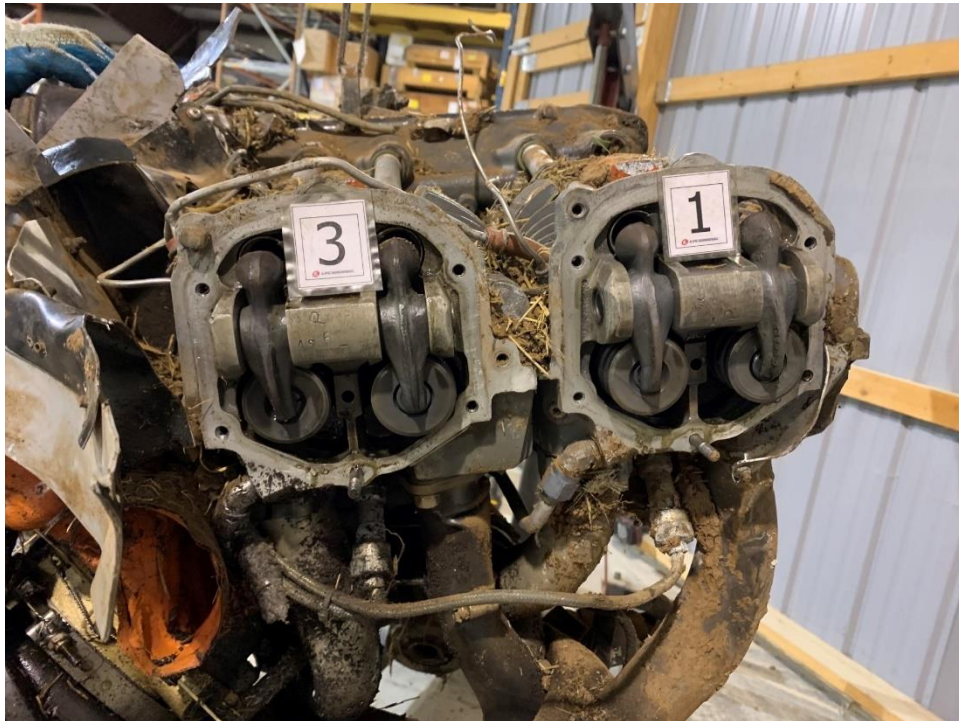
Figure 9. Right Engine, Right Side, Cylinders 1 and 3

The right engine was lifted from its crate. Soil was removed and the firewall and engine mounts were removed. The rocker box covers were removed, and the rockers examined. All rockers for the intake and exhaust valves were intact and moved freely. Several pushrods and covers were bent. The aft pushrod tube to the right front cylinder showed corrosion. The

crankshaft was fractured about 4 inches aft of the flange. The fracture was consistent with torsional and sideload tearing. The front of the crankcase was cracked and broken around the crankshaft fracture. The top spark plugs were removed and examined. They showed excessive wear but were within operational tolerances when compared with a spark plug wear chart.

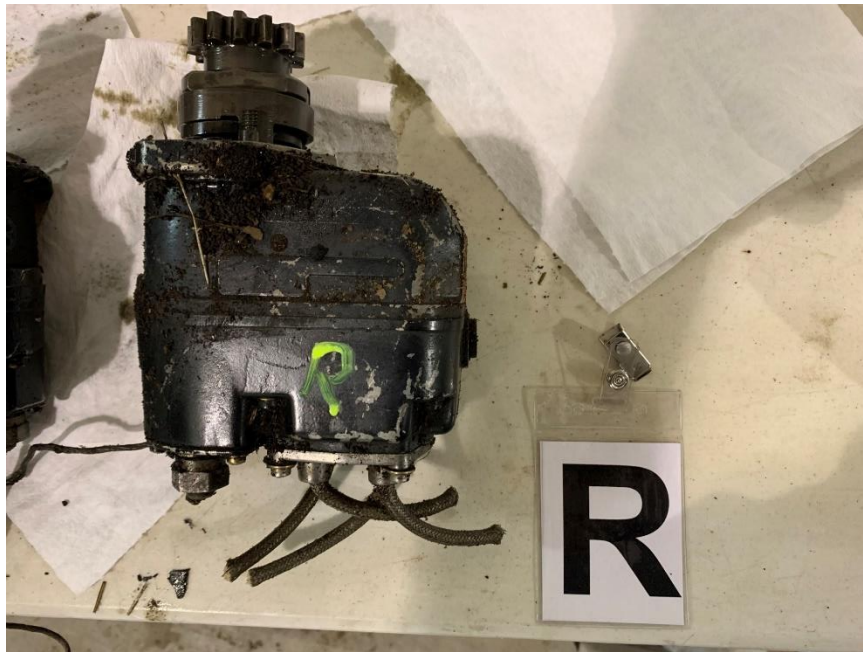
Figure 11. Right Magneto

The right magneto was intact. The leads were cut, and the impulse coupling was rotated. Spark was observed at all four leads.

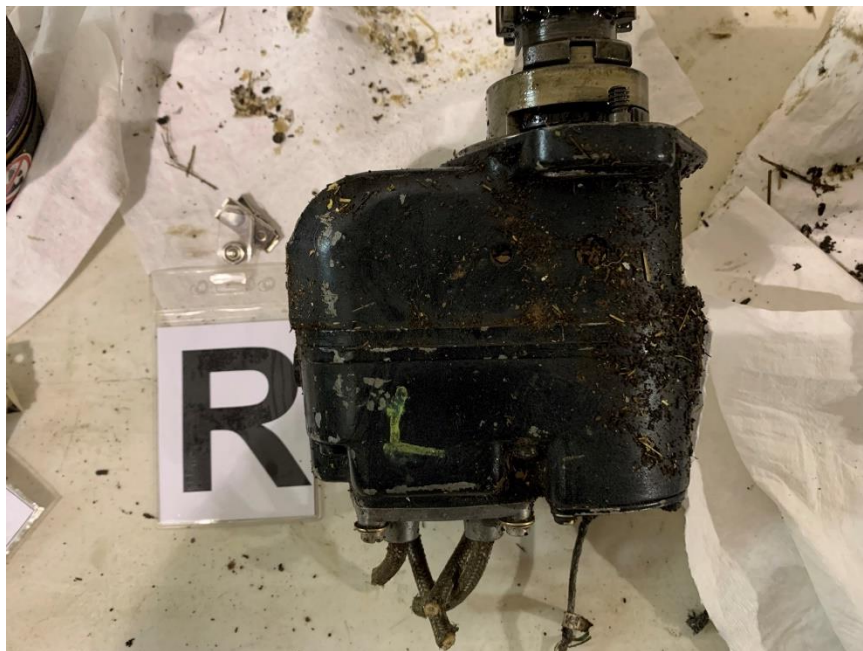
Figure 12. Left Magneto

The left magneto was intact. The leads were cut, and the impulse coupling was rotated. Spark was observed at all four leads.

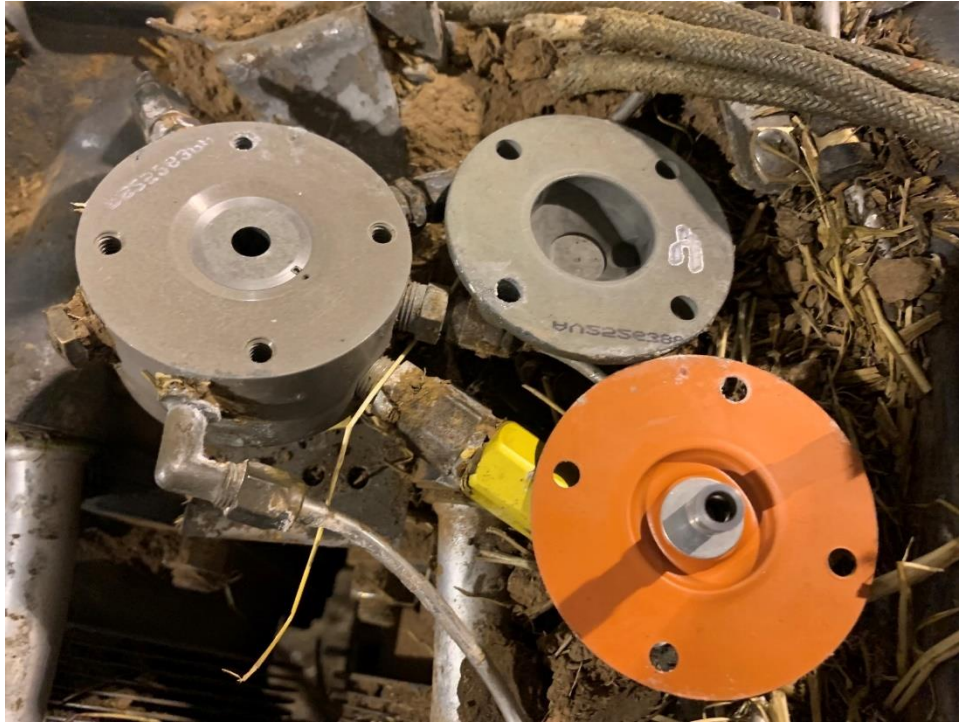
Figure 13, Disassembled Fuel Distribution Manifold

The fuel distribution manifold was opened. The diaphragm was removed and examined. The diaphragm showed no damage and was clean. No debris was observed in the manifold housing or the ports to the lines leading to the cylinders.

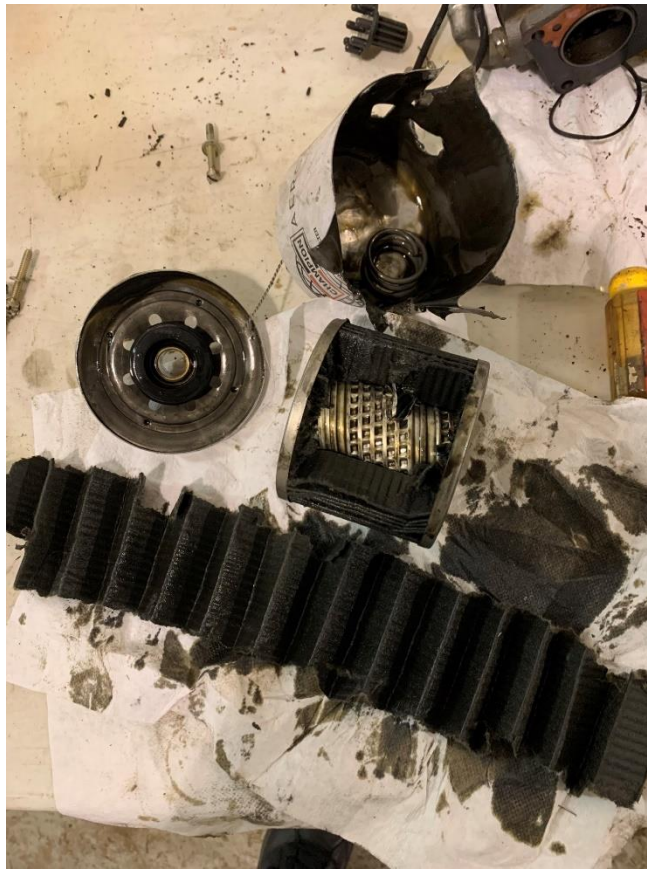
Figure 14. Disassembled Oil Filter

The oil filter was intact and showed minor top crushing. The filter was removed and disassembled. Little oil was in the filter, but what oil observed was clean. The filter was opened and examined. No debris was noted. Information written on the filter showed it had been installed in May 2021.

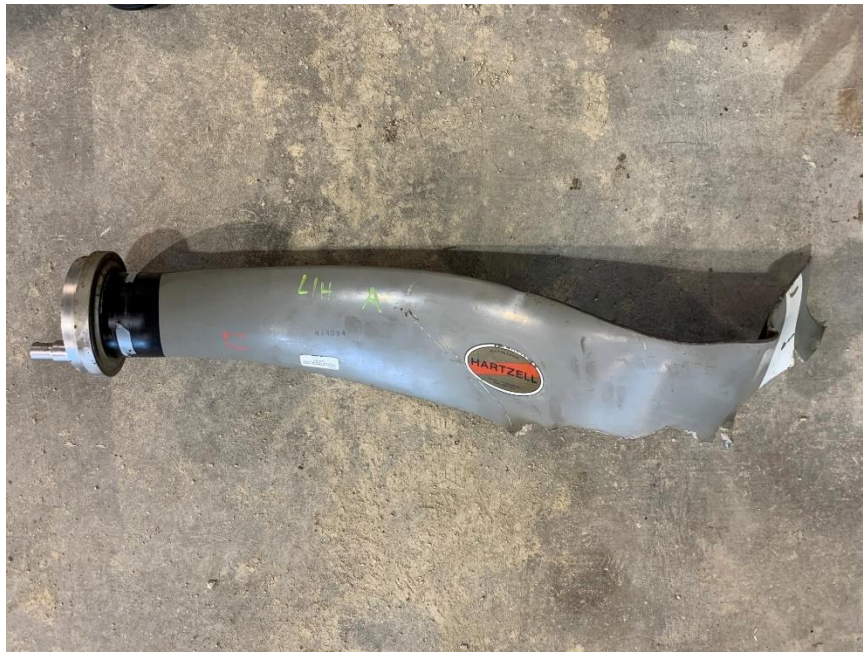
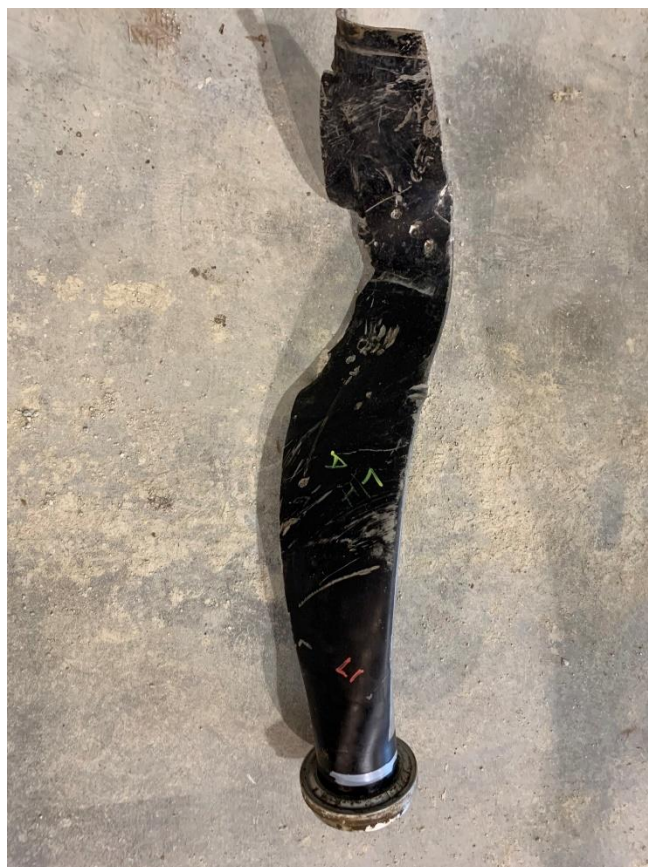
The left propeller consisted of four main pieces, the two propeller blades, the hub extension with the flange and about 4 inches of the crankshaft, and the piston cylinder with part of the spinner still attached. Blade A was broken out of the hub and was c-shaped aft beginning at mid span. A large part of the trailing edge was broken out due to impact. Three inches of the blade tip was broken off. The back side of Blade A showed several impact marks to include of the three hexagonal bolt imprints within the c-shaped bend.

Figure 15. Left Propeller, Blade A, Front Side

Figure 16. L Propeller, Blade A, Back Side

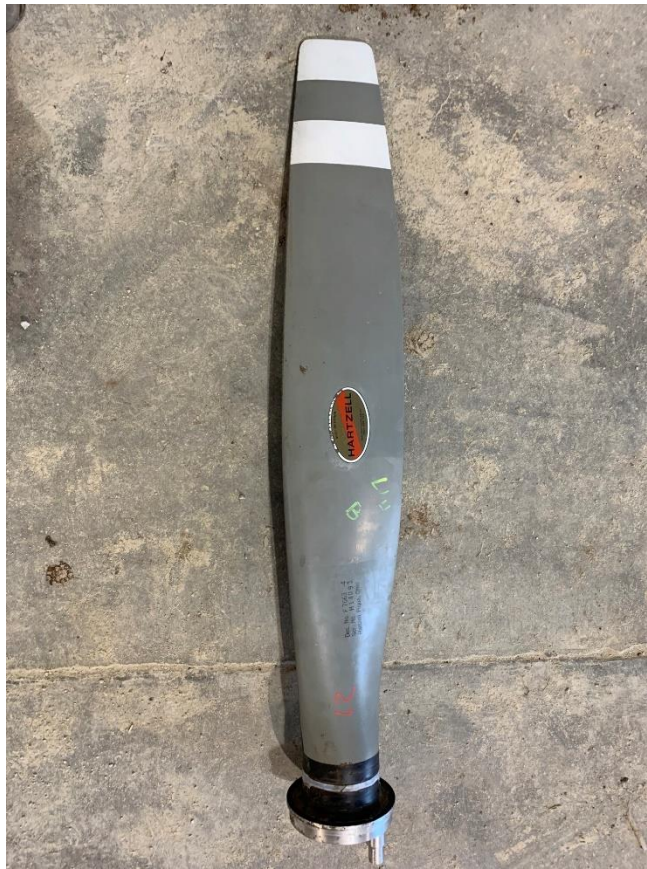
Figure 17. Left Propeller Blade B

Blade B was intact and bent slightly aft. The blade showed little damage.

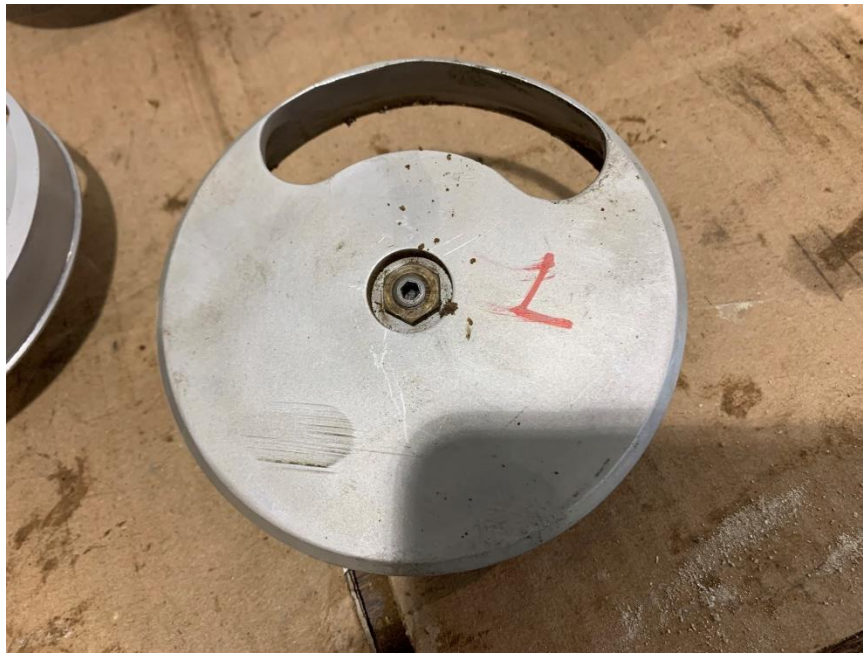
Photo 18. Left Propeller Preload Plate

One of the two left propeller preload plates showed several faint witness marks. The marks corresponded with blade angles of 32 to 36 degrees or high-speed cruise.

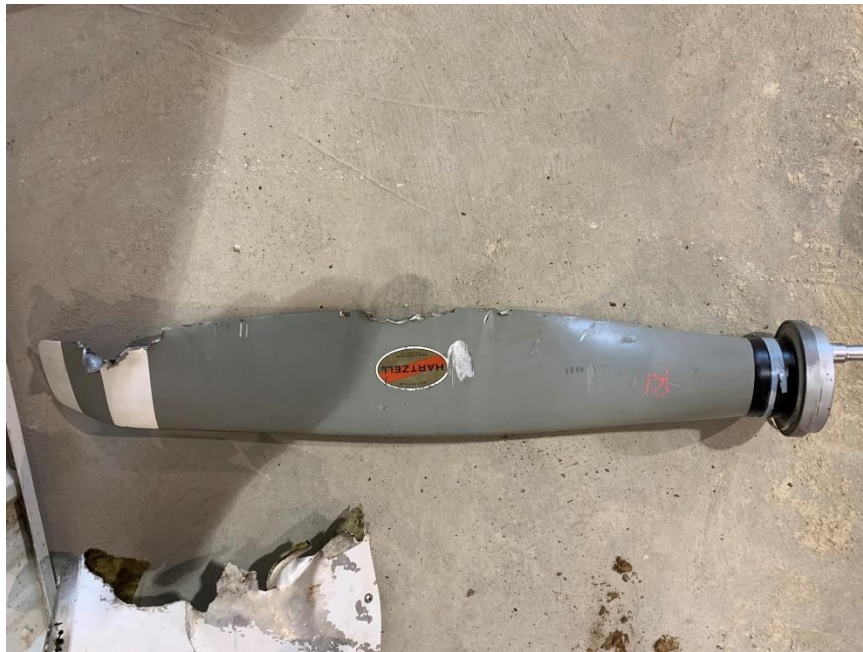
Figure 19. Right Propeller, Blade 1

Blade 1 was mostly intact and bent forward in a shallow c-shape. The training edge of the blade showed gouges and at mid-span. Additional gouges were at the trailing edge of the blade tip.

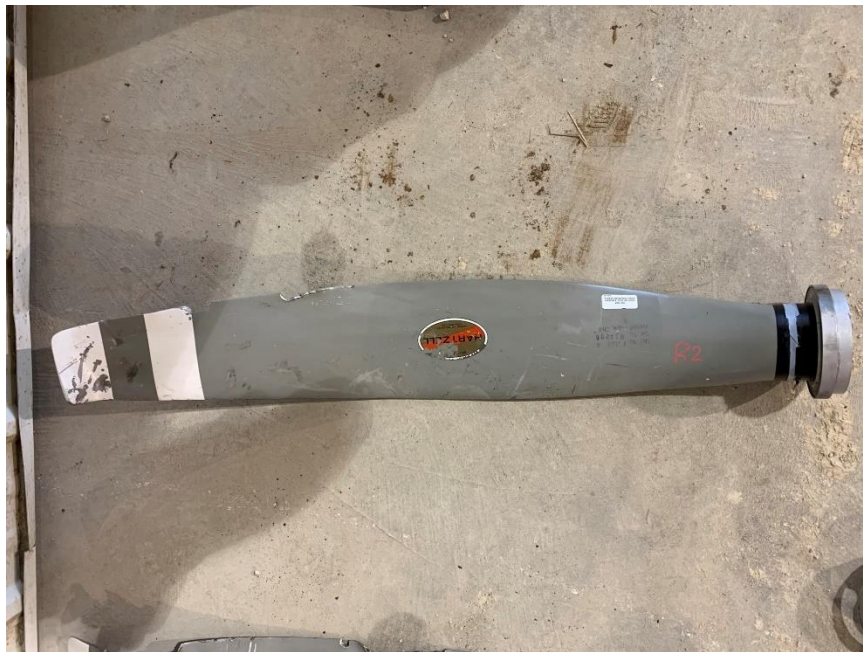
Figure 20. Right Propeller, Blade 2

Blade 2 was mostly intact and was also bent forward in a shallow c-shape. The trailing edge of the blade showed gouges two-thirds the distance from the hub and at the tip. There were also leading-edge nicks along the first half of the blade.

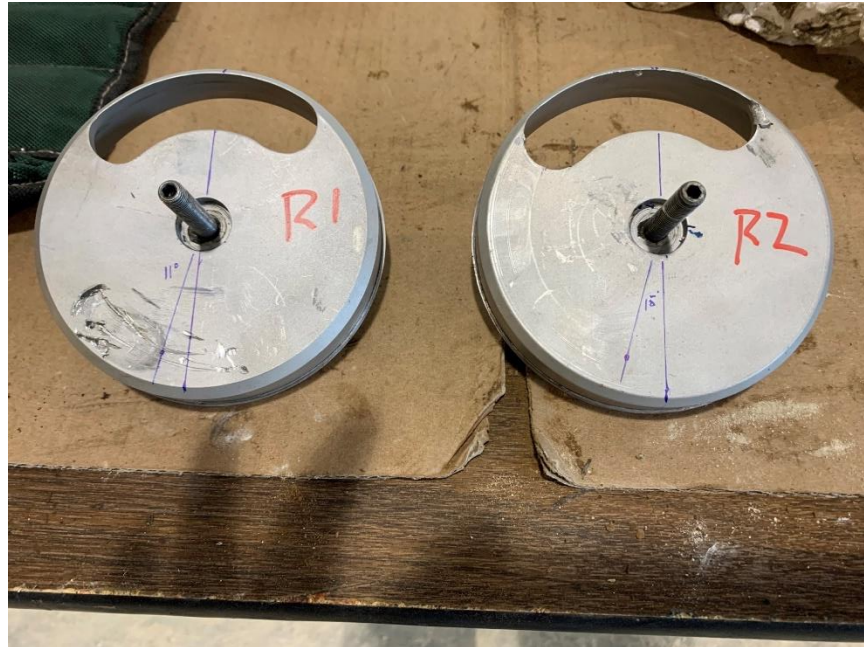
Photo 21. Right Propeller Preload Plates

The two right propeller preload plates showed several witness marks. The marks corresponded with blade angles of 32 to 36 degrees or high-speed cruise.

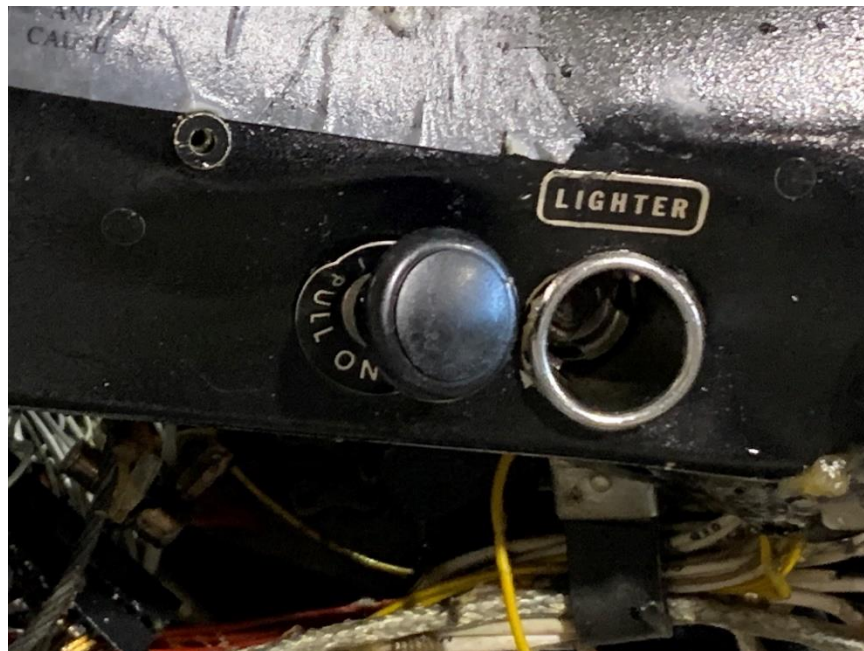
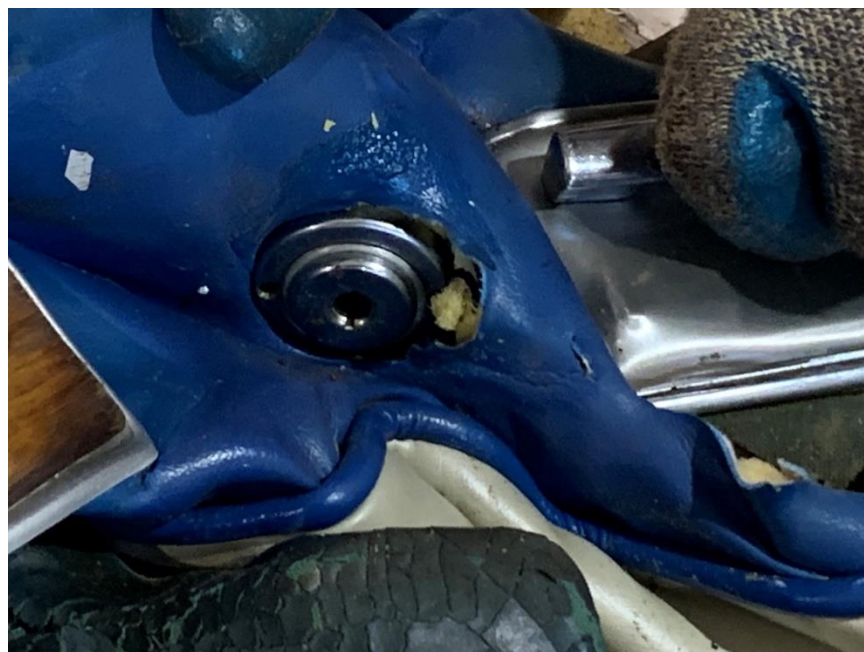
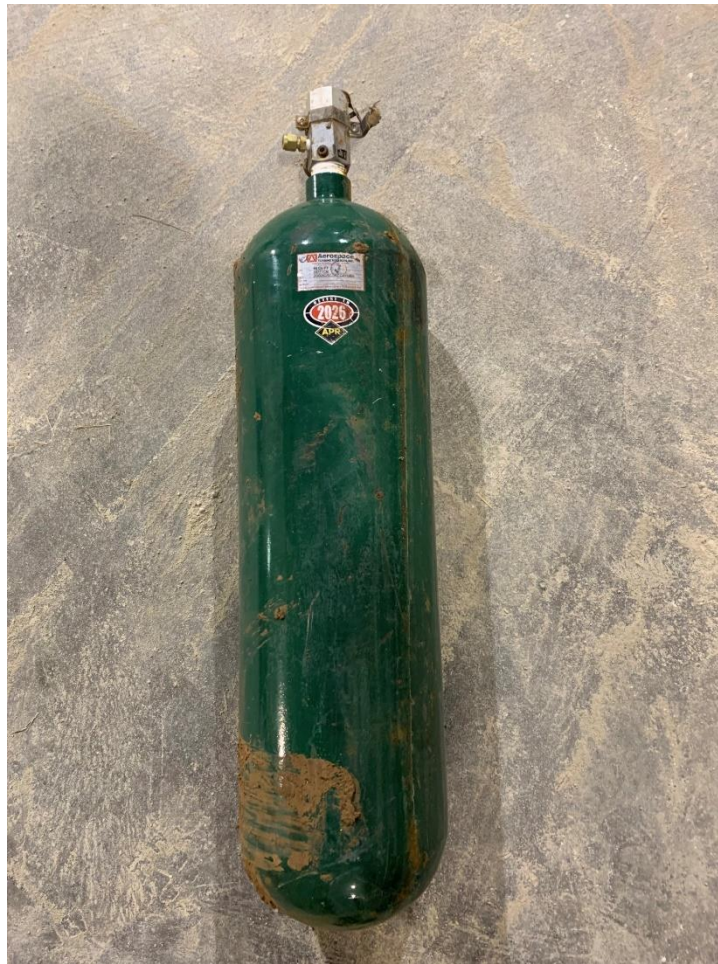
The airplane's oxygen bottle was examined. It was intact and broken out from the aft fuselage. Oxygen lines from where the bottle originated, through the cabin walls to the five oxygen ports was traced and showed some line fractures due to ground impact. The oxygen ports, where the oxygen canula/mask lines would be plugged in were clear. The system is activated by a push/pull knob on the lower right side instrument panel. The knob was in, as in the Off position. A thorough examination of the airplane's cabin produced no oxygen masks or cannulas.

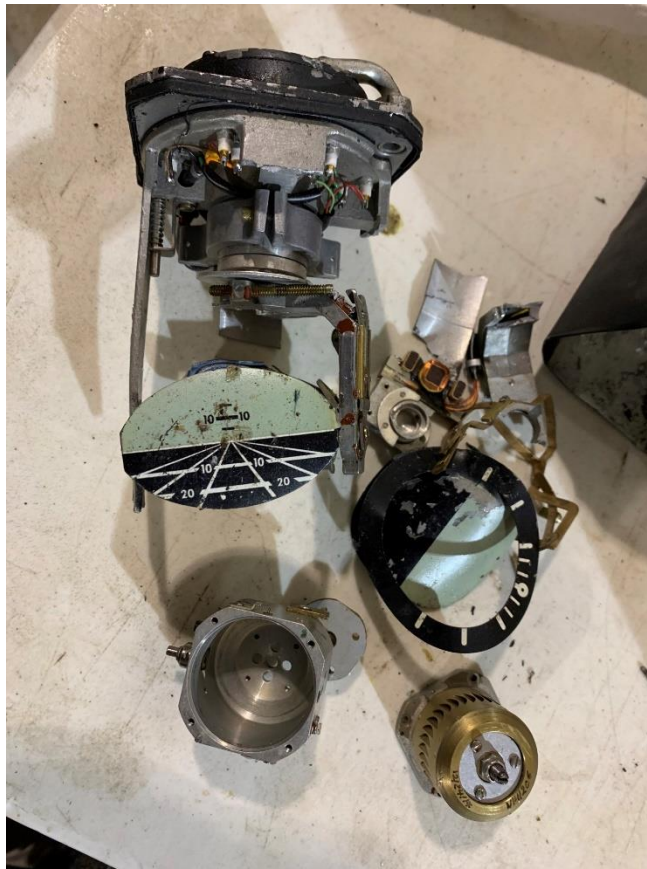
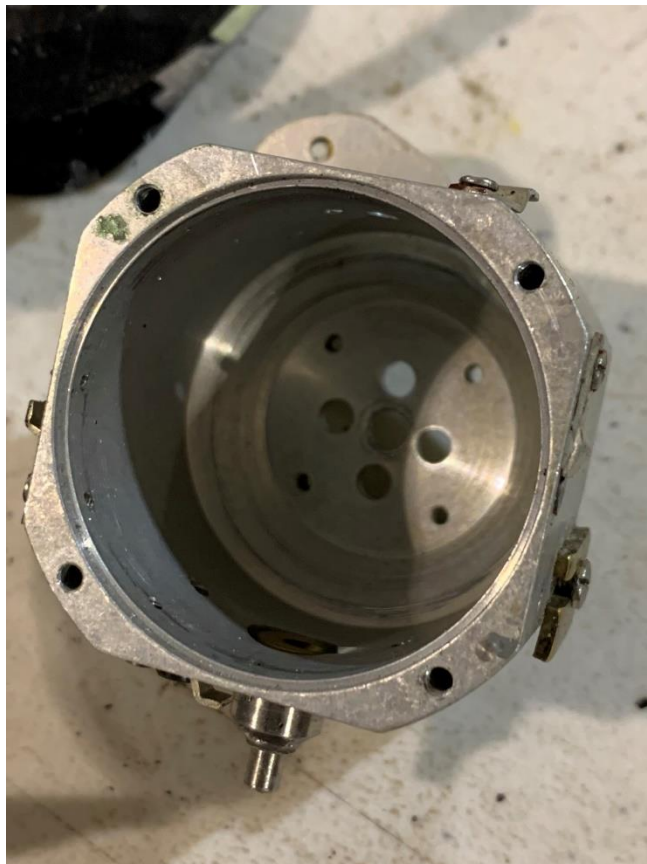
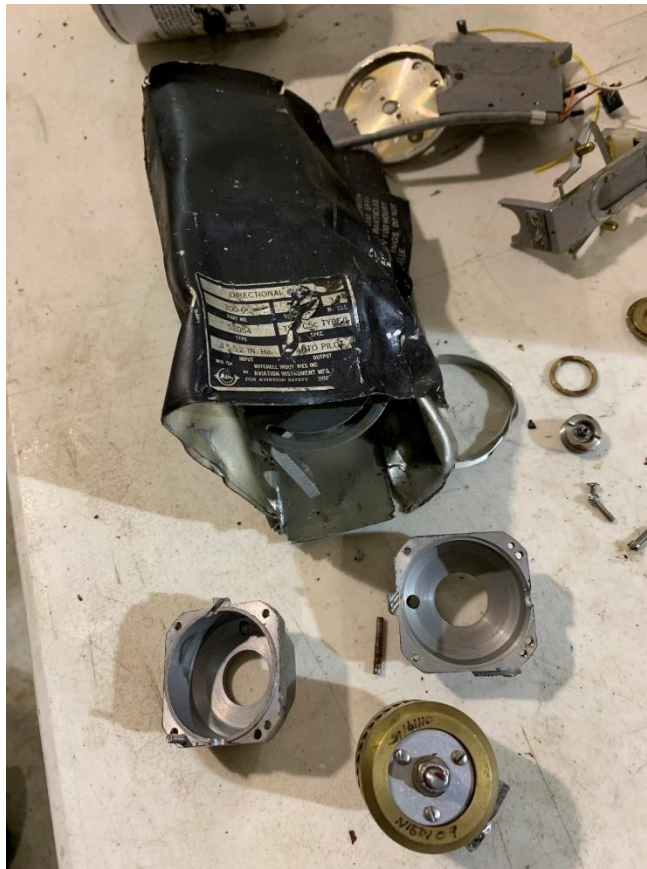
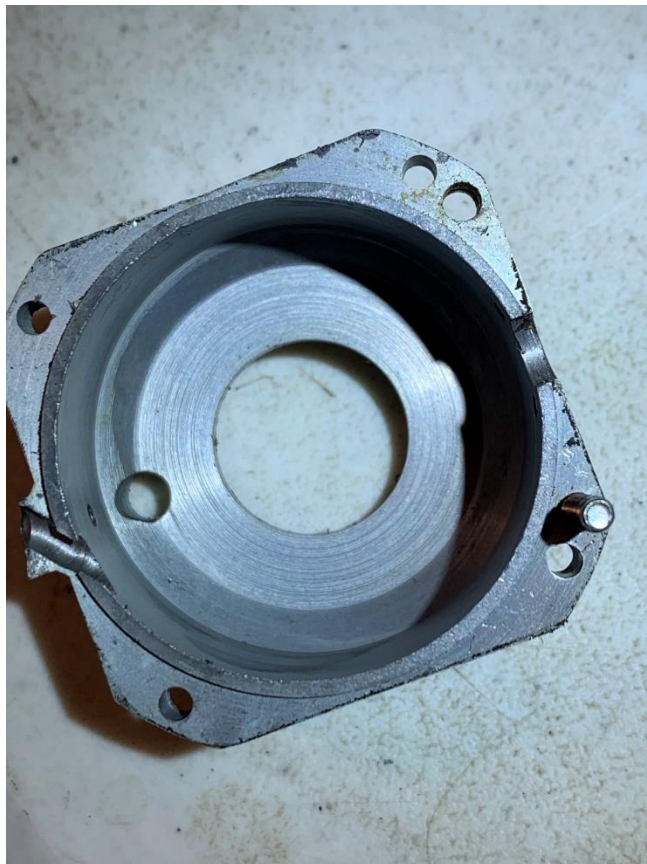
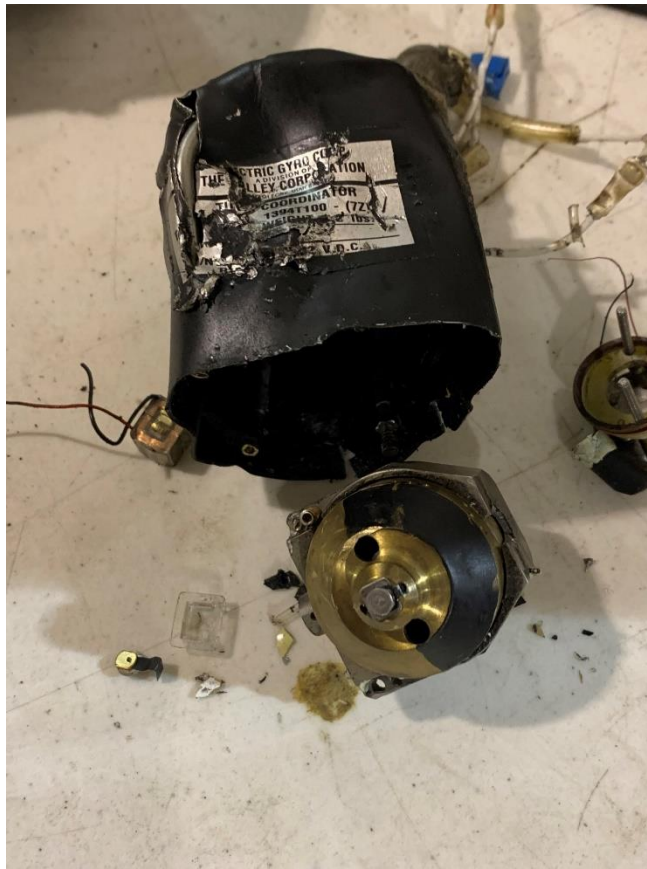
The airplane's attitude indicator, turn coordinator, and heading indicator were disassembled and their gyros and gyro cases examined. The two vacuum system driven gyros, the attitude indicator and heading indicator, gyro cases showed rotational scoring at the back and back case walls. The turn coordinator gyro was broken out and pinned inside its crushed case. When removed, it rotated. However, the gyro shaft was bent. The gyro showed no rotational scoring marks.

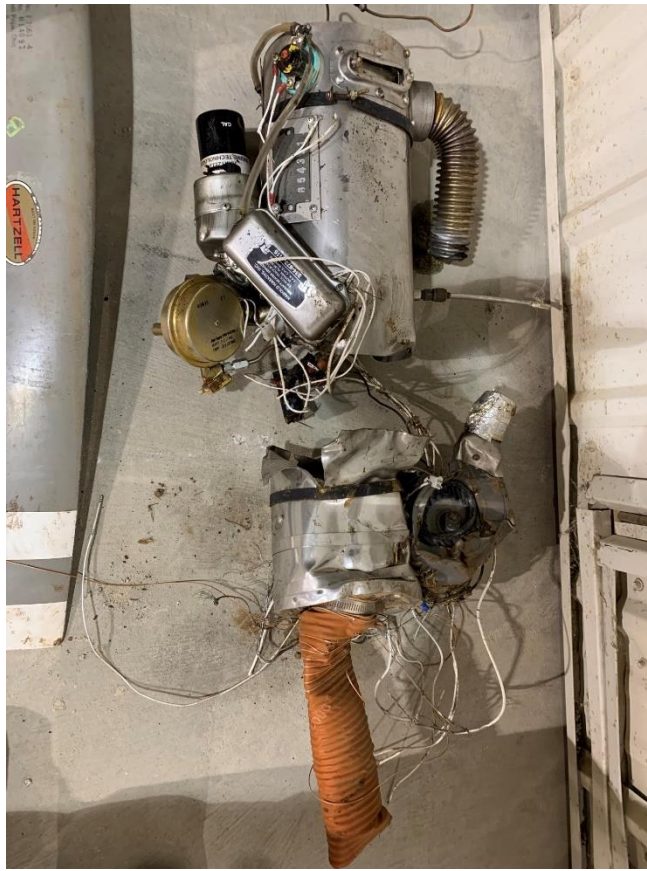
Figure 30. Airplane Heater

The airplane heater was laid out and examined. It consisted of two pieces that were recovered from the field adjacent to the main airplane wreckage at the accident site. The examination of the components showed no preaccident failures or malfunctions that would have precluded normal operation.
