# The National Transportation Safety Board

Office of Aviation Safety  
Central Region  
Memorandum for the Record  
Accident Site and Airframe  
Examination Findings  
CEN22FA151  
Rowlett, Texas  
March 25, 2021

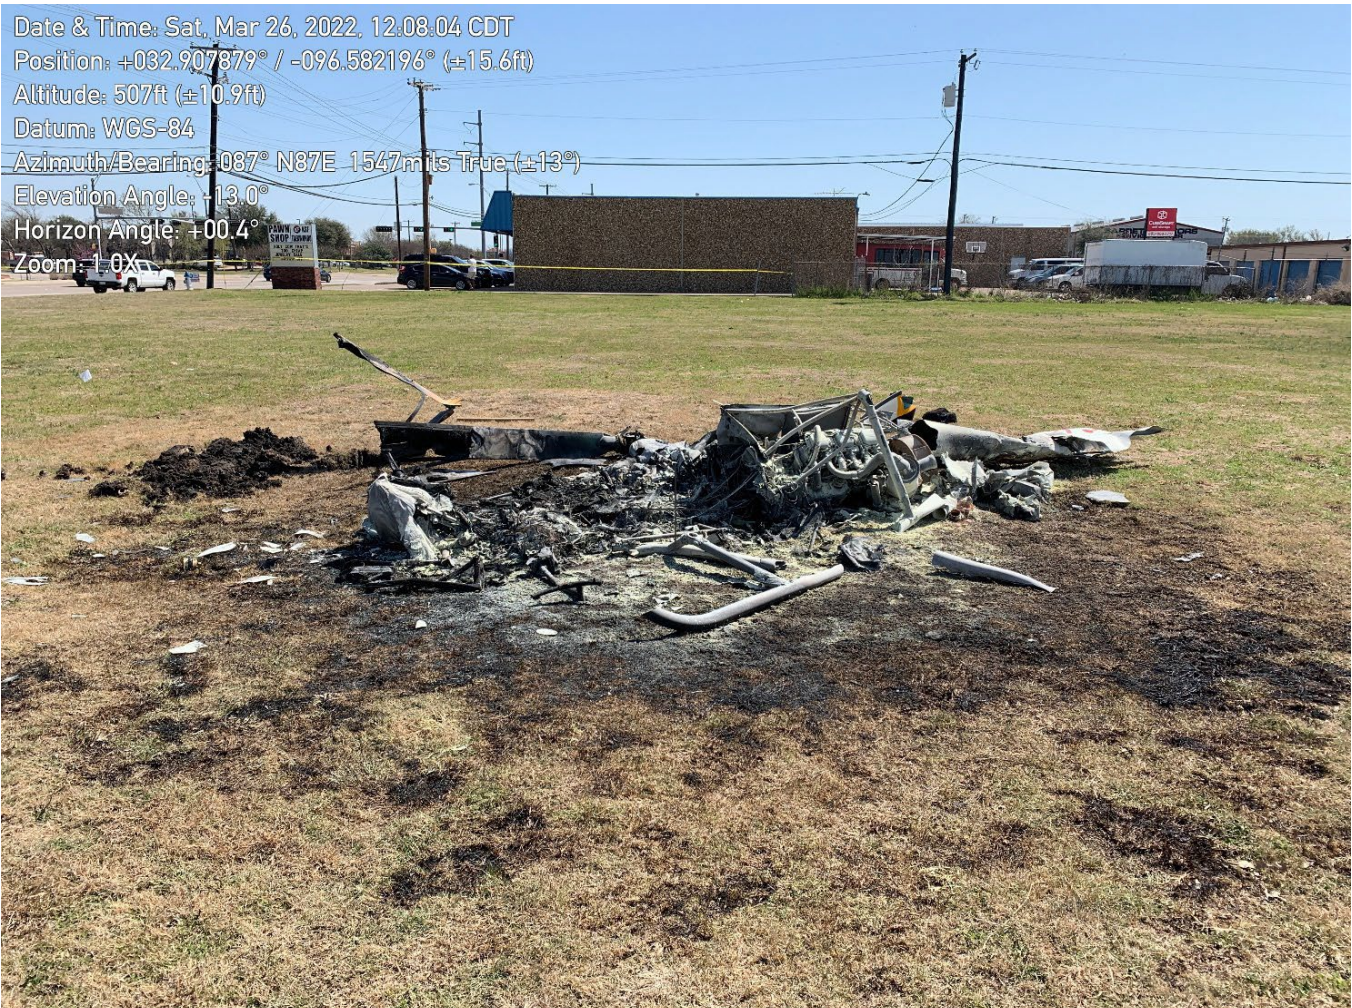
Date & Time: Sat, Mar 26, 2022, 12:08:04 CDT  
Position: +032.907879° / -096.582196° (±15.6ft)  
Altitude: 507ft (±10.9ft)  
Datum: WGS-84  
Azimuth/Bearing: 087° N87E 1547mils True (±13°)  
Elevation Angle: +13.0°  
Horizon Angle: +00.4°  
Zoom: 1.0X

The main section of the helicopter was found in a vacant lot in between a commercial strip mall and a municipal roadway. The main wreckage was mostly consumed by a post-impact fire. A 4-ft. section of the tail boom with the tail rotor assembly attached, impacted the top of a one-story commercial building about 300-feet from the main helicopter wreckage. Main rotor blade impact marks on the separated section of the tail boom were consistent with main rotor blade contact of the tail boom in flight. Although most of the helicopter was consumed by a post-impact fire, detailed examinations of the airframe, drive system, annunciator light panel, flight controls, main rotor, tail rotor, drive system, powerplant controls, and fuel system did not reveal any obvious pre-impact anomalies.

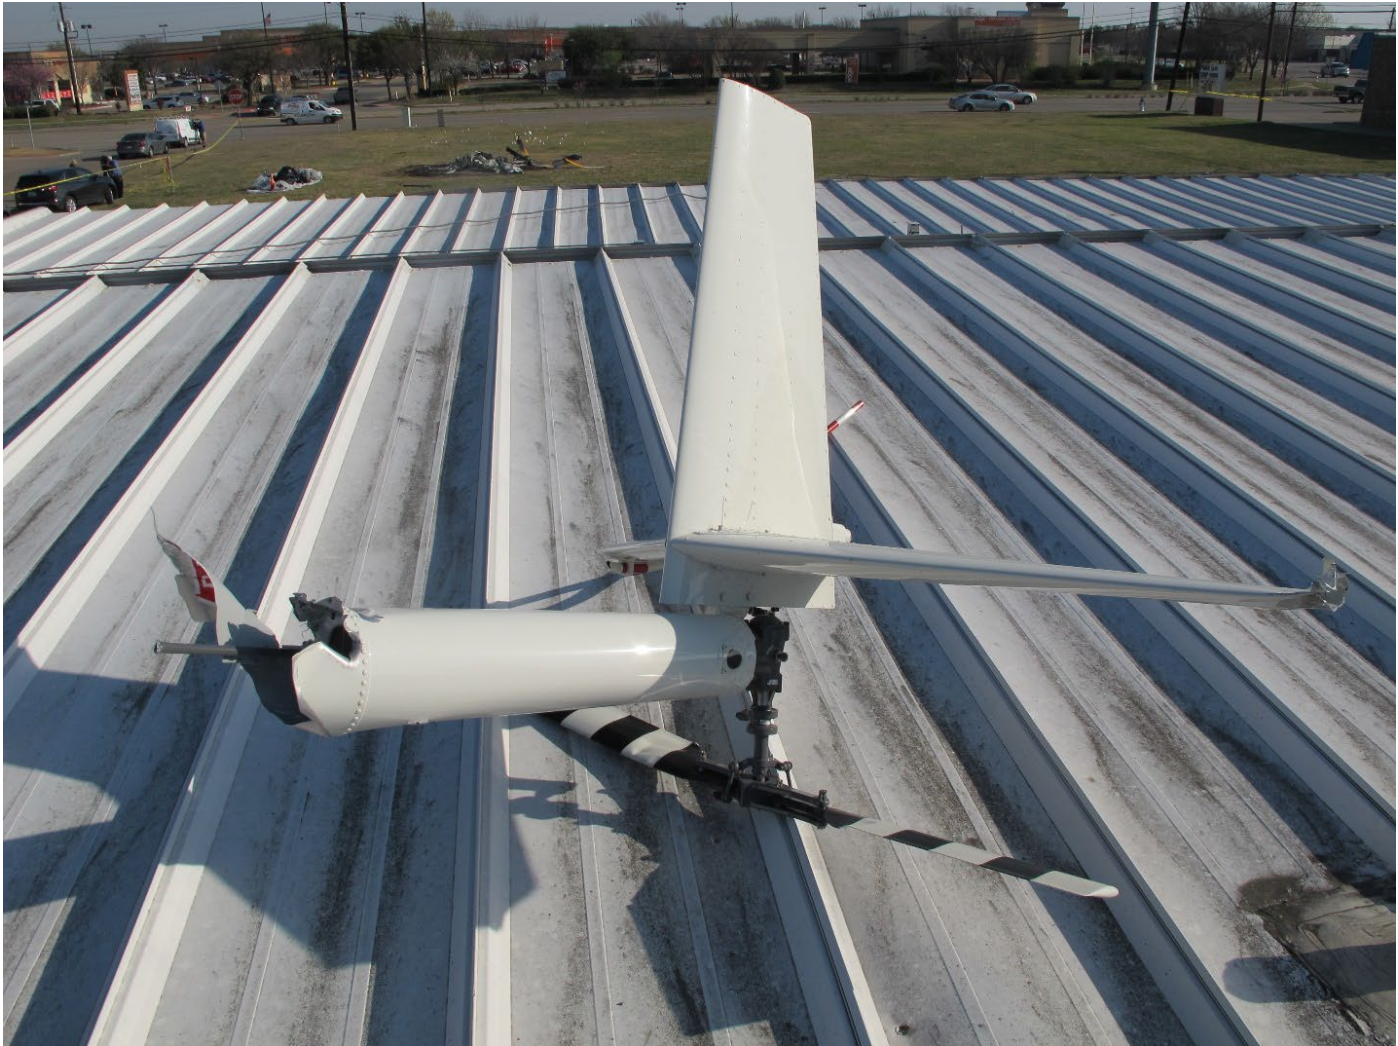
Portion of Tail Section with Tail rotor Assembly Still Attached. Main Wreckage in Background.

separated consistent with multiple main rotor blade strikes. Dents and paint transfer marks that matched the main rotor blade leading edges were present. The empennage sustained minimal impact damage. Damage to the top of the upper vertical stabilizer was consistent with contact with a main rotor blade (black paint transfers). Steel tube frames were bent and distorted along with significant thermal damage.
