# Aviation Investigation Final Report

| <b>Location:</b> | Rowlett, Texas | <b>Accident Number:</b> | CEN22FA151 |
| <b>Date &amp; Time:</b> | March 25, 2022, 11:27 Local | <b>Registration:</b> | N514CD |
| <b>Aircraft:</b> | ROBINSON HELICOPTER R44 | <b>Aircraft Damage:</b> | Destroyed |

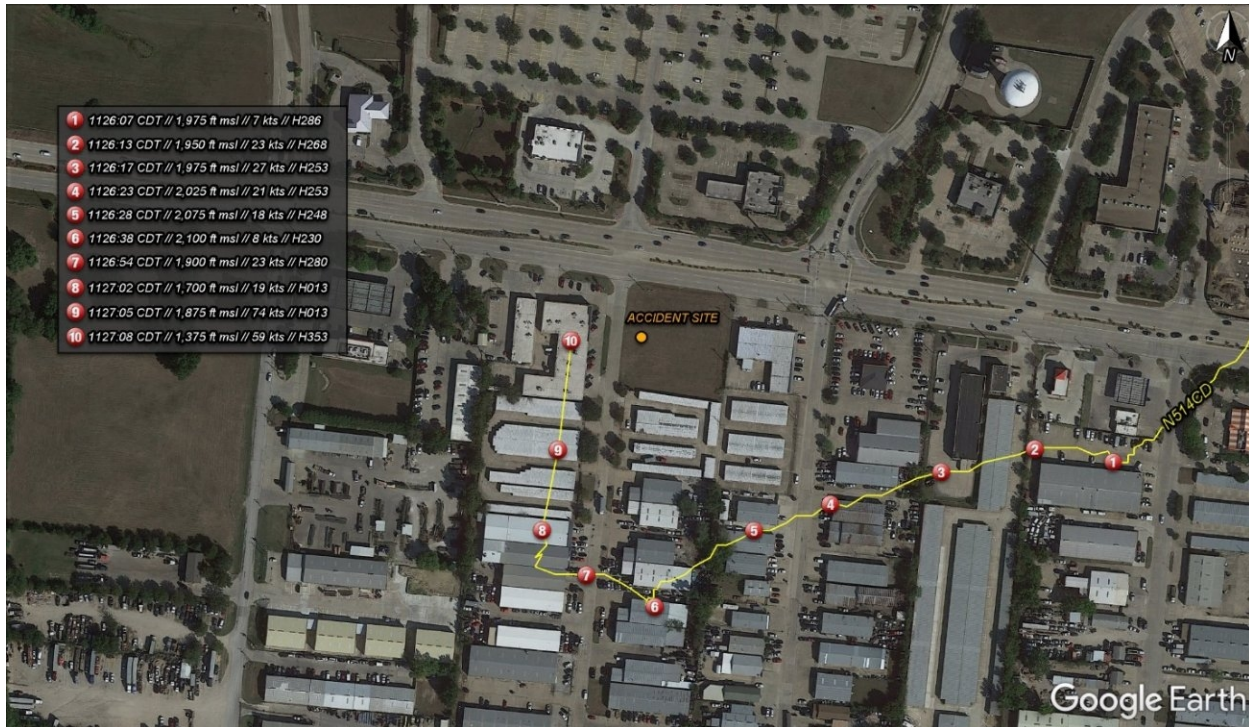
Figure 1. Final Minute of Flight Track from ADS-B Data

Video provided to the National Transportation Safety Board (NTSB) showed the helicopter and its separated tailboom and tail rotor section falling. The video did not show the actual in-flight separation of the tail section. About the last minute of the automatic dependent surveillance – broadcast (ADS-B) data for the flight showed that the helicopter was maneuvering at various slow airspeeds and altitudes. At 1126:07, the helicopter was about 1,975 ft mean sea level (msl) and flying at 7 knots ground speed. (See figure 1.)
