**NATIONAL TRANSPORTATION SAFETY BOARD  
Office of Aviation Safety  
Washington, DC 20594**

**SUMMARY OF AIRCRAFT EXAMINATION**

**CEN22FA168**

Aircraft: Cessna TU206F (S/N TU20603437) N858JA

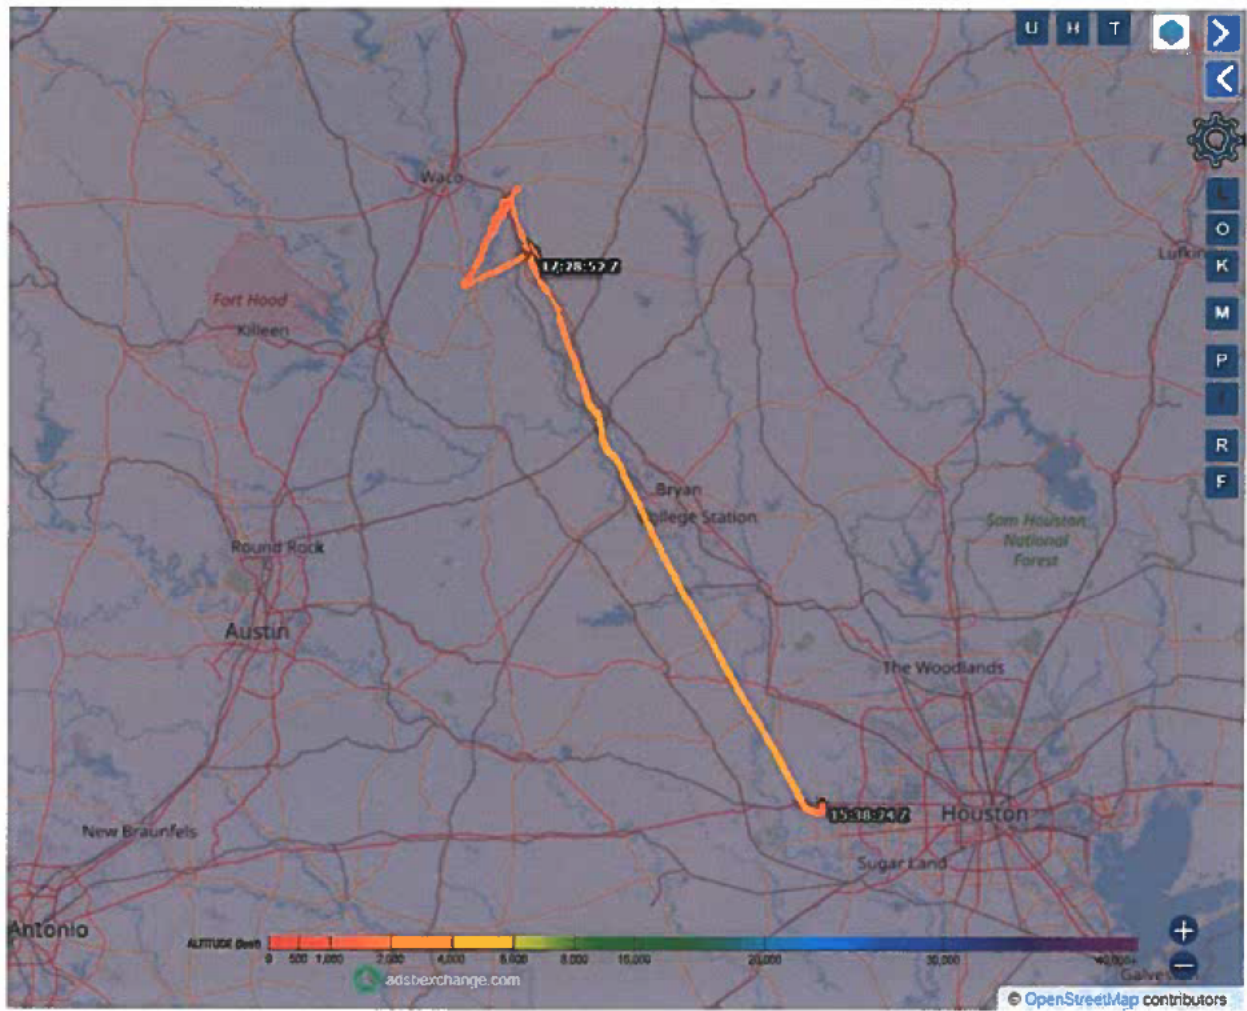
Figure 1. ADS-B Flight Track.

The airplane departed the Houston Executive Airport (TME), Houston, Texas, on a pipeline inspection flight with a destination of Waco, Texas. Preliminary radar and Automatic Dependent Surveillance-Broadcast (ADS-B) data indicated the airplane first appeared at 1038 near TME. The airplane tracked north northeast toward Waco, Texas, and climbed to 4,000 ft msl. About an hour and a half into the flight, the airplane turned southwest and began a series of maneuvering turns over the area where the pipeline was located. The airplane continued to maneuver southwest and worked its way to a location 20 miles south of Waco. It then turned to the east toward the Marlin Airport (T15), Marlin, Texas. The pilot contacted Waco Approach Control and informed them that he was landing at T15.

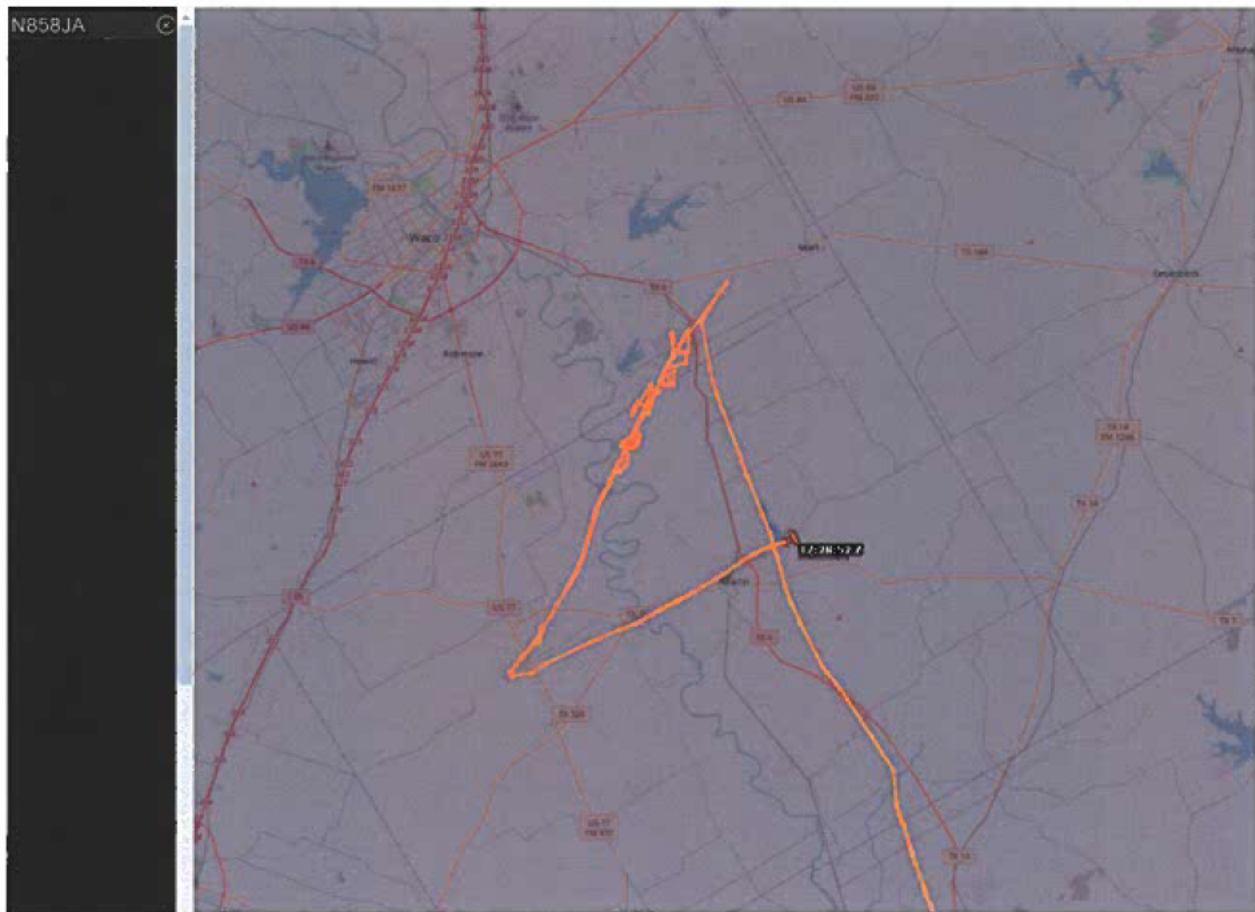
Figure 2. Enlarged ADS-B Image depicting the end of the End of the Flight Track.

The airplane overflew the airport and entered a left downwind traffic pattern for runway 17. The airplane continued to a left base leg and then final. An Armory security camera located on the airport recorded the airplane on final approach. The airplane touched down just past the approach end of the runway and bounced back into the air. It touched down a second time in the grass just right of the runway, struck a runway light, veered back on the runway, crossed the runway, and departed the left side of the runway. The airplane then disappeared behind a building. Mode C position reporting data showed three more airplane positions in close proximity just east of the airport. All track data was lost at 1231. The airplane was about 1,800 ft. southeast of the approach end of runway 17 at T15 when track data was lost.
