# National Transportation Safety Board

CEN22FA208

## **AIRPLANE PERFORMANCE STUDY**

Location: Broomfield, Colorado  
Date: May 22, 2022  
Time: 1149 MDT  
1749 GMT  
Airplane: Piper PA-32-260 Cherokee Six, N85CT

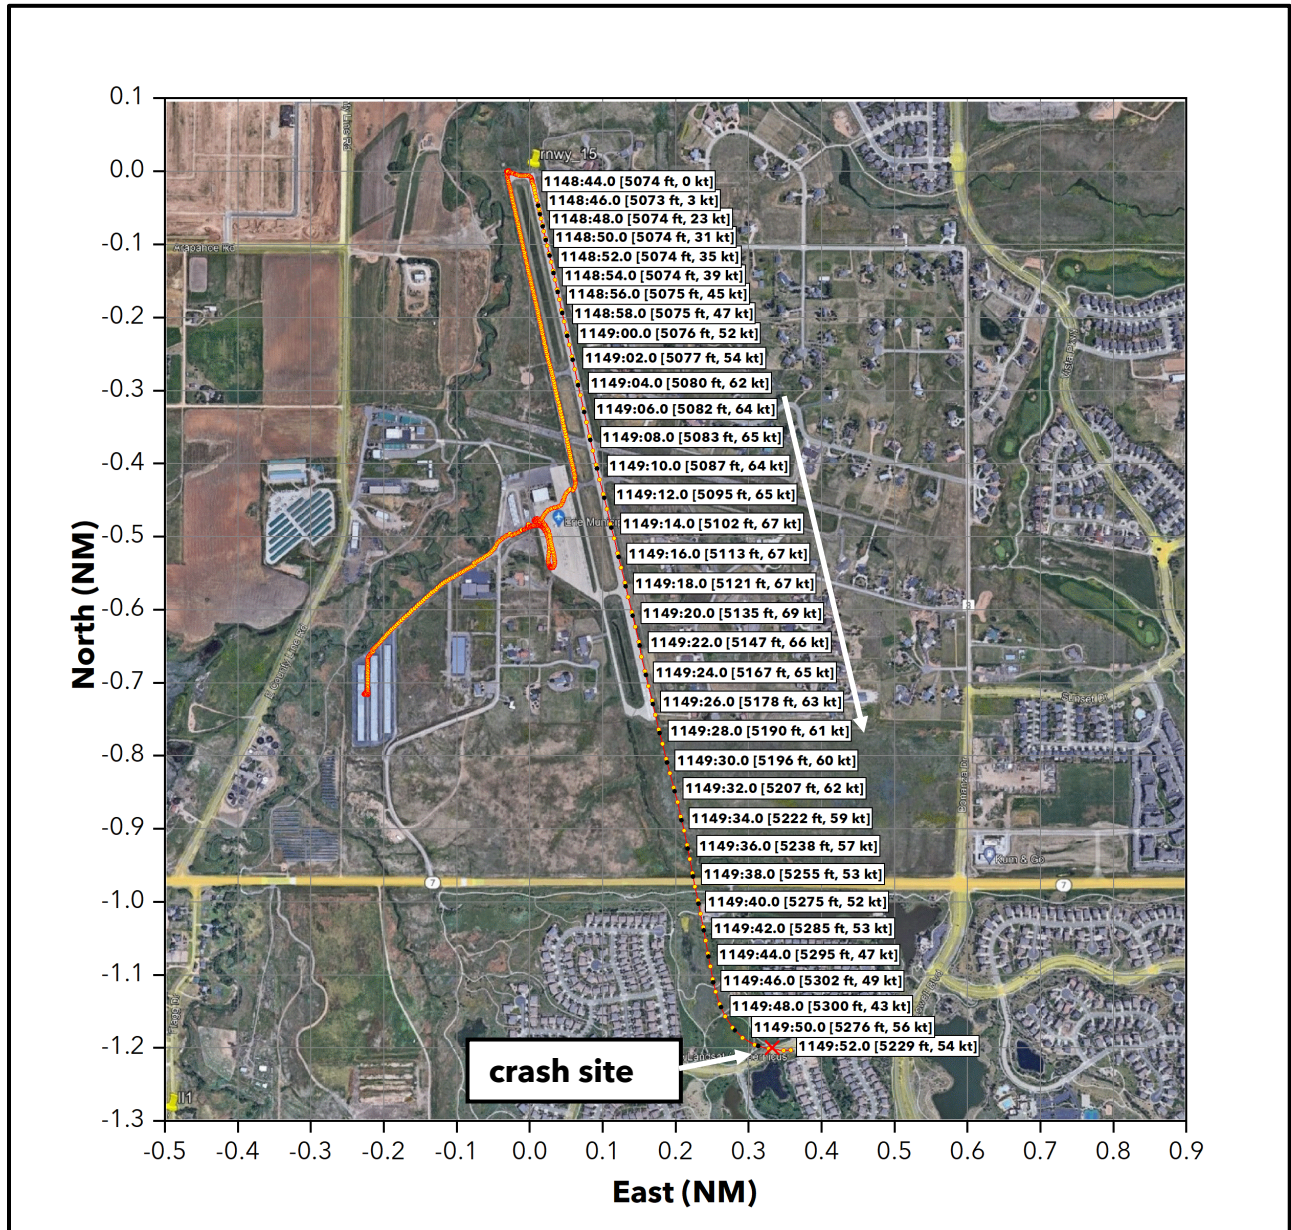
According to the Preliminary report for this accident, the airplane departed Erie Municipal Airport (EIK) on Runway 16. About 3,000 ft from the departure end of the runway, the airplane made a left turn, descended, and impacted terrain. See Figures 1 and 2.

**Figure 1: Overview of Accident Take-off from Erie Municipal Airport Runway 16 with Recorded Altitude and Indicated Airspeed**

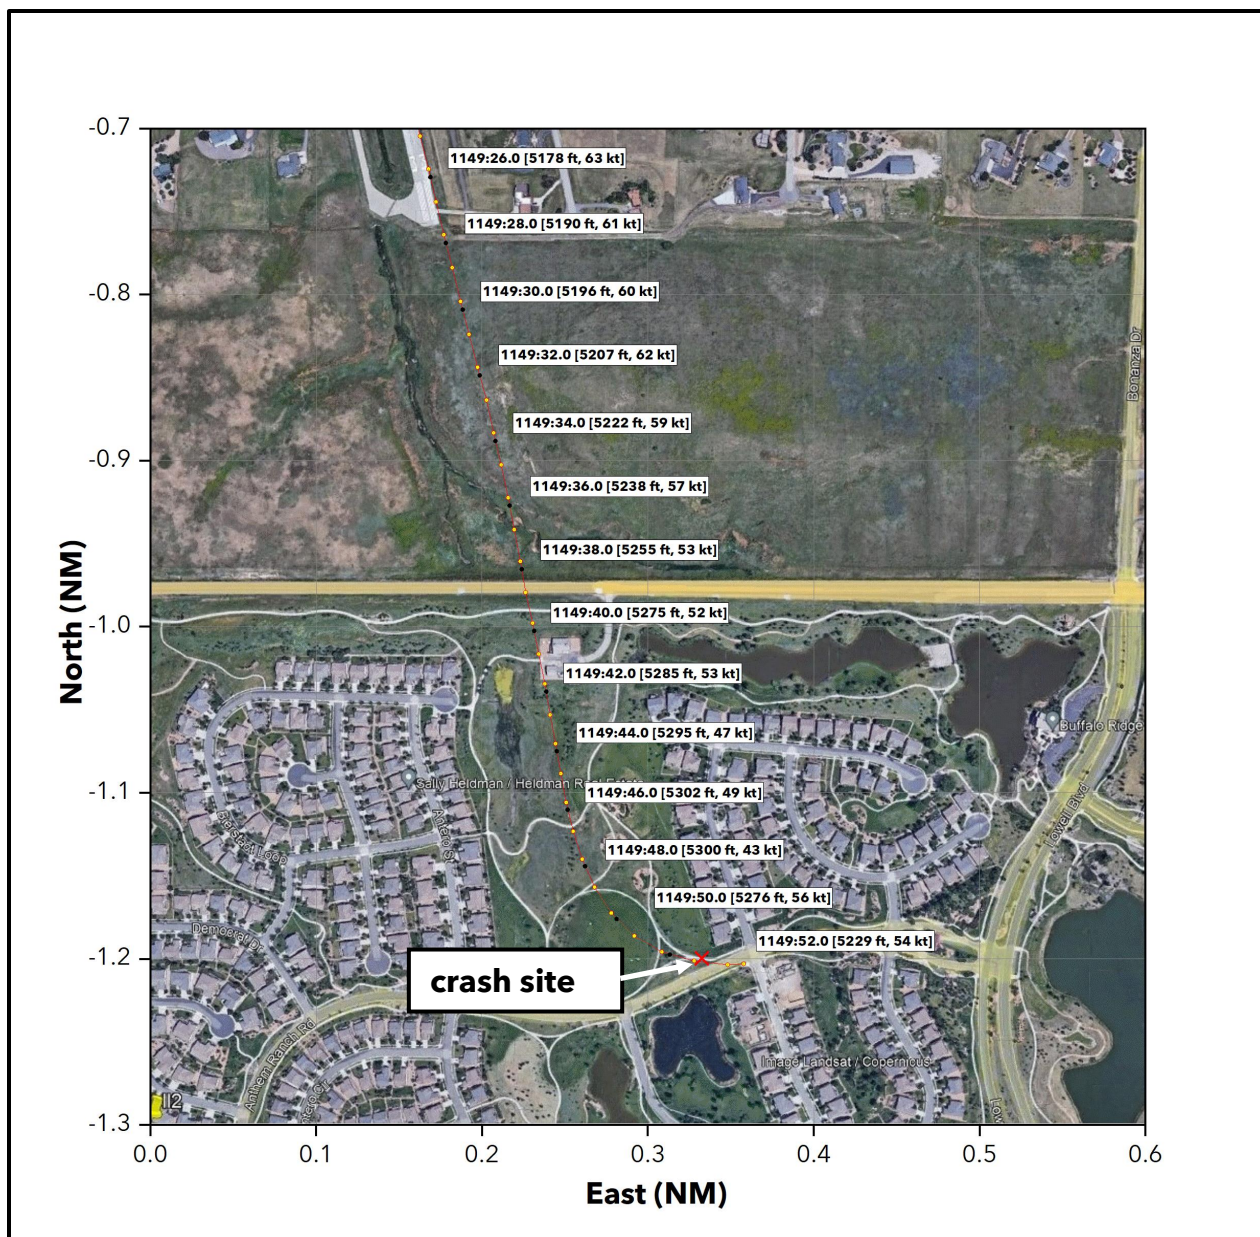
The airplane impacted a grassy area of a residential community. About 35 ft beyond the initial impact, six propeller strike marks spaced about 1 ft apart were located on a paved road. The airplane bounced and subsequently impacted a large tree about 100 ft from the propeller strike marks, which resulted in the engine/cockpit area separating from the remainder of the fuselage.

**Figure 2: Overview of Accident Site with Recorded Altitude and Indicated Airspeed**

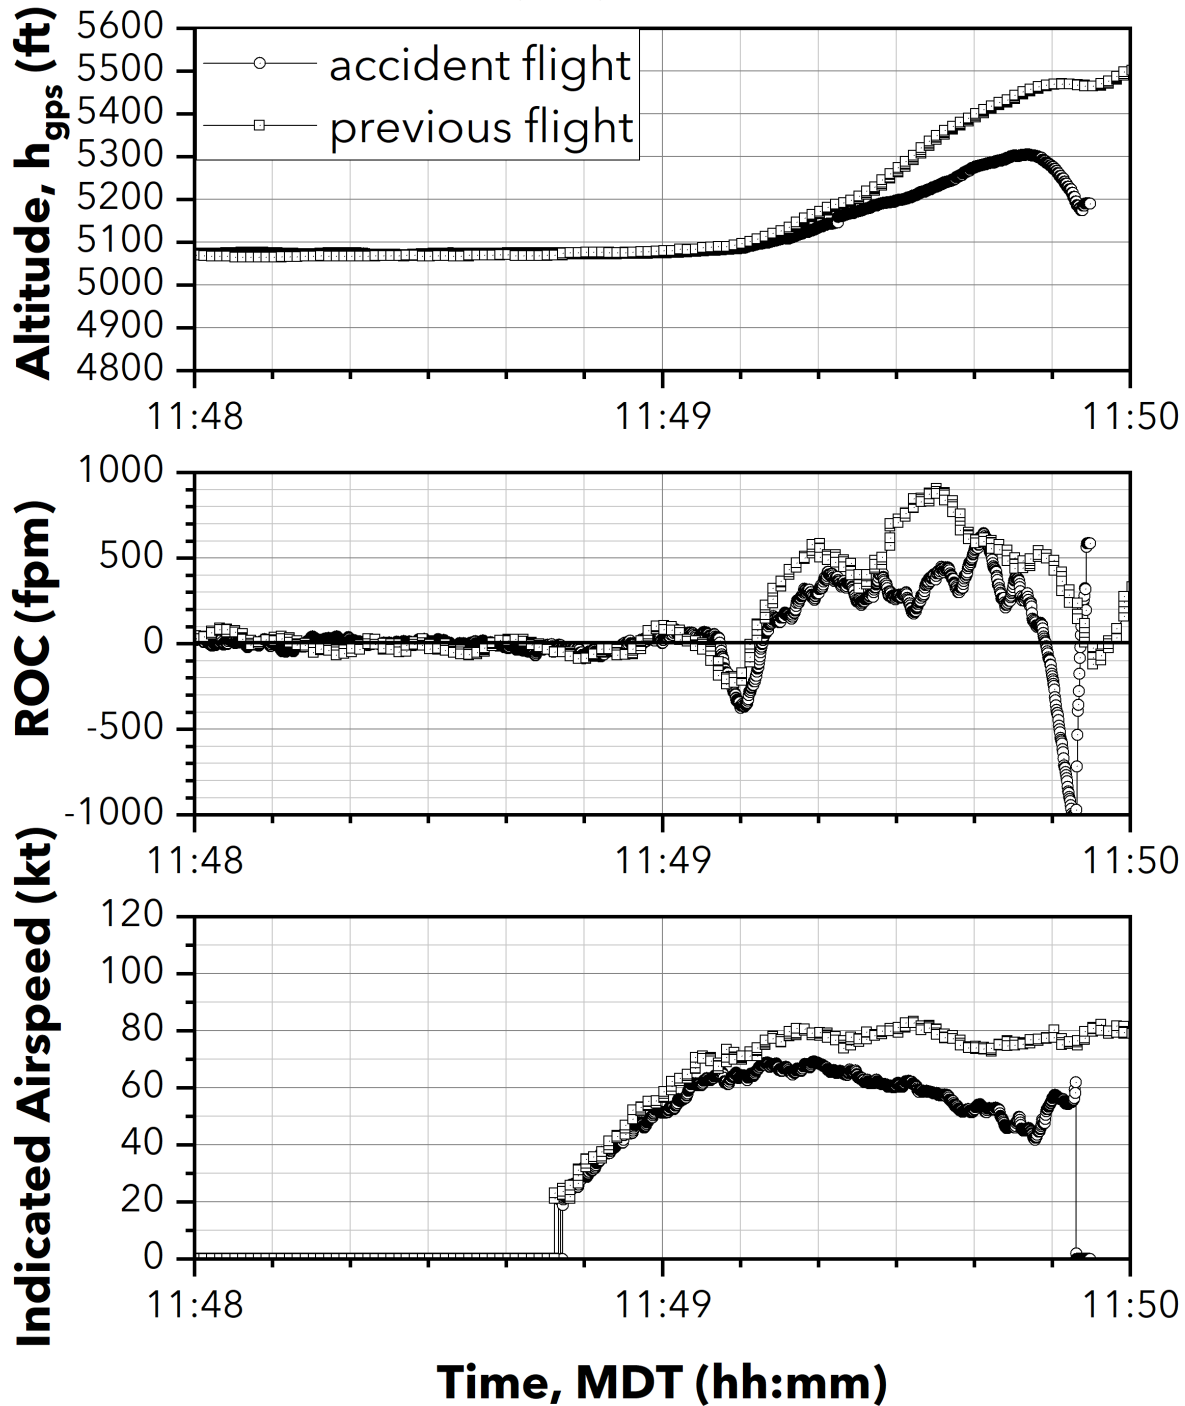
Altitude and airspeed data recorded on the Dynon HDX1100 during take-off are shown in Figure 4 for the accident flight as well as for a take-off on the same runway three weeks earlier<sup>1</sup>. Rotation on both flights was at about 60 kt. However, on the accident flight, the airplane did not accelerate much beyond the rotation speed, and the rate of climb (ROC) was 200-300 feet per minute (fpm) less than the previous take-off. The airplane was airborne less than a minute and reached a maximum altitude of 5,300 ft above mean sea level (msl) or about 230 ft agl before abruptly pitching down, descending, and impacting the ground.

**Figure 4: Altitude, ROC, and Airspeed for Accident and Previous Flight**

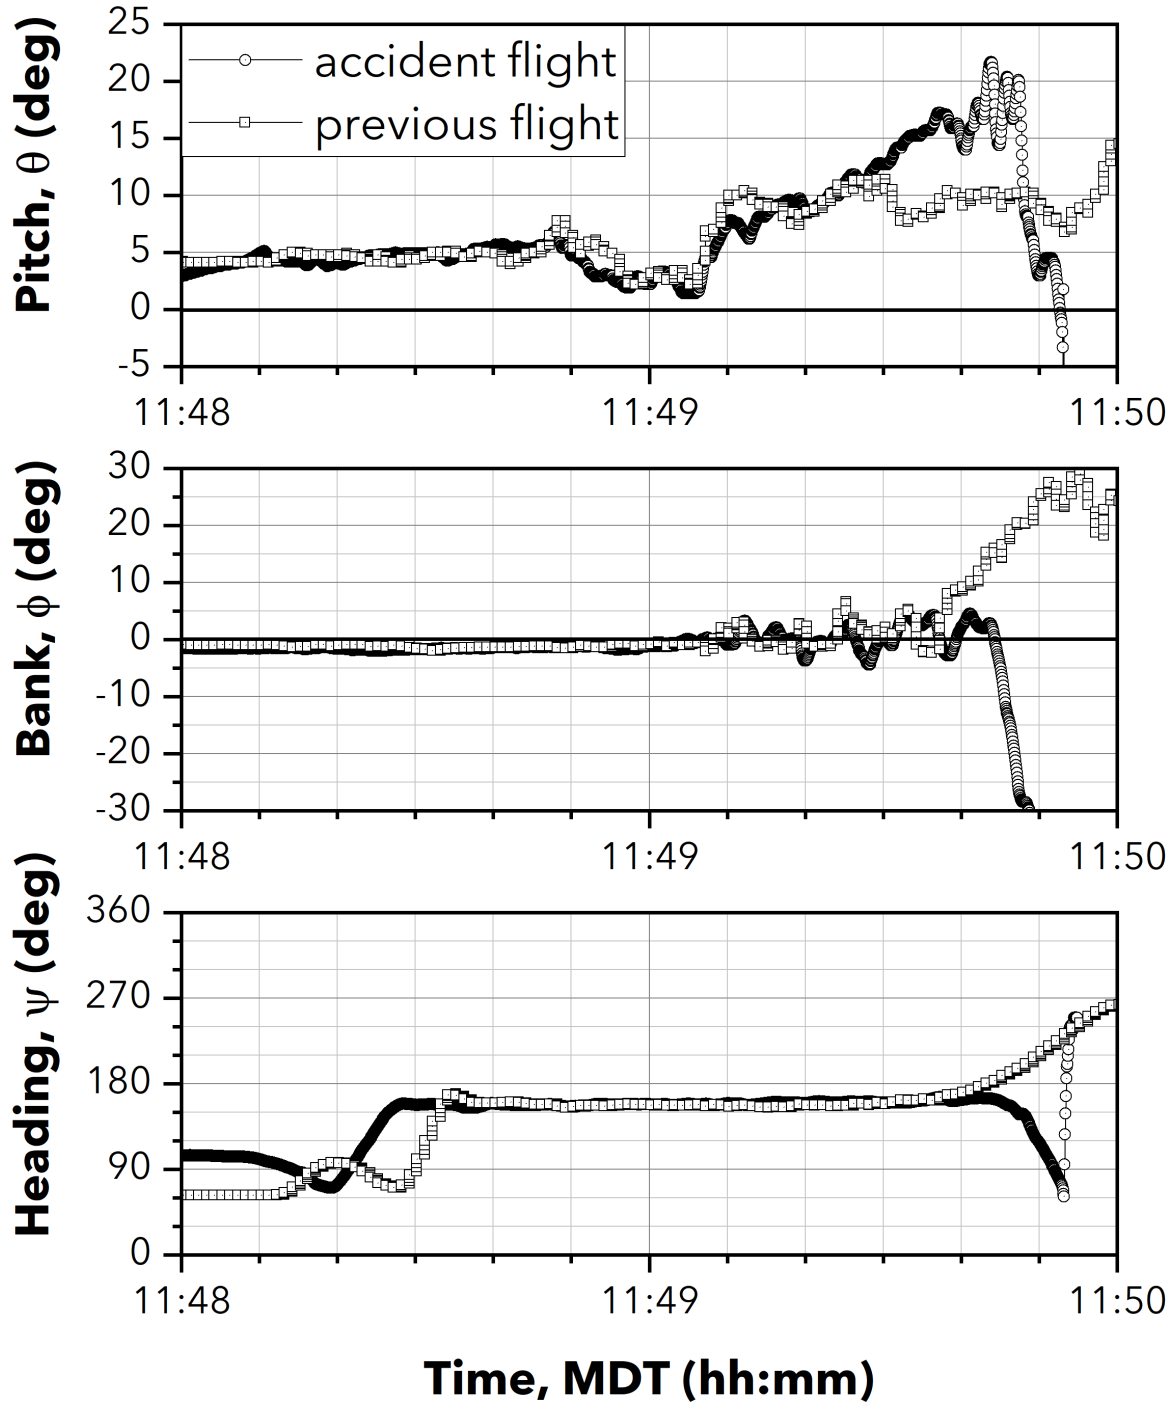
Figure 5 indicates that the airplane pitched up to over 20° during the accident take-off attempt, approximately twice the pitch attitude obtained during the previous take-off. The airplane banked left to about 30° during the accident flight and 30° to the right during the earlier take-off: runway 16 at EIK has a right traffic pattern.

**Figure 5: Pitch, Bank, and Heading Angles for Accident and Previous Flight**

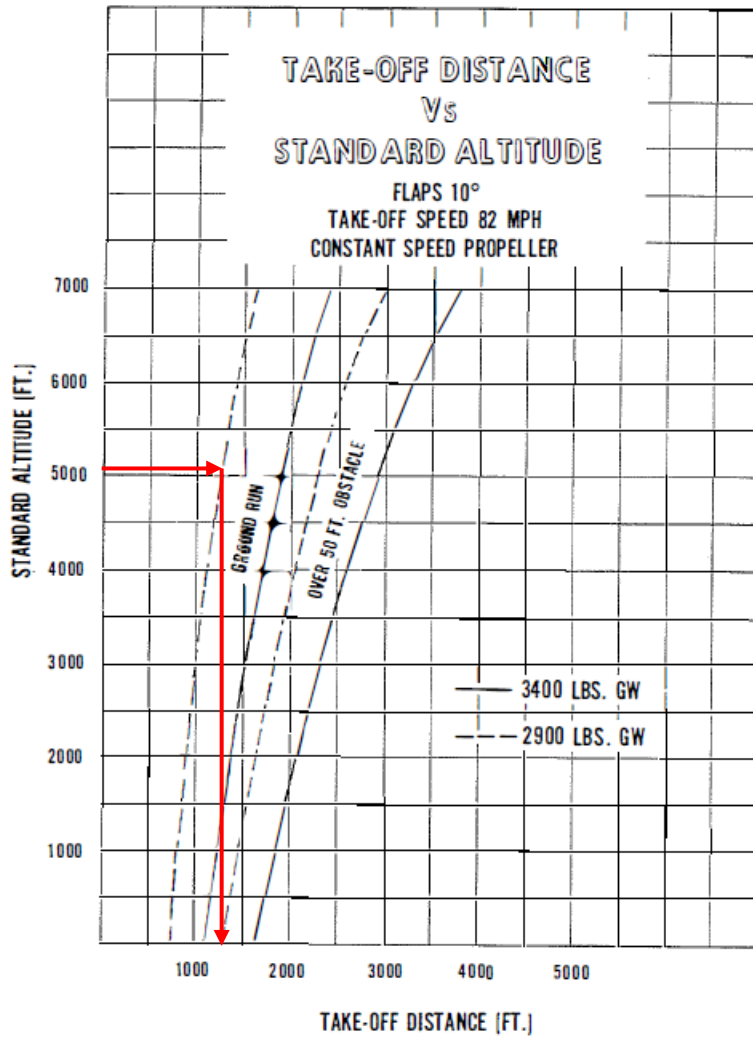
The Piper Cherokee Six Owner's Handbook indicates a take-off distance of approximately 1,300 ft is required at a "standard altitude" or density altitude<sup>2</sup> of about 5,100 ft and a take-off weight of 2,900 lb<sup>3</sup>. See Figure 6. The manufacturer's performance data along with the 4,700 ft of runway available on EIK runway 16 indicate that N85CT should have had sufficient runway to successfully take-off.

Figure 6: Take-off Distance from Piper Cherokee Six Owner's Handbook

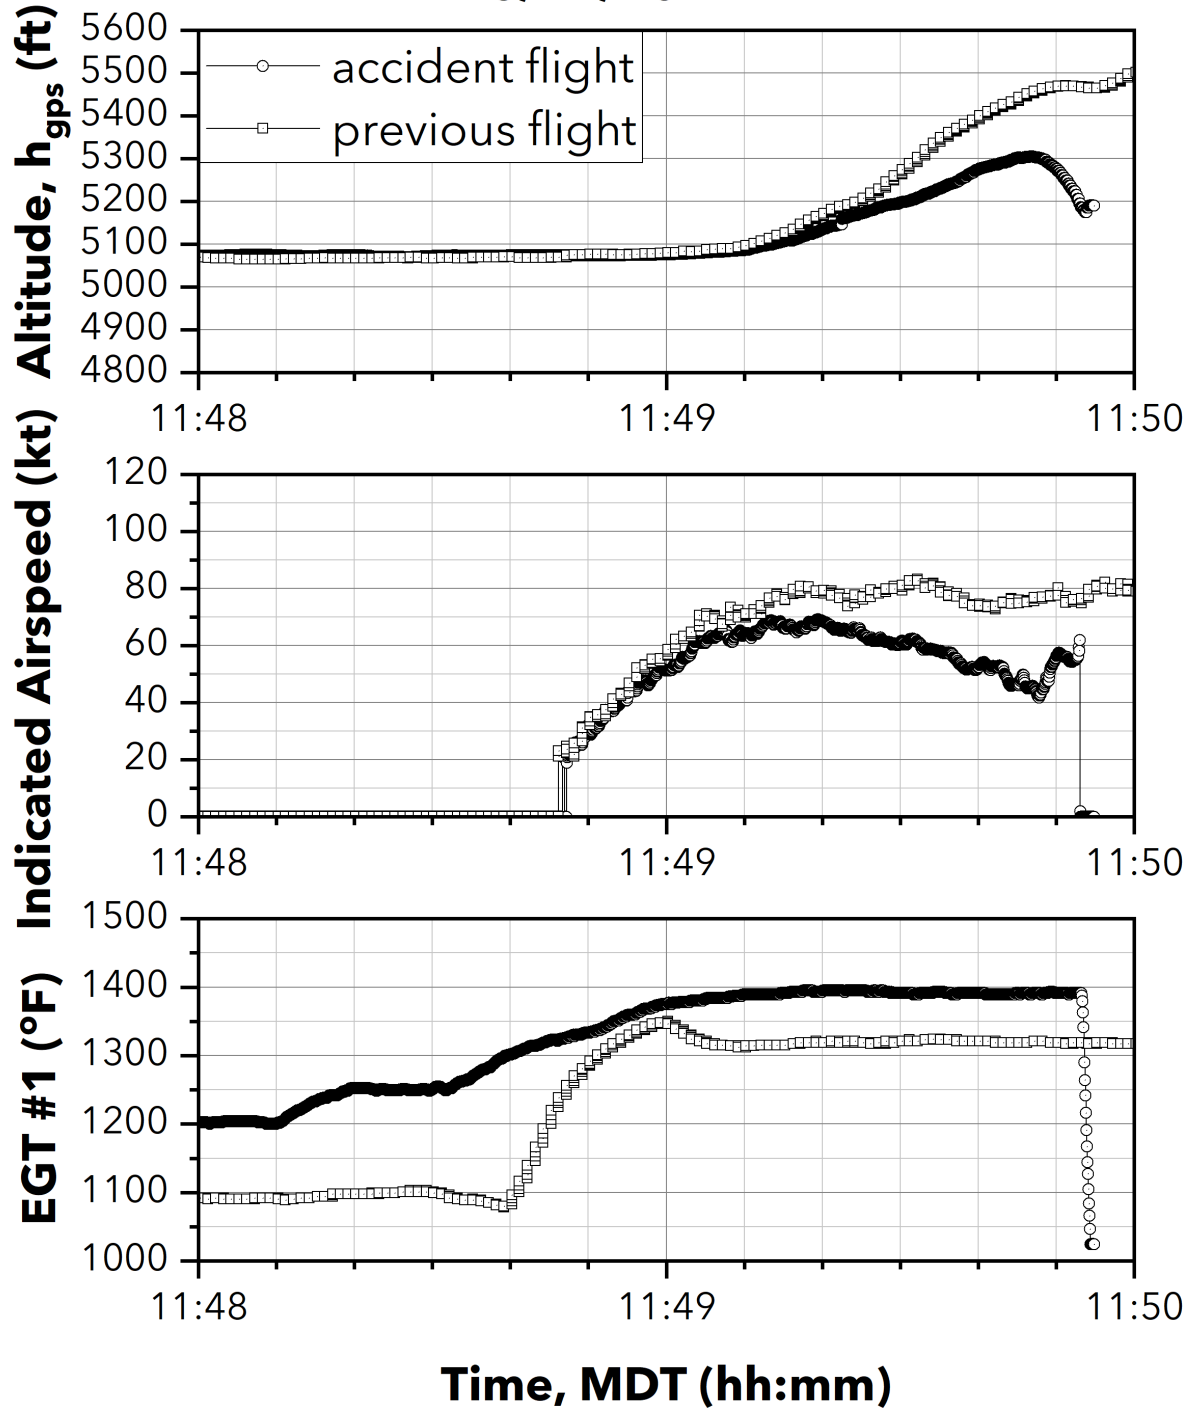
The EGT's on cylinders #1, #5, and #6 were 70°F, 65°F, and 130°F hotter for the accident take-off compared to the previous take-off, respectively, while cylinders #2, #3, and #4 had similar EGT's. In addition, the fuel flow was 5 gph less (16 gph vs. 11 gph) on the accident take-off (or about 45%) while the engine RPM and manifold pressure during the two take-offs were similar.

**Figure 7: EGT for Cylinder #1 for Accident and Previous Flight**

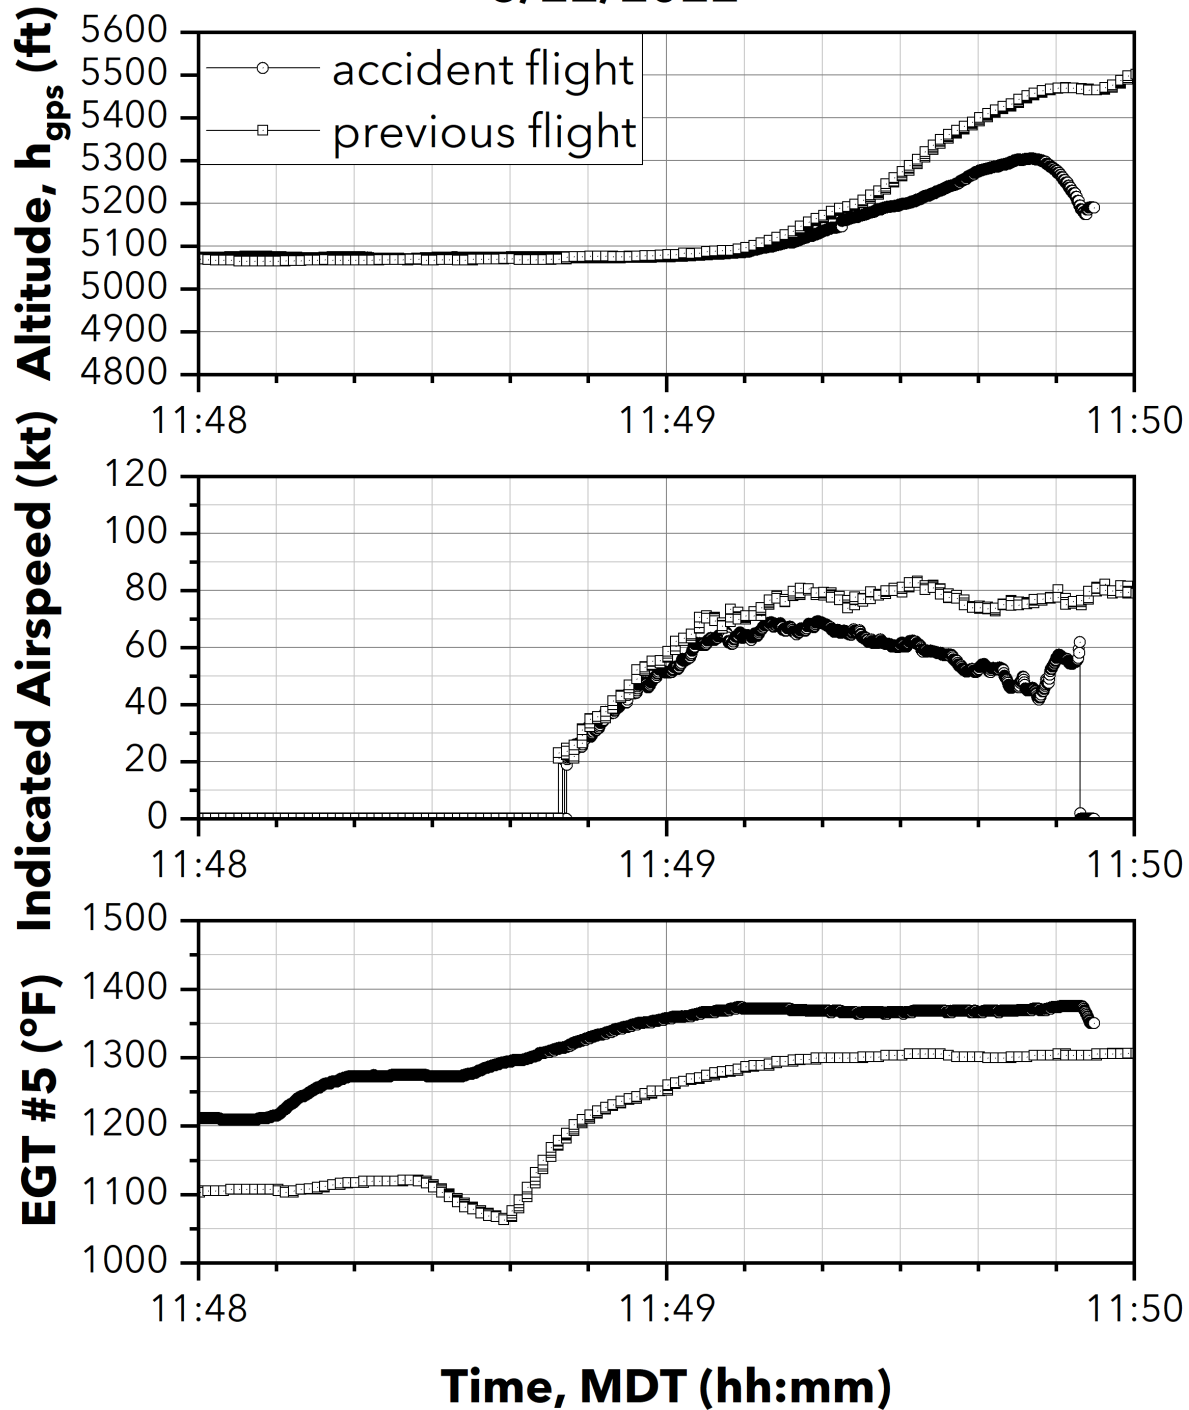
**Figure 11: EGT for Cylinder #5 for Accident and Previous Flight**

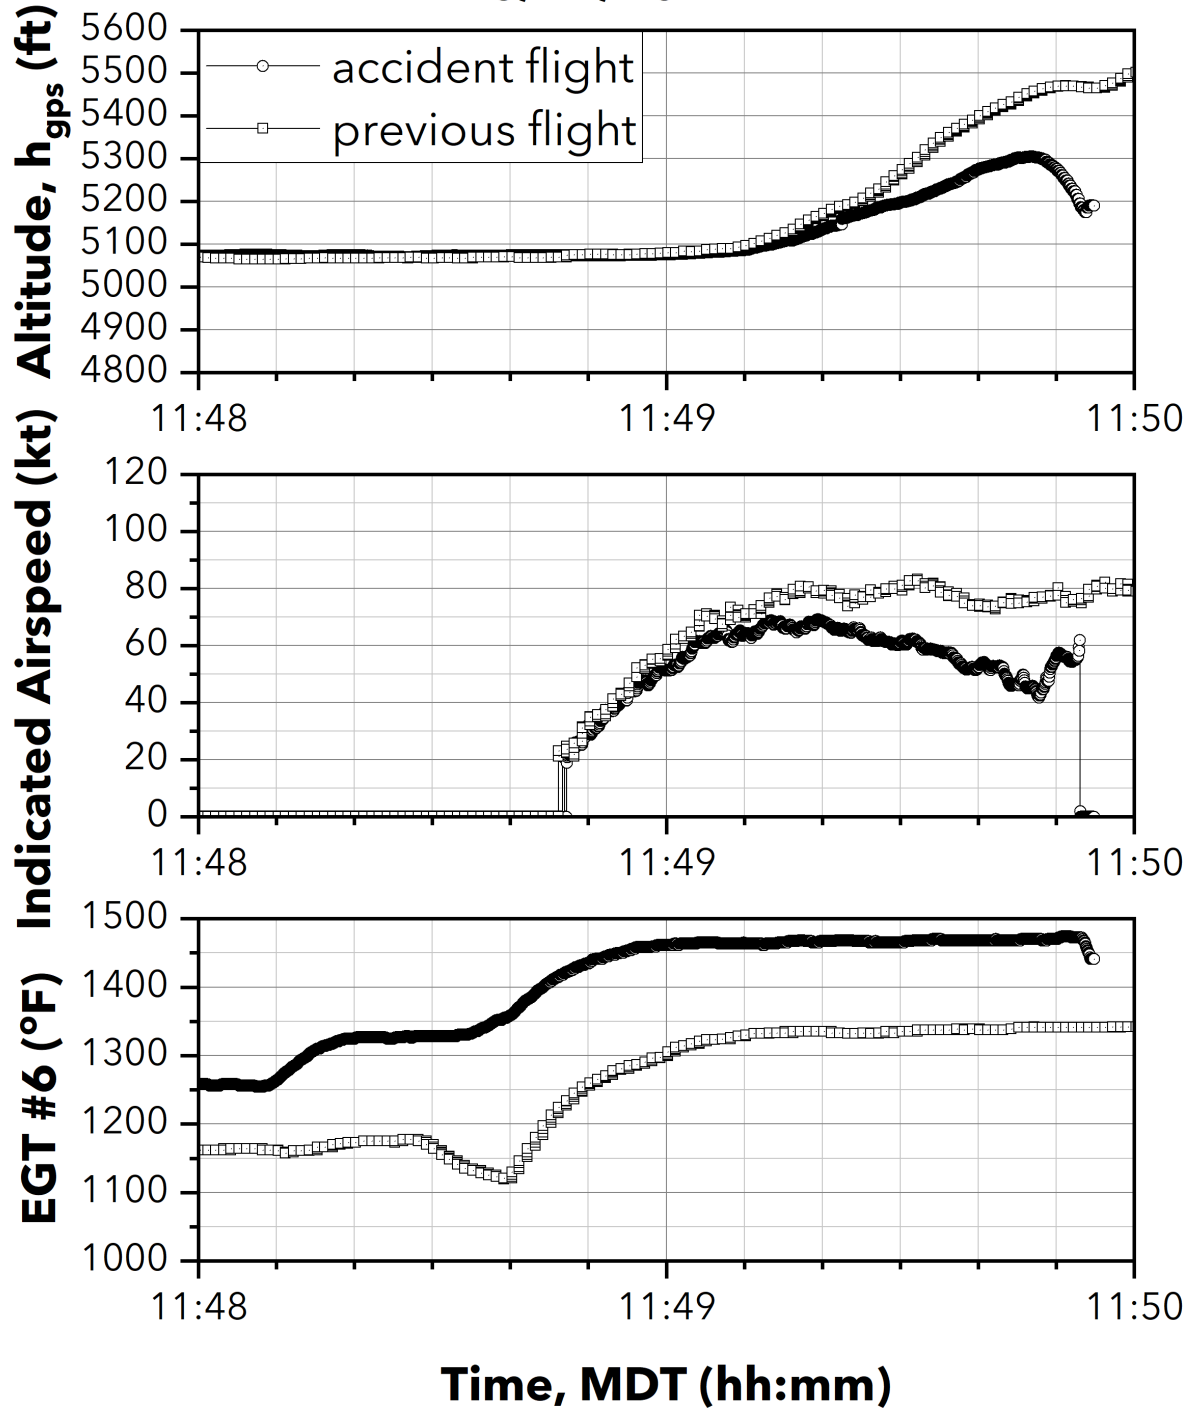
**Figure 12: EGT for Cylinder #6 for Accident and Previous Flight**

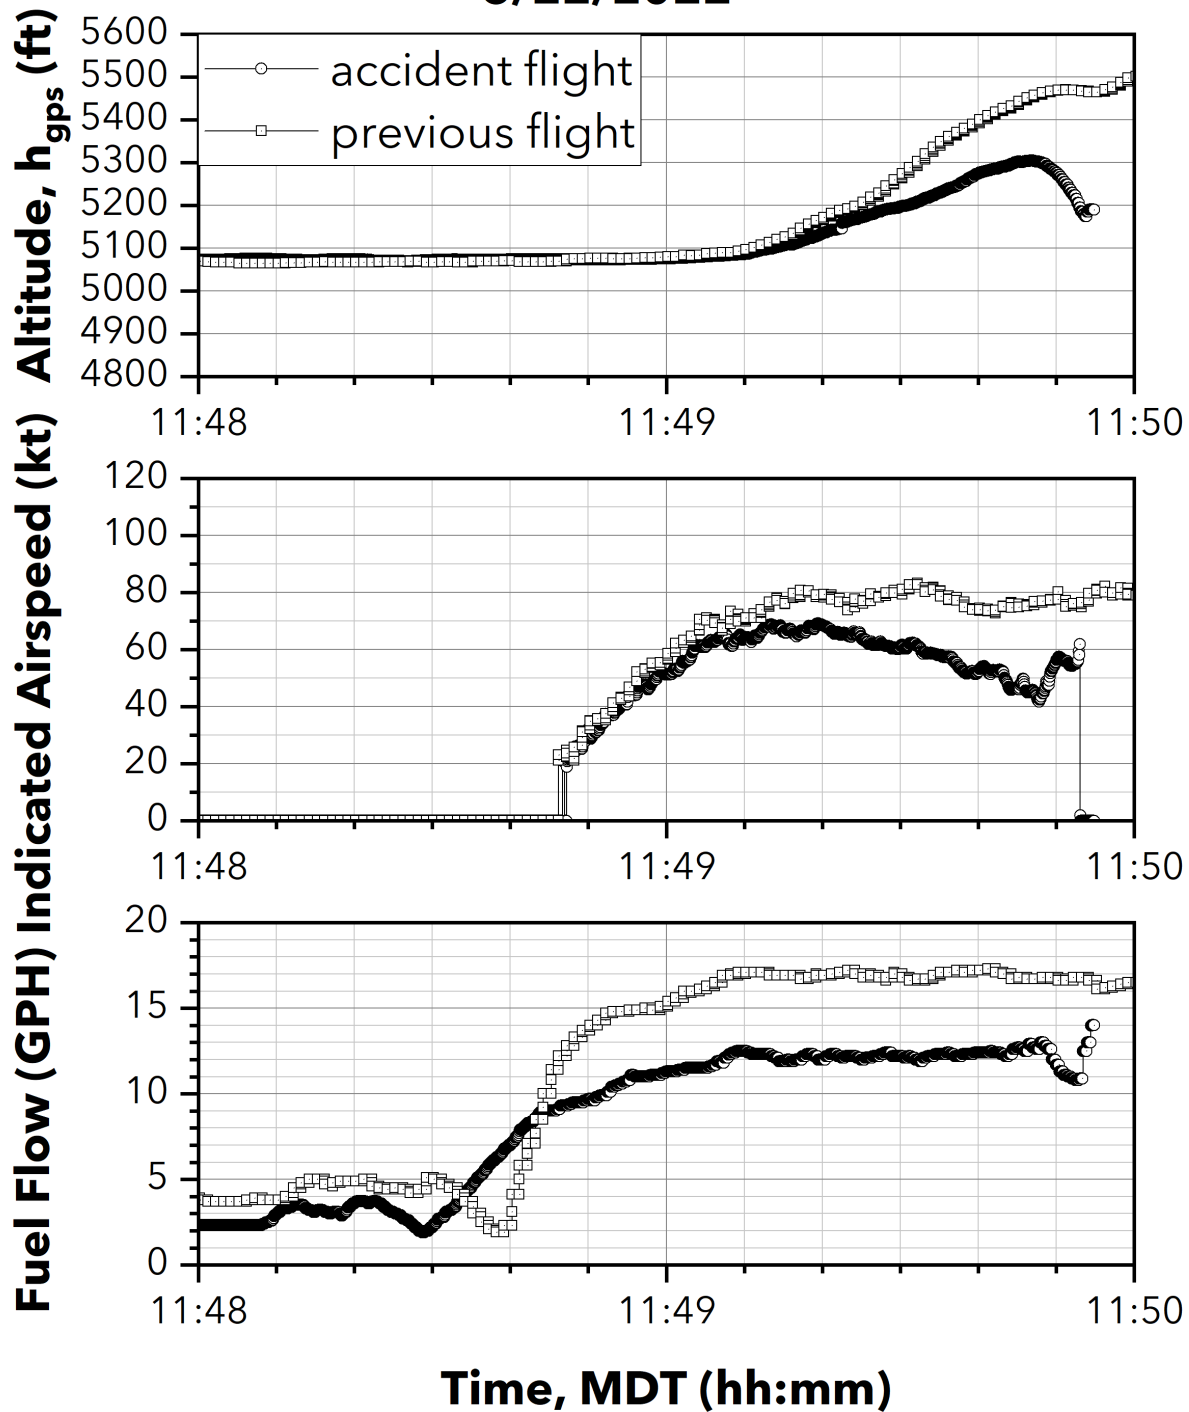
The recorded fuel flows shown in Figure 13 average about 11 gph during the accident take-off in the final five seconds and equivalently 16 gph during the previous take-off. The resulting horsepower estimates are:

- $14.72 \text{ BHP/gph} \times 11 \text{ gph} = 162 \text{ BHP}$  in final five seconds of the accident flight
- $14.72 \text{ BHP/gph} \times 16 \text{ gph} = 235 \text{ BHP}$  for previous take-off (or about 45% more)

**Figure 13: Fuel Flow for Accident and Previous Flight**

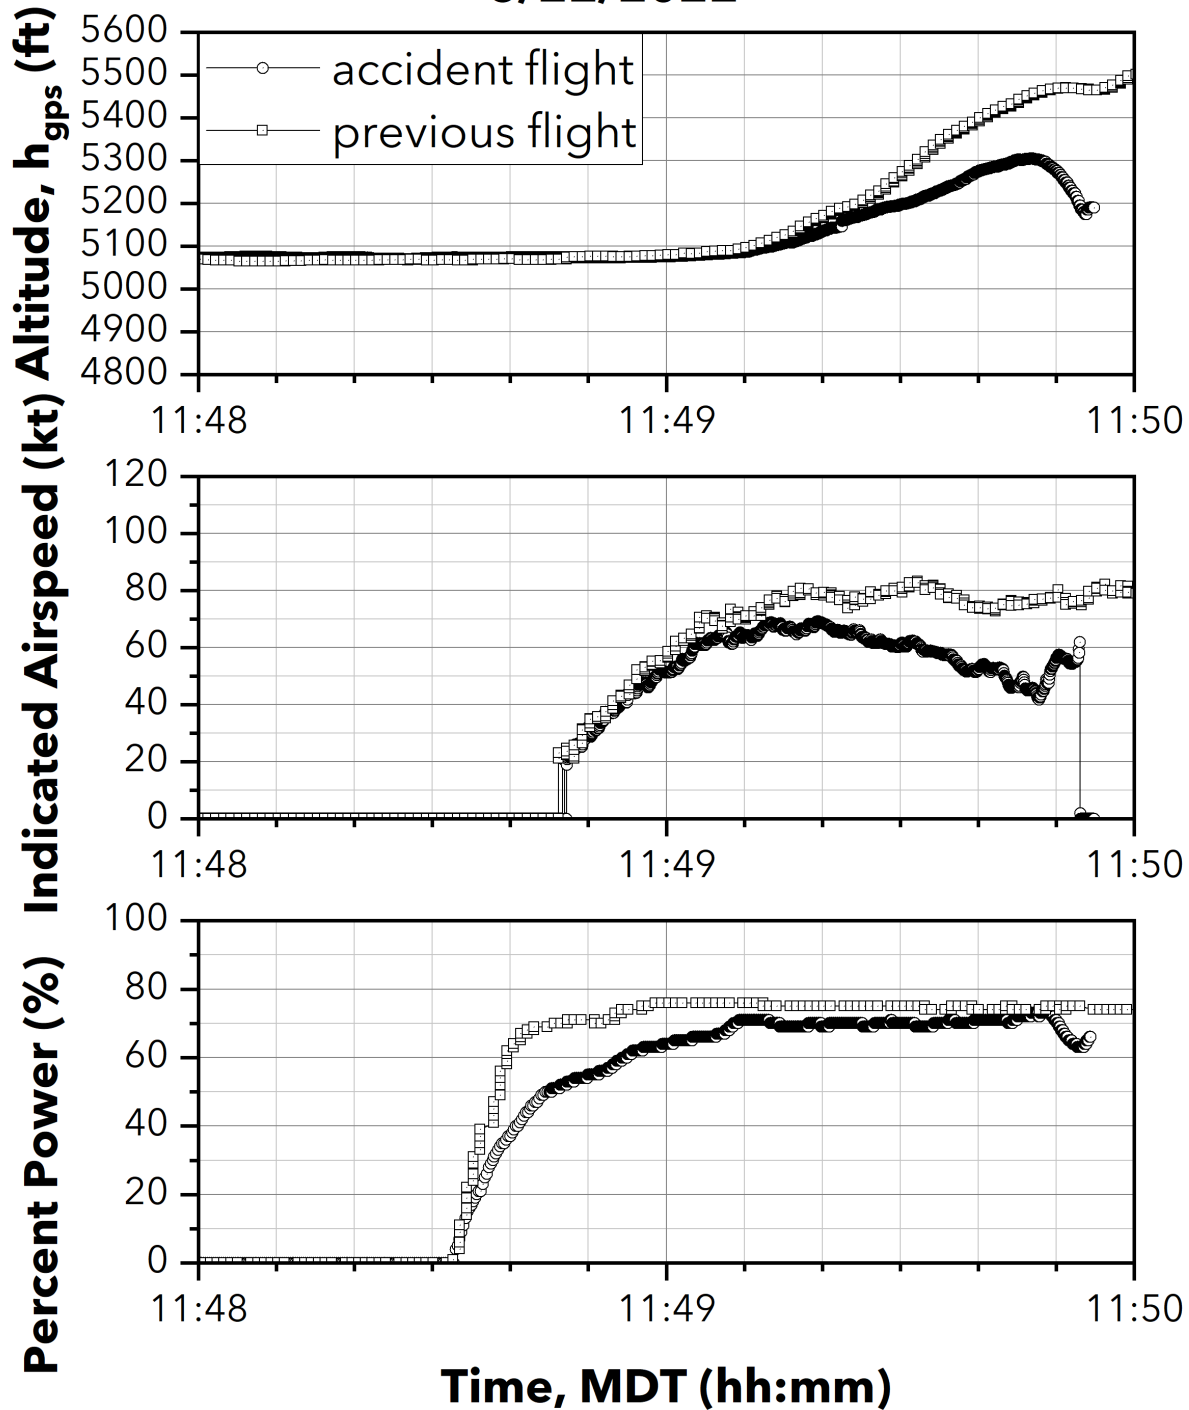
In addition to fuel flow, the Dynon records "percent power". The percent power parameter recorded by the Dynon at 1149:52 (just before impact) was 64% and is shown in Figure 16. Assuming it is a percent of the 260 BHP rated horsepower, the recorded horsepower was 64% or  $260 \text{ BHP} \times 0.64 = 166 \text{ BHP}$ . This compares well with the horsepower estimated from fuel flow in the accident. However, on the previous take-off, the Dynon recorded about 75%, which would equate to about 195 BHP, substantially less than the 235 BHP calculated from the fuel flow.

**Figure 16: Recorded Percent Power for Accident and Previous Flight**

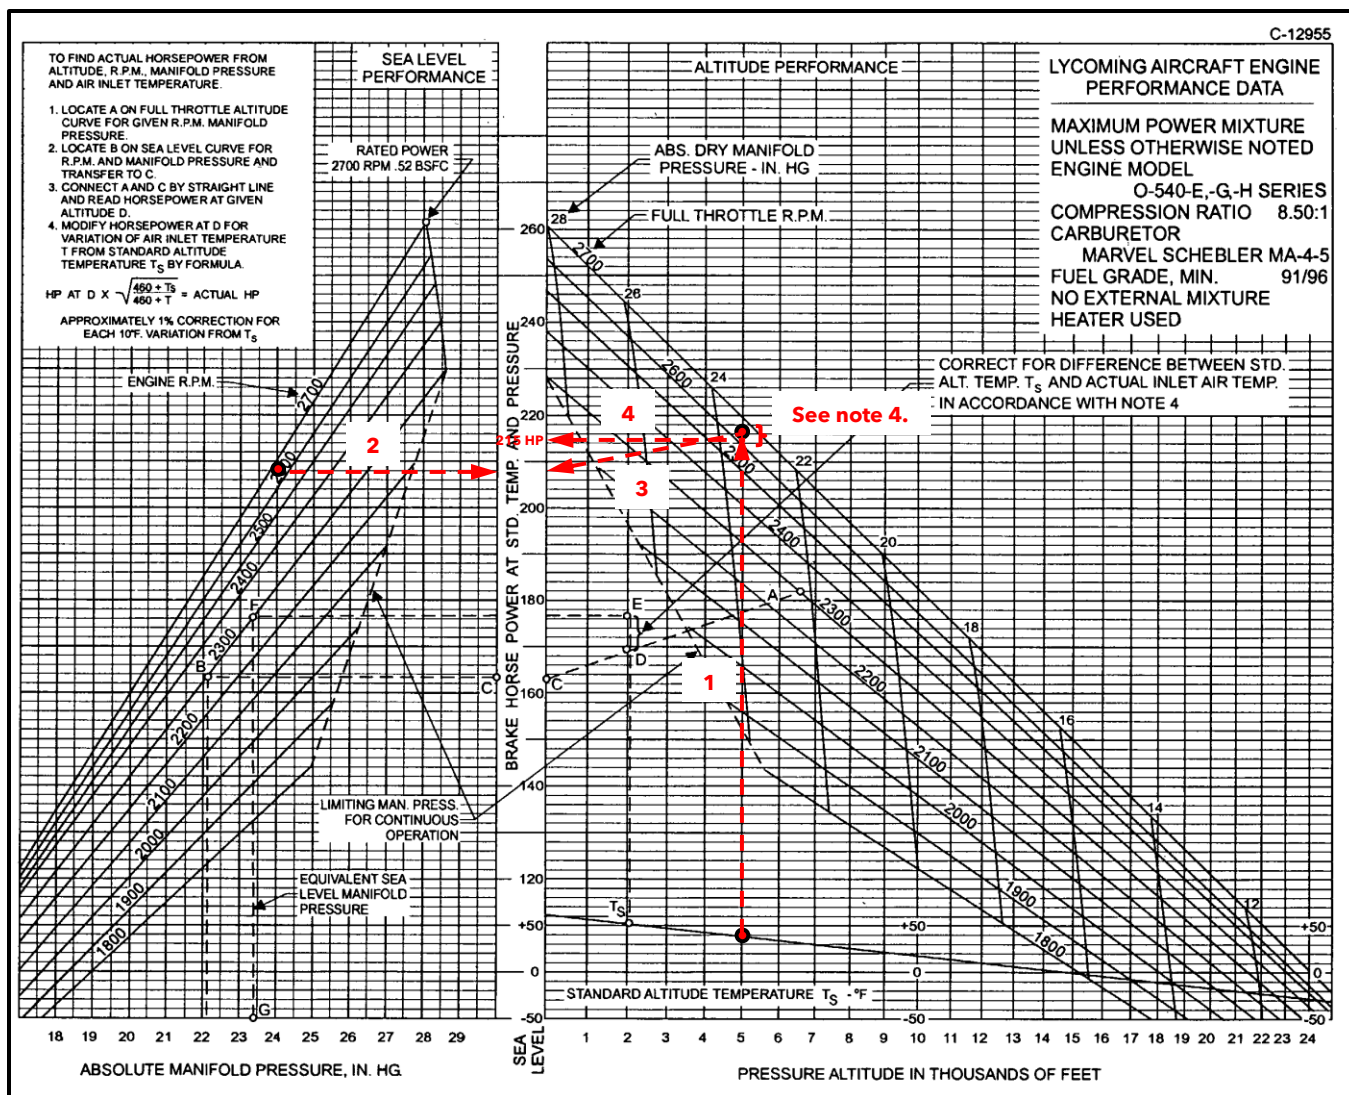
Finally, Lycoming Power Chart #12955 at the manifold pressure, RPM, altitude, and temperature recorded at 1149:52 and shown in Figure 17 results in a peak power of approximately 215 BHP. While this is 33% more than the accident fuel-flow based power estimate and 30% more than the recorded Dynon percent power, this is to be

expected: the Lycoming Power Chart assumes a fuel flow that is higher than that recorded in the accident.

**Figure 17: Sea Level and Altitude Performance Curve - O-540-E, -G, -H**  
**MP = 24 inHg, RPM = 2640, Hp=5,000 ft, T = 54°F: BHP = 215 HP**

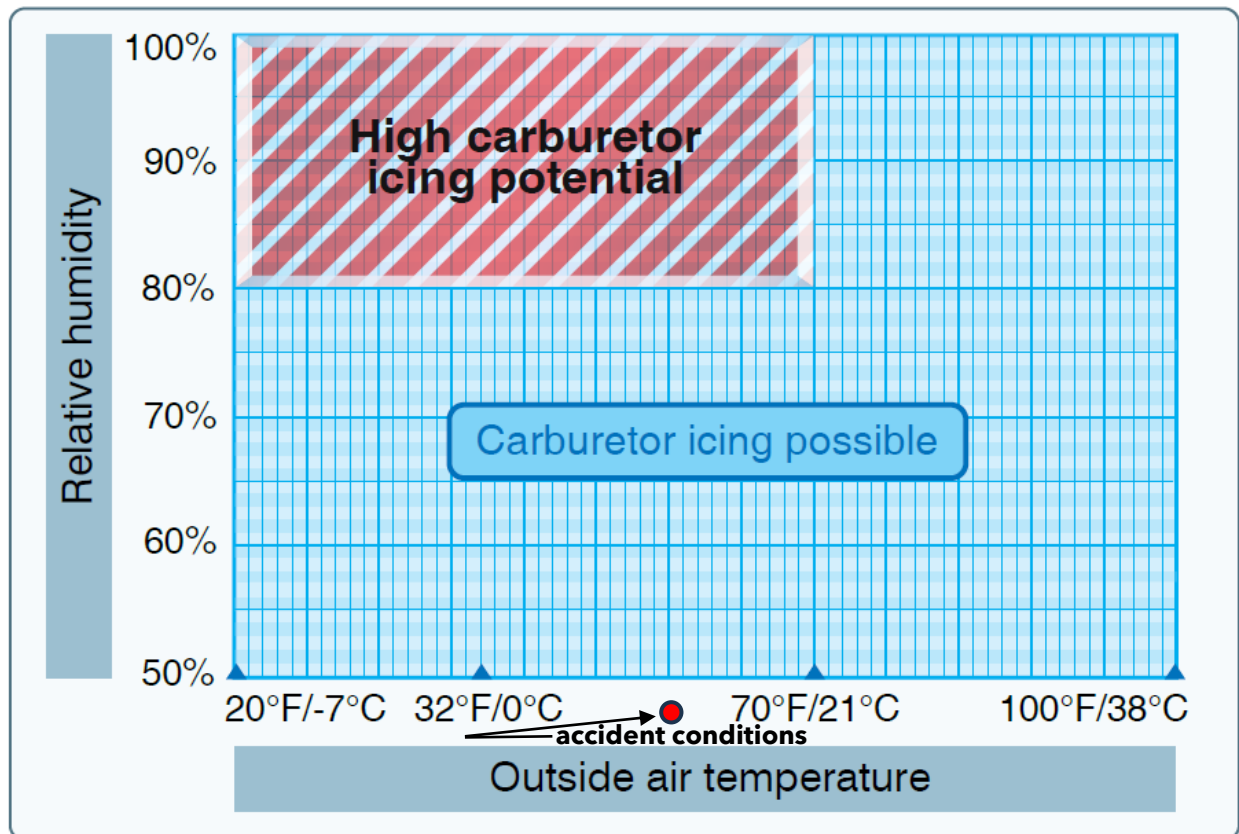
Figure 18 is an excerpt from the FAA Pilot's Handbook of Aeronautical Knowledge and suggests that carburetor ice was not likely<sup>5</sup>. Alternatively, Figure 19 includes the carburetor icing possibility as predicted by the National Weather Services' (NWS) High-Resolution Rapid Refresh Model (HRRR). The HRRR model shows a possibility of carburetor ice between 5,000 ft and 10,000 ft msl with the greatest potential between 7,000 ft and 9,000 ft msl.

**Figure 18: Carburetor Icing Potential Envelope from FAA Pilot's Handbook of Aeronautical Knowledge**

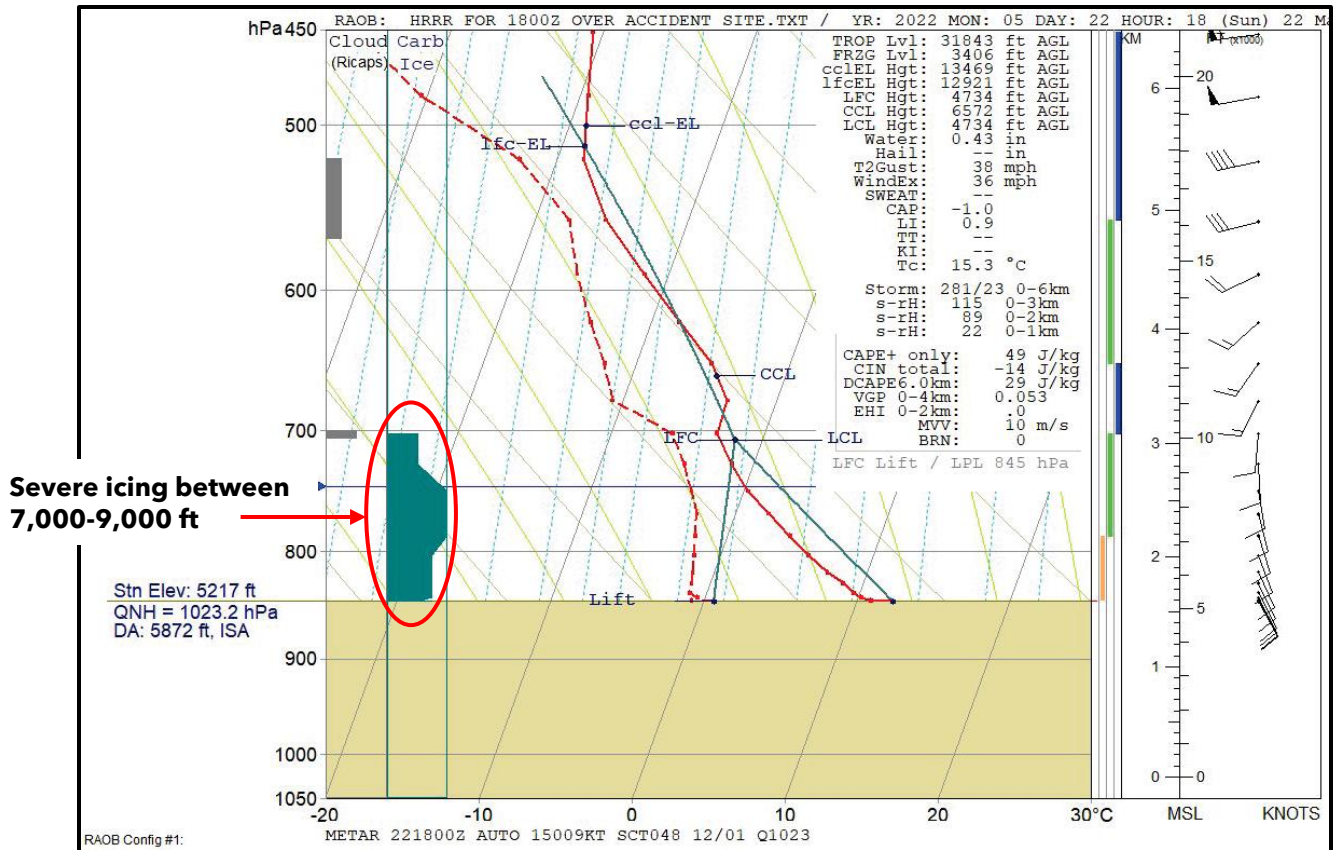
**Figure 19: Carburetor Icing Possibility from NWS High-Resolution Rapid Refresh Model**
