# National Transportation Safety Board

CEN22FA211

## **WRECKAGE EXAMINATION**

Location: Seagraves, TX  
Date: May 24, 2022  
Time: Unknown Time  
Airplane: Piper PA-18; N78466

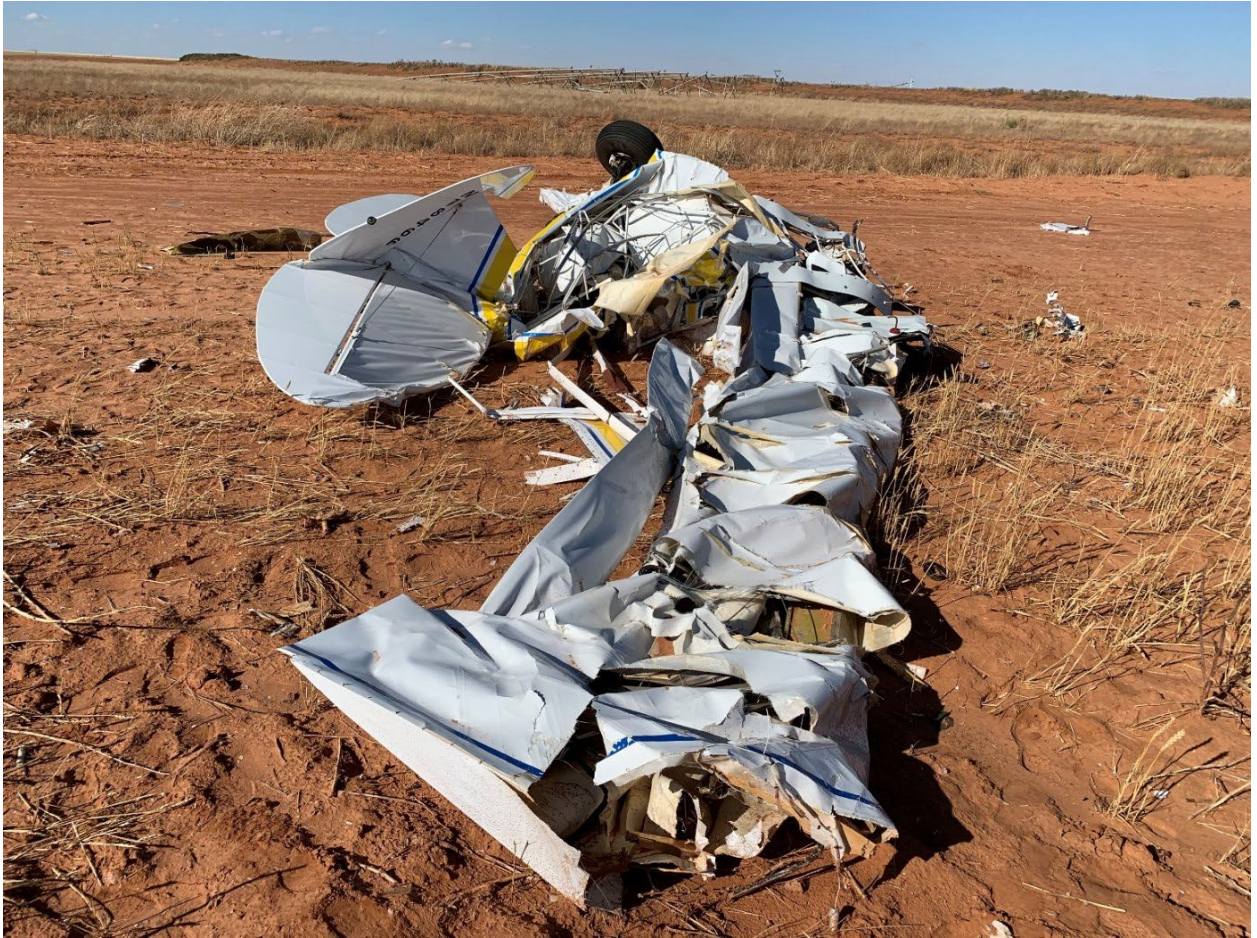
Postaccident examination of the accident site revealed the airplane impacted the terrain in a nose and right-wing low attitude. The initial ground scar was consistent with the propeller, engine, forward fuselage, left and right wings. The main wreckage was located about 45 ft forward of the initial ground scar. Plexi-glass debris was noted between the ground scar and main wreckage. The airplane sustained substantial damage to the fuselage, wings, and empennage.

The propeller blades displayed forward twist in the direction of rotation, s-bending, chordwise scratching, and leading-edge damage. The propeller spinner was crushed and molded around the propeller hub.
