## **NATIONAL TRANSPORTATION SAFETY BOARD**

### **ON SCENE OBSERVATIONS**

**CEN22FA214**

Location: Wauwatosa, WI  
Date: May 26, 2022  
Aircraft: Cessna 152, Registration N4978B  
NTSB IIC: Samantha Link

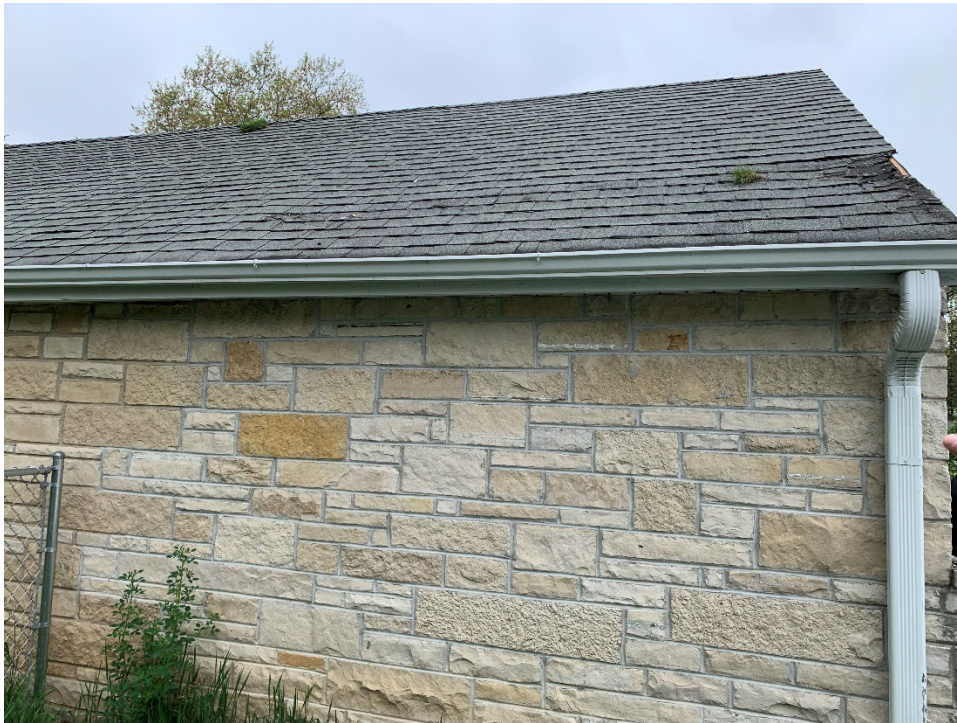
The airplane impacted the ground in a residential neighborhood about ¼ mile from the departure end of runway 22R. The first identified point of impact was damage to a garage roof. Some singles were damaged and separated at the edge of the garage; damaged shingles extended inward along a narrow path, consistent with the shape of a wing leading edge. The airplane itself came to rest nose down with the engine in a deep impact crater. The cabin area extended upward, and the aft fuselage was fractured just aft of the baggage area. The empennage remained mostly whole and came to rest on the ground. Both wings remained partially attached to the fuselage and their leading edges sustained aft crush damage.

Figure 1: Damage to Garage Roof

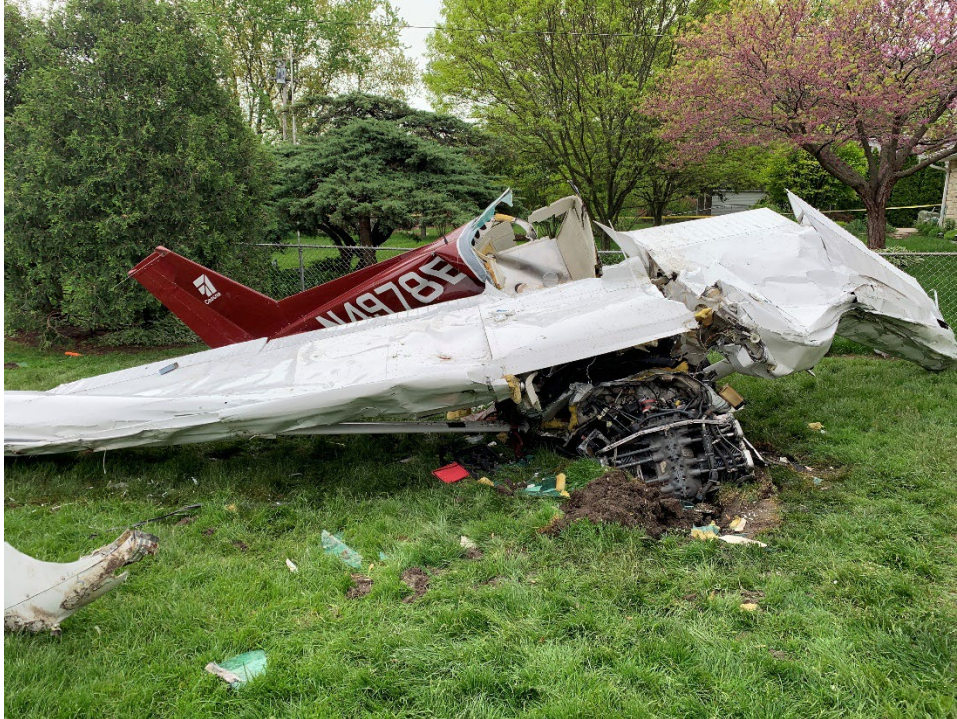
Figure 2: Overall View of Wreckage

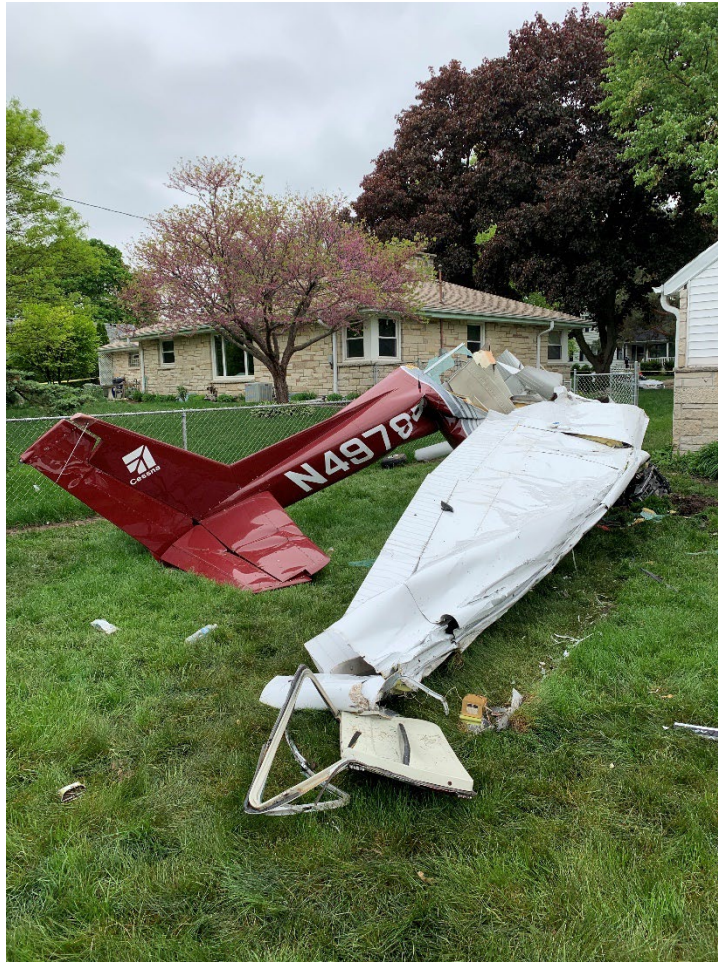
Figure 3: Right side of Airplane

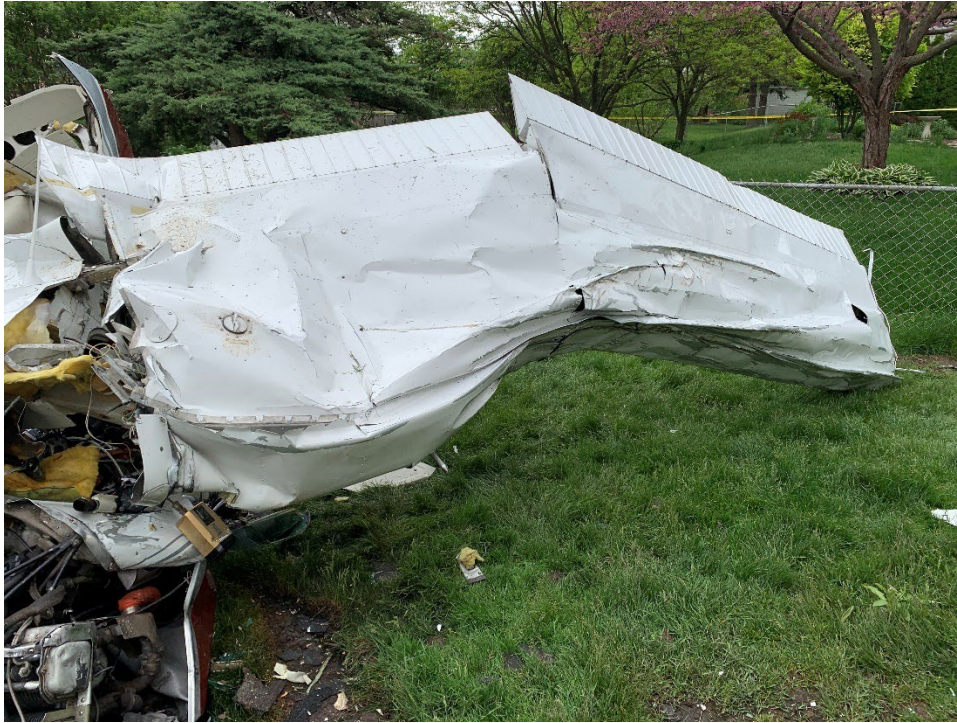
- Left Wing:
  - The left wing was partially separated from the fuselage at the wing root.
  - A large indent was present in the inboard portion of the left wing.

- The left-wing flap was in the up and locked position; however, the outboard track was slightly loose.
  - Aileron flight control continuity was established from the aileron control surface to wing root.

Figure 4: Left Wing

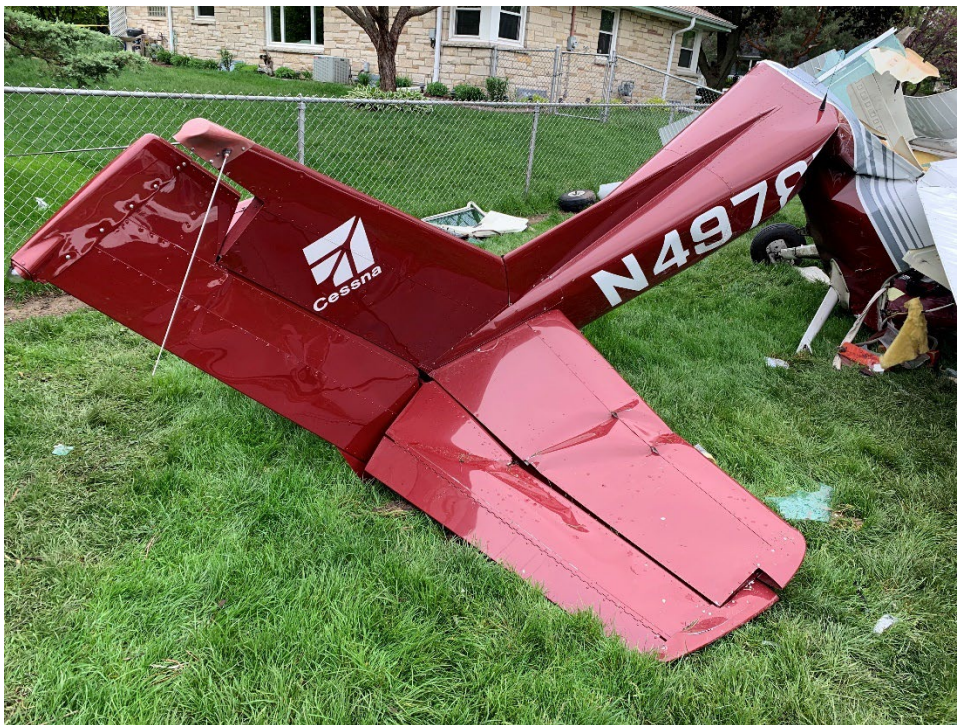
- The flap actuator jack screw was examined.
    - No threads were exposed which is consistent with the flaps in the up position.
- The aft fuselage was fractured just aft of the baggage area and was bent down and to the right.

- The aft fuselage sustained a large bend on its right side.
  - The empennage came to rest on the ground.
  - The left horizontal stabilizer remained mostly intact, and the elevator remained attached.

- The right elevator remained attached to the right horizontal stabilizer. Both were bent slightly inboard of midspan.
  - The rudder remained secured to the vertical stabilizer.

Figure 5: Aft Fuselage and Right side of Empennage

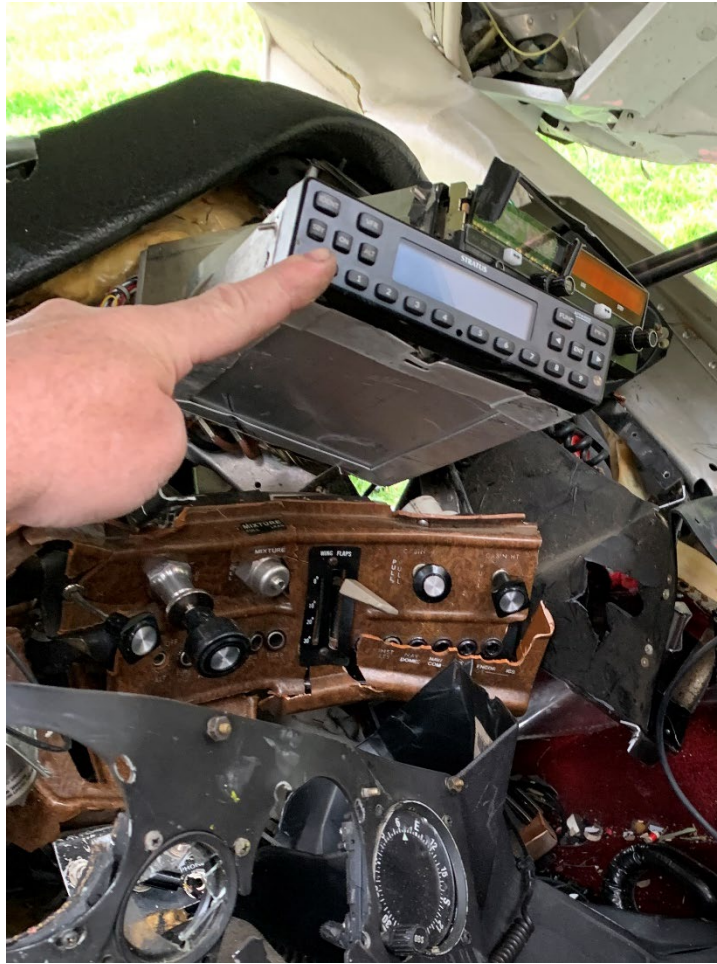
- The instrument panel sustained extensive damage; the instruments themselves were displaced and scattered.
  - The throttle was found in the full forward position.

- The mixture handle was fracture separated.
  - The carburetor heat was observed extended (into the “on” position).
    - It was bent about mid length.

- The electric flap control handle was found in the up position.
- A Garmin 396 was found loose within the cockpit, and it was off.
  - It was sent to the NTSB laboratory for download.

**Figure 6: Carburetor heat, Throttle, Mixture, and Flap Handle**

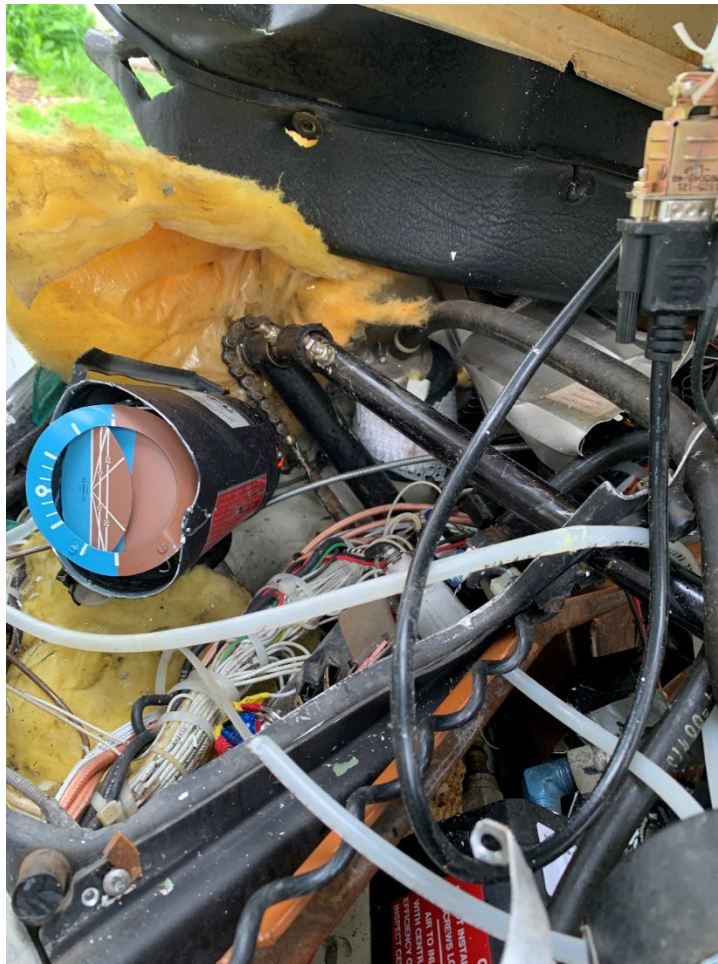
- The left pilot seat control yoke was fracture separated, however, the rod still extended forward into the instrument panel.
      - The forward most portion of the rod was exposed, and the aileron chain remained secured.

**Figure 7: Forward most Portion of Control Yoke**

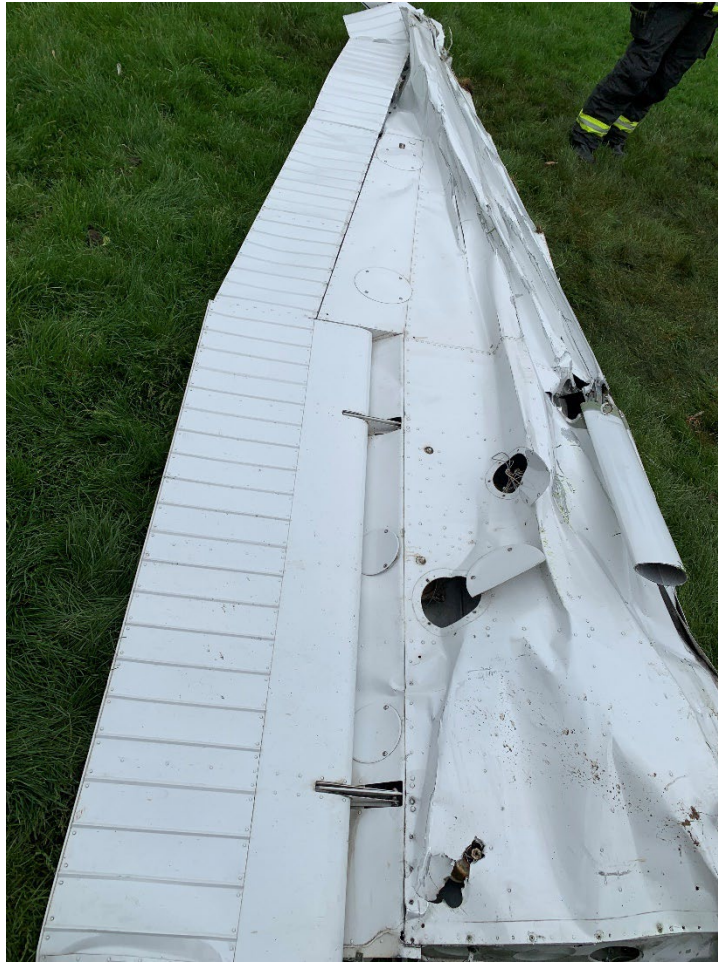
- The right wing remained attached at the fuselage and came to rest slightly lower than the left.
  - The leading edge was crushed aft along its entire edge,

- It was crushed somewhat aft near the wing root, and the crush damage went progressively further aft the further outboard on the wing.
      - Near the wing tip, the aft crushing extended into the aileron.

- The outboard portion of the aileron was bent.
    - The aileron was manipulated by hand and corresponding motion was observed at the wing root.
  - The right flap was secured in the up and locked position.

Figure 9: Underside of the Right Wing

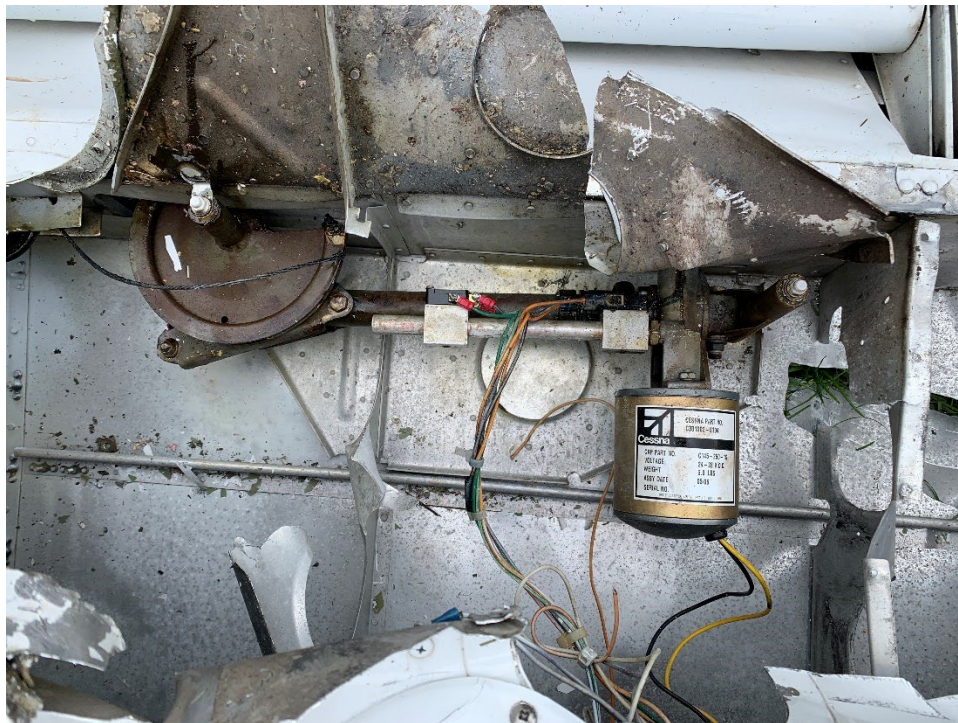
Figure 10: Flap Actuator and Jack Screw

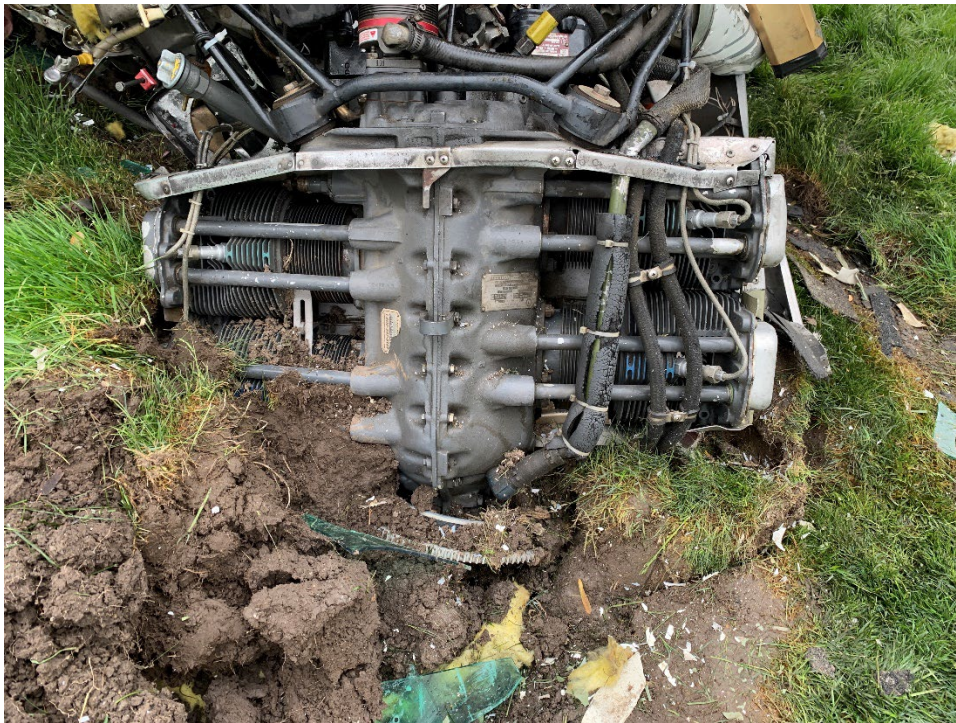
- The engine came to rest nose down in a deep impact crater.
  - The spinner along with one propeller blade were not visible.
  - The outboard portion of the second blade extended upward from the crater.
- The engine cowling was removed; and there were no visual indications of catastrophic failure.
- When the engine was removed from the ground, the spinner exhibited aft crushing.
- Both propeller blades were bent sweepingly aft.
- The lower portion of the engine was covered in dirt and no obvious visual anomalies were noted.
- The carburetor was fractured at its attachment point and a lot of oil was found in the impact crater.
- The left magneto and oil filter were fracture separated from their mounts.

Figure 11: Top of Engine

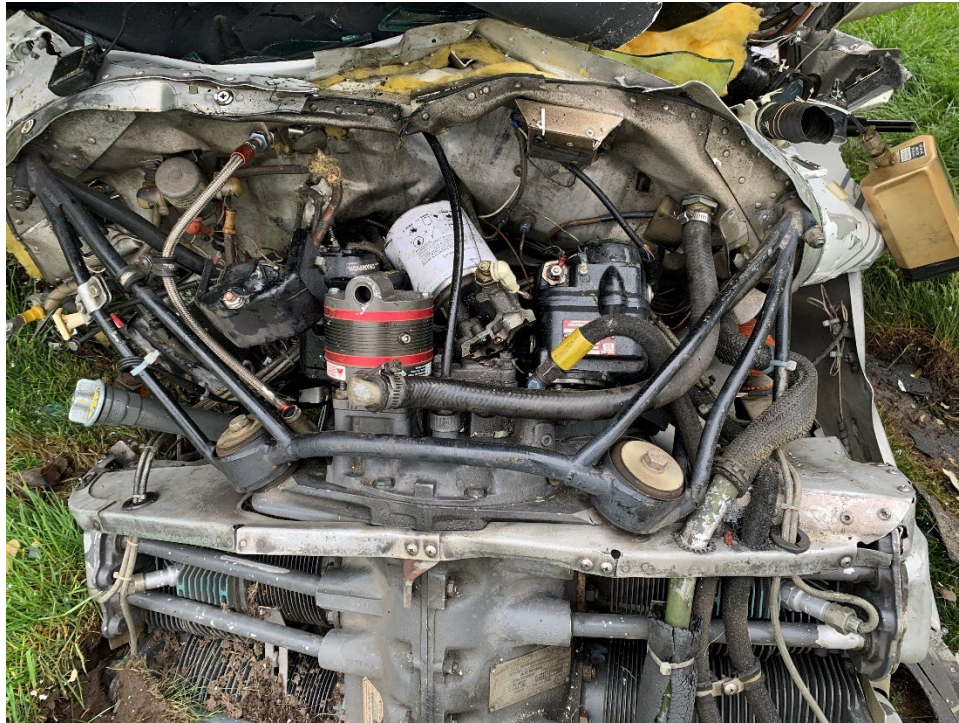
Figure 12: Accessory Section of Engine

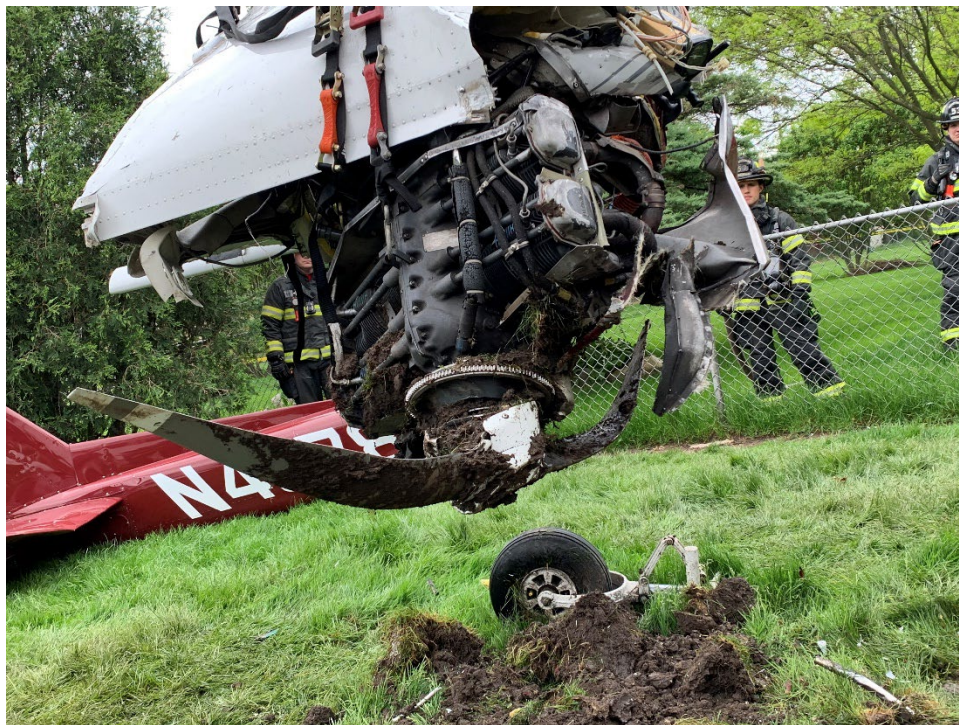
Figure 13: Spinner and Propeller Assembly
