# National Transportation Safety Board

CEN22FA216

## VEHICLE PERFORMANCE

Location: Cheyenne, Wyoming  
Date: May 30, 2022  
Time: 0748 MDT  
1348 GMT  
Airplane: Express 2000 RG, N44508

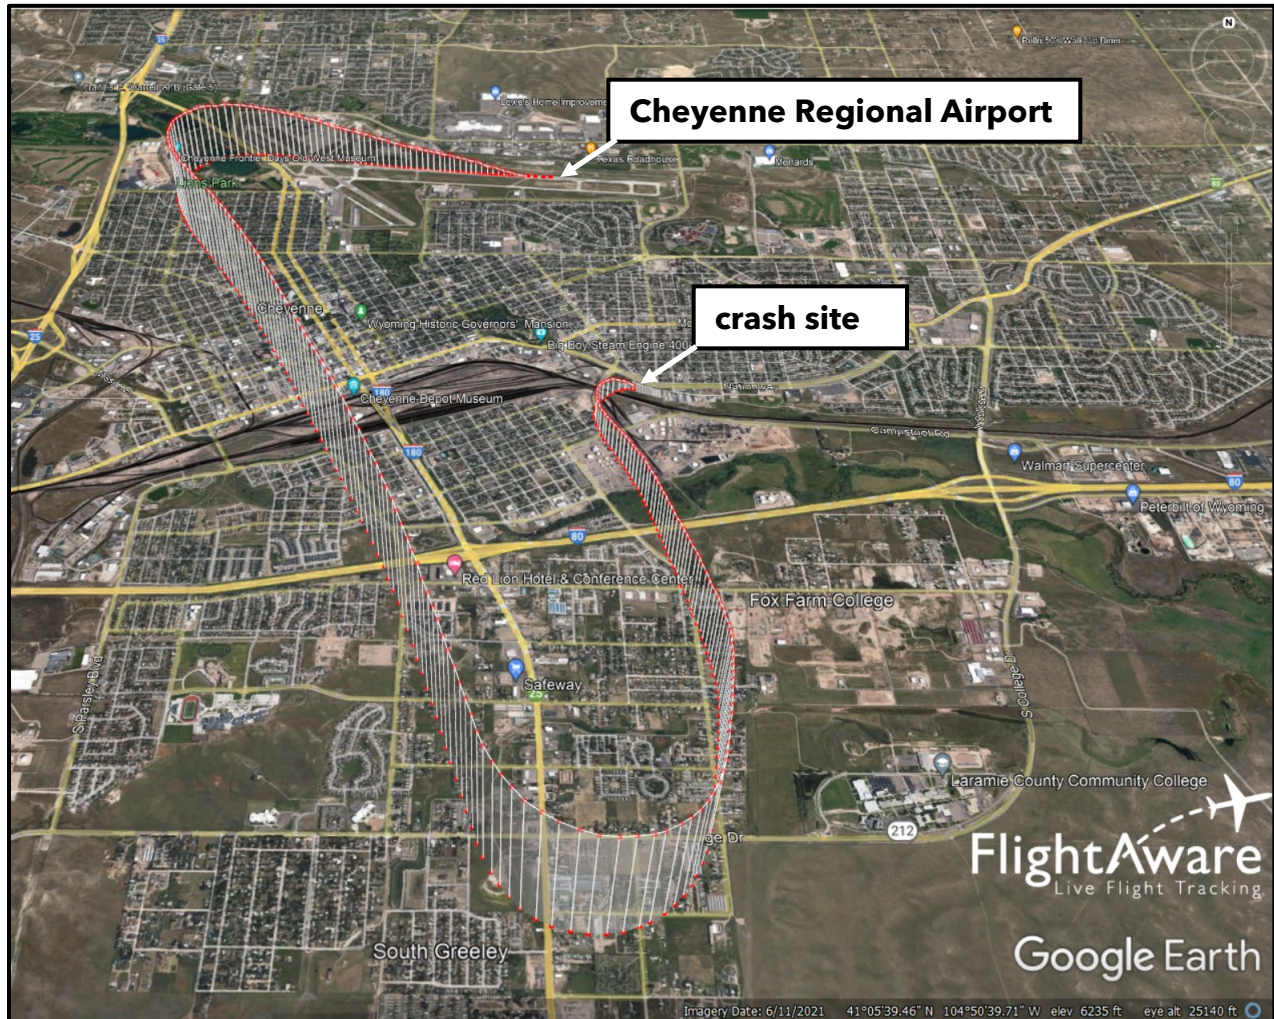
The airplane departed Cheyenne Regional Airport/Jerry Olson Field (CYS) from runway 27, about 0744, with the intention of flying to Texas. Shortly after takeoff, the pilot declared an emergency with air traffic control (ATC) tower personnel and informed them that he had “an engine failure” and was about four miles south of the airport. He later reported that he would not be able to land at the airport and intended to land in a field. He also stated that he was “on fire” and asked ATC to send fire rescue. Video cameras from a local business captured a portion of the accident sequence which showed the airplane descending, near vertical, with a right roll. See Figure 1.

**Figure 1: The Four Minute Flight Departed Cheyenne Regional Airport with Texas as the Intended Destination**

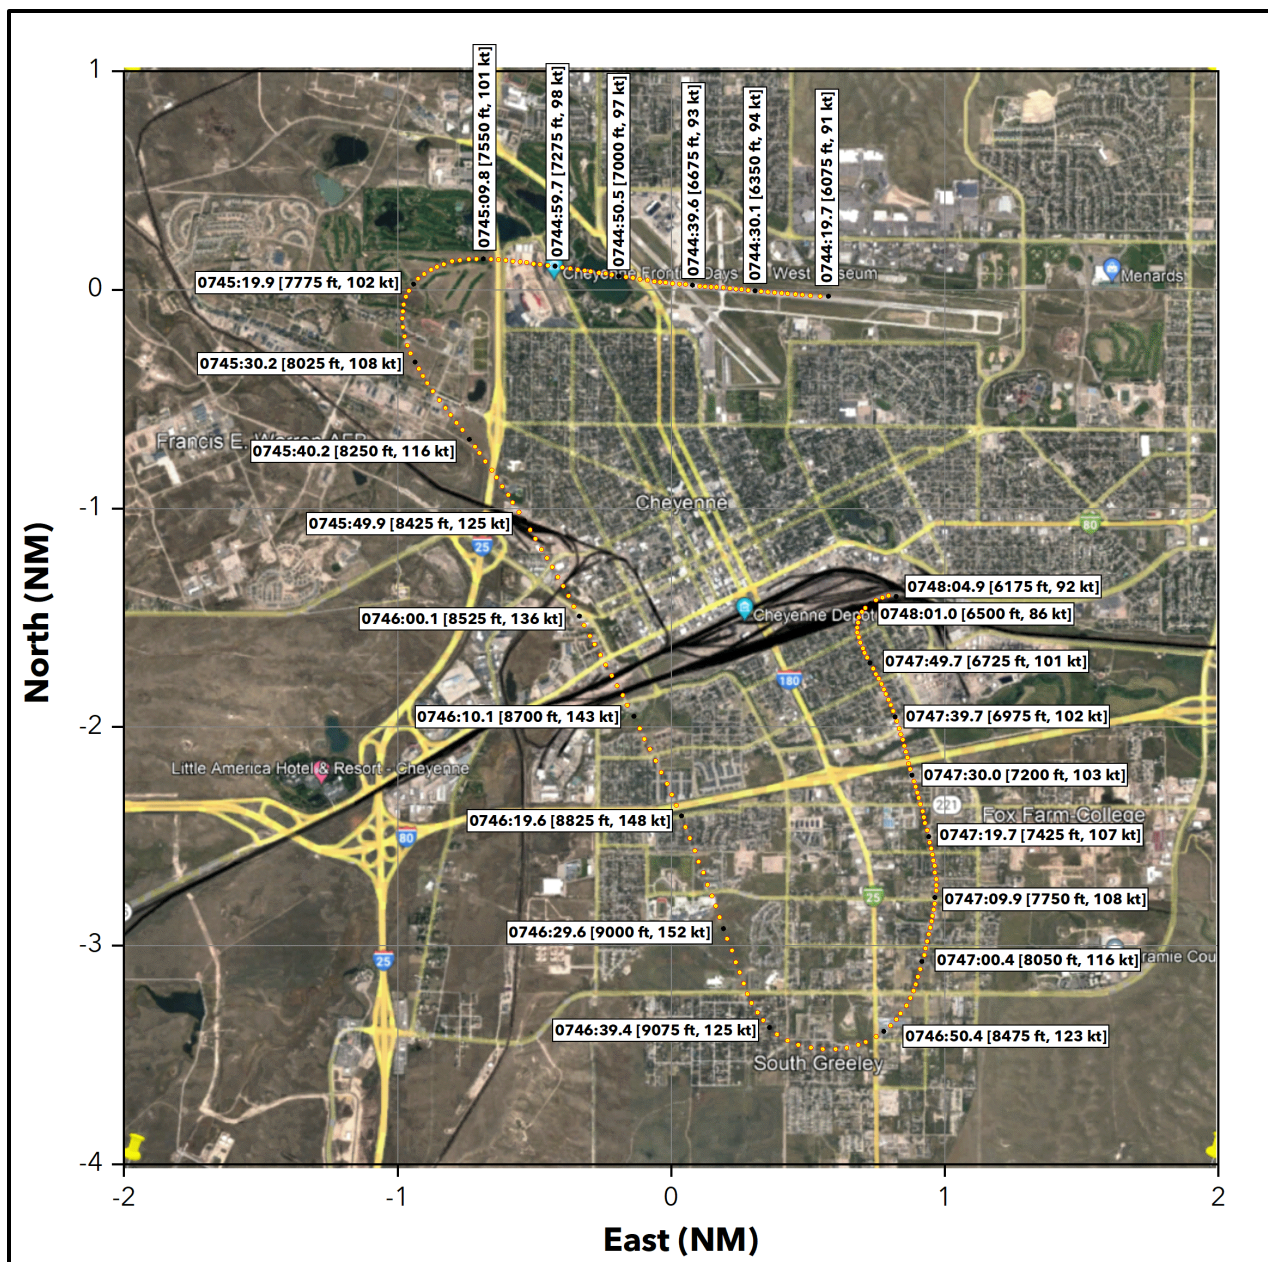
Figures 3 shows the ADS-B altitude and estimated airspeed for the four-minute flight in an overhead view. Figure 4 shows the same parameters as well as the estimated rate-of-climb (ROC) in a time history format.

**Figure 3: ADS-B Altitude and Estimated Airspeed for the Accident Flight**

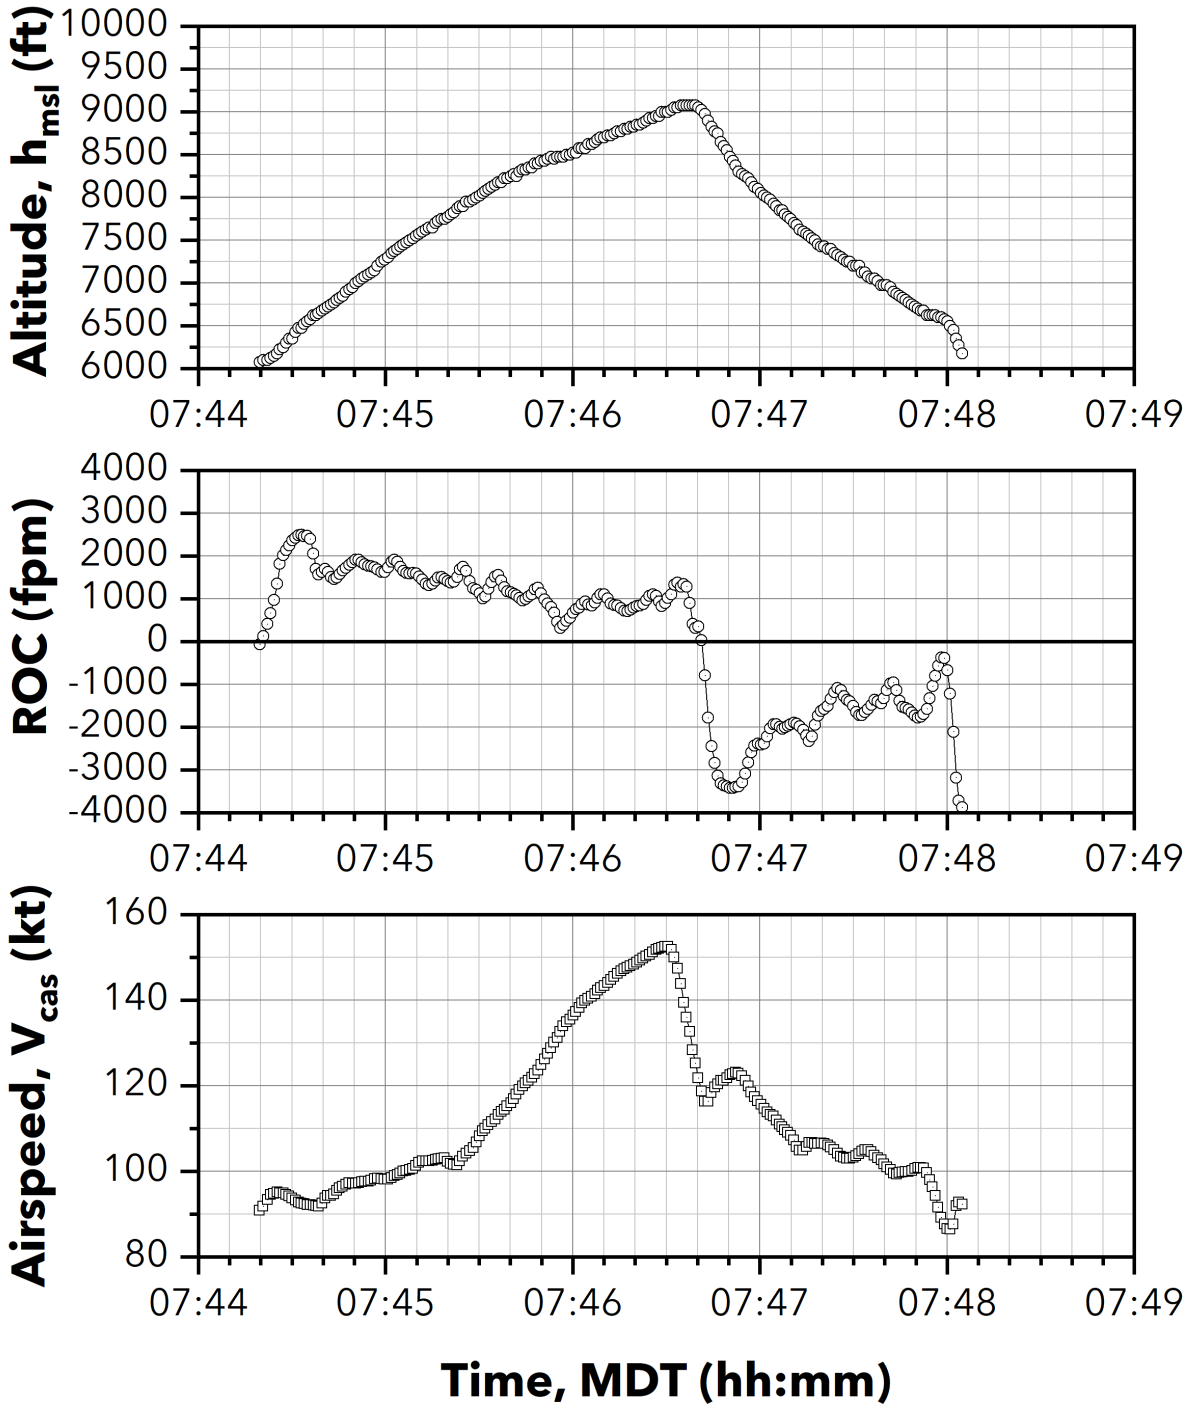
**Figure 4: ADS-B Altitude, ROC, and Estimated Airspeed for Accident Flight**

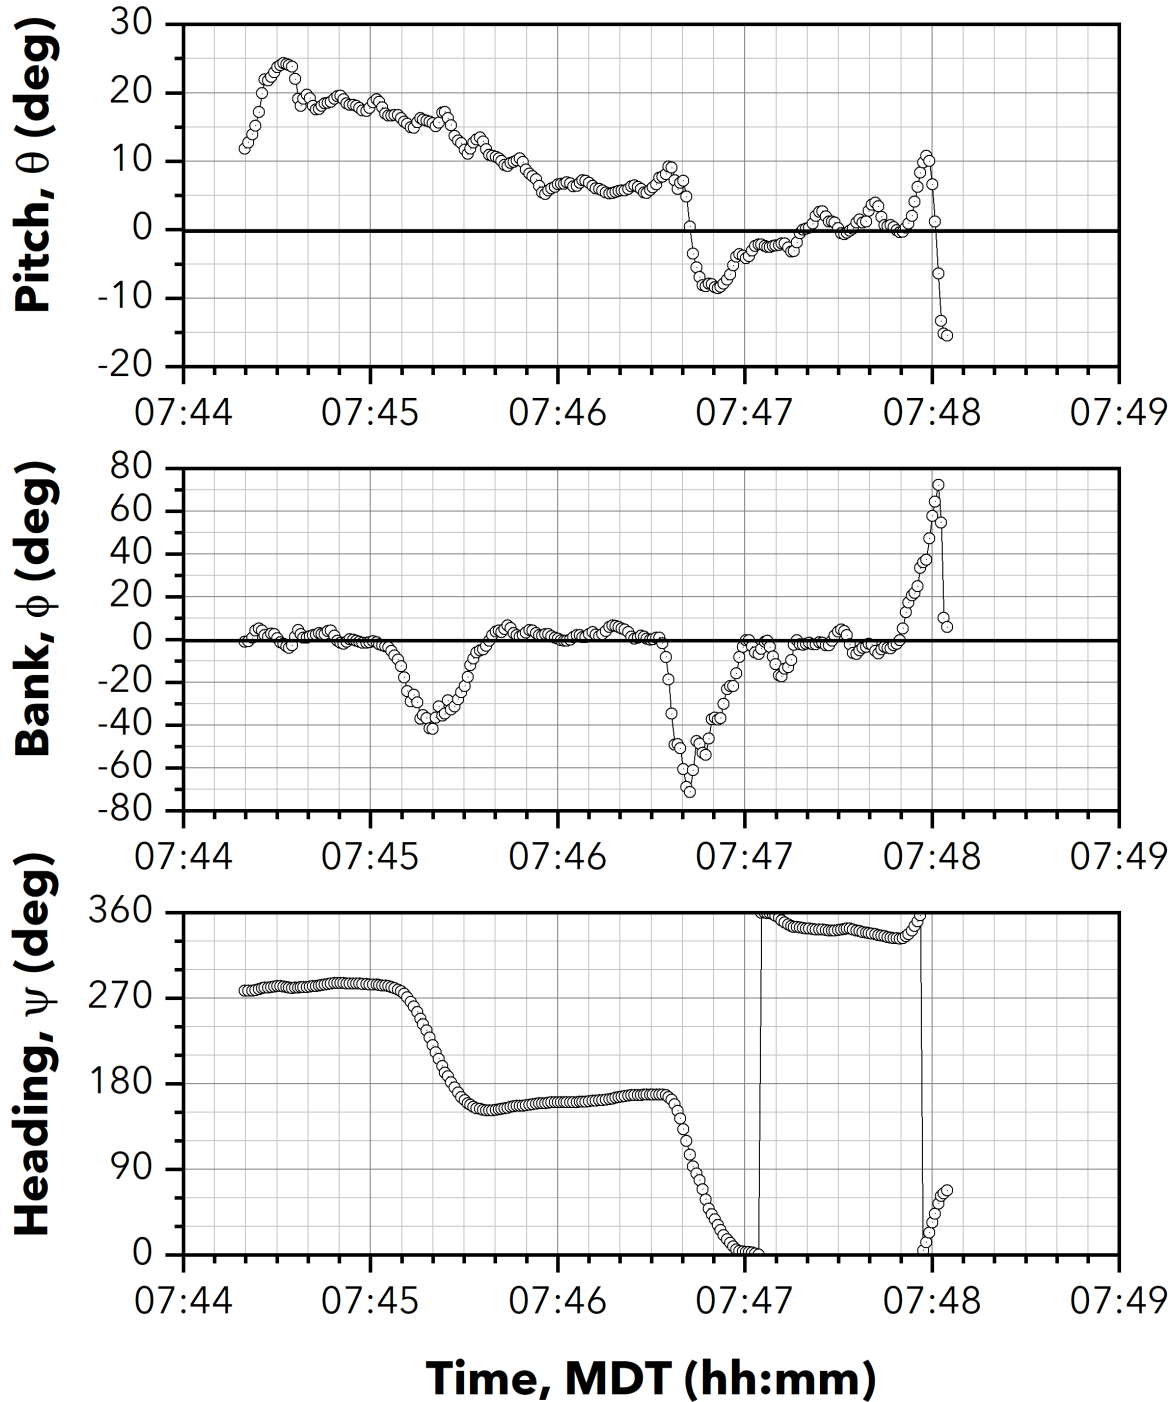
Figures 5 includes the airplane attitude information estimated from ADS-B data. Worth noting are the two 75° bank turns: the first to the left at 0746:42 and the second to the right at 0748:02. During the first turn the pitch attitude of the airplane was reduced from 10° to almost -10°. This would result in a reduction in airplane angle-of-attack. During the second turn to the right, the airplane's pitch attitude was increased from approximately zero to almost 11°. This would result in an increase in airplane angle-of-attack. Estimated angle-of-attack, as well as longitudinal and normal load factors, are shown in Figure 6.

**Figure 5: Estimated Pitch, Bank, and Heading Angles for Accident Flight**

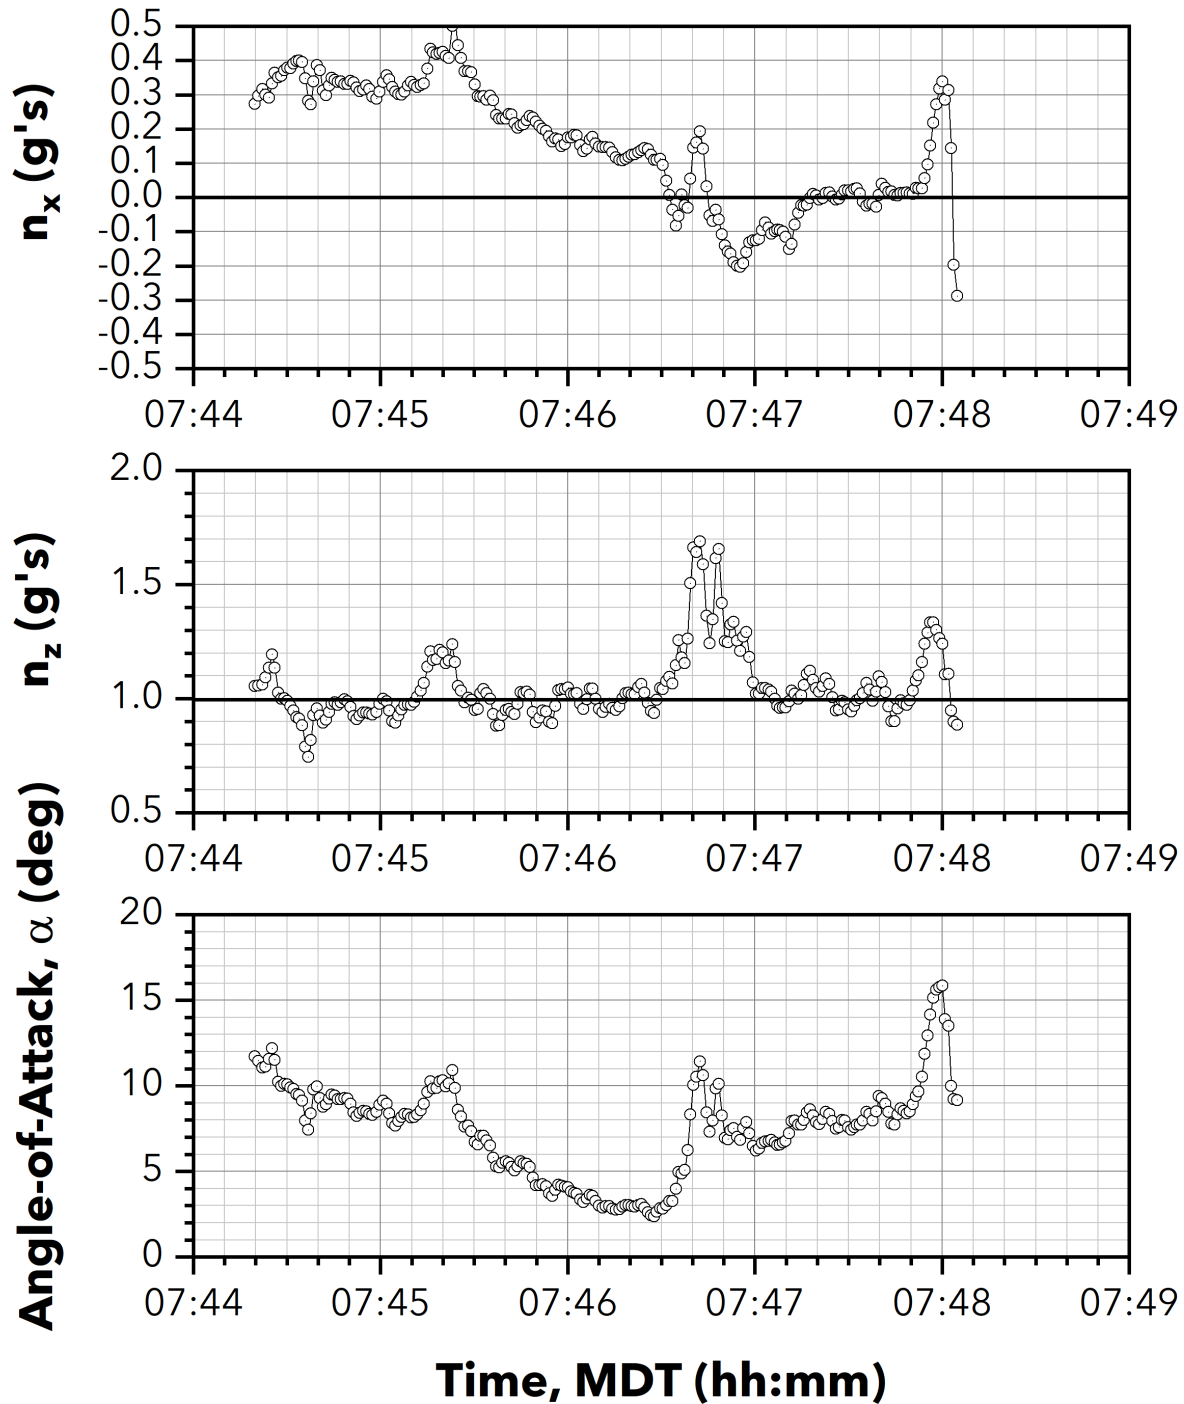
Airspeed and airplane attitude information estimated from ADS-B data provided by the FAA show that bank angles exceeding 75° were used to maneuver the airplane back towards the airport. In the final 75°-banked turn to the right, estimated angle-of-attack, rate-of-climb, and normal load factor data indicate that the airplane likely experienced an accelerated stall while less than 400 ft above the ground. The airplane impacted a storage facility seconds later.

**Figure 6: Estimated Longitudinal / Normal Load Factors and Angle-of-Attack for Accident Flight**
