# National Transportation Safety Board

CEN22FA223

## **EXAMINATION SUMMARY**

Location: Bowling Green, MO  
Date: 06/02/2022  
Time: 1745  
Airplane: Aeronca 7AC; N1976E

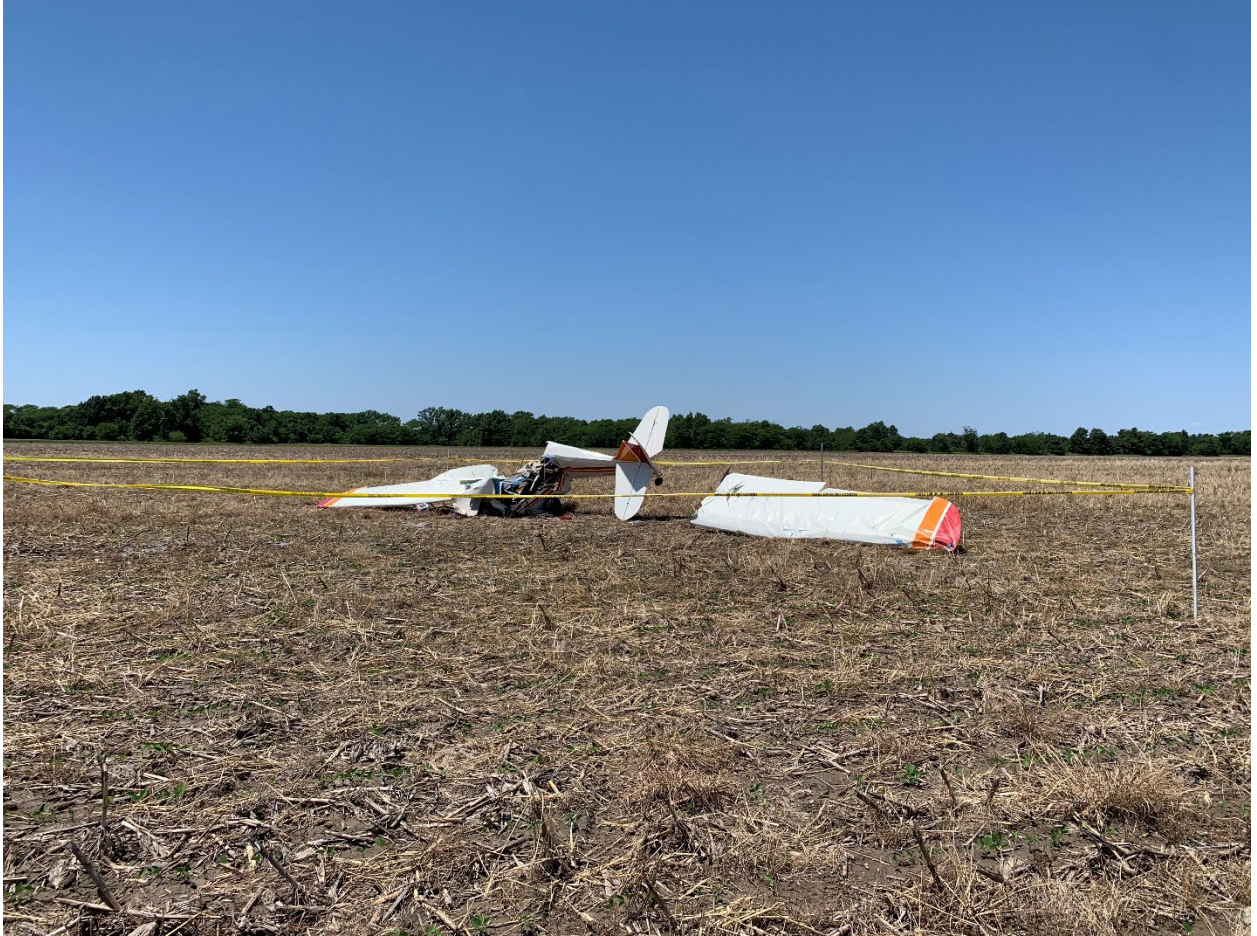
Postaccident examination of the accident site revealed the airplane impacted the terrain in a nose and left-wing low attitude and came to rest upright on a measured magnetic heading of 135°. The airplane sustained substantial damage to the fuselage, wings, and empennage (see Figure 1).

Figure 1. Accident site
