**Subject:** Engine Examination Findings after Recovery N4124D

In support of CEN22FA288, the engine, a Lycoming IO-540-AE1A5 was examined to determine if it contributed to the accident. The examination took place at Air Salvage of Dallas, Lancaster, Texas, with David Harsanyi, Lycoming Engines, in attendance and telephone consultation with Thom Webster, Robinson Helicopters.

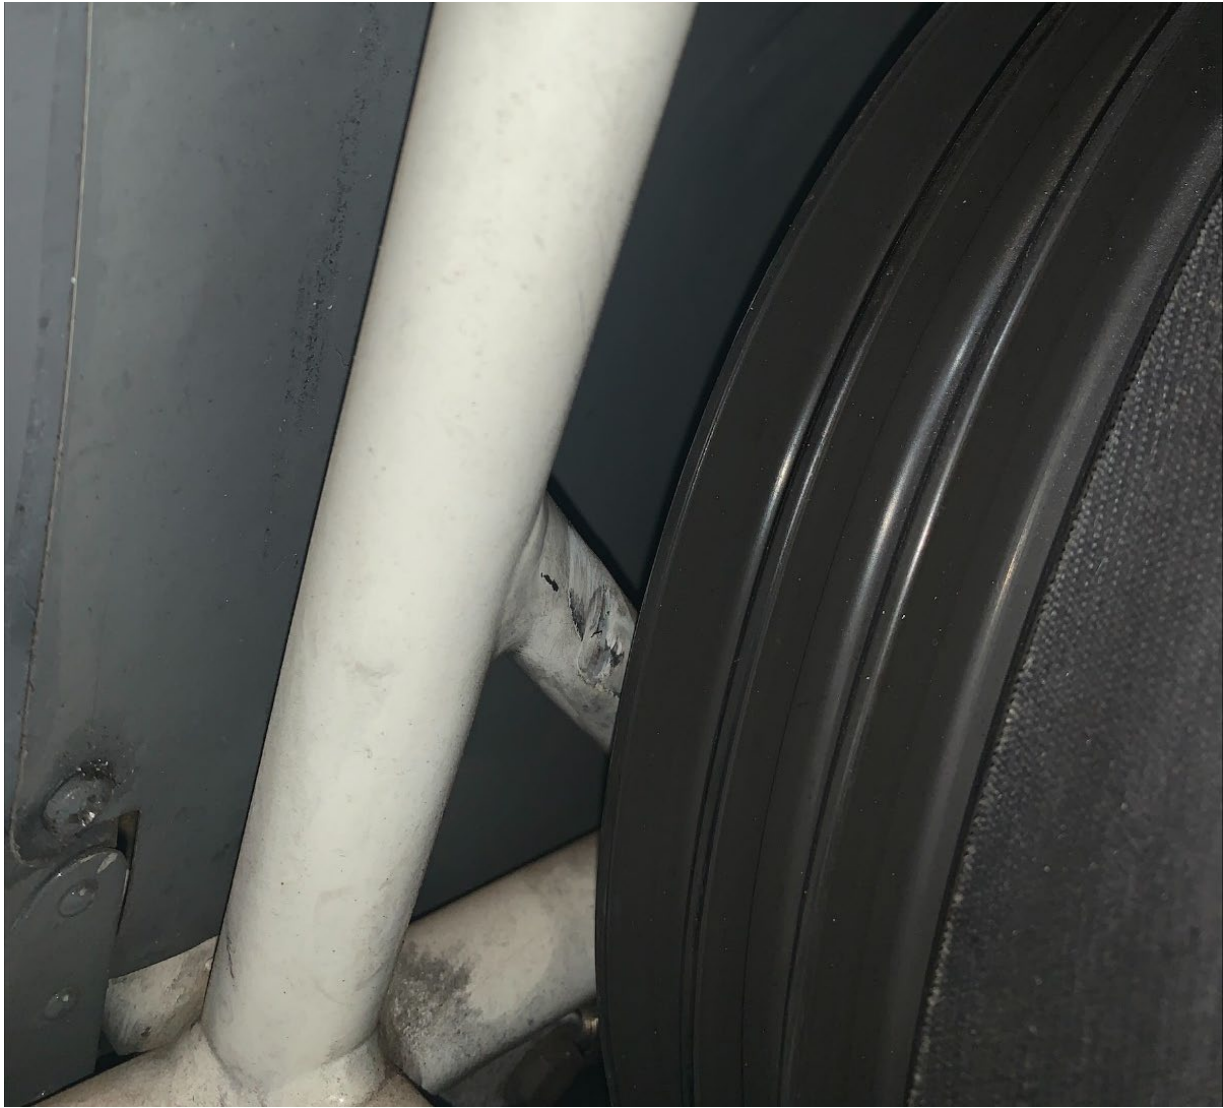
In consideration the depth of the engine examination, several contact marks were documented on the forward face of the frame tubes consistent with the engine drive belts rubbing against the tube while rotating at impact.

*Figure 1 Left Side of Mount*

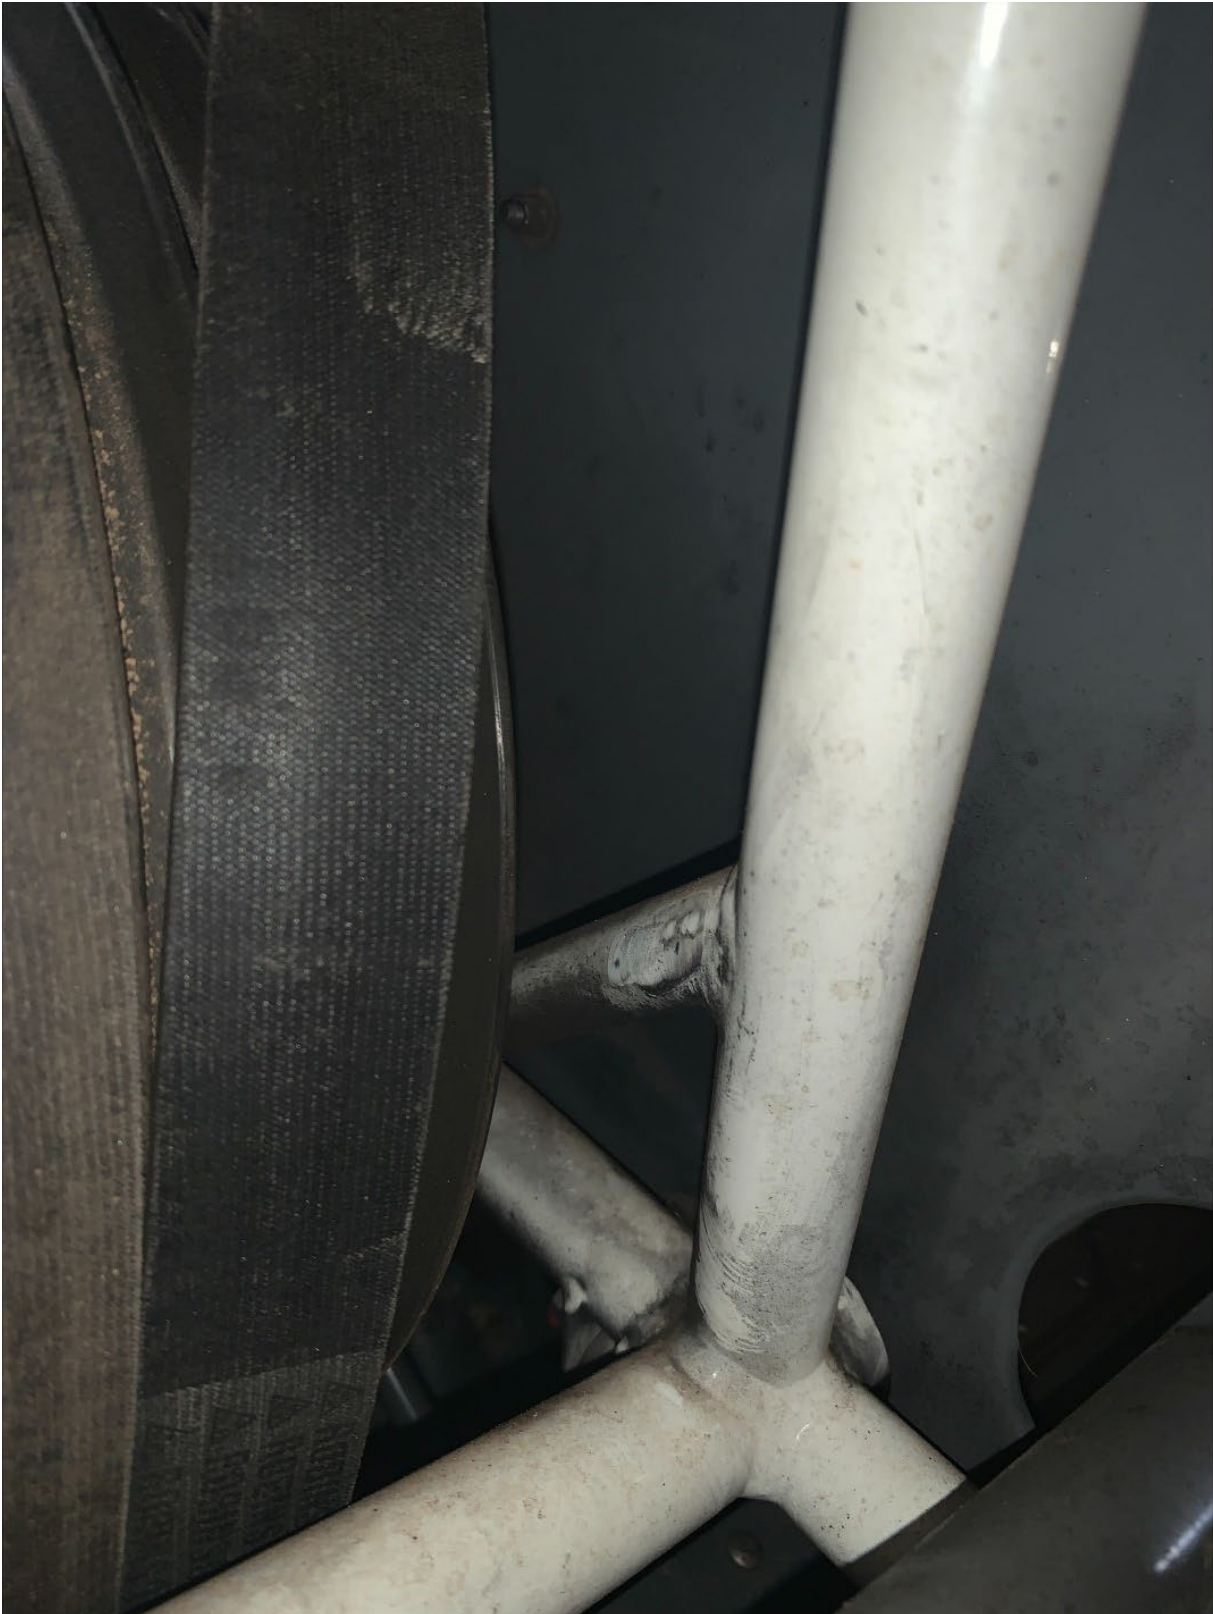
*Figure 2 Right Side of Mount*

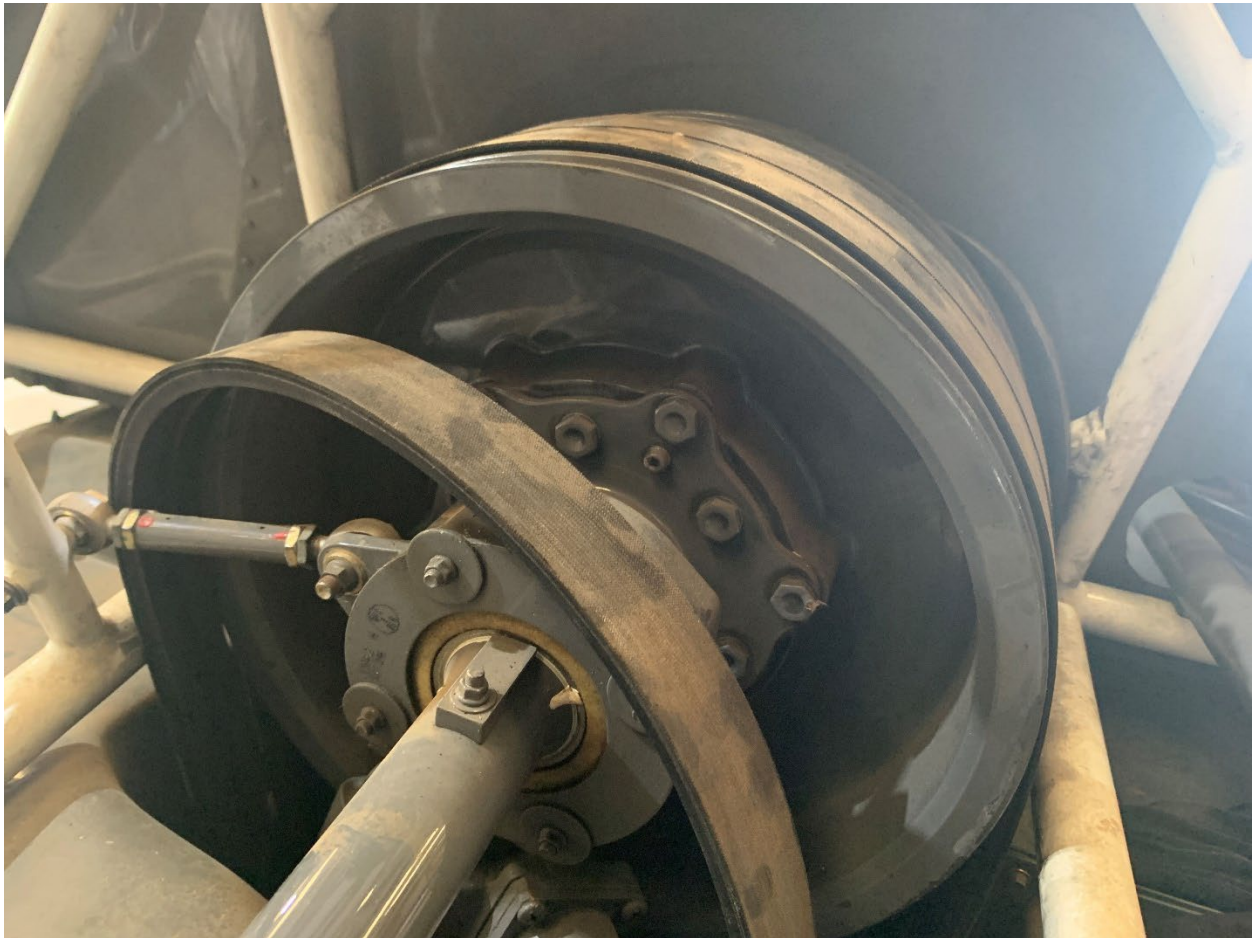
The upper sheaves were examined for any transfer marks. One of the drive belts was dislocated, but lack of damage to the belt suggested that occurred during impact.

*Figure 3 Upper Sheaves*
