CEN22FA288

## INVESTIGATION PHOTOGRAPHS

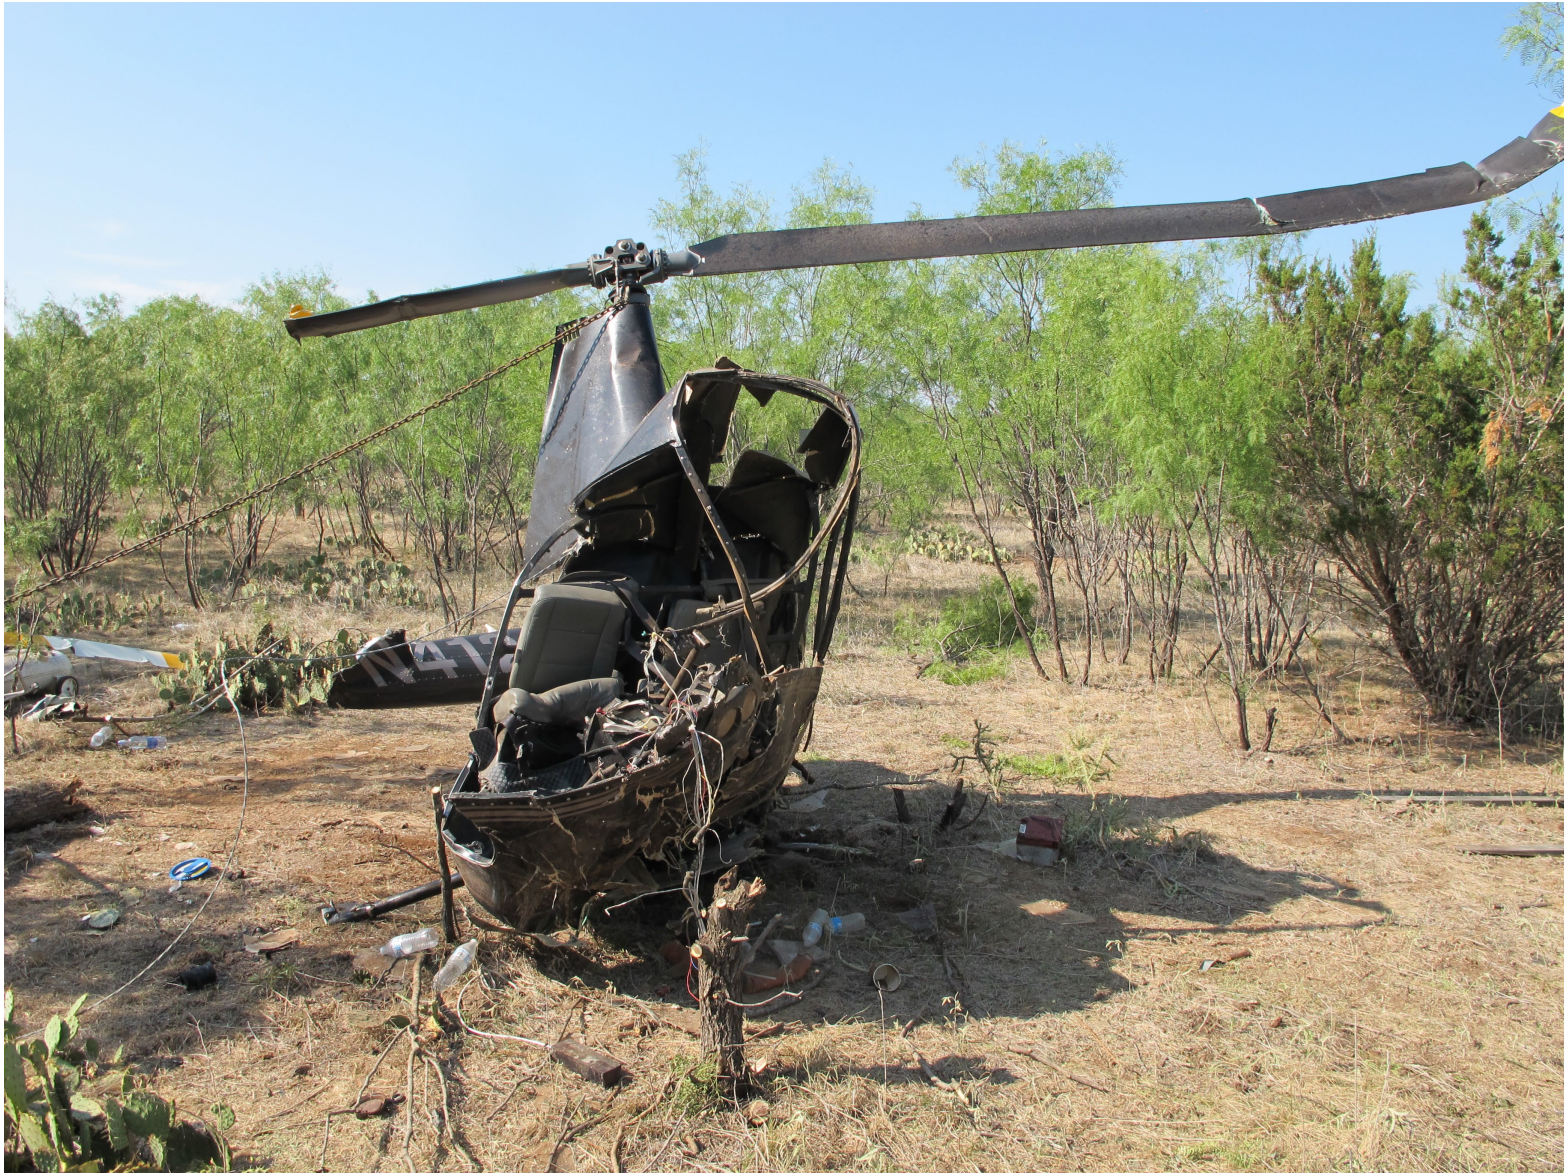
**Photograph 1 - Helicopter Wreckage at Accident Site (Courtesy of NTSB)**

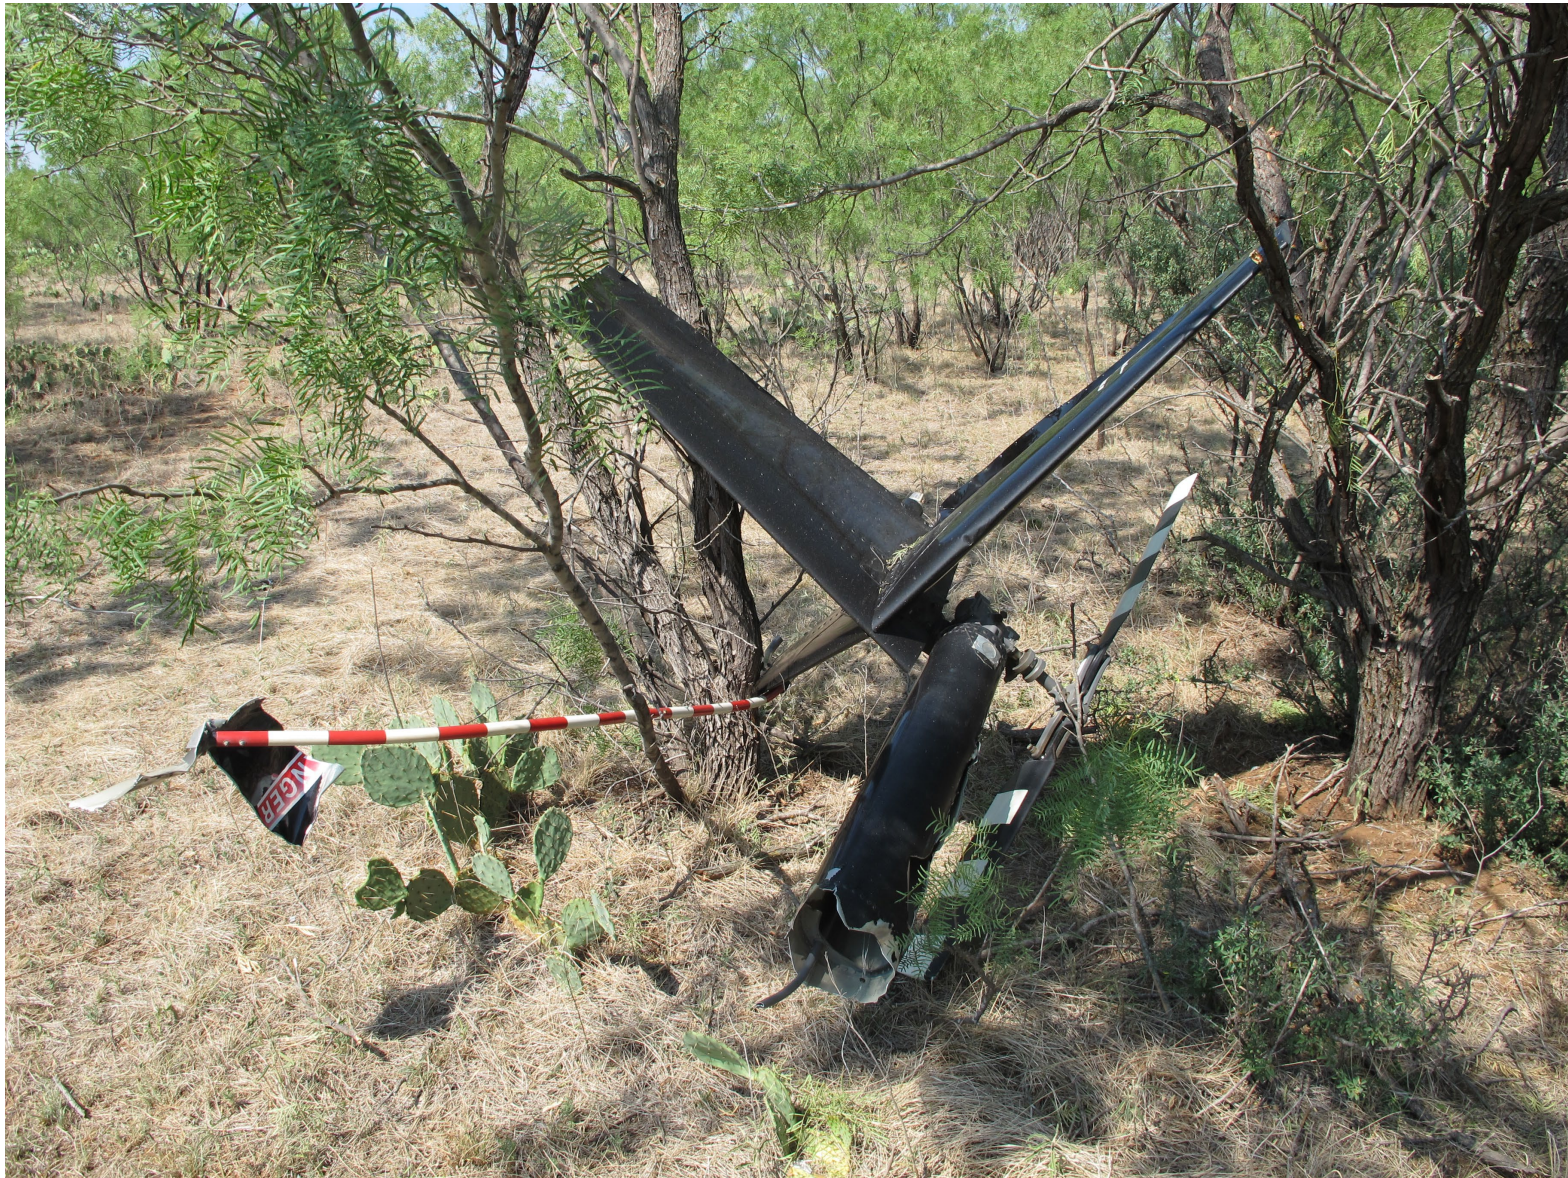
**Photograph 2 - Separated Tail Rotor Section at Accident Site (Courtesy of NTSB)**

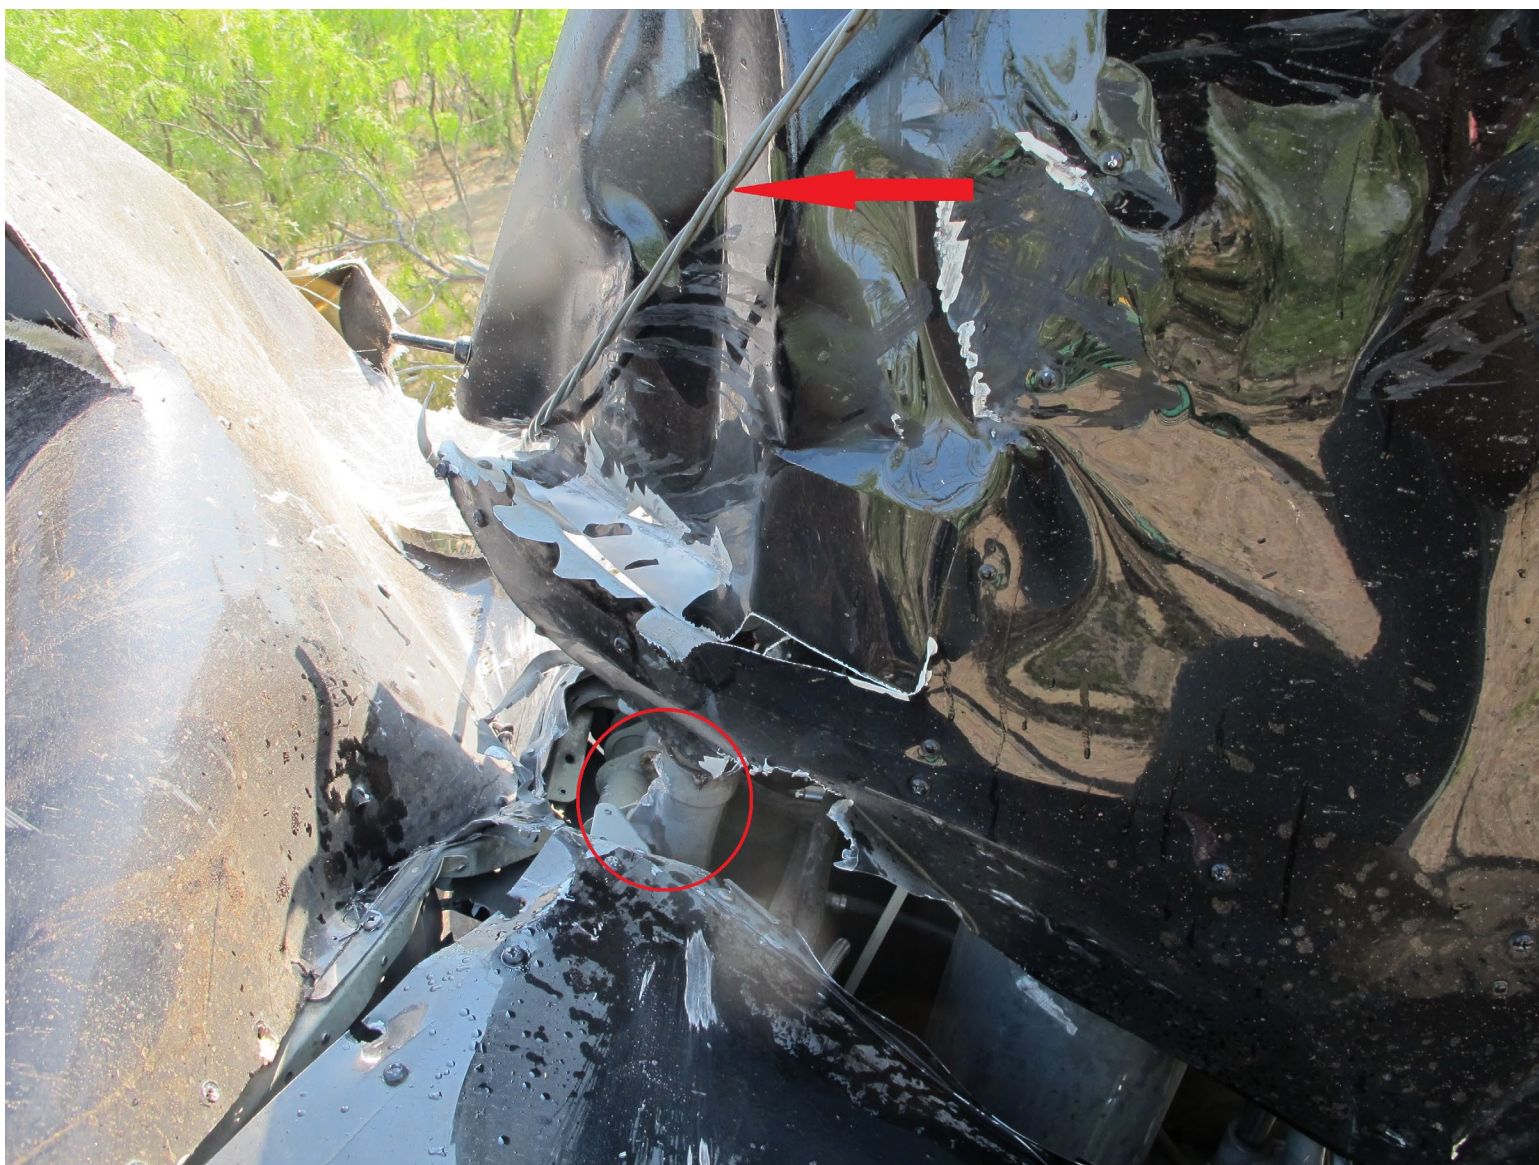
**Photograph 3 - Wire Wrapped Around Swashplate and Mast Fairing (Courtesy of NTSB)**

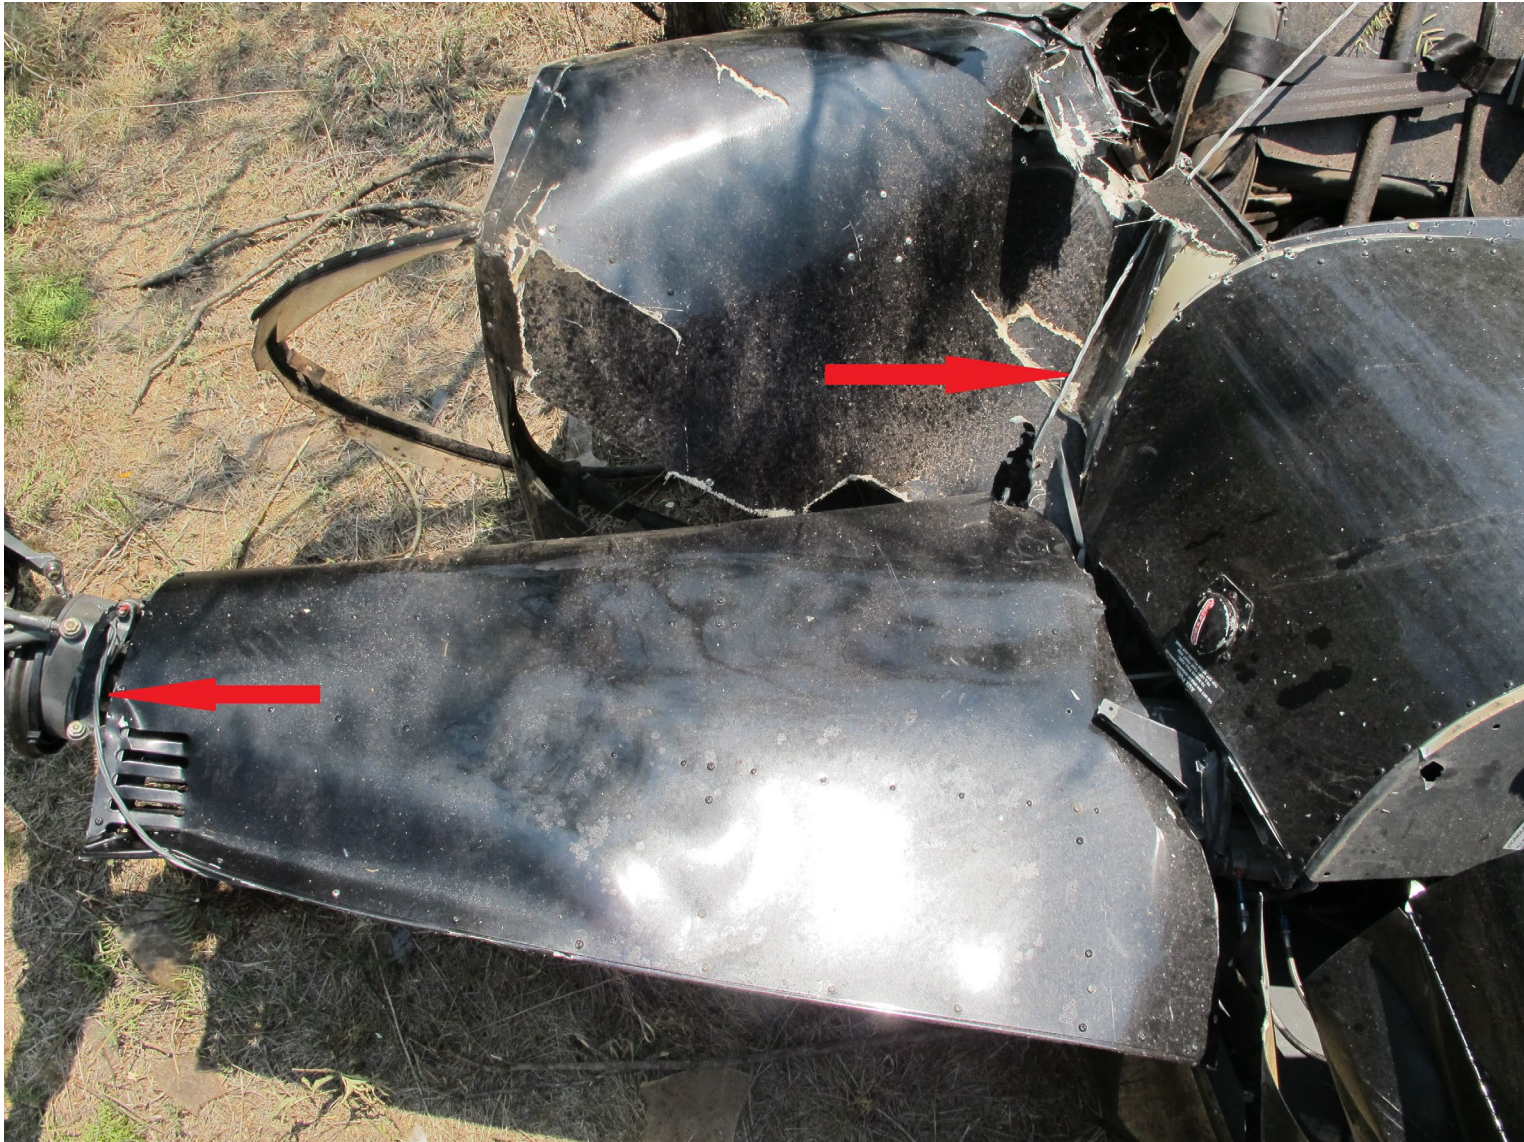
**Photograph 4 - Wire Wrapped Around Swashplate and Lower Mast Fairing (Courtesy of NTSB)**

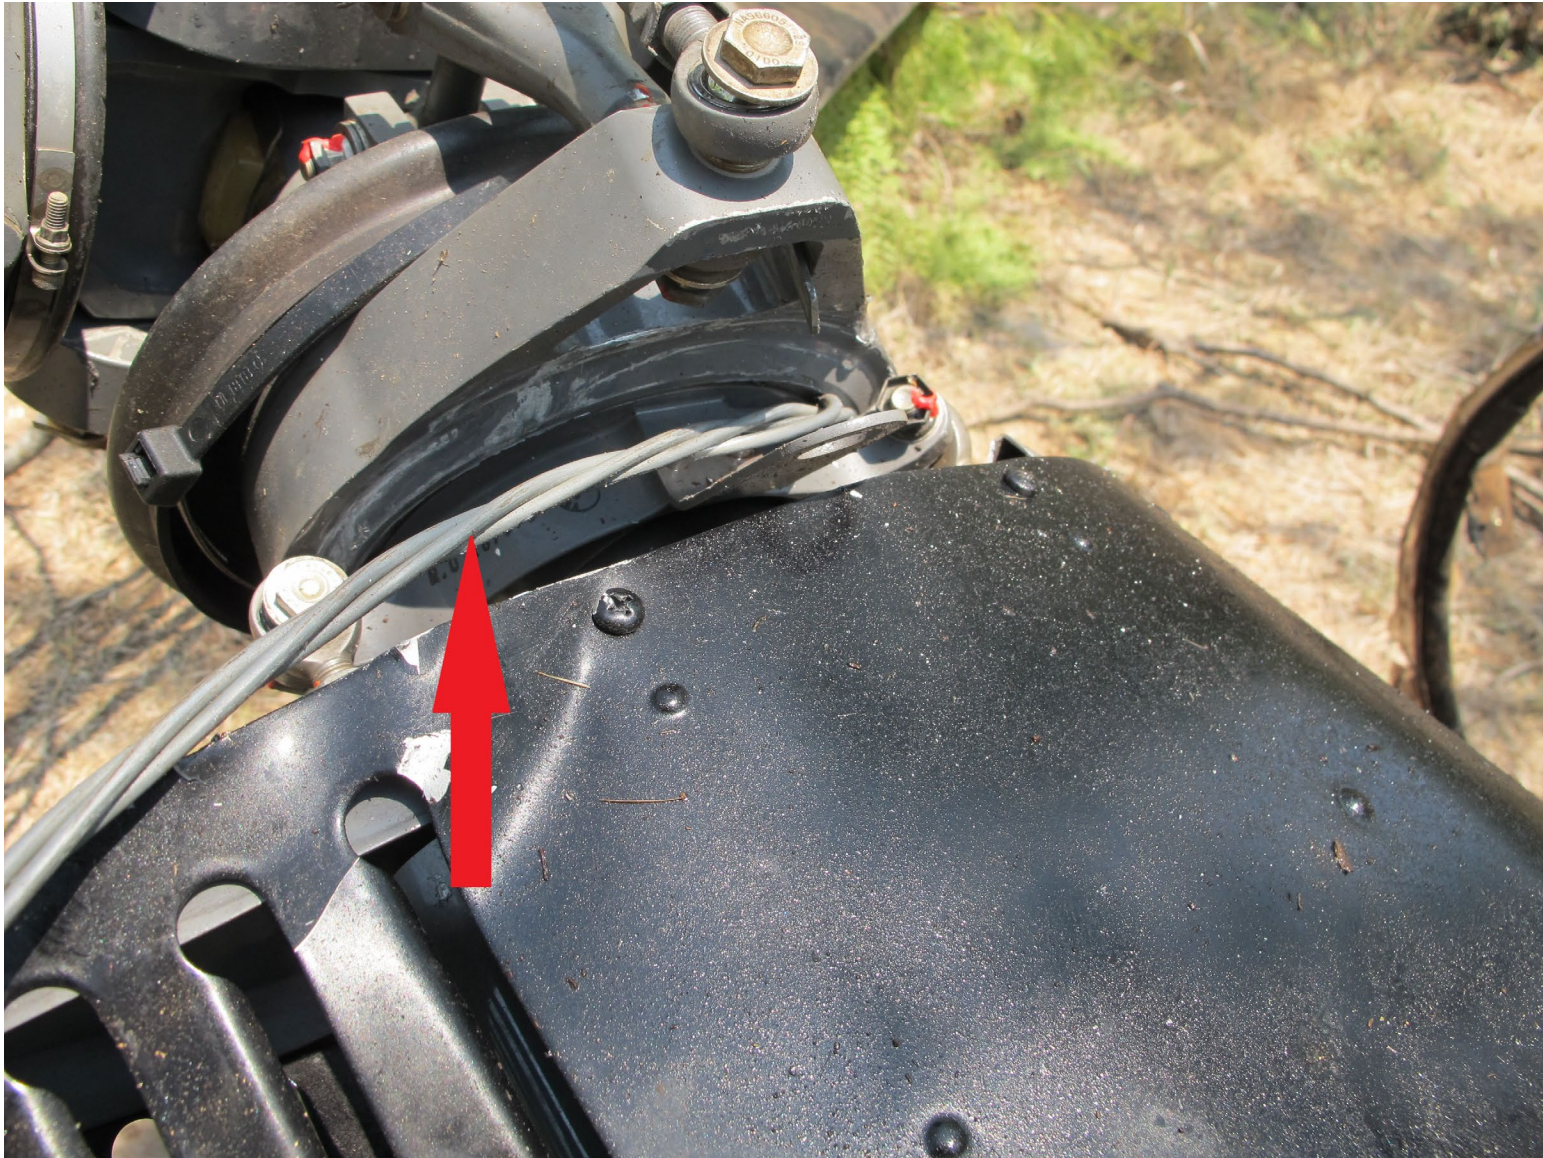
**Photograph 6 - Wire Wrapped Around Leading Edge of Swashplate (Courtesy of NTSB)**

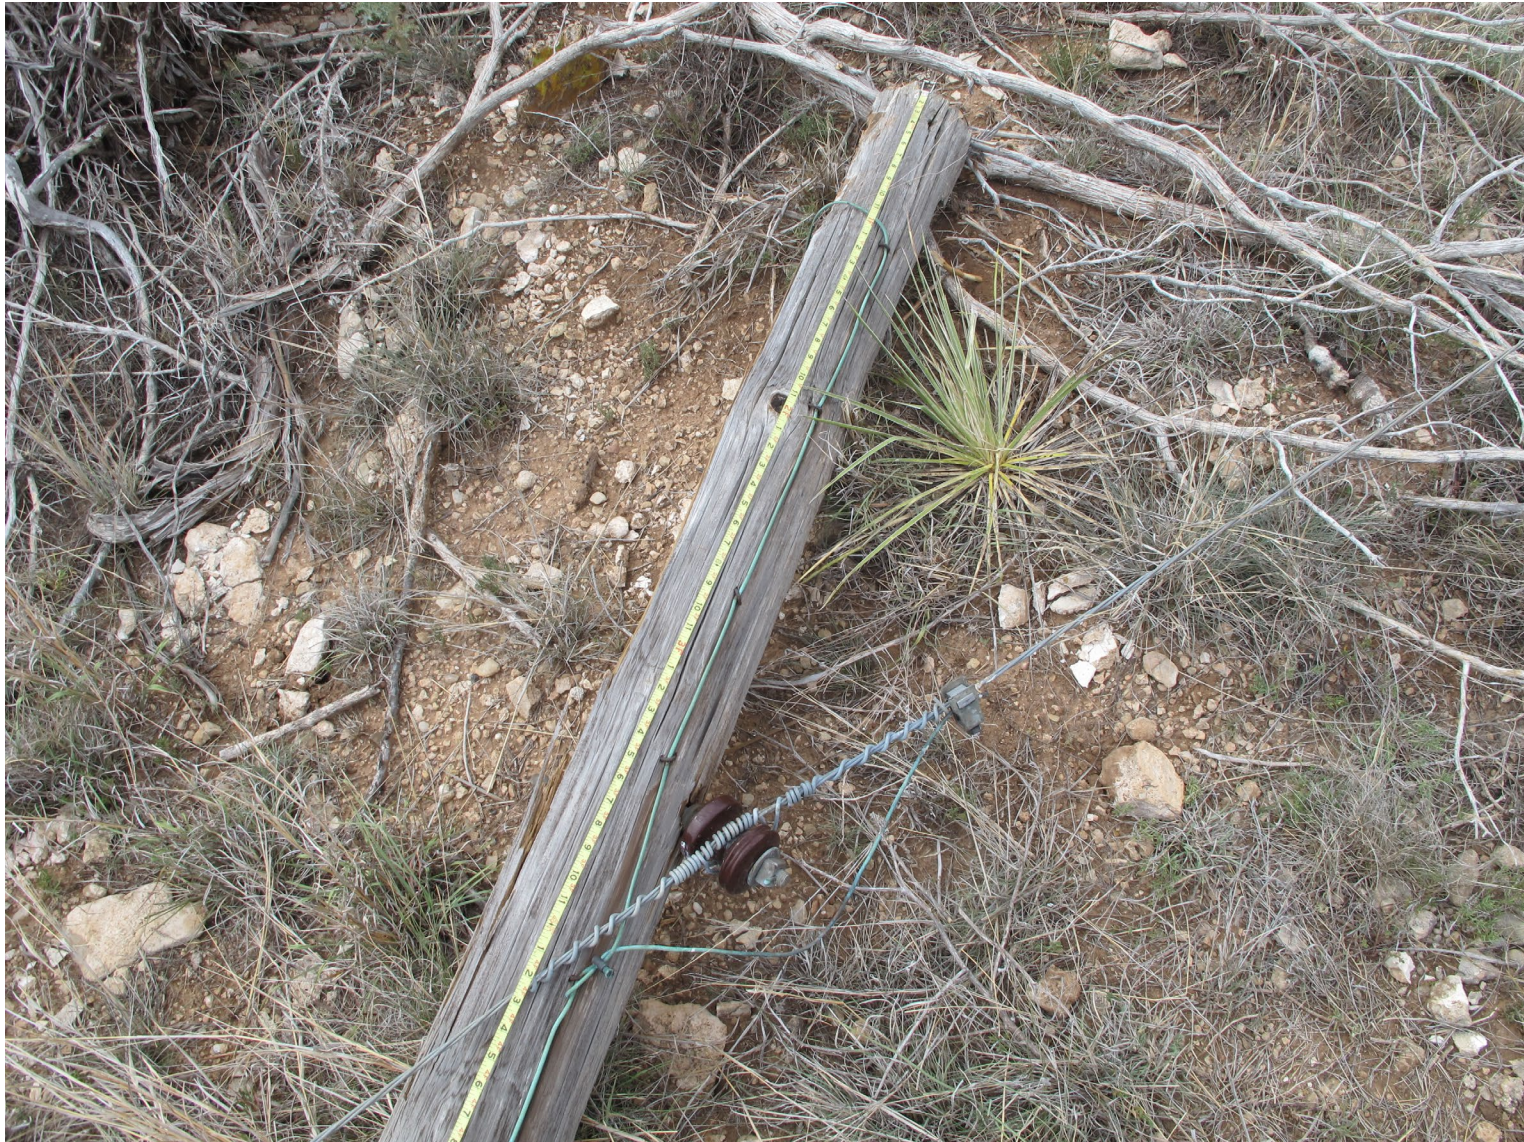
**Photograph 7 - Broken Pole and Wire (Courtesy of NTSB)**

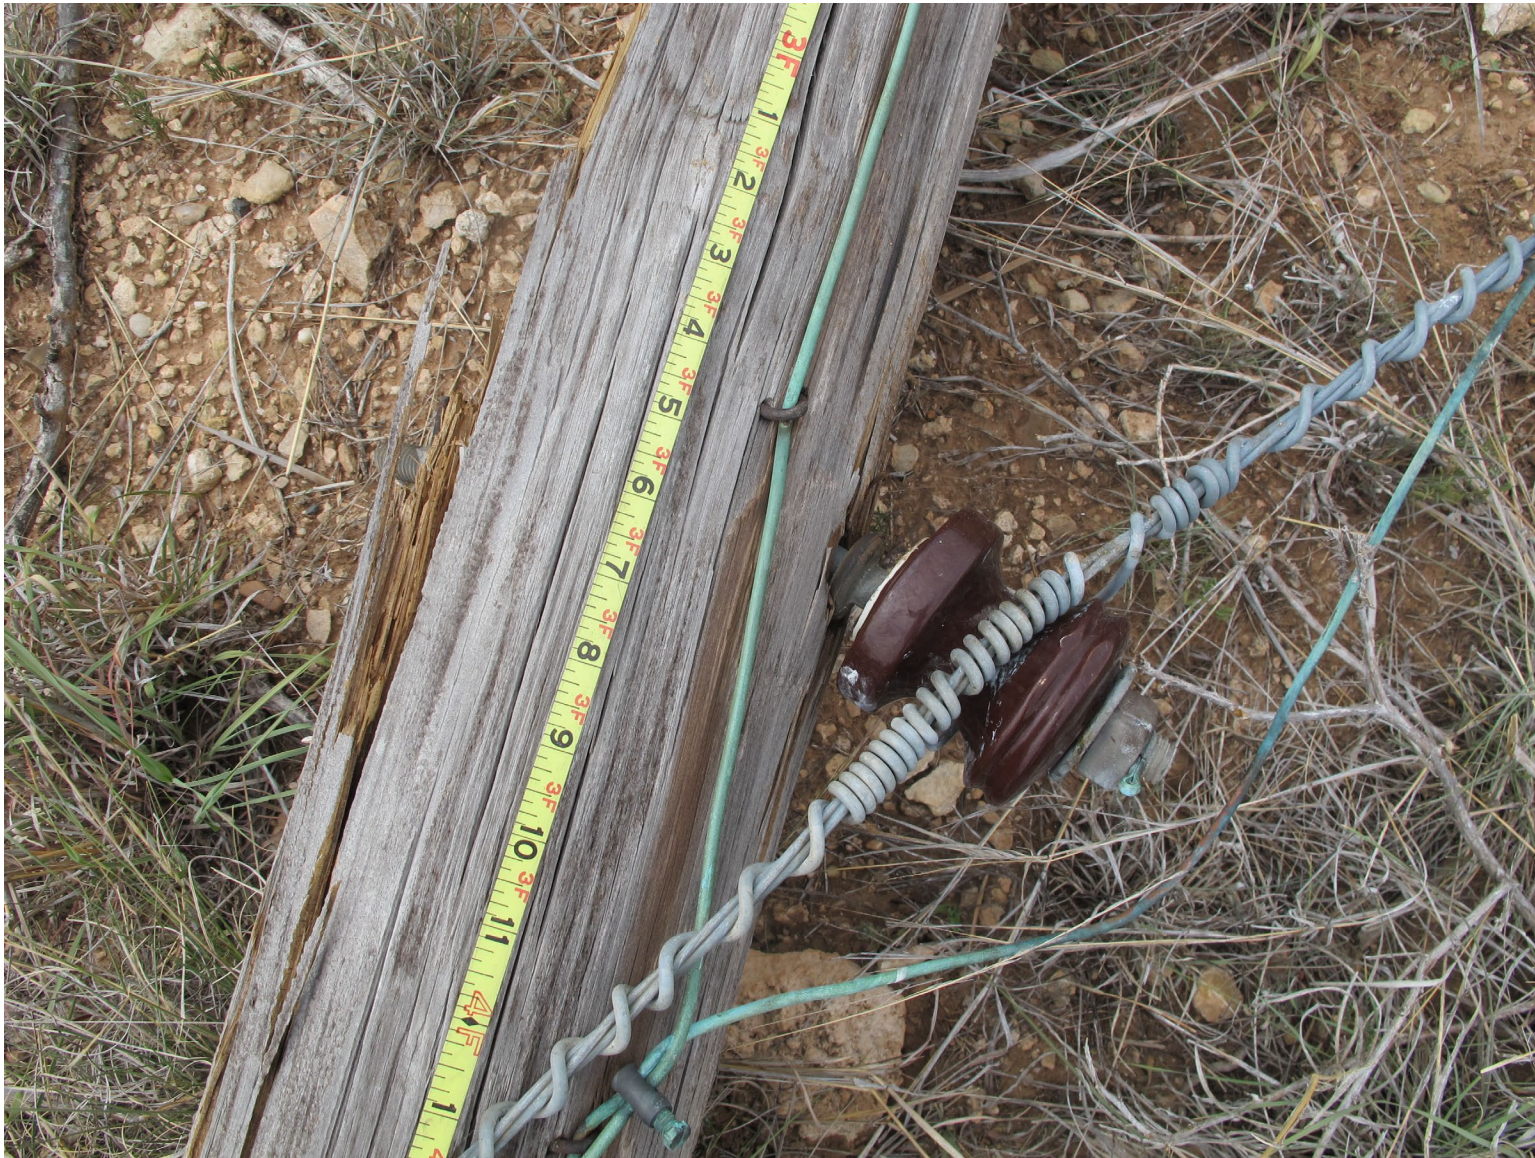
**Photograph 8 - Closeup of Broken Pole and Wire (Courtesy of NTSB)**
