# National Transportation Safety Board

CEN22FA331

## COMPUTED TOMOGRAPHY

Helicopter: Columbia Helicopters CH-47D, N388RA, SN 88-0097

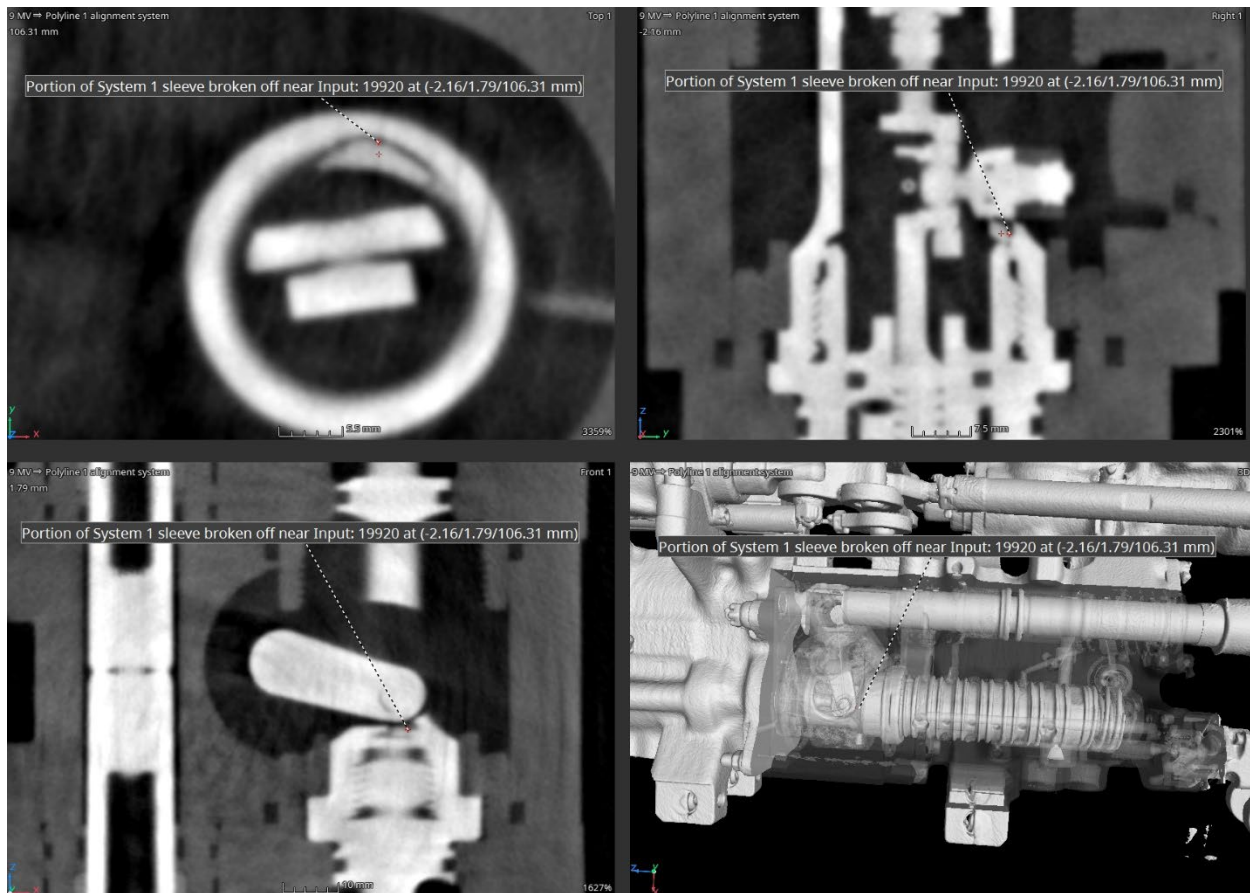
The CT images of the System 1 boost section of the yaw ILCA were examined. A piece of the sleeve assembly was fractured near the input connection (Figures 8 and 9). There were indications of medium density material in the C4 passageway annular groove (Figure 10), jam pressure passageway annular groove (Figure 12), P2 passageway annular groove (Figures 13 and 14), C3 passageway annular groove (Figure 15) and inboard R2 passageway annular groove of the servo assembly (Figure 17). The filter screens appeared to be intact for the C4 passageway annular groove (Figures 10 and 11), P2 passageway annular groove (Figures 13 and 14), and C3 passageway annular groove (Figures 15 and 16). The MS16555-619 pin was correctly located in the 12 o'clock position (Figure 18). The lower boost valve nut retaining pin (part number 145H7329-1) was installed (Figure 19). There were indications of a low density area in the 145H7356-2 piston ring set (Figure 20).

**Figure 8.** CT images of System 1 portion of yaw ILCA illustrating damage to sleeve near input connection.

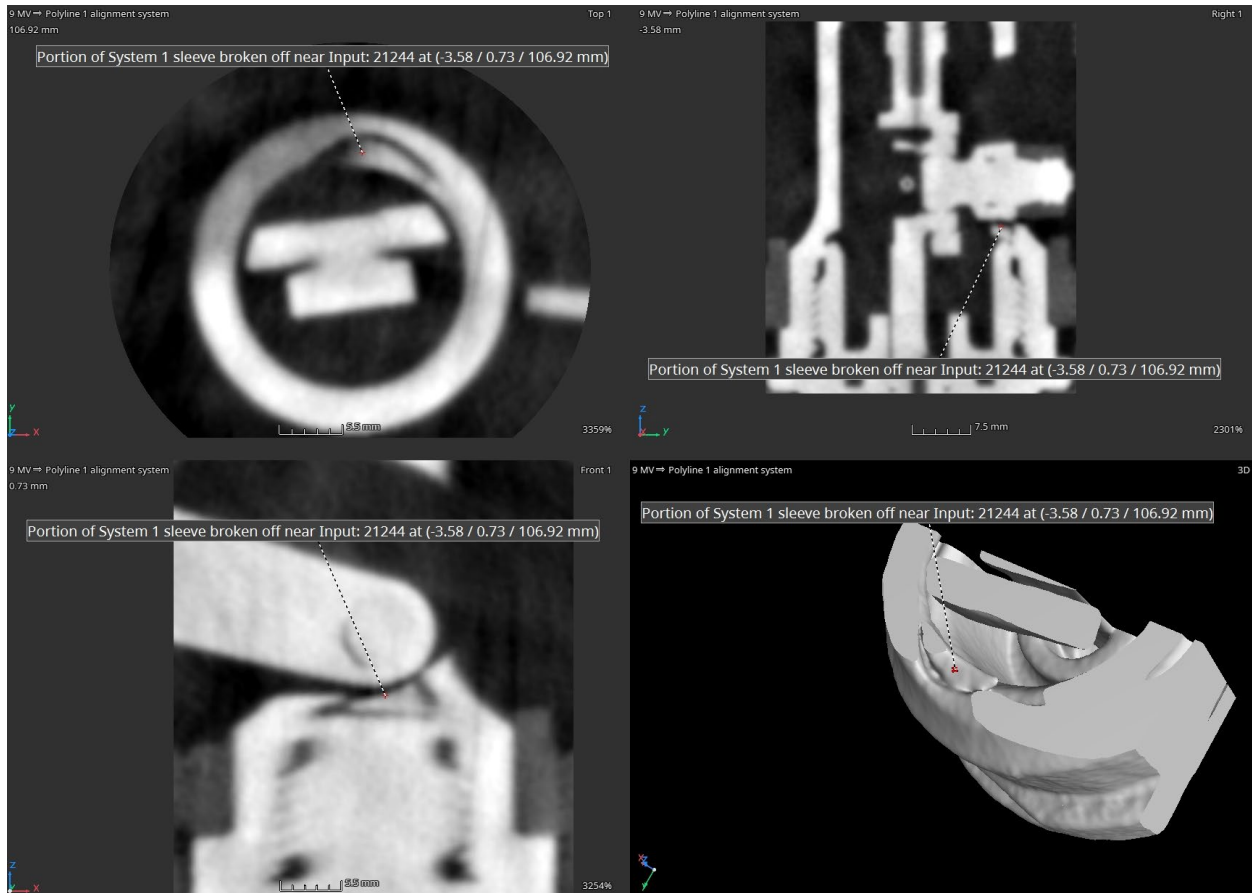
**Figure 9.** CT images of System 1 portion of yaw ILCA close-up of damage to sleeve near input connection.

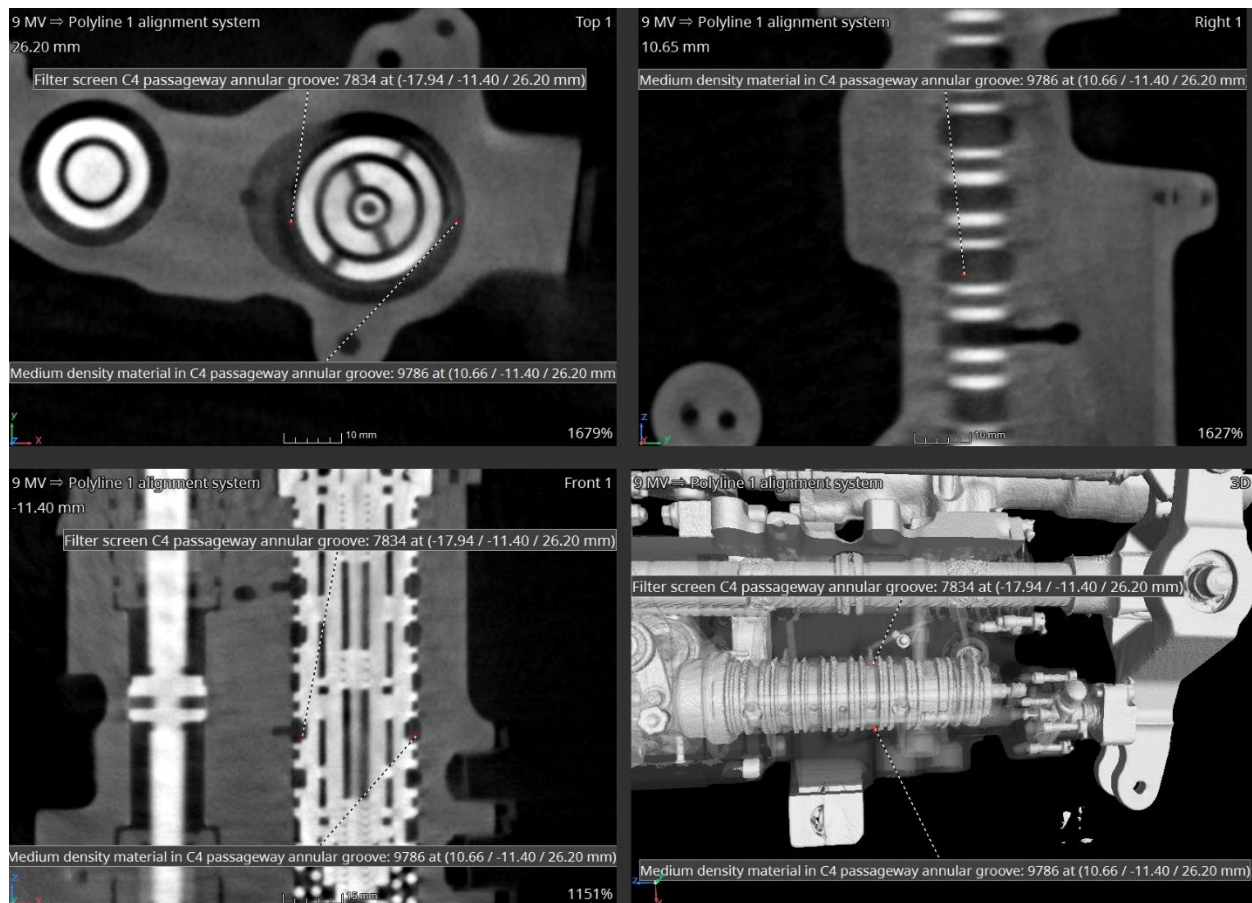
**Figure 10.** CT images of System 1 portion of yaw ILCA illustrating medium density material and filter screen in the C4 passageway annular groove between the sleeve and housing. (9 MV)

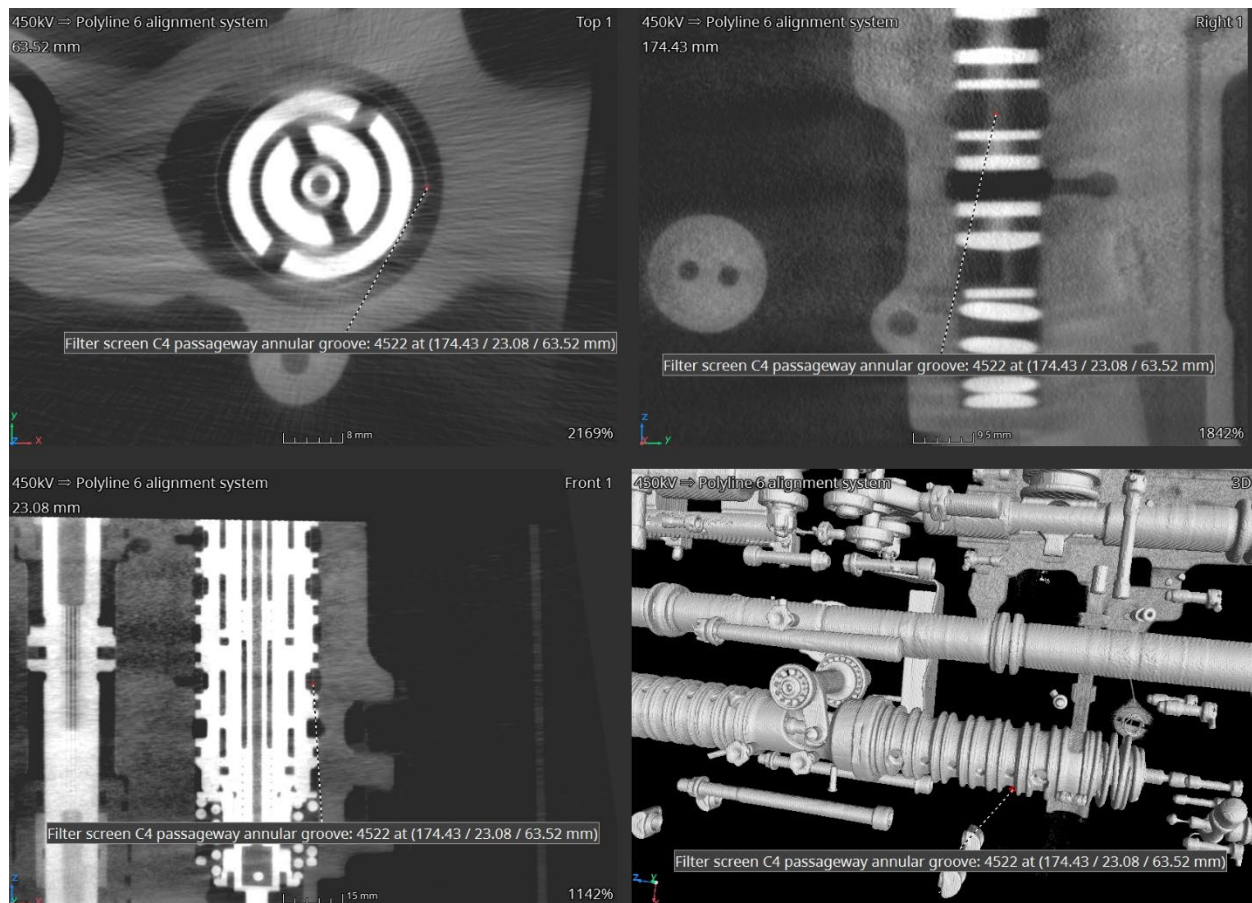
**Figure 11.** CT images of System 1 portion of yaw ILCA illustrating the filter screen in the C4 passageway annular groove. (450 kV)

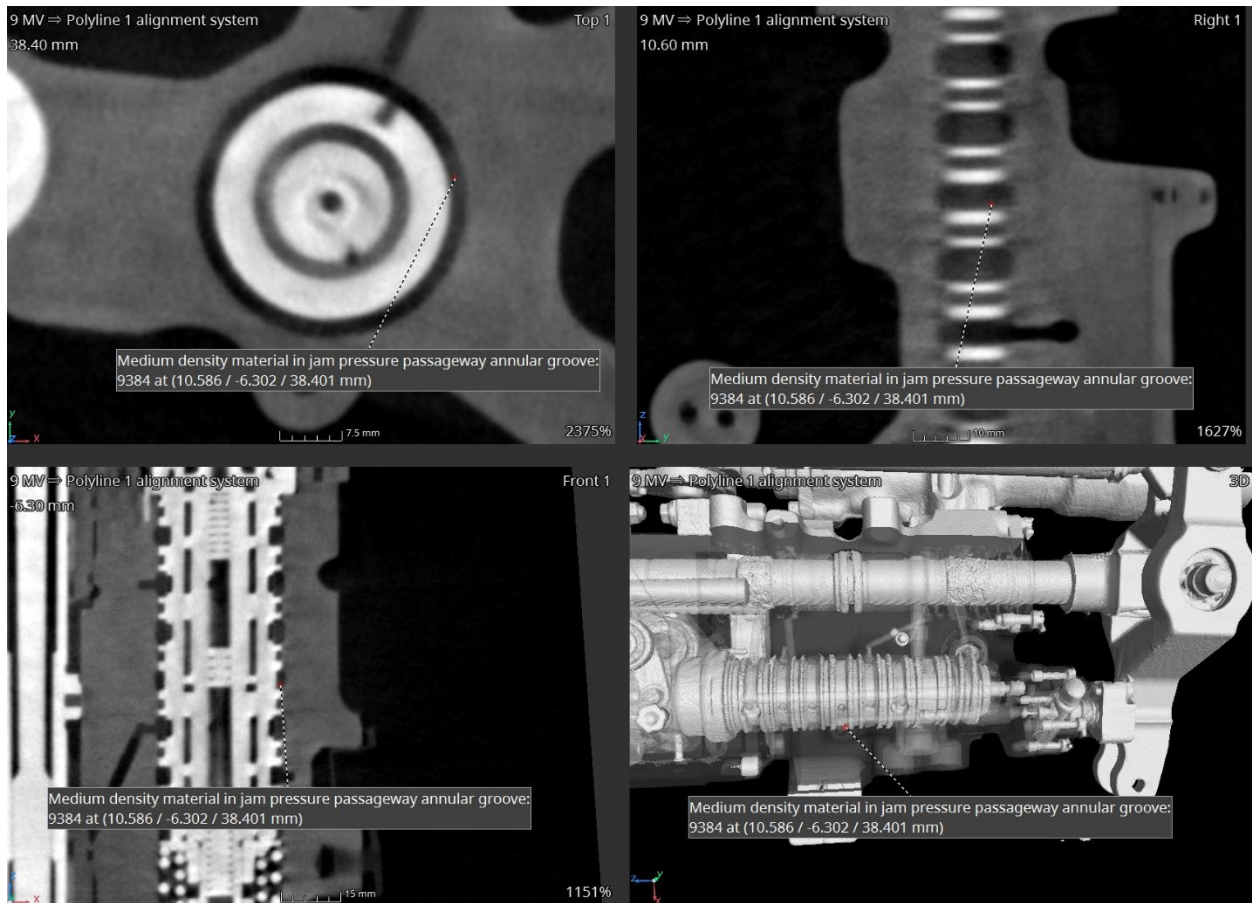
**Figure 12.** CT images of System 1 portion of yaw ILCA illustrating medium density material in jam pressure passageway annular groove between the sleeve and housing. (9 MV)

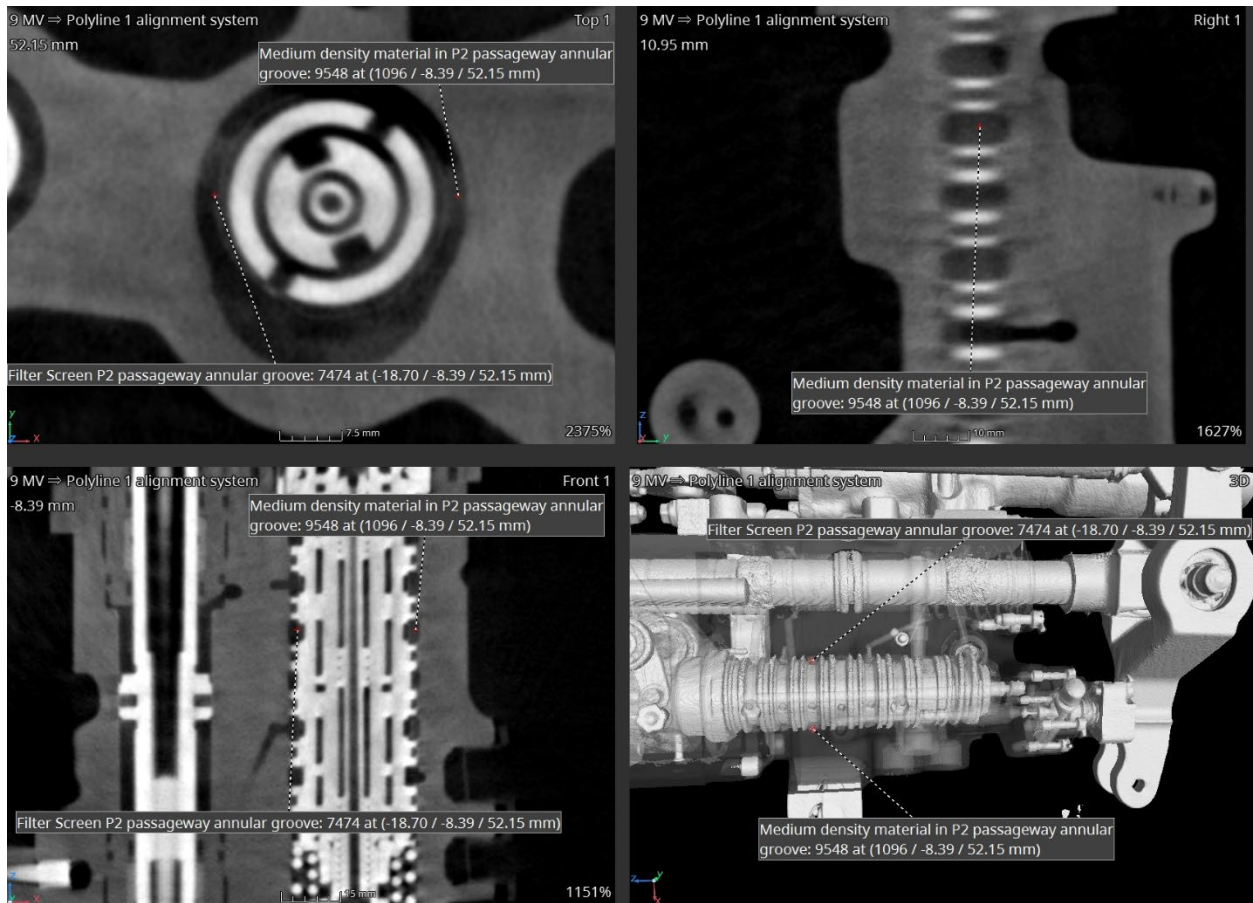
**Figure 13.** CT images of System 1 portion of yaw ILCA illustrating medium density material and filter screen in the P2 passageway annular groove between the sleeve and housing. (9 MV)

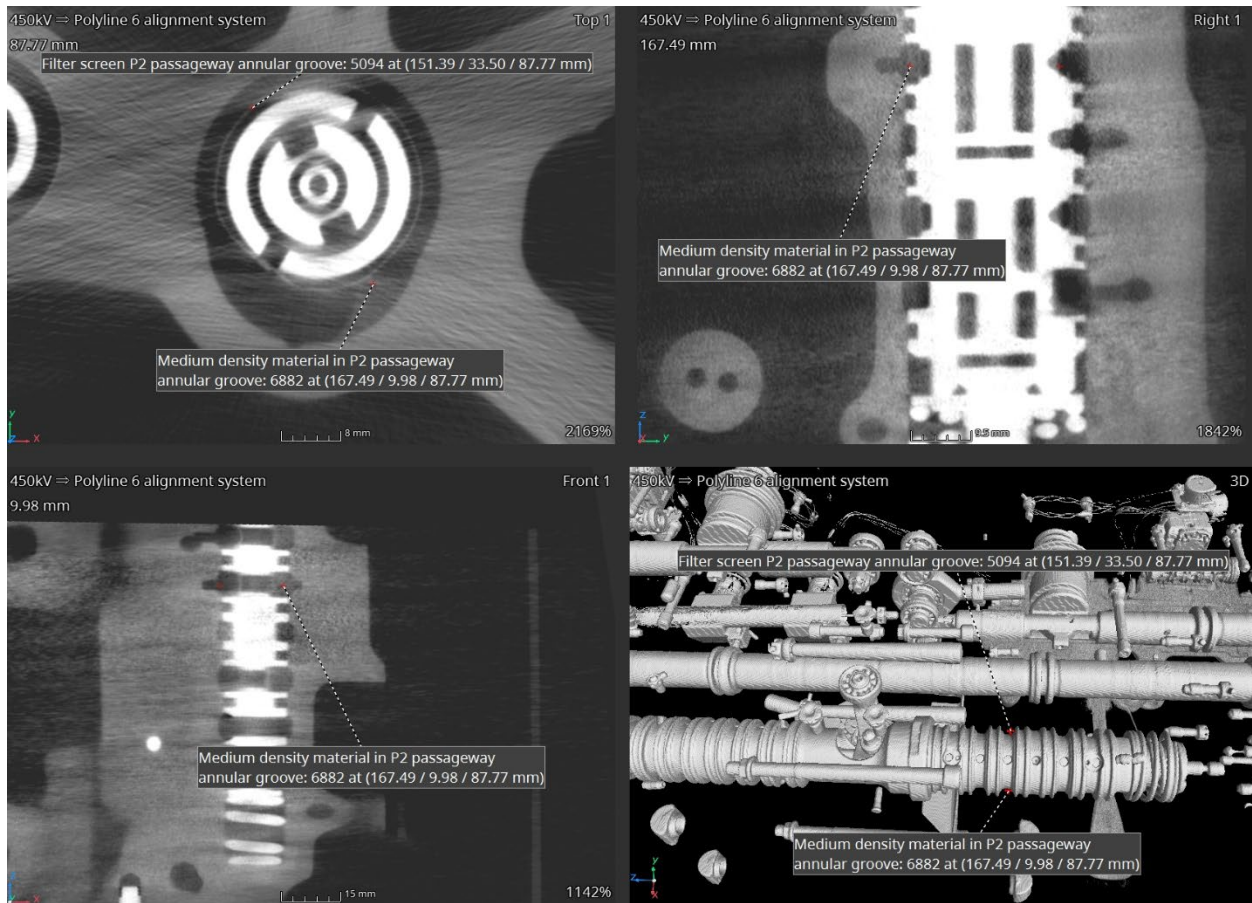
**Figure 14.** CT images of System 1 portion of the yaw ILCA illustrating medium density material and the filter screen in the P2 passageway annular groove between the sleeve and housing. (450 kV)

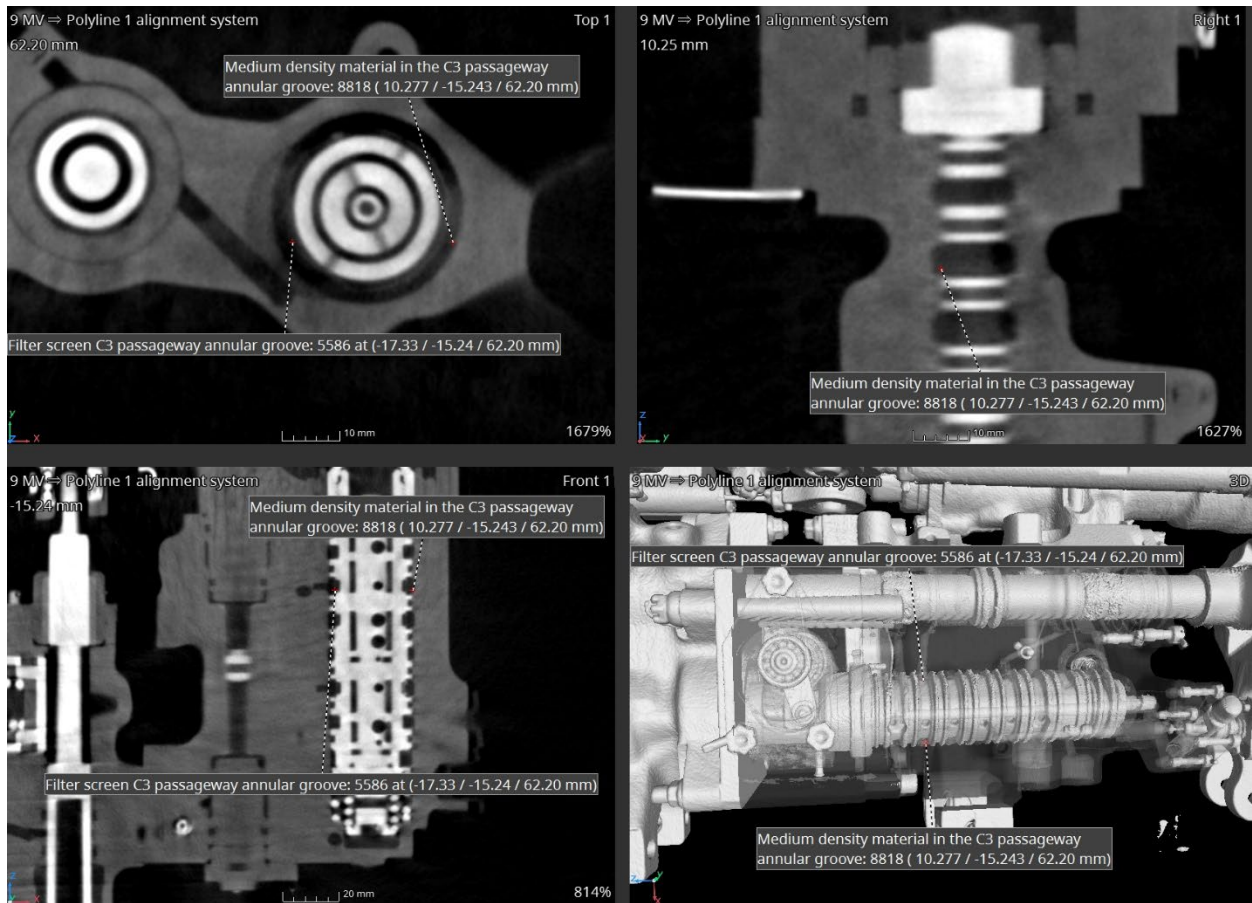
**Figure 15.** CT images of System 1 portion of the yaw ILCA illustrating medium density material and the filter screen in the C3 passageway annular groove between the sleeve and housing. (9 MV)

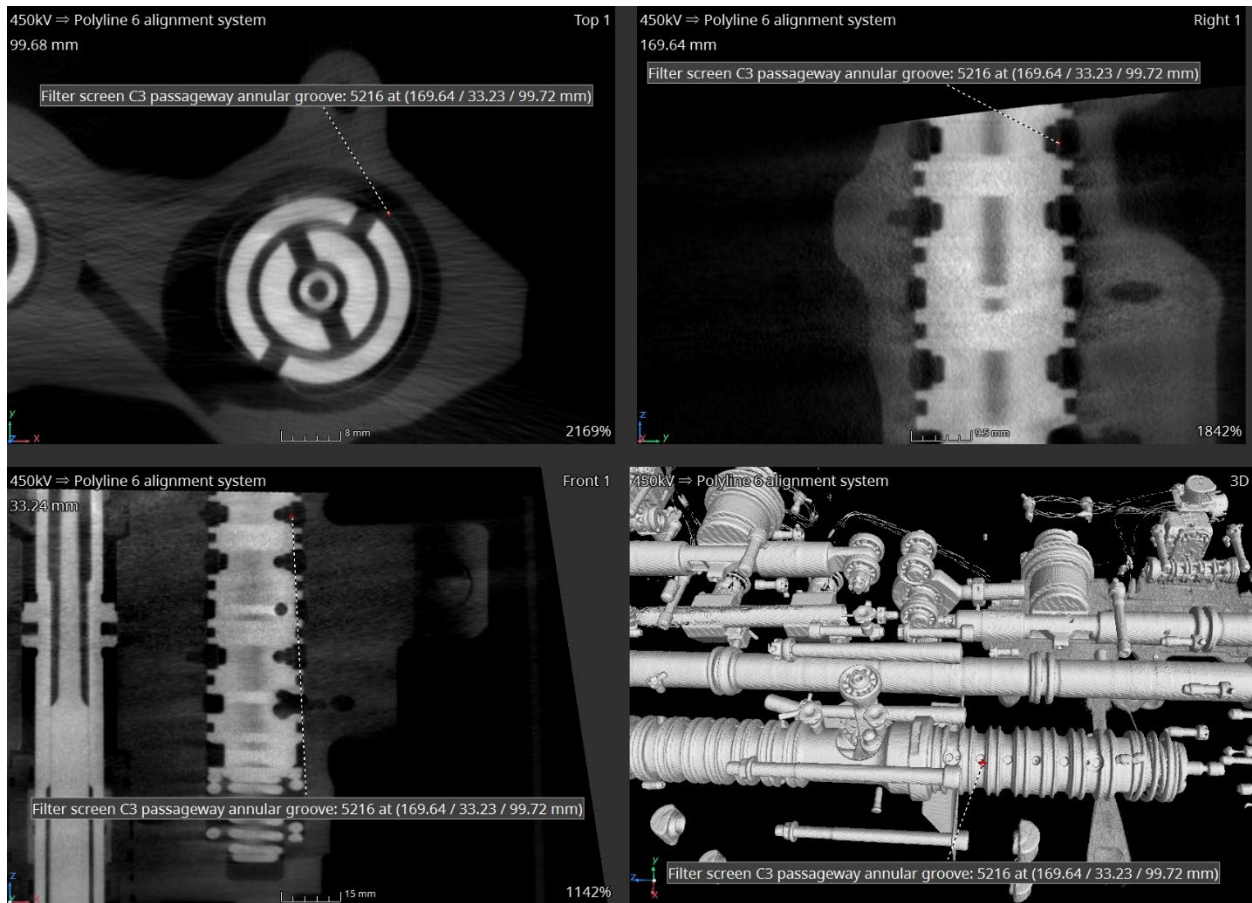
**Figure 16.** CT images of System 1 portion of the yaw ILCA illustrating the filter screen in the C3 passageway annular groove between the sleeve and housing. (450 kV)

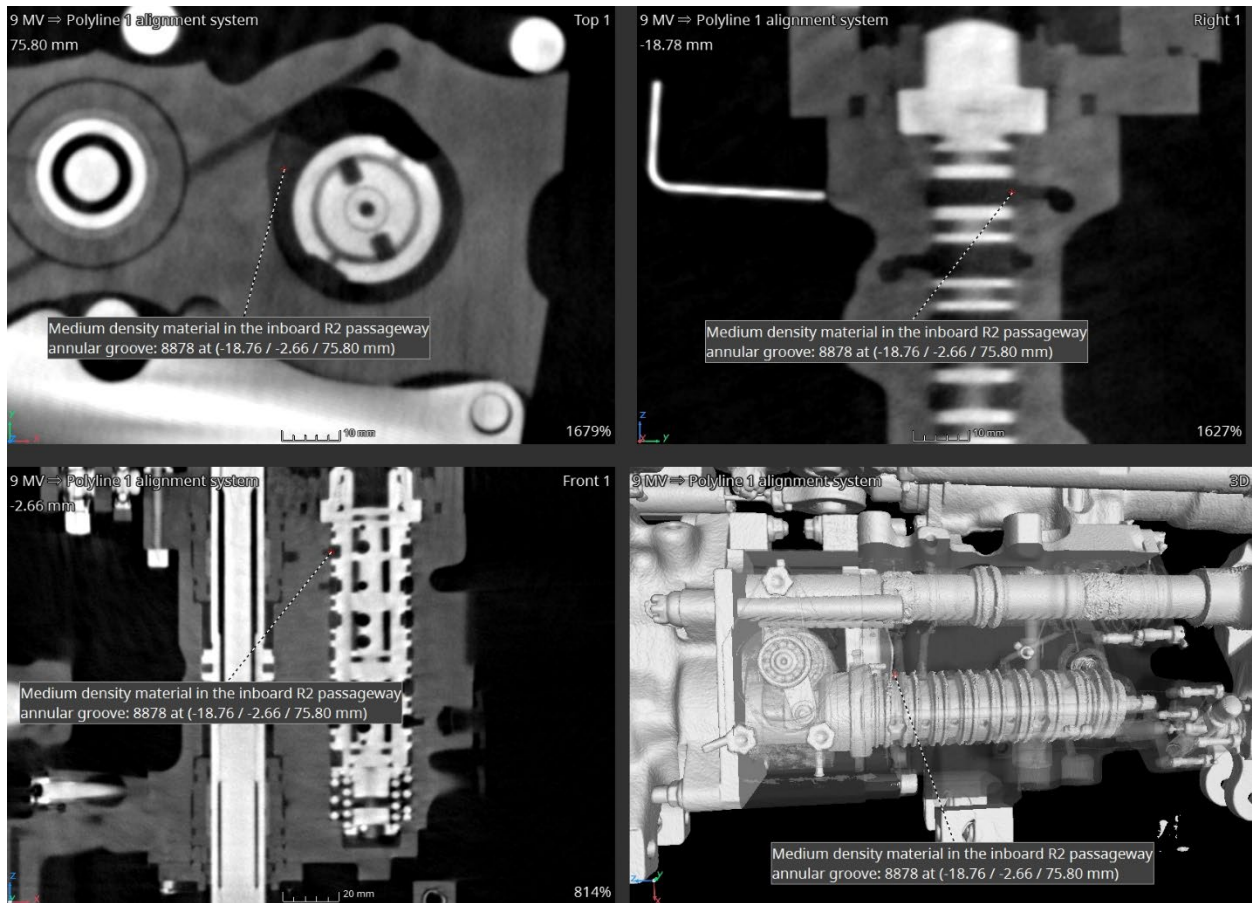
**Figure 17.** CT images of System 1 portion of the yaw ILCA illustrating medium density material in the inboard R2 passageway annular groove between the sleeve and housing.

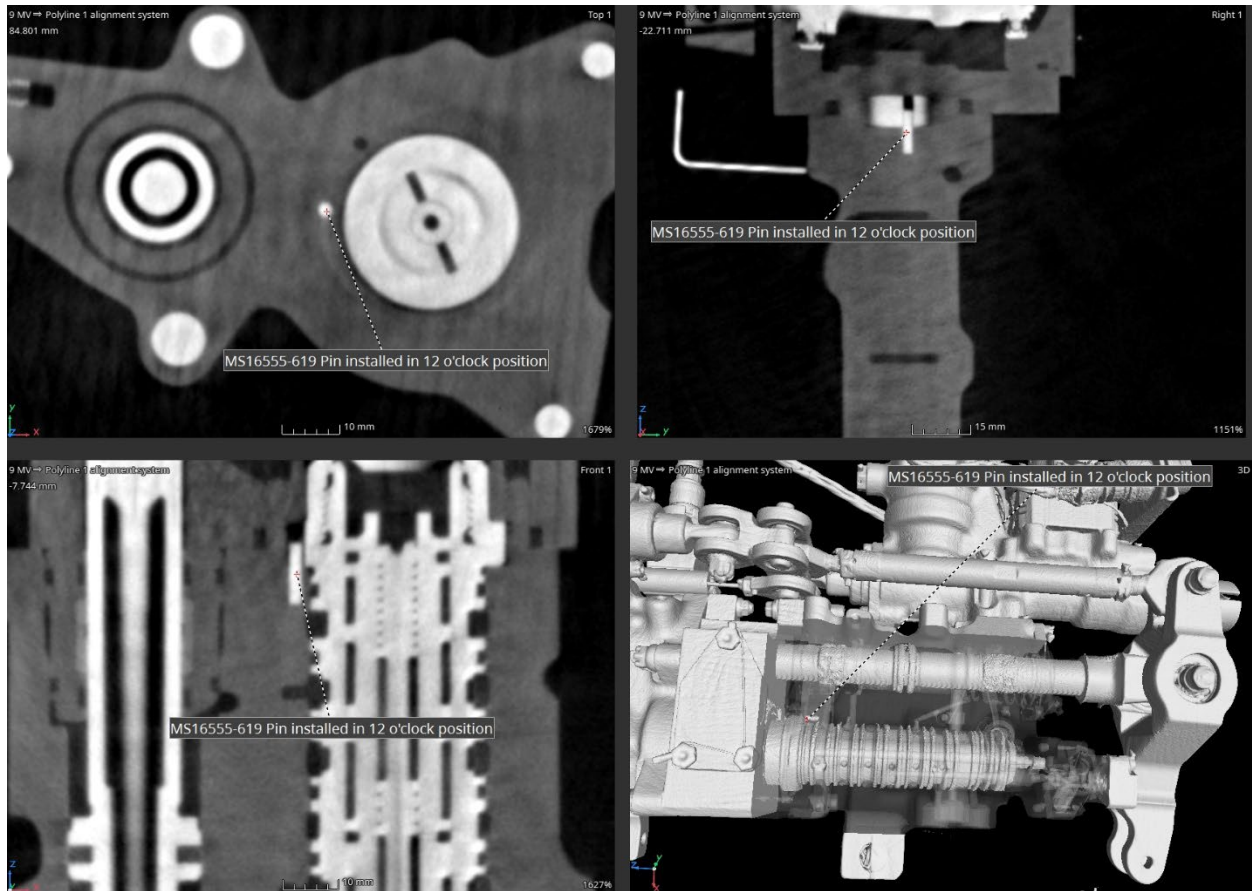
**Figure 18.** CT images of System 1 portion of the yaw ILCA illustrating the MS16555-619 pin installed in the 12 o'clock position.

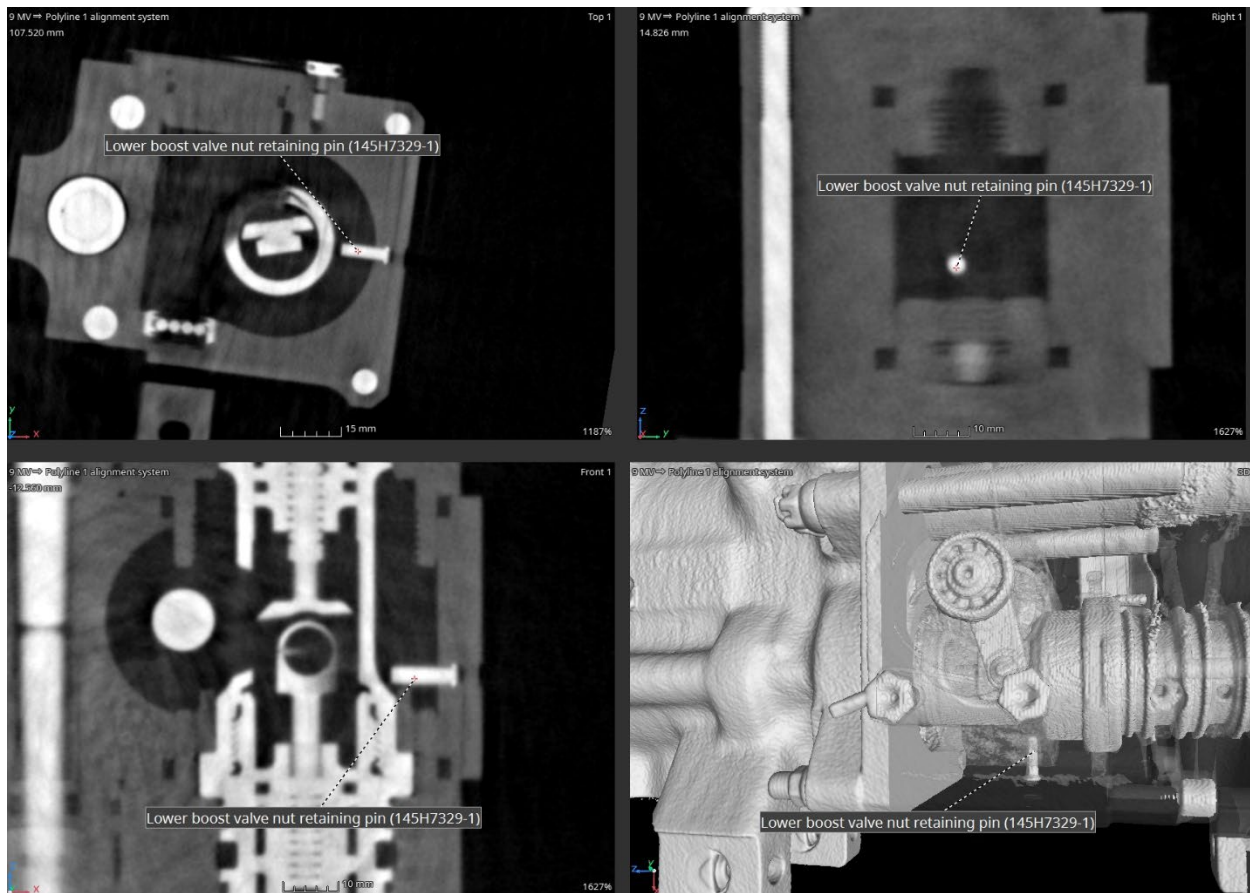
**Figure 19.** CT images of System 1 portion of the yaw ILCA illustrating the lower boost valve nut retaining pin (145H7329-1).

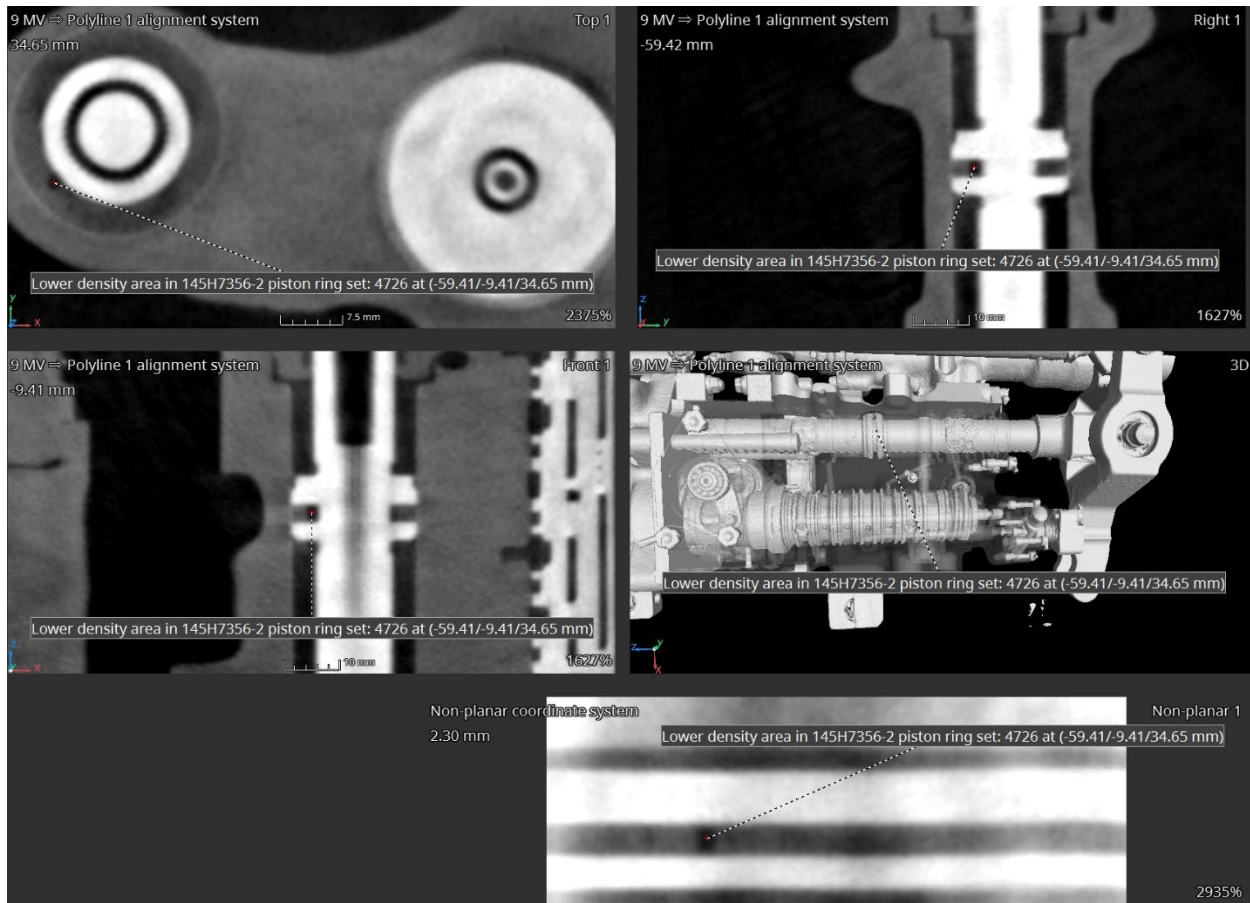
**Figure 20.** CT images of System 1 portion of the yaw ILCA illustrating lower density area in 145H7356-2 piston ring set.

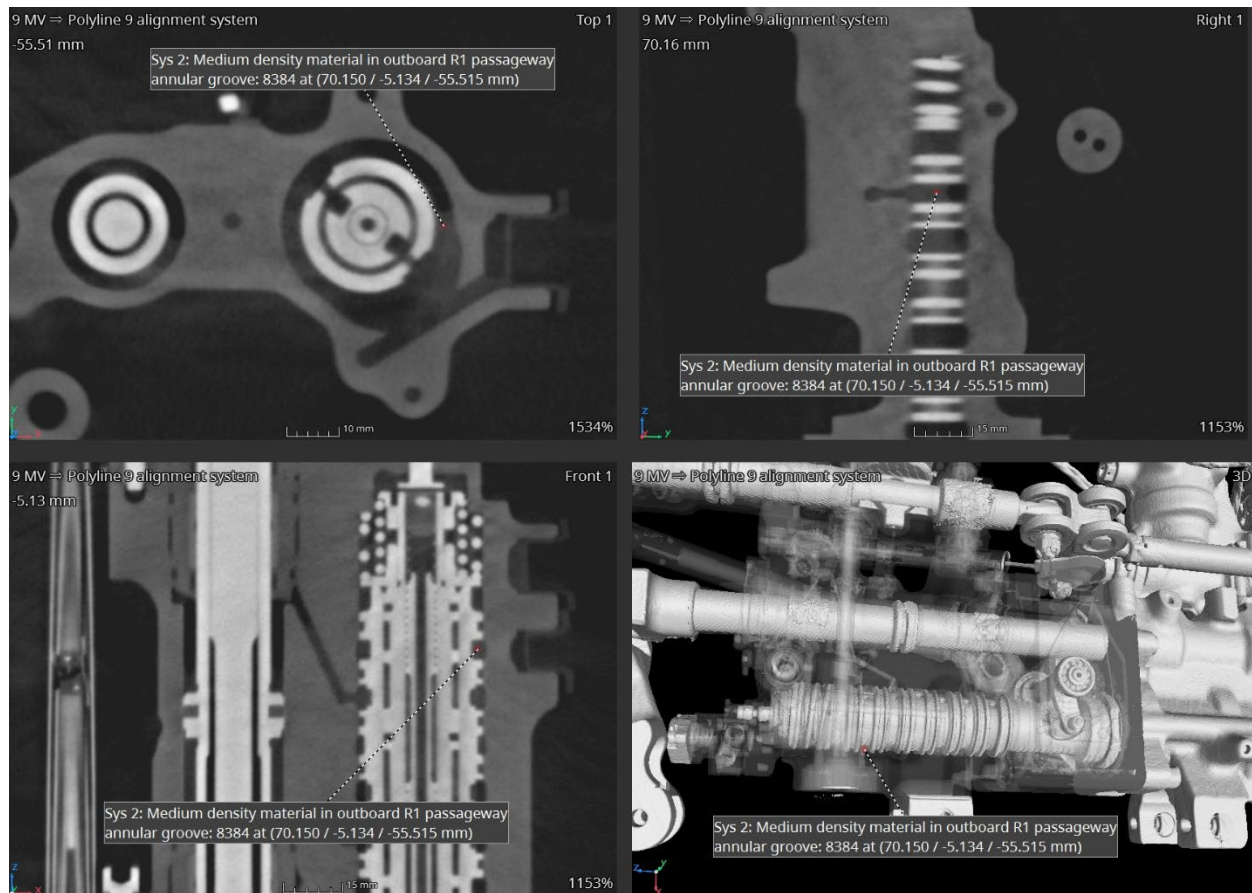
The CT images of the System 2 boost section of the yaw ILCA were examined. There were indications of medium density material in the outboard R1 passageway annular groove (Figure 24), C1 passageway annular groove (Figure 25), P1 passageway annular groove (Figure 26), C2 passageway annular groove (Figure 27) and the inboard R1 passageway annular groove of the servo assembly (Figure 28). The filter screens appeared to be intact for the C1 passageway annular groove (Figure 25), P1 passageway annular groove (Figure 26), and C2 passageway annular groove (Figure 27). There were indications of a low density area in the 145H7356-2 piston ring set (Figure 29). There were indications of medium density material around the piston shaft (Figure 30).

**Figure 24.** CT images of System 2 portion of the yaw ILCA illustrating medium density material in the outboard R1 passageway annular groove between the sleeve and housing. (9 MV)

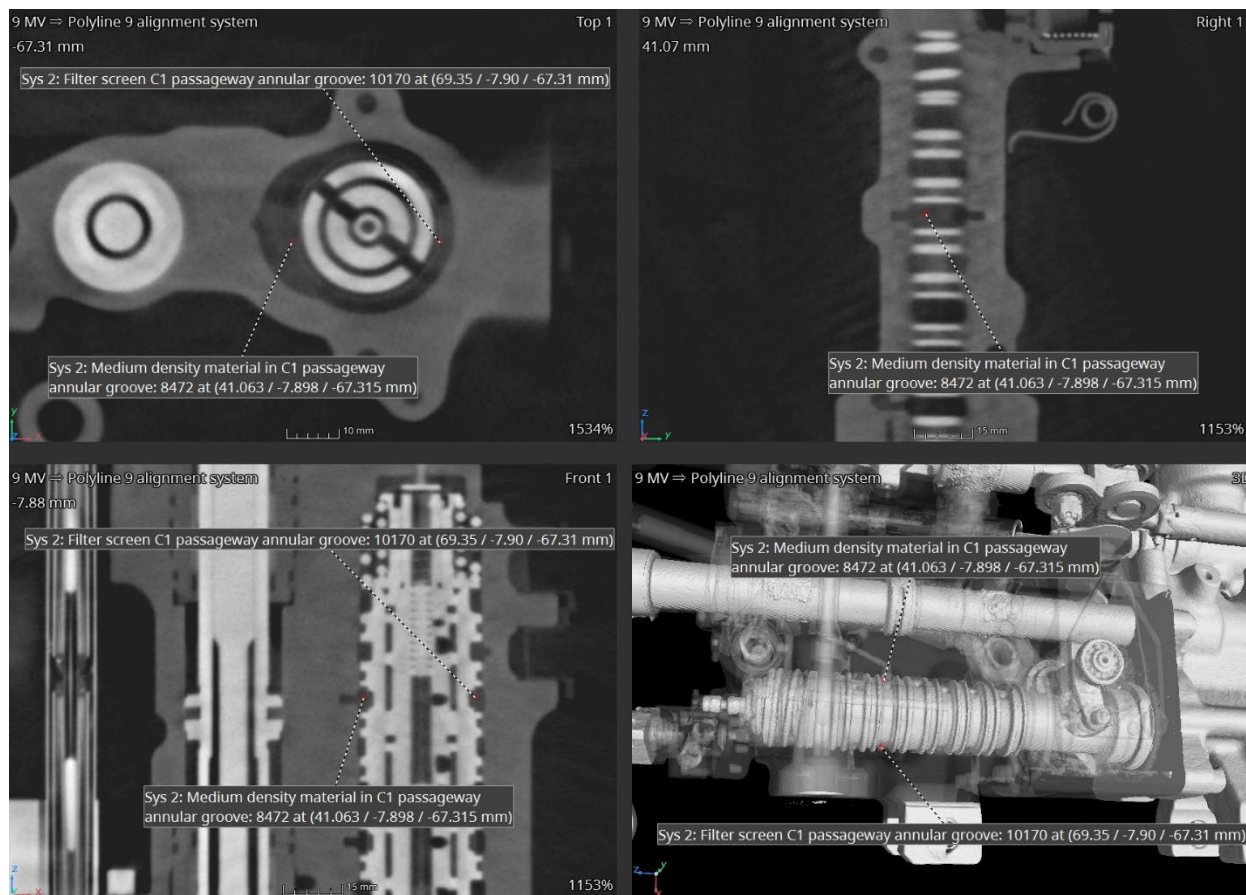
**Figure 25.** CT images of System 2 portion of the yaw ILCA illustrating medium density material and filter screen in the C1 passageway annular groove between the sleeve and housing. (9 MV)

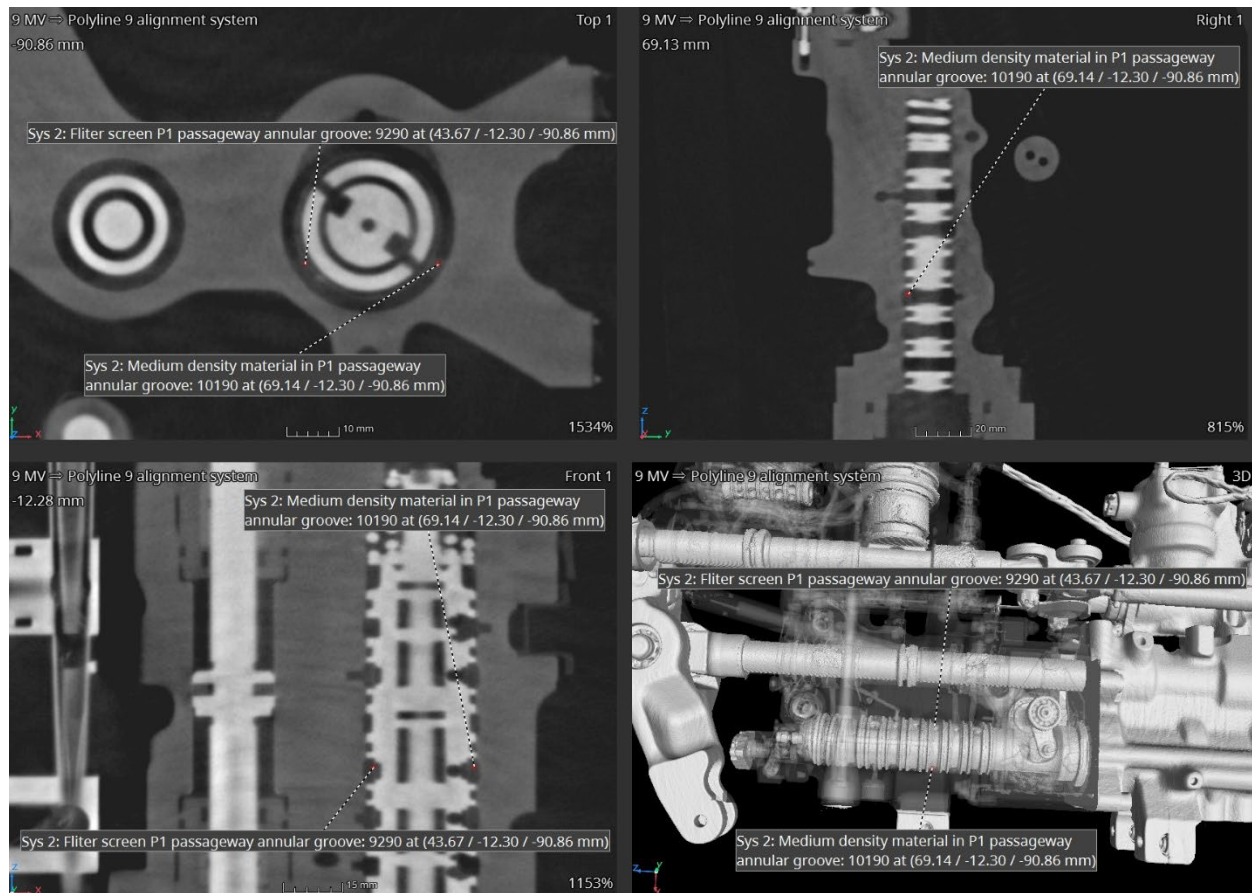
**Figure 26.** CT images of the System 2 portion of yaw ILCA illustrating medium density material and filter screen in the P1 passageway annular groove between the sleeve and housing. (9 MV)

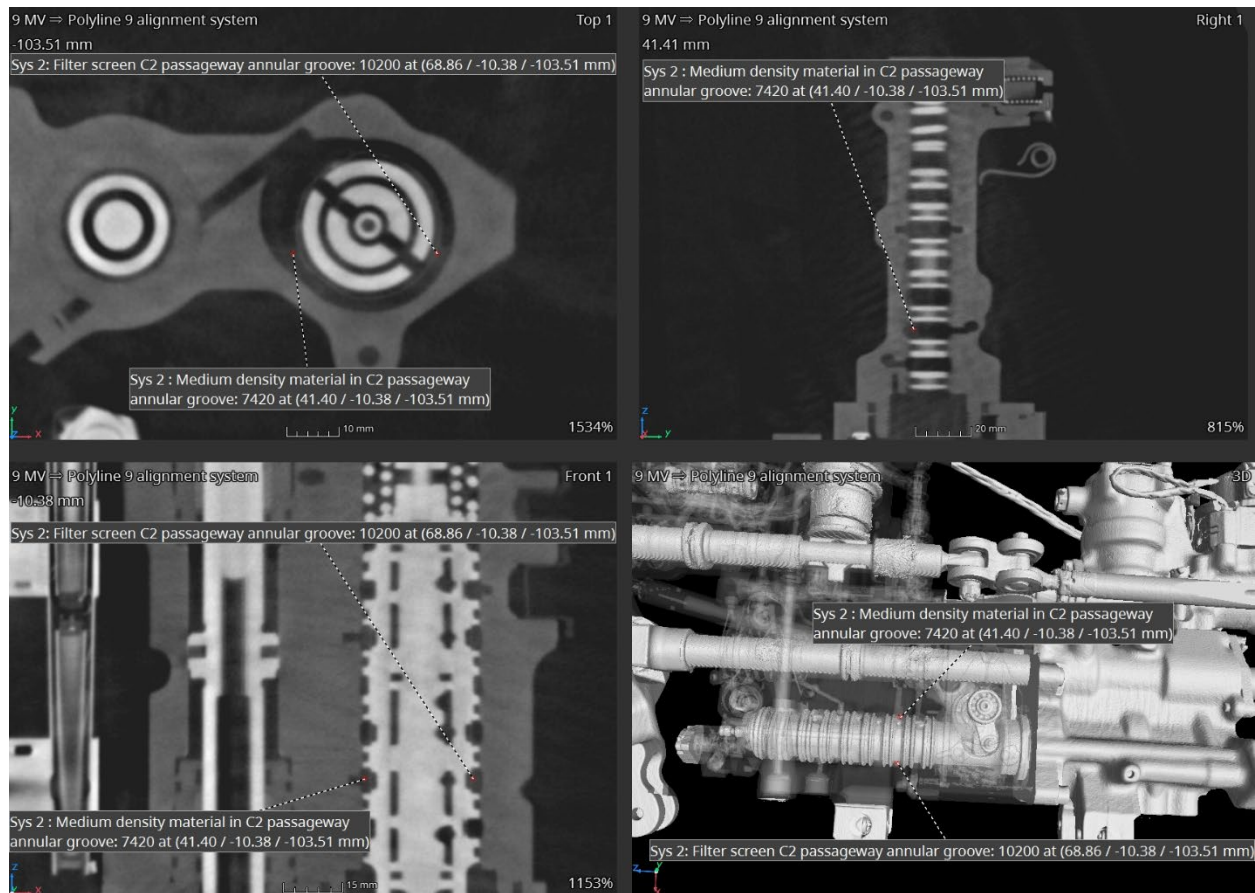
**Figure 27.** CT images of the System 2 portion of yaw ILCA illustrating medium density material and the filter screen in the C2 passageway annular groove between the sleeve and housing. (9 MV)

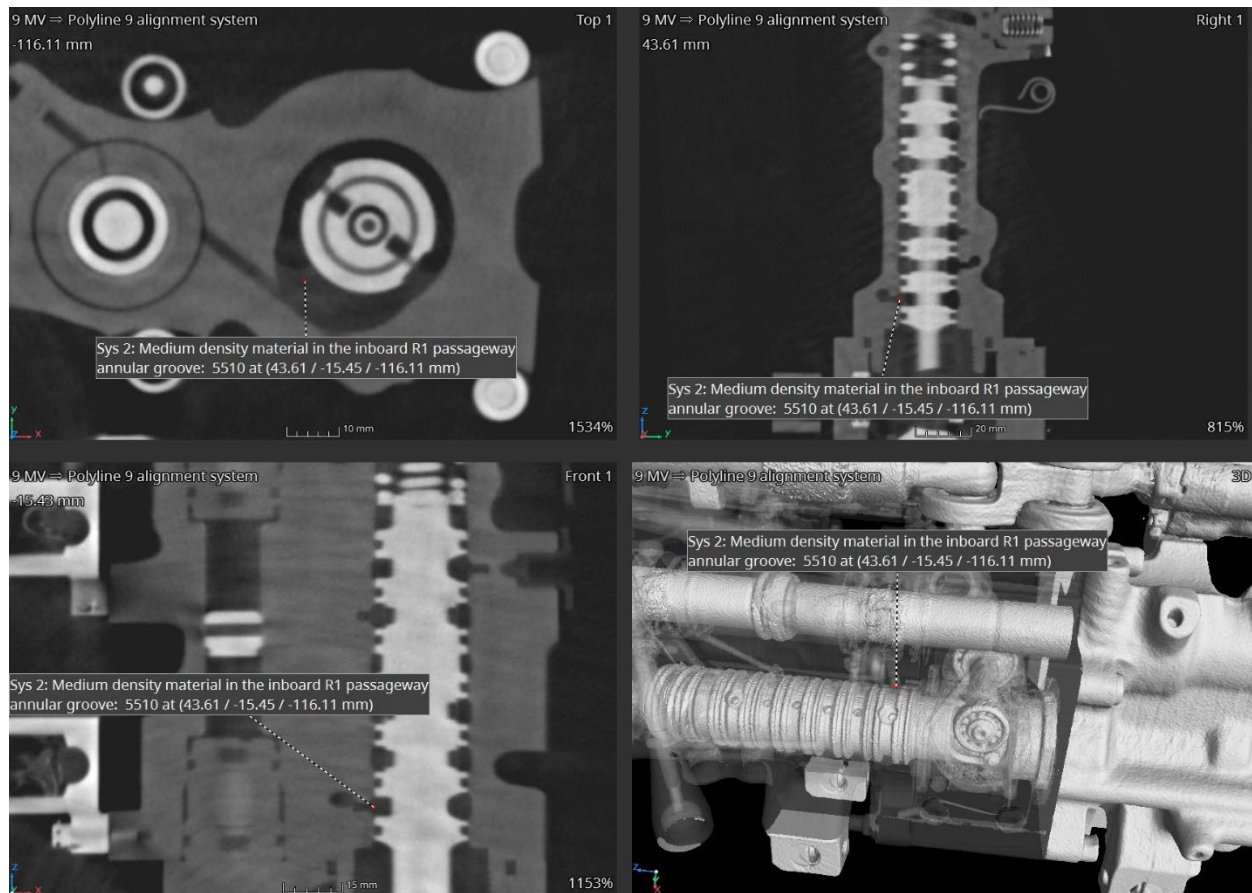
**Figure 28.** CT images of System 2 portion of yaw ILCA illustrating medium density material in the inboard R1 passageway annular groove between the sleeve and housing. (9MV)

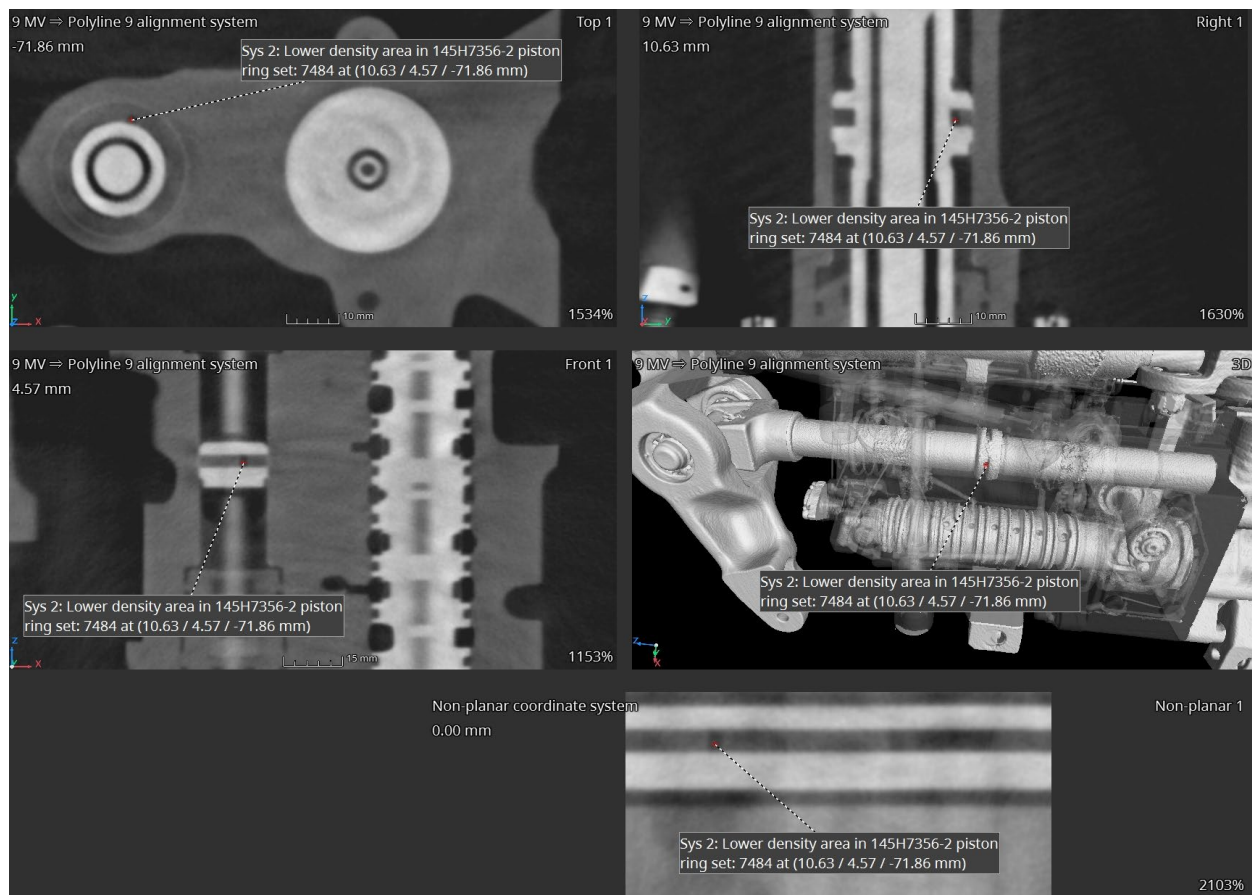
**Figure 29.** CT images of the System 2 portion of yaw ILCA illustrating lower density area in 145H7356-2 piston ring set.
