# National Transportation Safety Board

CEN22FA331

## COMPUTED TOMOGRAPHY

Helicopter: Columbia Helicopters CH-47D, N388RA, SN 88-0097

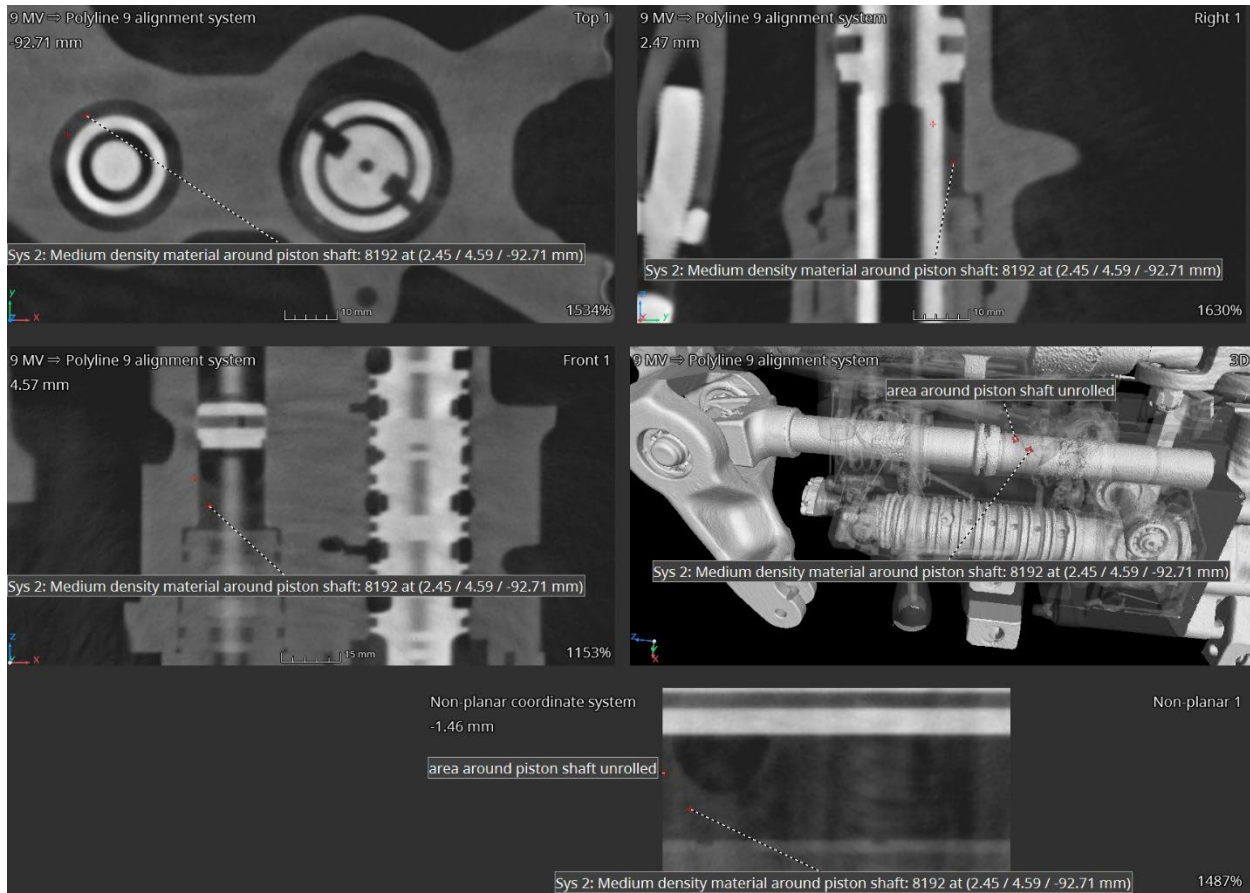
The CT images of the System 2 boost section of the yaw ILCA were examined. There were indications of medium density material in the outboard R1 passageway annular groove (Figure 24), C1 passageway annular groove (Figure 25), P1 passageway annular groove (Figure 26), C2 passageway annular groove (Figure 27) and the inboard R1 passageway annular groove of the servo assembly (Figure 28). The filter screens appeared to be intact for the C1 passageway annular groove (Figure 25), P1 passageway annular groove (Figure 26), and C2 passageway annular groove (Figure 27). There were indications of a low density area in the 145H7356-2 piston ring set (Figure 29). There were indications of medium density material around the piston shaft (Figure 30).

**Figure 30.** CT images of System 2 portion of yaw ILCA illustrating medium density material around the piston shaft.

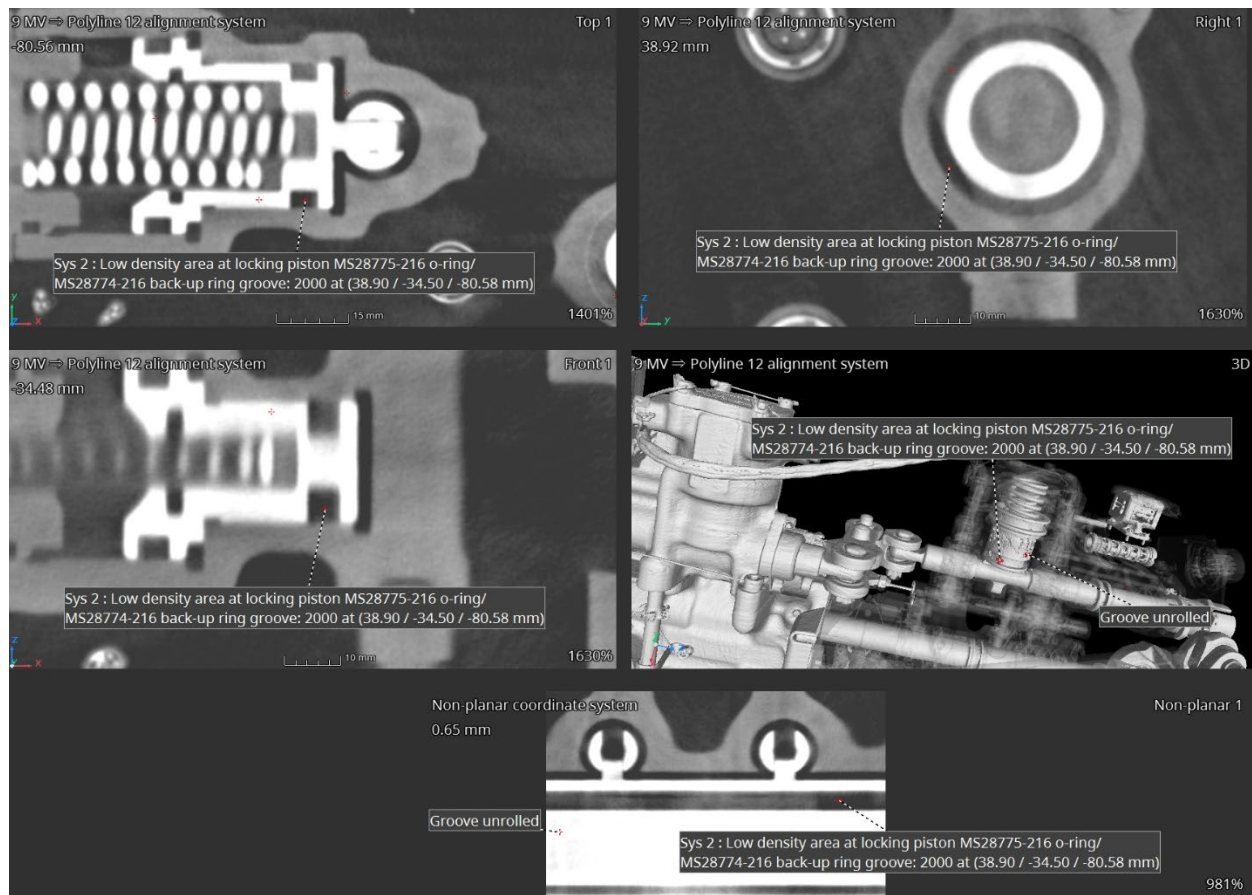
The CT images of the System 2 extensible link section of the yaw ILCA were examined (Figure 31). There were indications of a low density area in the locking piston MS28775-216 O-ring/MS28774-216 backup ring groove (Figure 32). The 90 micron strainer in the extensible link electro hydraulic servo-valve assembly is shown in Figure 33.

**Figure 32.** CT images of System 2 extensible link low density area at locking piston MS28775-216 o-ring/MS28774-216 back-up ring groove. (450 kV)
