# National Transportation Safety Board

CEN22FA331

## **AIRWORTHINESS**

Location: North Fork, Idaho  
Date: July 21, 2022  
Time: 1644 mountain daylight time  
Helicopter: Columbia Helicopters CH-47D, registration N388RA

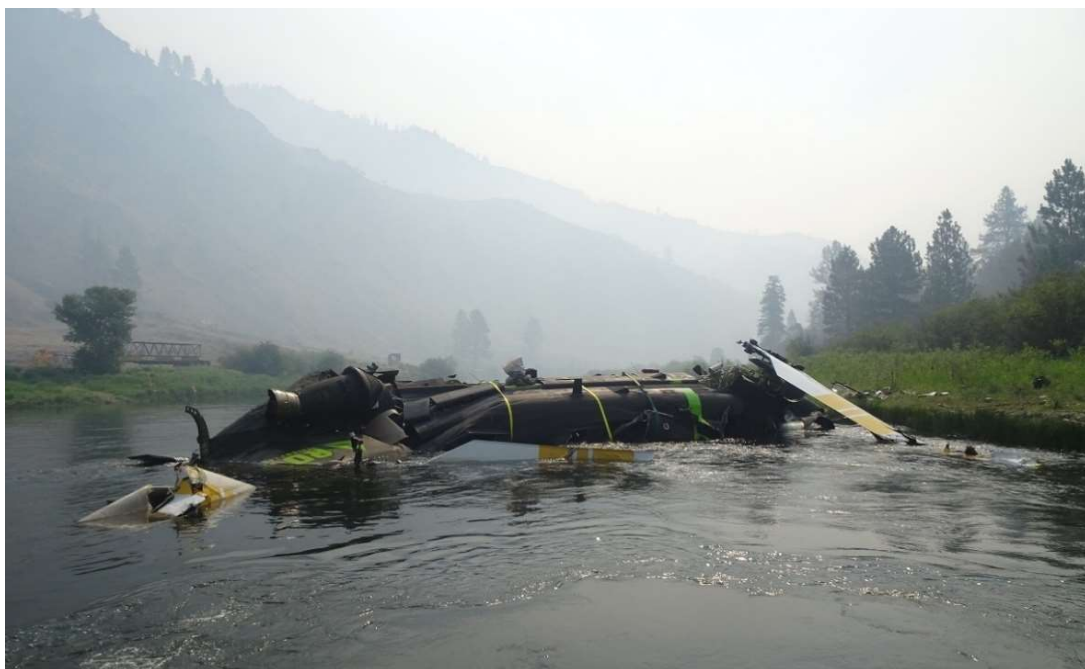
The airframe came to rest upright in the Salmon River except for the aft fuselage and aft pylon (**Figure 1**). The aft pylon partially separated from the aft fuselage and came to rest on its right side and was partially submerged in the water (**Figure 2**). The lower portion of the airframe exhibited significant upward deformation and crushing due to ground impact. The cockpit floor and the ramp were submerged in the water while the cabin floor was deformed significantly upward. The two cockpit doors were already separated from the airframe by the time the investigation group examined the wreckage.

**Figure 1.** The accident helicopter in the Salmon River.

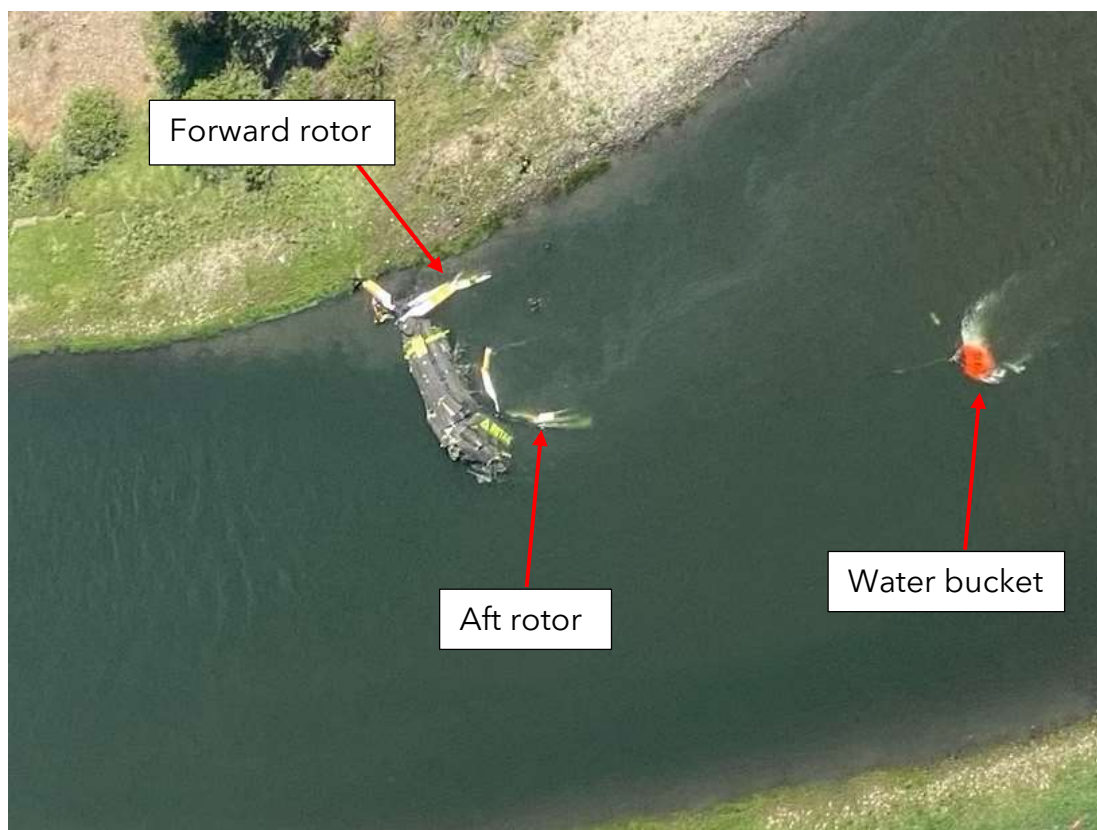
**Figure 2.** An aerial view of the accident helicopter. (Image courtesy of ROTAK)

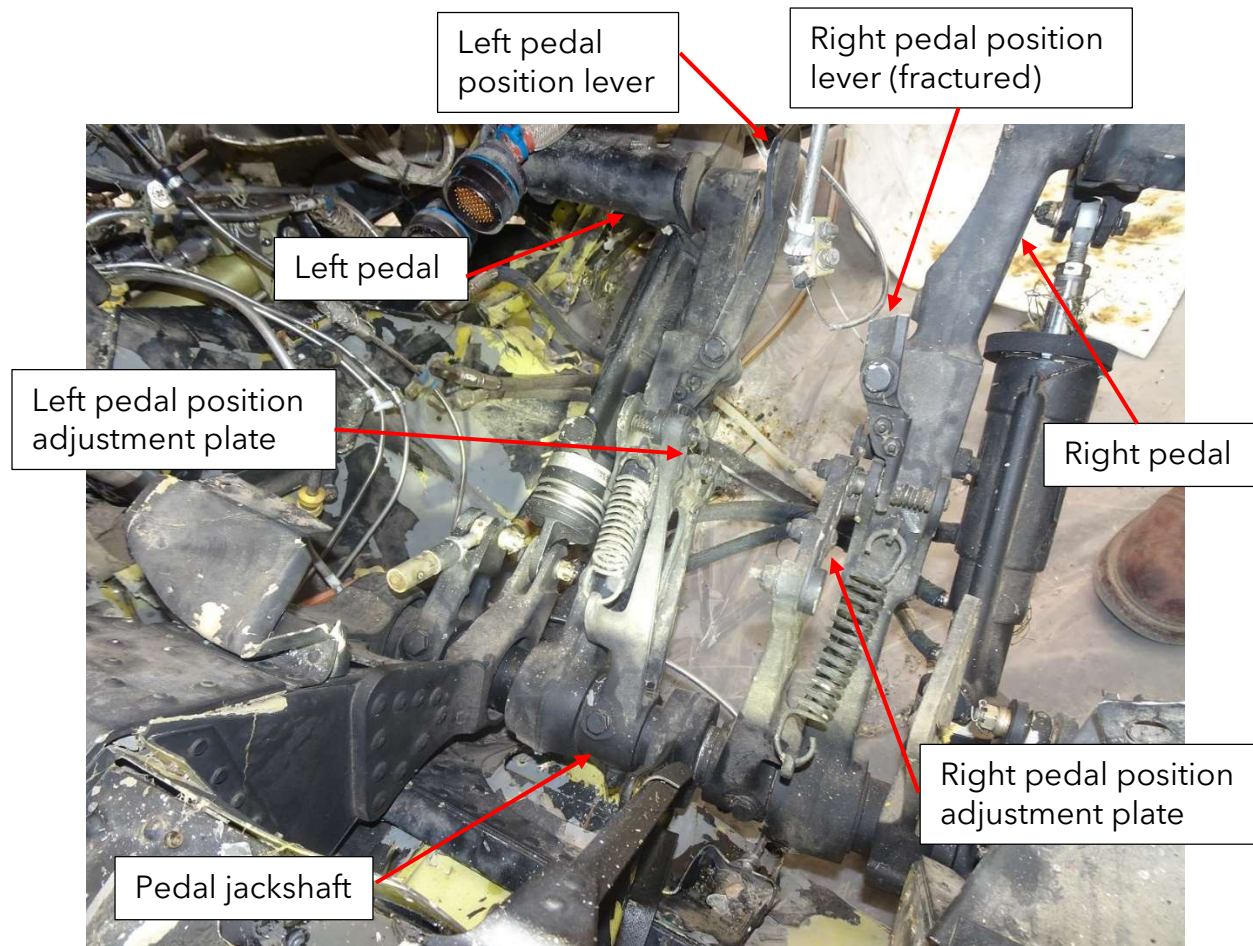
The copilot's pedal set was present, and both remained connected to their respective pedal position adjustment plates (**Figure 5**). The left pedal was in the "5"

position and the right pedal was in the "3" position. The left pedal position lever was intact. The right pedal position lever was fractured near its base. Both left and right brake levers remained installed, and all brake lines remained attached. The right pedal shaft support, attaching to the airframe, had separated from the airframe but remained attached to the right pedal jackshaft with all rivet heads present on the support. The left pedal control rod, connecting to the left side of the left pedal jackshaft, had separated from its control tube, the latter of which remained installed.

**Figure 5.** The copilot's pedal set.

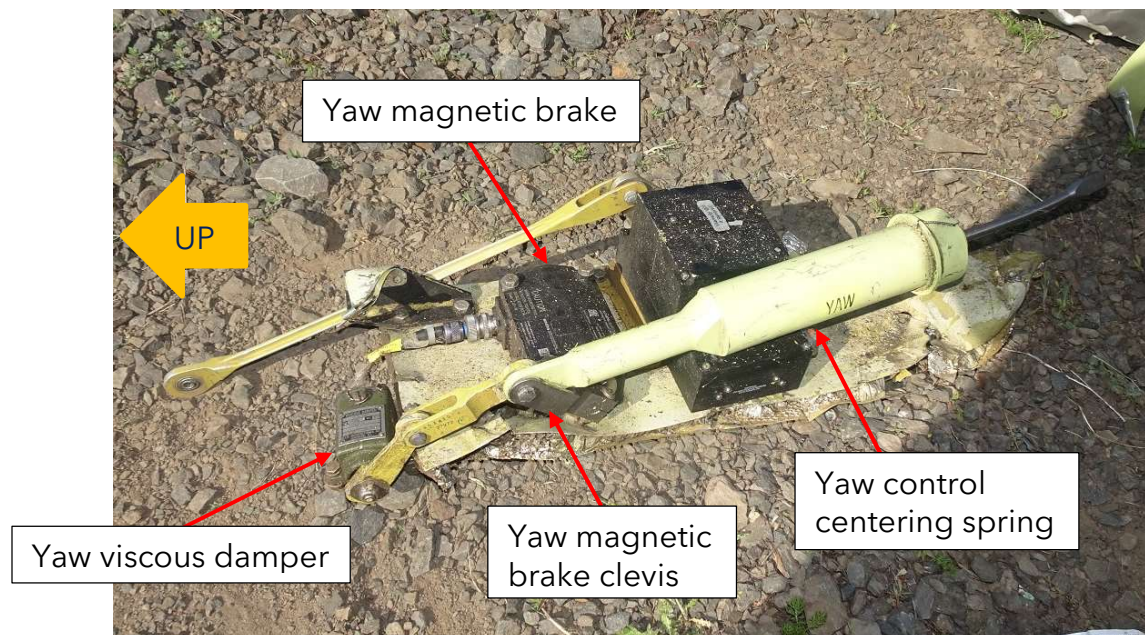
travel. The yaw magnetic brake's clevis was in the up position, consistent with a cockpit left pedal forward position (**Figure 6**).<sup>2</sup>

**Figure 6.** The thrust/yaw pallet removed from the wreckage.

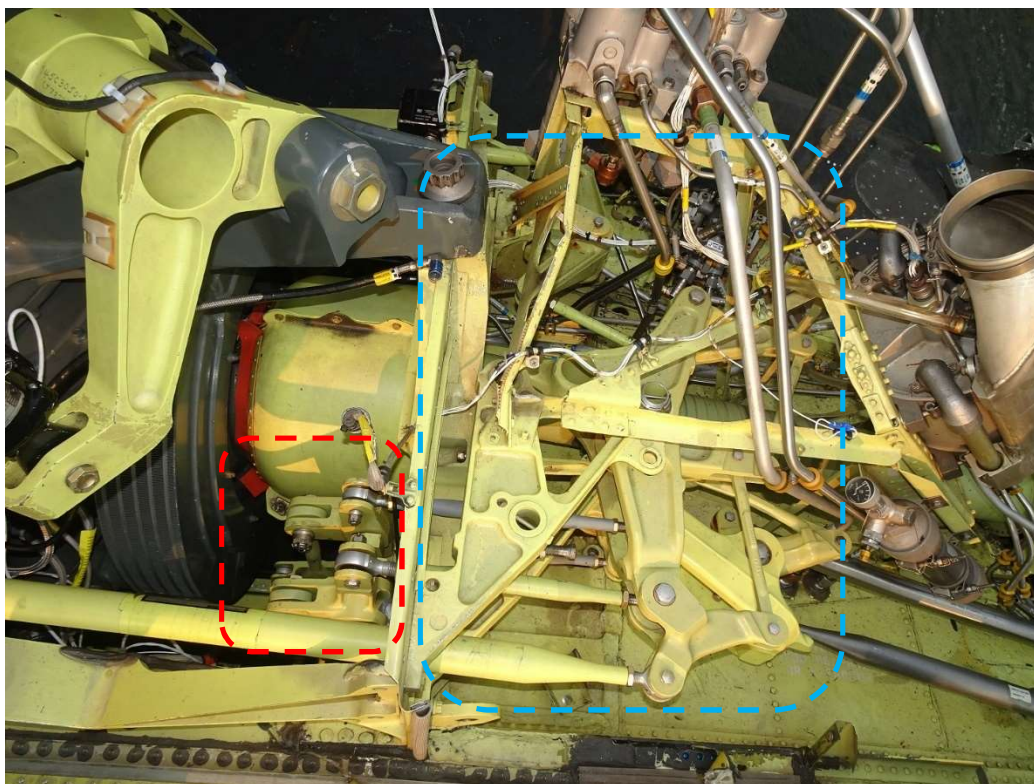
The two mixing units remained installed on the airframe (**Figure 8**). All linkages from the first stage mixing unit to the second stage mixing unit remained connected and intact except for the left yaw/right roll control rod. The left yaw/right roll control rod was fractured at its forward rod end, behind the rod end threads, but remained connected the aft rotor control bellcrank via its aft rod end; the forward rod end remained connected to the first stage mixing unit. The left yaw/right roll control rod exhibit signatures consistent with overload at its threads. The aft rotor control bellcrank was found swiveled aft beyond its aft control stop and the two aft rotor control rods (routed through the tunnel) had impacted its adjacent hydraulic lines. The aft stop was fractured and separated from the airframe and had pivoted upward from its normally installed location. The aft stop was pushed through its installation bore, resulting in the two forward jam nuts moving to the underside of the bolt head.

**Figure 8.** The upper portion of the first stage mixing unit (red dashed box) and the second stage mixing unit (blue dashed box).

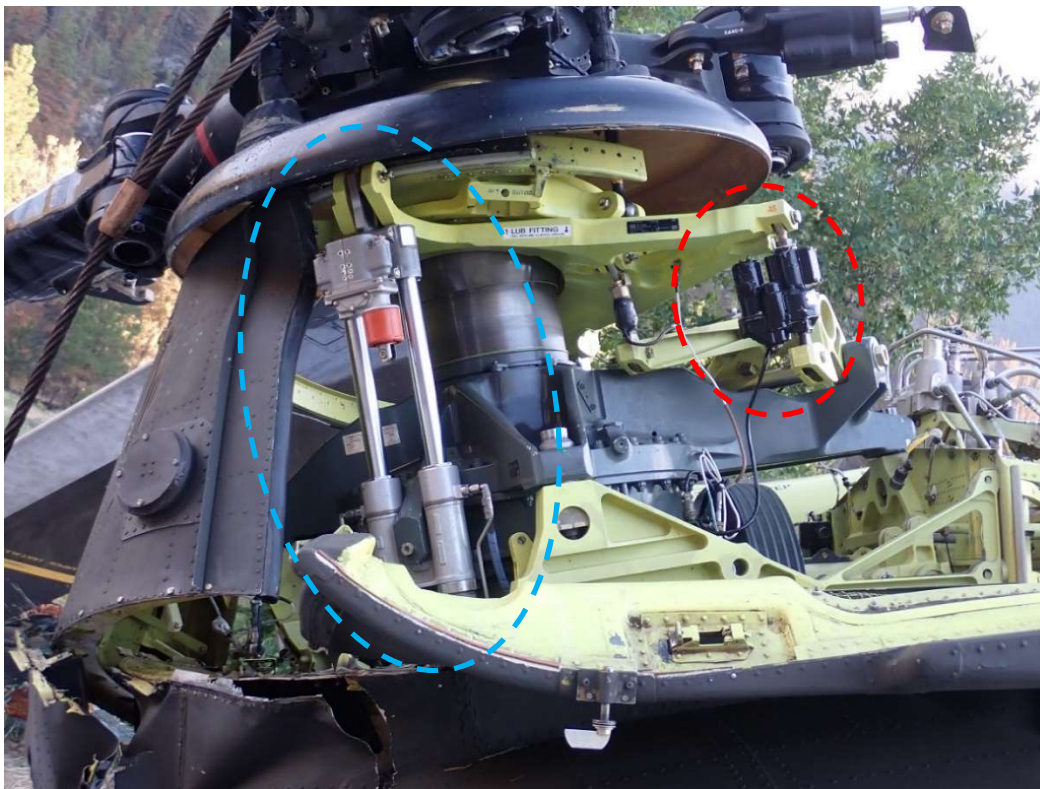
The forward rotor UBAs remained installed between the airframe and swashplate, and their exteriors appeared undamaged (**Figure 9**). For the pivoting UBA, both jam indicators were not extended. For the swiveling UBA, both jam indicators were extended. All hydraulic lines to the forward swiveling and pivoting UBAs remained installed.

**Figure 9.** The forward rotor's swiveling UBA (blue dashed circle) and LCT (red dashed circle). The pivoting UBA is obscured in this view. (Image courtesy of Honeywell)

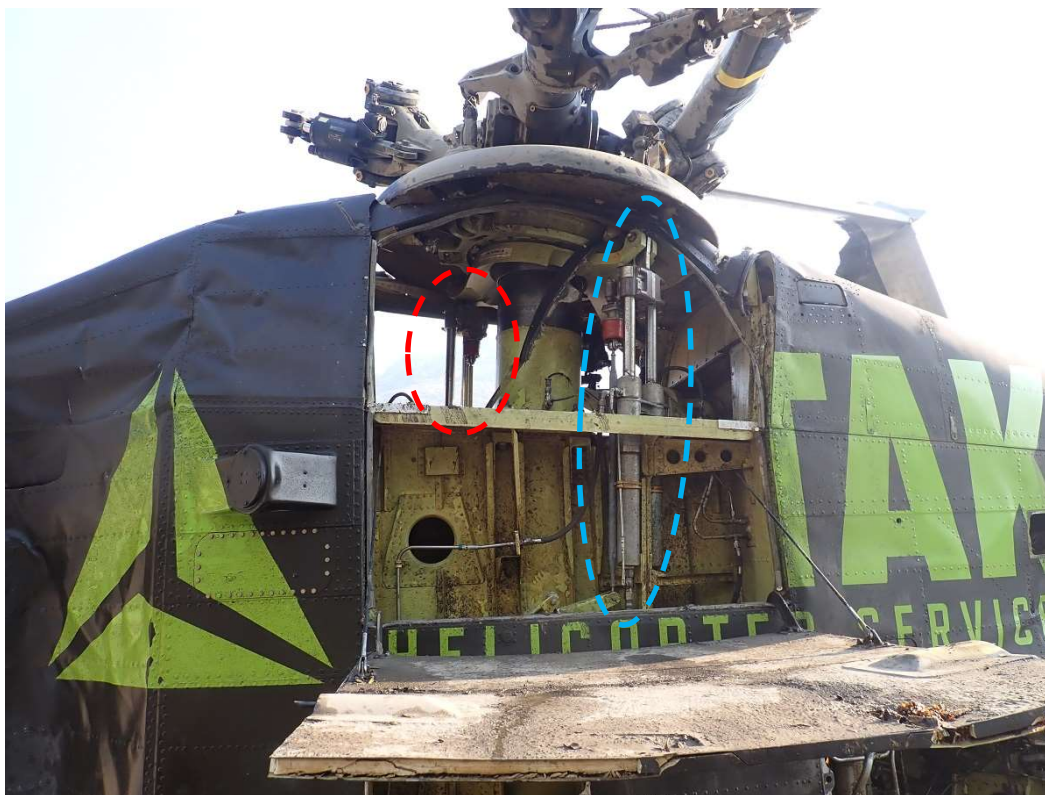
The aft rotor UBAs remained installed between the airframe and swashplate (**Figure 10**). The pivoting UBA was underwater but was visible and appeared to be fully extended. The swiveling UBA was not visible while the helicopter remained in the water. After the wreckage was recovered, the aft rotor UBAs' piston extension was measured. The pivoting UBA piston had a 11.75-inch extension with silt present on 10.5 inches of the extended piston. The swiveling UBA piston had a 9-inch extension with silt present on about 7.75 inches of the extended piston. All jam indicators on the two aft UBAs were extended. The pivoting UBA pressure line for the No. 1 hydraulic side was removed and there was no residual fluid; the No. 2 hydraulic pressure side was removed and there was some residual fluid. The pivoting UBA No.1 hydraulic return line was removed and there was water and hydraulic fluid that came out of it; the No. 2 hydraulic return line was removed and only hydraulic fluid came out.

**Figure 10.** The aft rotor's swiveling UBA (blue dashed circle) and the upper portion of the pivoting UBA (red dashed circle). (Image courtesy of Honeywell)

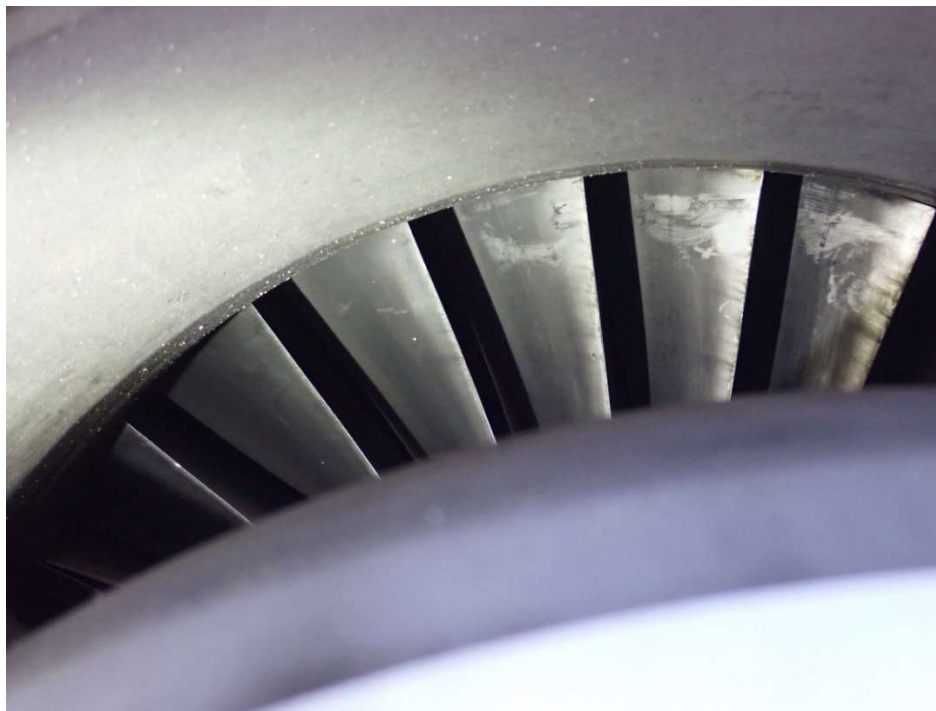
The left engine remained installed in the airframe. The left engine was not submerged in the water. No damage was noted on the exterior of the engine. The FOD screen was removed to access the compressor. The first compressor was intact and appeared undamaged (**Figure 11**). The gas producer section rotated without resistance.

**Figure 11.** A view of the first stage compressor blades from the No. 1 engine. (Image courtesy of Honeywell)

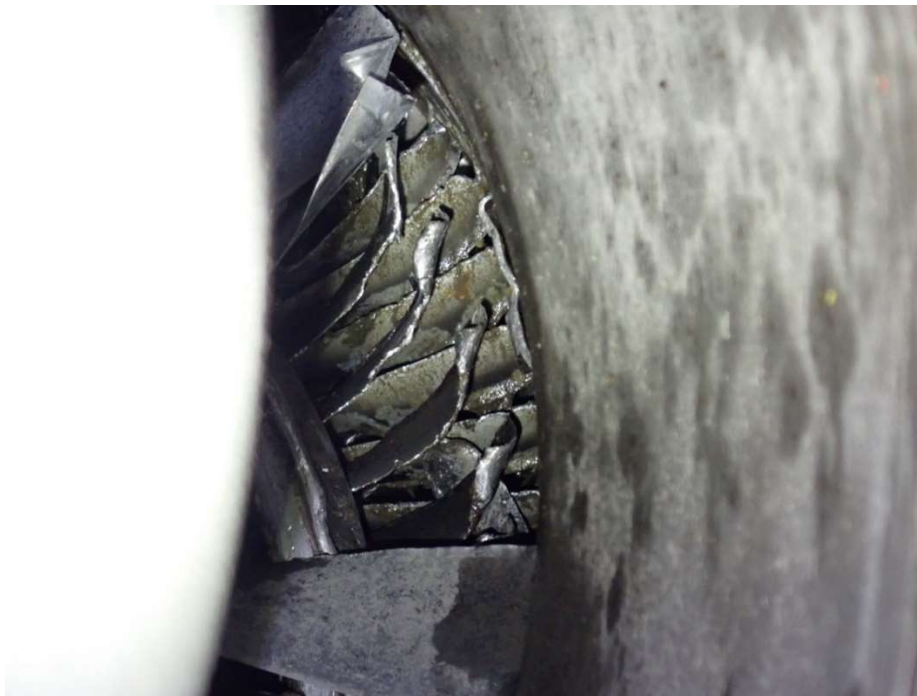
The right engine remained installed in the airframe. The right engine was submerged in the water due to the aft pylon resting on its right side. The engine exterior was intact and appeared undamaged except one starter bolt was sheared. The FOD screen was not present on the right engine. The exhaust was bent upward and to the left. Corrosion was present on several bolt heads on the exterior of the engine. Multiple first stage compressor blades were bent in the direction opposite of normal rotation, with one blade separated at its root (**Figure 12**). The first stage stators were not present. The second stage compressor blades were bent in the direction opposite of normal rotation. The second stage compressor blades exhibited leading edge and tip damage whereas the first stage compressor blades had primarily tip damage. The second stage stator exhibited leading edge damage. The gas producer section was unable to be rotated by hand.

**Figure 12.** A view of the first stage compressor blades from the No. 2 engine. (Image courtesy of Honeywell)

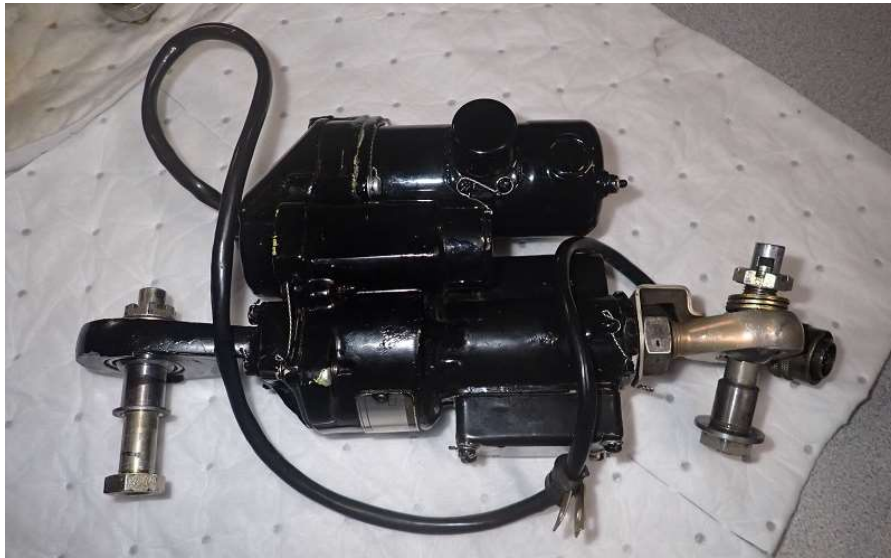
The forward LCT actuator data plate showed P/N 541604-8-1 and S/N 33-197. The forward LCT actuator position appeared to be in the fully retracted position

(**Figure 13**). The lower rod end bearing was stiff and could not be easily moved by hand. The upper rod end bearing was able to be easily moved by hand. Prior to installation on the test bench, the limit switch resistance was measured, using an ohmmeter, to be 0.7 ohms, below the requirement of 20 ohms for when the limit switch is in the retract position and consistent with the retract limit switch being activated. The switch cover was removed and the pin and the two switch nuts [that ride longitudinally along the pin] were present. The switch nut appeared to be on the retract limit switch. Adjacent to the pin, cables coming from the braided cable assembly had a blue-colored conduit. It could not be determined if this blue-colored conduit was a cable sleeve or a splice.

**Figure 13.** The forward LCT actuator. (Image courtesy of Honeywell)

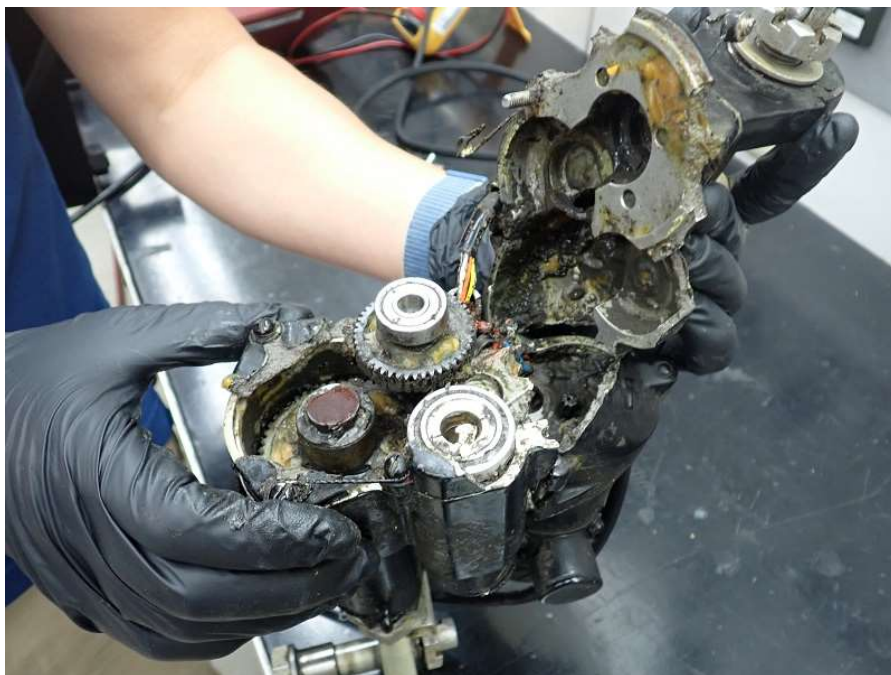
actuator to remove the fractured rod end fitting. The fracture on the acme screw side was cleaned using acetone and dried using compressed air.

**Figure 14.** The aft LCT actuator. (Image courtesy of Honeywell)

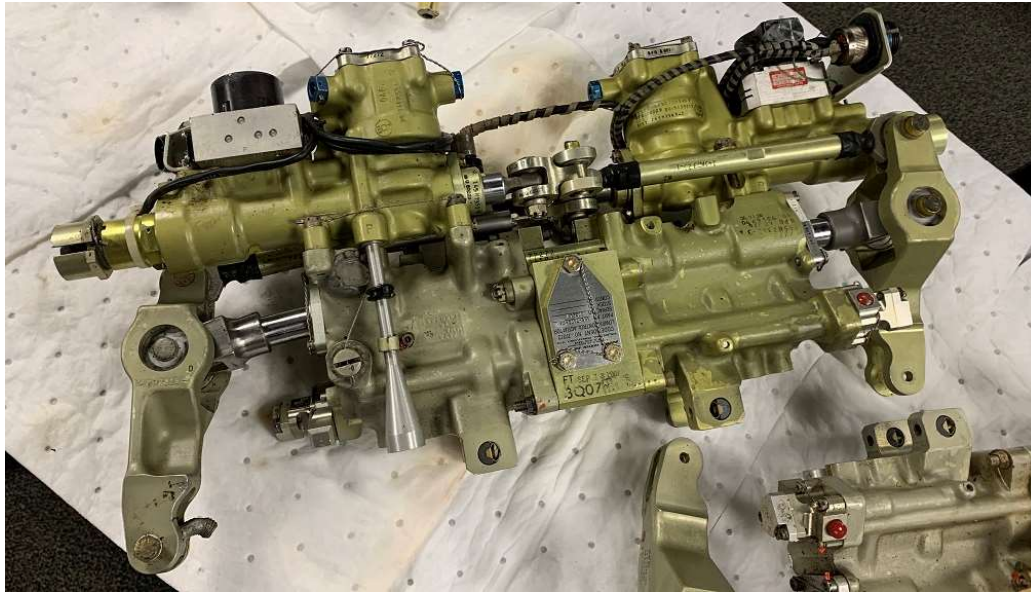
The pitch ILCA data plate showed P/N 145H7300-21 and S/N 0022LV (**Figure 15**). The input rod stop for actuator extension, on the center housing of the ILCA, was fractured due to impact with the control rod and lever. The crank was also fractured at its splined connection to the input rod lever, but the remnant crank remained retained within the lever. The range of motion for the output piston was limited due to the piston being bent. The actuator was installed on the test bench and the output piston was manually actuated in the retract direction to collect residual fluid from the two systems in separate jars. The fluid had a clear appearance and color consistent with military performance specification MIL-PRF-83282 hydraulic fluid. The motion of the output piston [in the retract direction] exhibited no binding or restrictions. The piston friction was measured to be 12 pounds (lbs) in the extend direction and 17 lbs

in the retract direction. The limit for piston friction was 20 lbs. An ATP of the stability augmentation system (SAS) side of the ILCA was performed, the results of which can be found in **Attachment 1** of this report. An ATP of the stick boost actuator portion of the ILCA was not able to be performed due to the bend in the output piston and the fractured crank (to which the input arm connects).

**Figure 15.** The pitch ILCA.

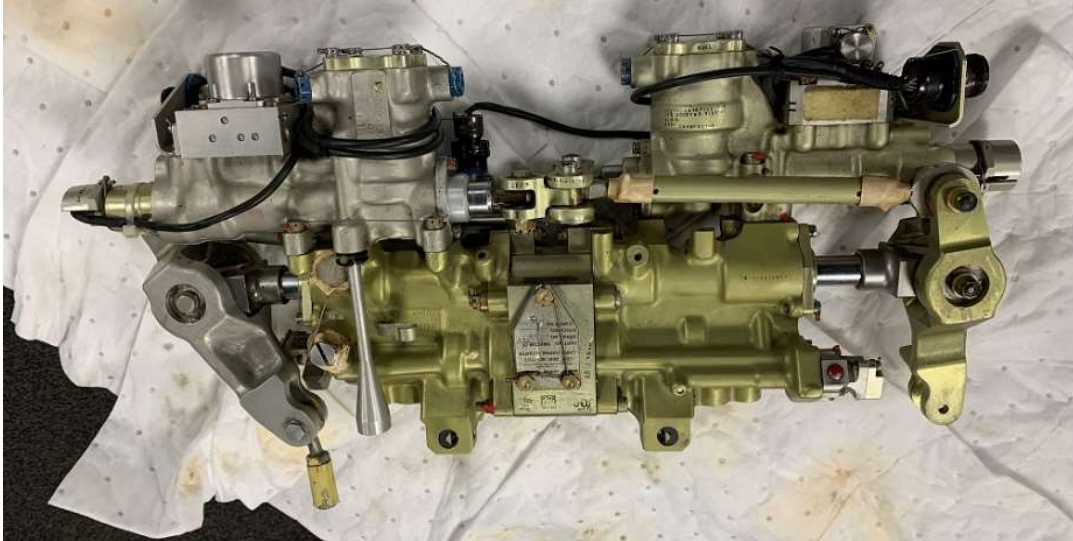
The roll ILCA data plate showed P/N 145H7300-25 and S/N YW3390LV (**Figure 16**). The input rod stop for actuator extension, on the center housing of the ILCA, was fractured due to impact with the control rod and lever. The control rod and lever were jammed onto this extension stop, so the lever was removed. The crank could not be manually moved to recenter it. The actuator was subsequently installed on the test bench and the output piston was manually actuated to collect residual fluid from the two systems in separate jars. The fluid had a clear appearance and color consistent with MIL-PRF-83282 hydraulic fluid. The piston friction was measured to be 16 lbs in the extend direction and 10-11 lbs in the retract direction. The limit for piston friction was 20 lbs. An ATP of the SAS side of the ILCA was performed, the results of which can be found in **Attachment 1** of this report. An ATP of the stick boost actuator portion of the ILCA could not be performed due to the shifted crank. However, with hydraulic pressure applied to the stick boost actuator, manipulation of the input lever and crank resulted in movement of the output piston that was smooth with no judder or binding.

**Figure 16.** The roll ILCA.

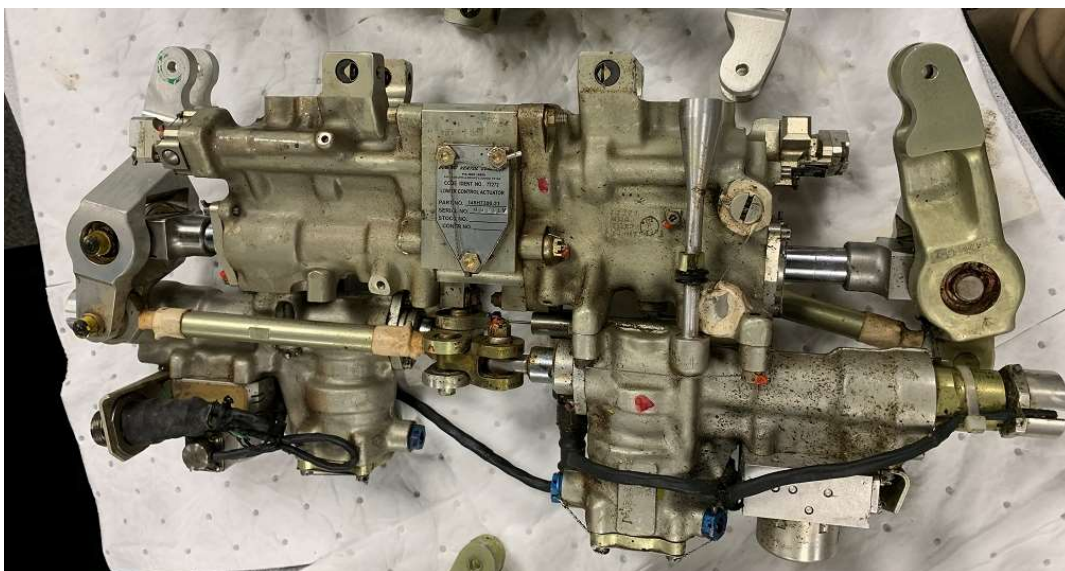
The yaw ILCA data plate showed P/N 145H7300-31 and S/N 0029LV (**Figure 17**). The input rod stop for actuator extension, on the center housing of the ILCA, was fractured due to impact with the control rod and lever. The control rod and lever were jammed onto this extension stop, so the lever was removed. The crank could not be manually moved to recenter it. The actuator was subsequently installed on the test bench and the output piston was manually actuated to collect residual fluid from the two systems in separate jars. The fluid had a clear appearance and color consistent with MIL-PRF-83282 hydraulic fluid. The piston friction was measured to be 15 lbs in the extend direction and 14 lbs in the retract direction. The limit for piston friction was 20 lbs.

**Figure 17.** The yaw ILCA.

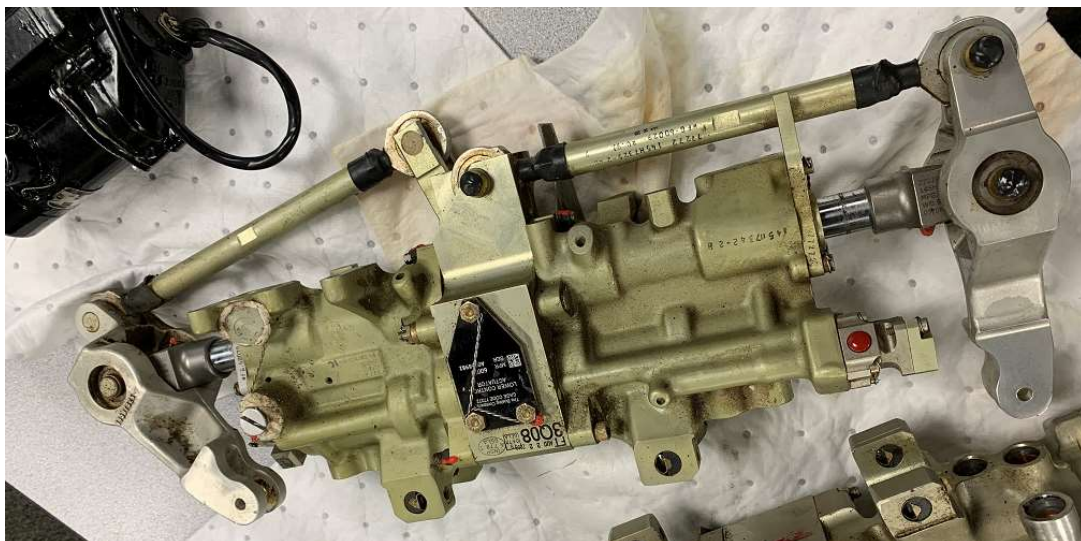
The thrust ILCA data plate showed P/N 145H7300-26 and S/N A0058982 (**Figure 18**). The input rod stop for actuator extension, on the center housing of the ILCA, was fractured due to impact with the control rod and lever. The actuator was installed on the test bench and the output piston was manually actuated to collect residual fluid from the two systems in separate jars. The fluid had a clear appearance and color consistent with MIL-PRF-83282 hydraulic fluid. The piston friction was measured to be 12 lbs in the extend direction and 15 lbs in the retract direction. The limit for piston friction was 20 lbs. An ATP was performed, the results of which can be found in **Attachment 1** of this report. The output piston exhibited no evidence of binding or judder with commanded actuations. During the proof pressure test, the pressure relief valve on the No. 1 system made a “pop” noise at a bench supply pressure of 1,000 psi, but the source of this sound could not be identified and there was no noticeable leakage from this relief valve.

**Figure 18.** The thrust ILCA.

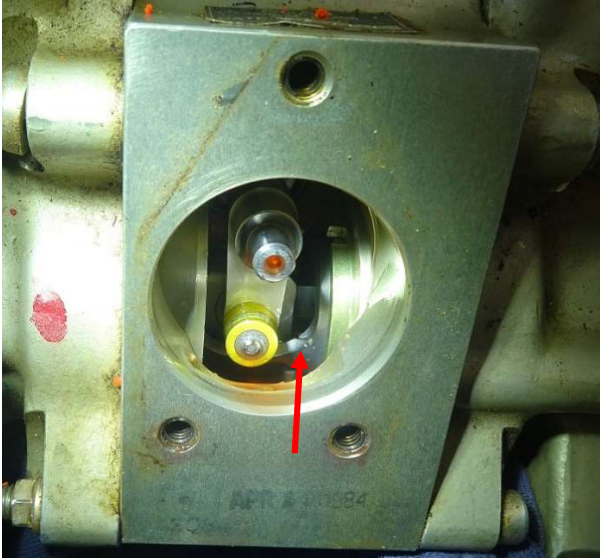
From October to November 2022, the yaw ILCA was scanned using CT to document the internal condition of the actuator prior to disassembly. The CT imaging showed a crack on the outer sleeve near the No. 1 side of the ILCA. Additional details of the CT imaging can be found in the Computed Tomography Specialist Report in the docket for this investigation.

**Figure 19.** The crack (red arrow) as seen on the outer sleeve after removal of the cam cover.

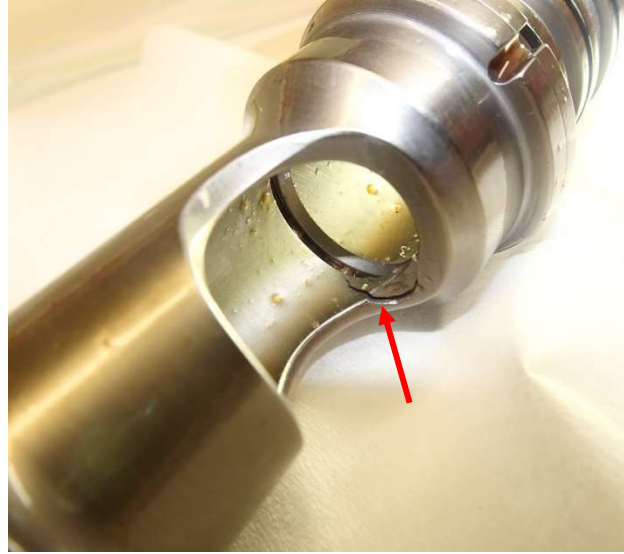
**Figure 20.** The crack (red arrow) on the outer sleeve of the yaw ILCA.

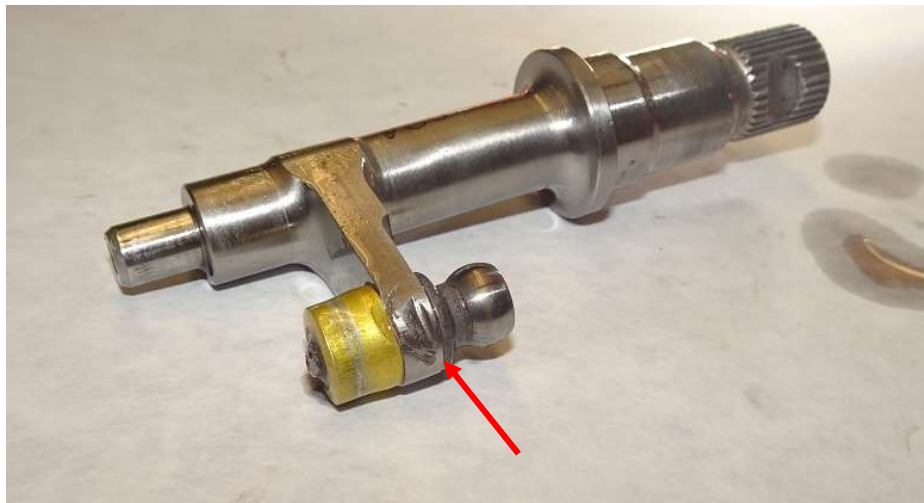
**Figure 21.** The red arrow points to the impact mark on the cam of the yaw ILCA.

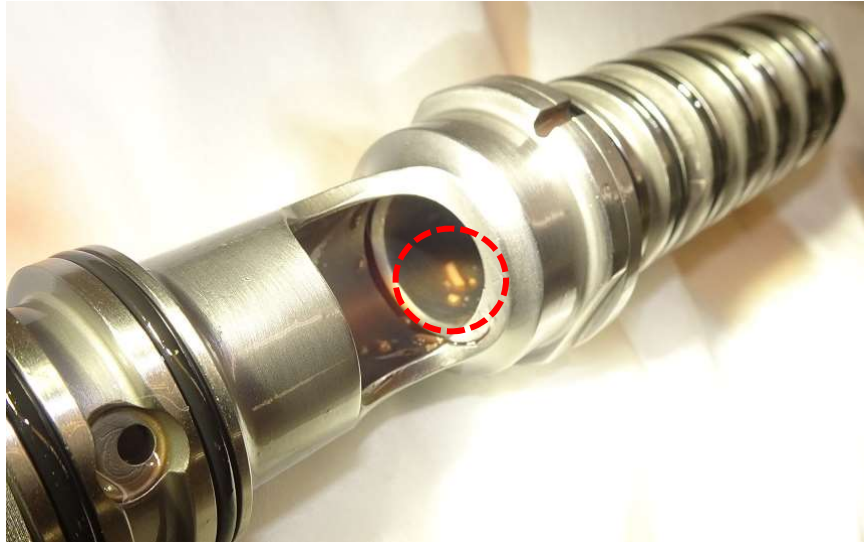
**Figure 23.** The white-colored material (red circle) observed within the No. 1 side of the outer sleeve of the yaw ILCA.

The inner diameter of the outer sleeve, with both inner sleeves and the spool removed, was rinsed with alcohol and the liquid was collected to filter the debris present within the outer sleeve. The inner surfaces of the center housing were also rinsed with alcohol and the liquid was collected to filter the debris within the center housing. The debris was collected and retained for further analysis.<sup>7</sup>
