# National Transportation Safety Board

CEN22FA331

Group Chair's Factual Report - Addendum 2

Location: North Fork, Idaho  
Date: July 21, 2022  
Time: 1644 mountain daylight time  
Helicopter: Columbia Helicopters CH-47D, registration N388RA

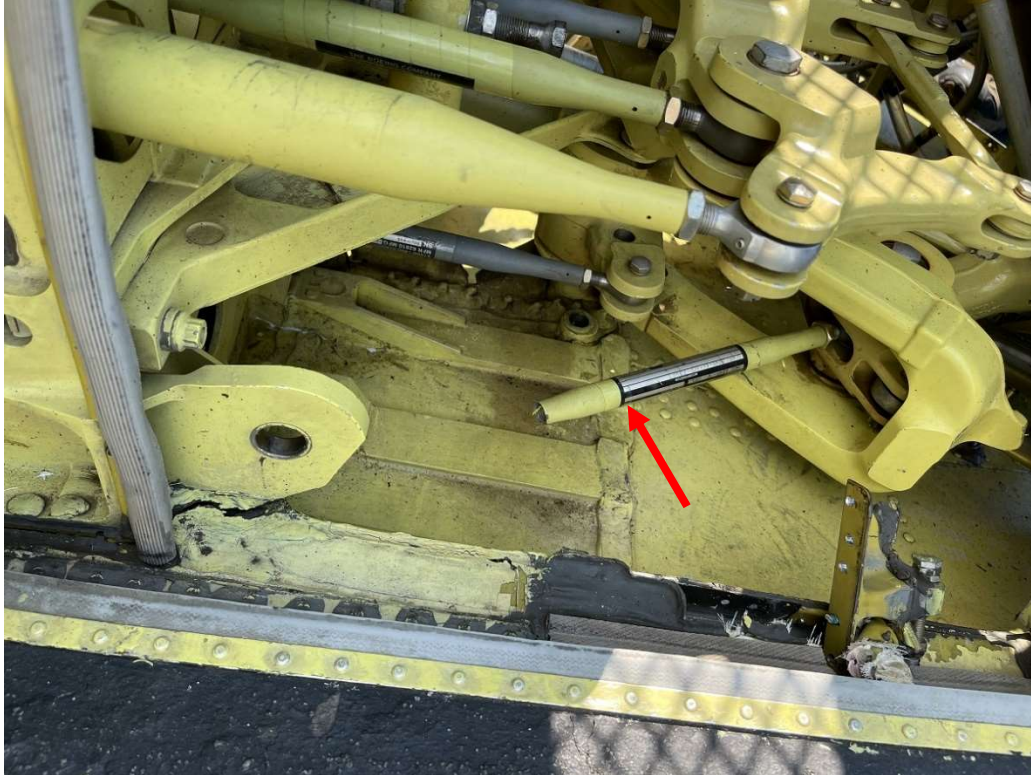
During the on scene wreckage examination, the left yaw/right roll control rod, within the second stage mixing unit, was observed within the flight control wreckage.<sup>1</sup> The left yaw/right roll control rod was fractured at its forward end, behind the rod end threads, but remained connected to the aft rotor control bellcrank via its aft rod end (**Figure 1**). The forward rod end remained connected to the first stage mixing unit (**Figure 2**). The left yaw/right roll control rod exhibited signatures consistent with overload at its threads and did not exhibit evidence of corrosion on the fracture surfaces or the visible threads (**Figures 3 thru 5**). The left yaw/right roll control rod had a data plate affixed to the rod that showed part number (P/N) "145C3340-9 NEW" with a [manufacture] date of "05-26-2010" (**Figure 6**).<sup>2</sup>

**Figure 1.** The red arrow points to the fractured left yaw/right roll control rod.

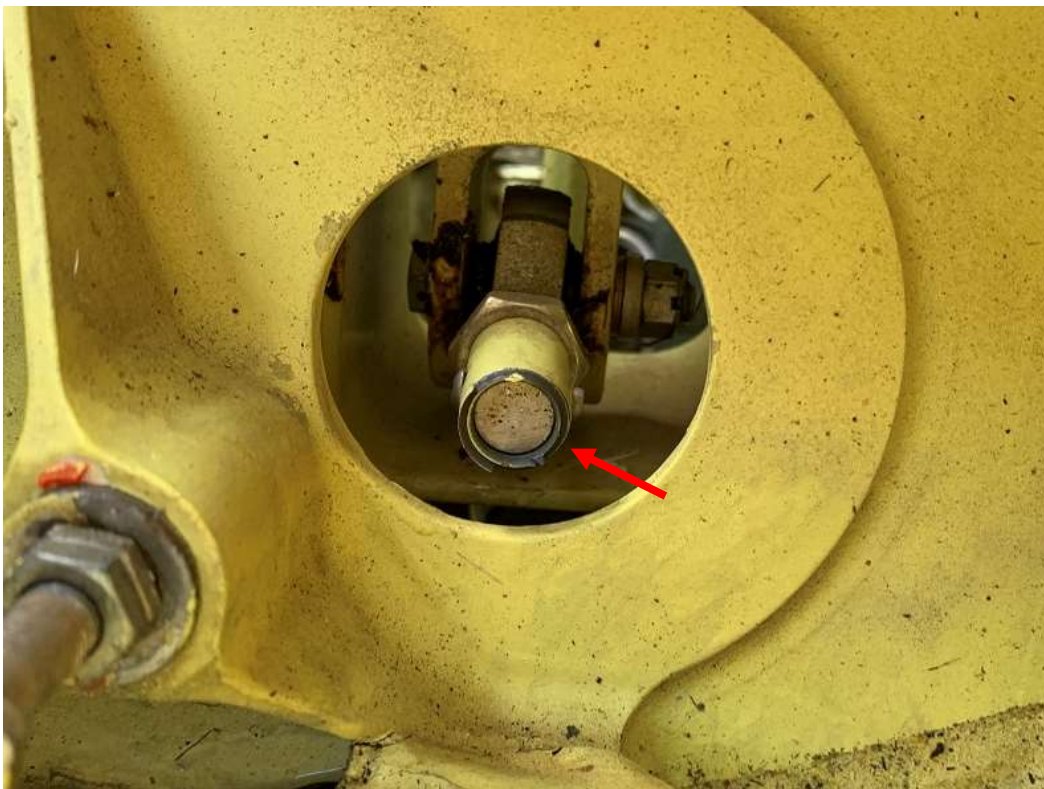
**Figure 2.** The red arrow points to the forward rod end of the left yaw/right roll control rod.

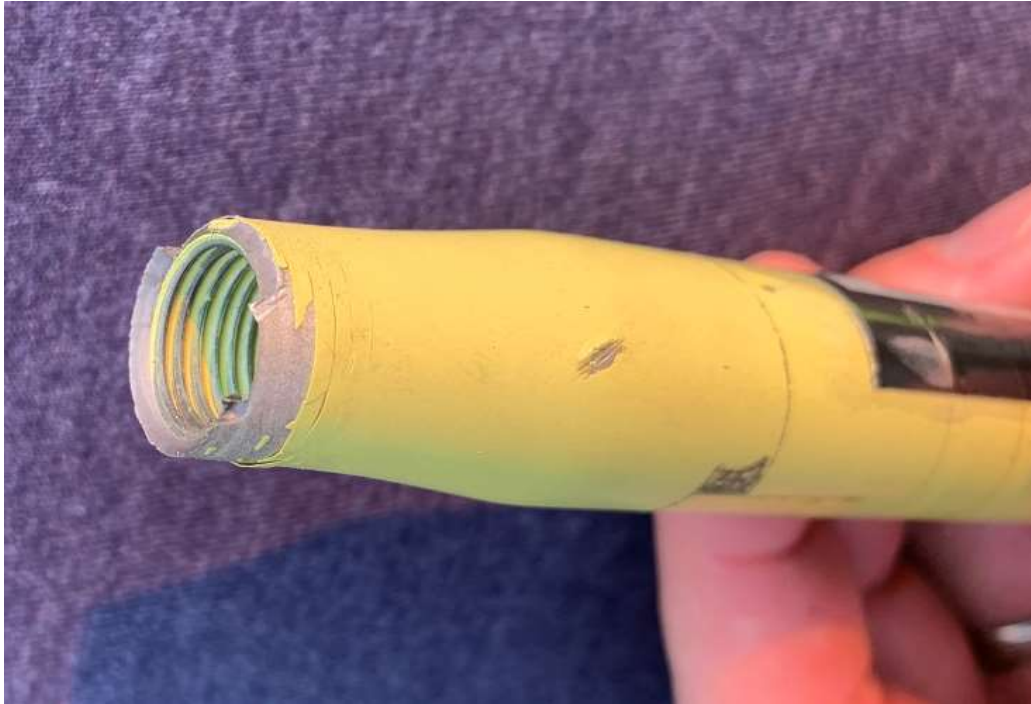
**Figure 3.** The fractured forward end of the left yaw/right roll control rod.

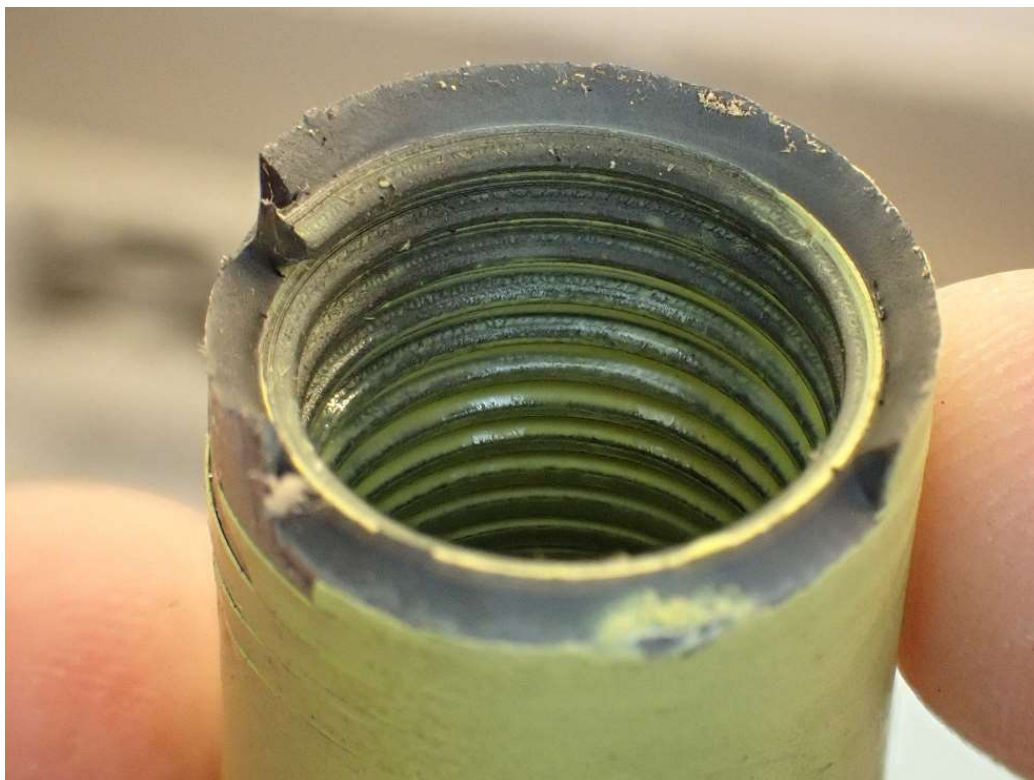
**Figure 4.** A closeup of the fracture surface of the left yaw/right roll control rod.  
(Image courtesy of Honeywell)

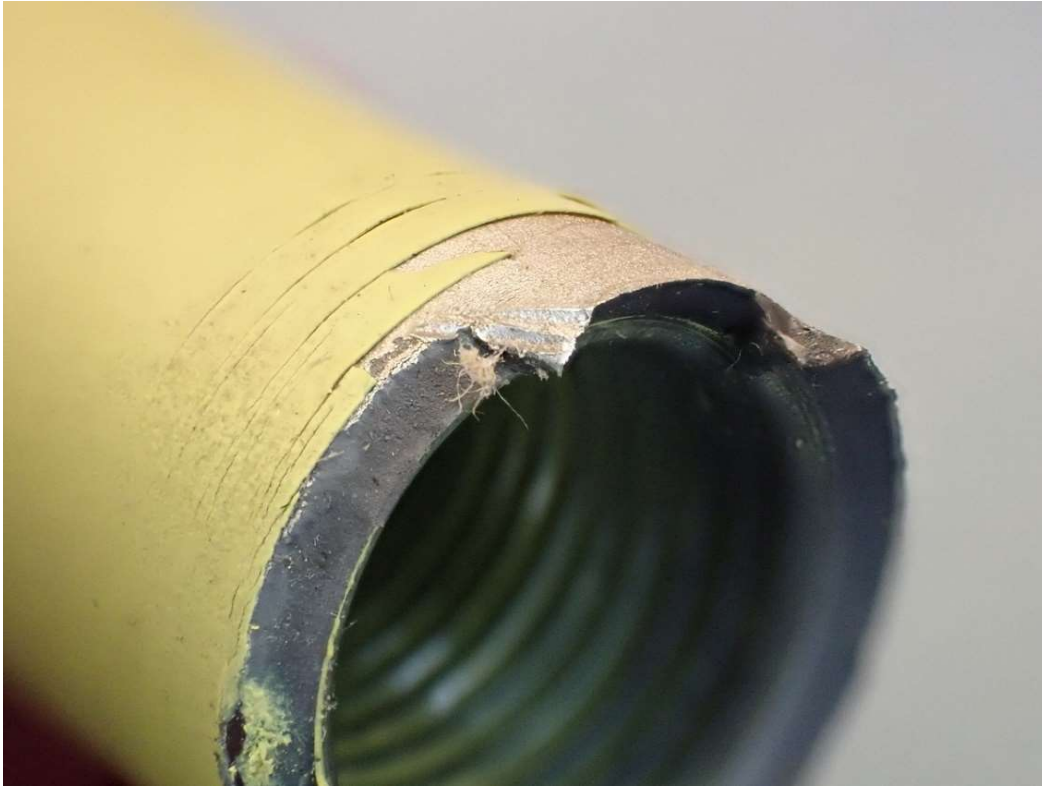
**Figure 5.** A closeup of the fracture surface of the left yaw/right roll control rod.  
(Image courtesy of Honeywell)

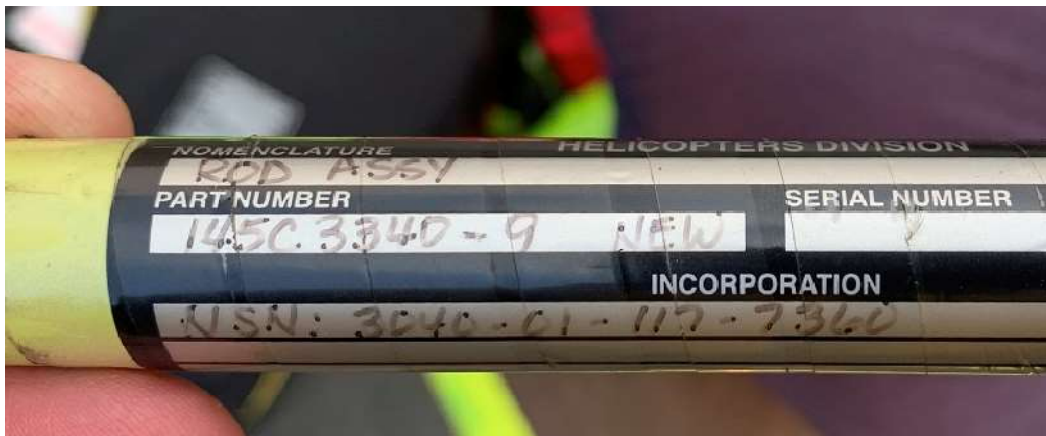
<sup>2</sup> US Army Aviation Safety Action Message (ASAM) No. H-47-11-ASAM-03, issued April 4, 2011, required control rods with P/N 145C3340-1, -2, -8, -9, -10, -11, and -12 suspected to not have corrosion protective coatings adequately coated within its interior surfaces to be replaced with a serviceable control rod, of the same P/N, that has the word "NEW" behind the P/N or with a manufacture date later than January 1, 2010. On October 22, 2012, the US Army issued ASAM No. H-47-13-ASAM-01 that had instructions similar to ASAM No. H-47-11-ASAM-03, but with the addition of control rod P/N 145C3340-7. On March 21, 2024, the US Army issued a Safety of Flight (SOF) message No. H-47-24-SOF-01 to require a one-time inspection to determine compliance with the intent of ASAM Nos. H-47-11-ASAM-03 and H-47-13-ASAM-01.

**Figure 6.** The data plate of the left yaw/right roll control rod.
