# National Transportation Safety Board

CEN22FA375

## **MATERIALS LABORATORY**

Fire Specialist's Factual Report 23-078

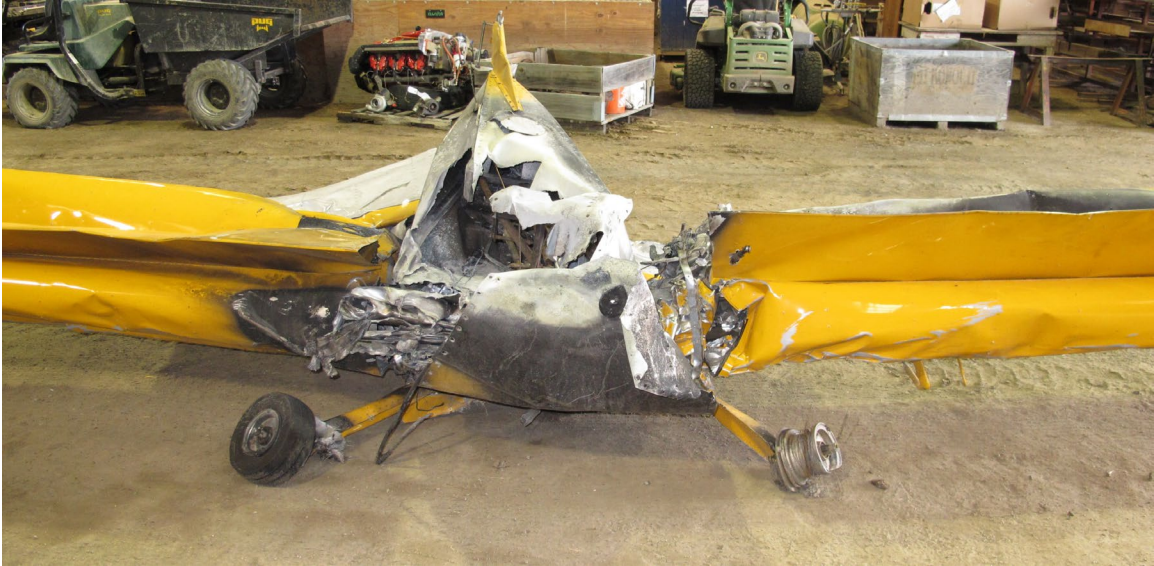
The aircraft was mostly intact with the wings and empennage still attached to the main fuselage as shown in Figure 1. The wings and empennage exhibited mechanical damage in the form of dents, bends, and some crushing. There was sooting over the entire surface of the empennage and right wing. The left wing

**Figure 1.** Overall photograph of accident aircraft.

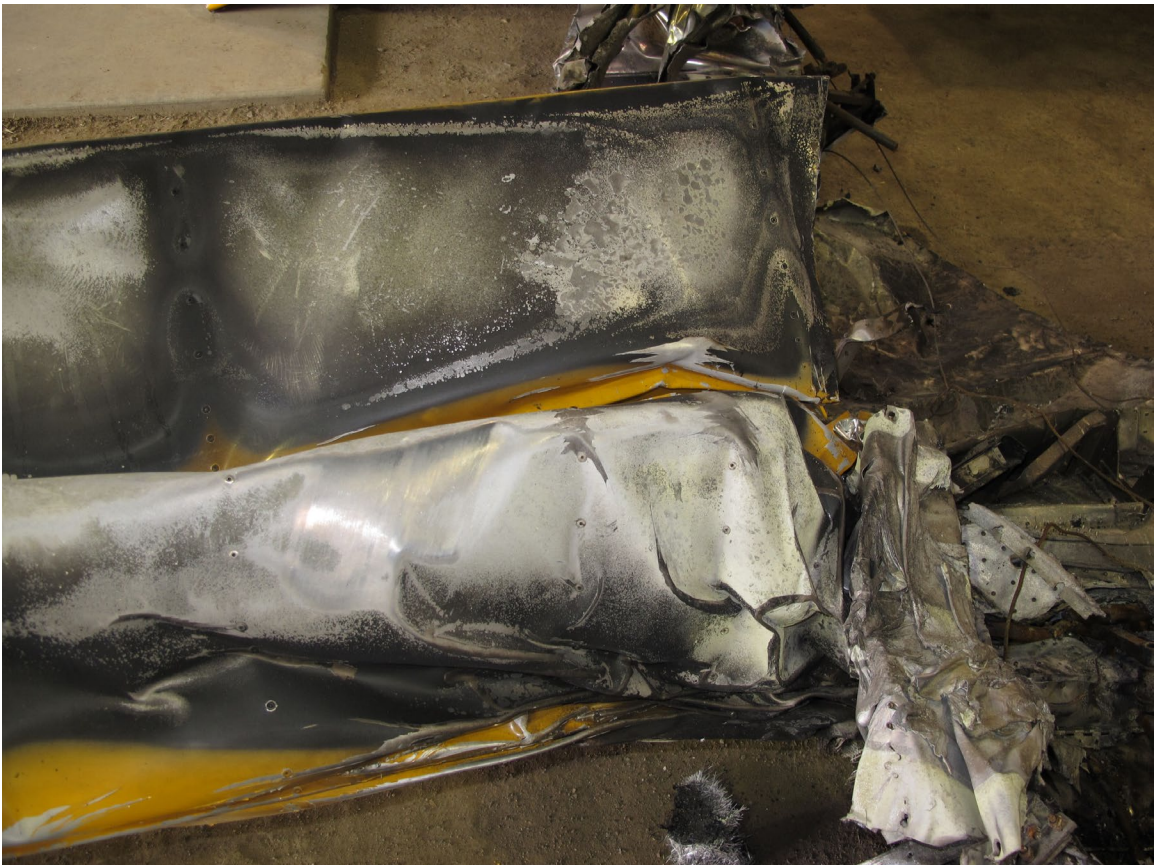
exhibited fire damage at the root as shown in Figure 2. The root area was heavily sooted and had some signs of melting. The paint in this area was missing exposing areas of bare metal.

**Figure 2.** Closeup of thermal damage to left wing.

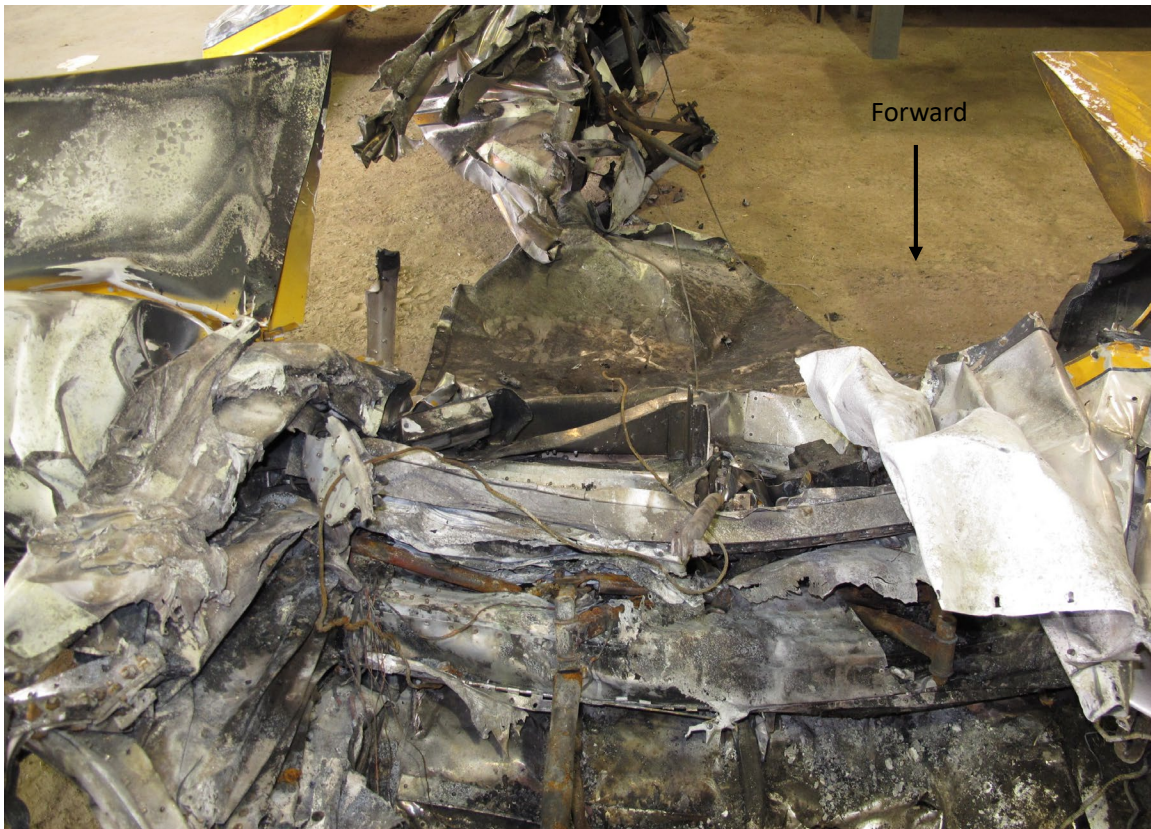
The fuselage was mostly destroyed. The remaining fuselage exhibited severe thermal and mechanical (crushing) damage shown in Figure 3. The upper portion of the fuselage was missing as was most of the cabin interior. There was severe crushing mechanical damage to the remaining forward fuselage section. The remaining fuselage structure exhibited melting and thermal discoloration. The thermal damage centered around the location of the fuel tank which was located under the aircraft cabin as shown in Figure 4. The fuel tank was partially consumed, and the remaining tank exhibited melting and thermal discoloration. No thermal damage specifically related to an in-flight fire was found.

**Figure 3.** Closeup of main fuselage/cabin area of accident aircraft.

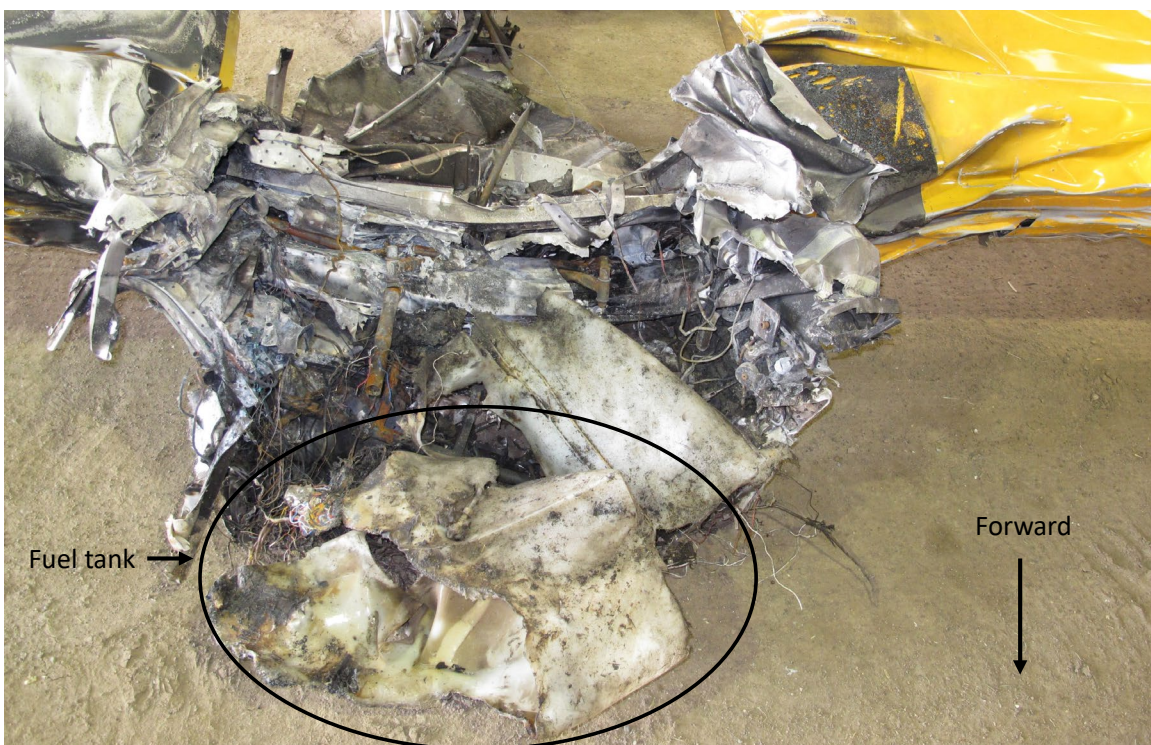
**Figure 4.** Closeup of aircraft cabin and fuel tank.

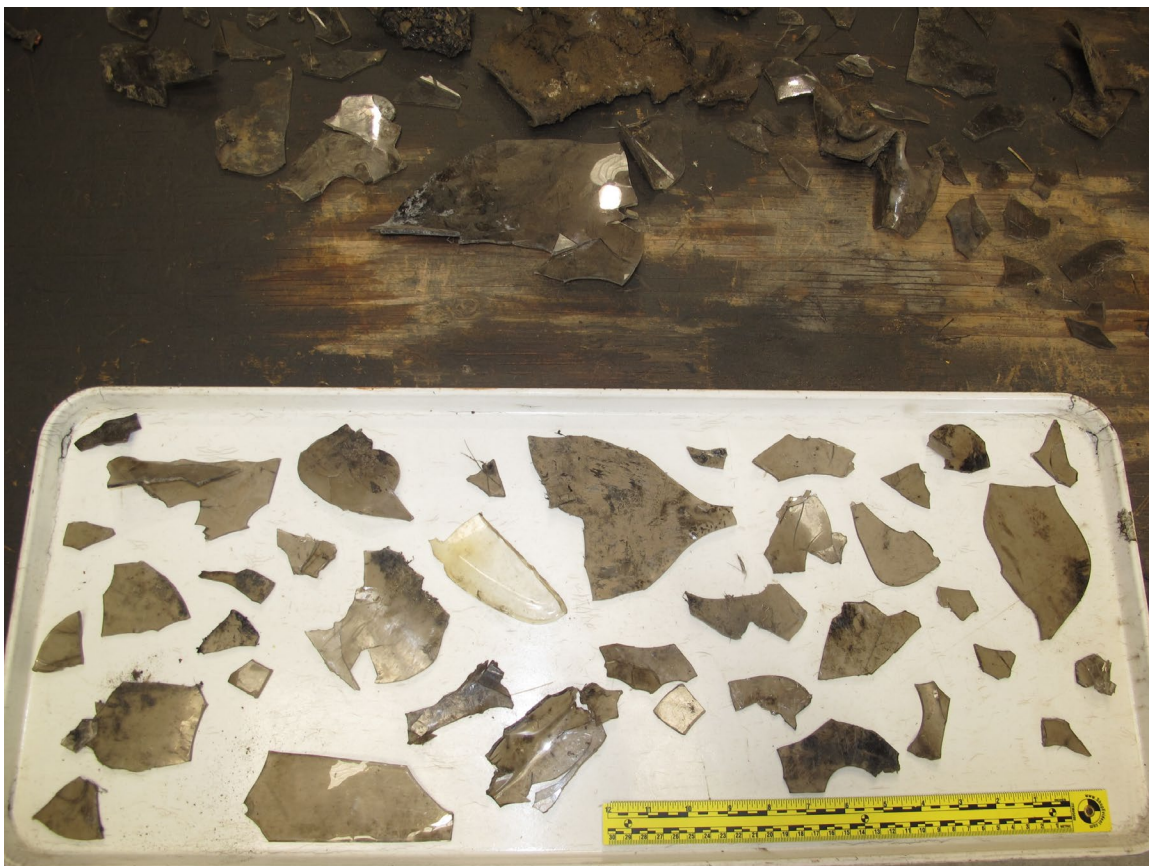
The windscreen/windshield was fragmented and scattered over the accident site. Over 100 pieces of recovered windscreen/windshield material were sent to the Materials Laboratory to look for evidence of hydrocarbon fluid (lubricant/hydraulic fluid/fuel) spray. A selection of fragments is shown in Figure 5. Most of the fragments were sooted in various amounts. Several pieces were discolored and exhibited localized melting and charring consistent with thermal exposure during the post-crash fire. The pieces were visually examined using various alternate light sources (ALS). The ALS uses varying wavelengths of light to improve the visualization of hydrocarbon residue on the surface of the windshield fragments. No evidence of hydrocarbon residue was found on any fragments.

**Figure 5.** Windshield fragments from accident aircraft.
