# National Transportation Safety Board

CEN22FA405

## **MATERIALS LABORATORY**

Factual Report 22-069

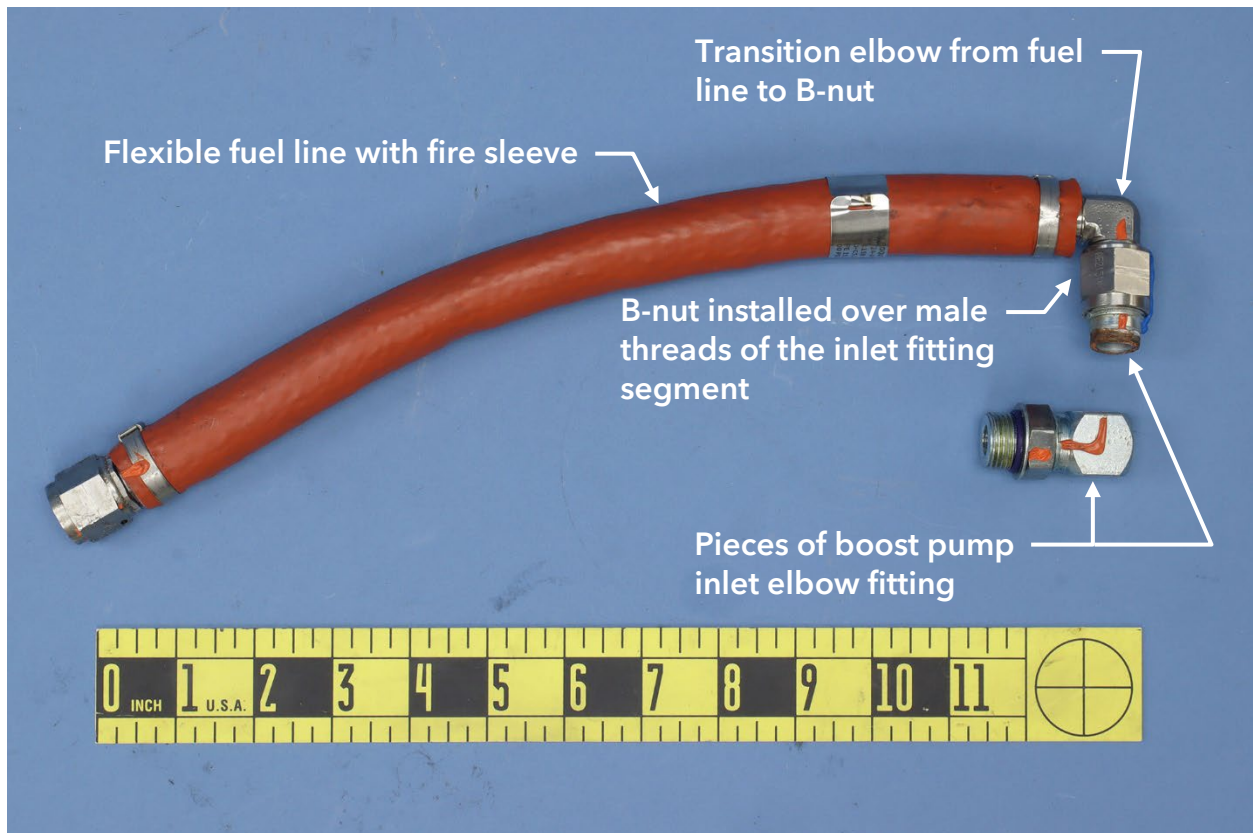
A 90° elbow fitting, separated into two pieces, and a flexible fuel line were submitted to the NTSB Materials Laboratory for examination as shown in figure 1. One segment of the elbow fitting was still connected to a B-nut at the end of a flexible fuel line. The other segment was free-standing. The fitting was part of the engine fuel system, with one end connected to the fuel boost pump inlet and the other end connected to the flexible fuel line. For reference, an exemplar boost pump with attached inlet and outlet fittings is shown in figure 2, with the inlet fitting indicated by red rectangles. According to an engineering drawing from the aircraft manufacturer, the specified fitting was MS51527-B8ZC, a nominal ½" diameter fitting made from plain carbon steel with a zinc-plate finish. The end connected to the fuel pump was straight threaded with an O-ring backed by a washer and compression nut. The other end was a straight-threaded tube with a 37° flared end for the B-nut connection to the flexible fuel line. The fitting was first examined on September 7, 2022 and September 8, 2022 with a representative from Cirrus Design Corporation dba Cirrus Aircraft in attendance, with additional examination occurring thereafter.

**Figure 1.** Image of the as-received separated elbow fitting and flexible fuel line.

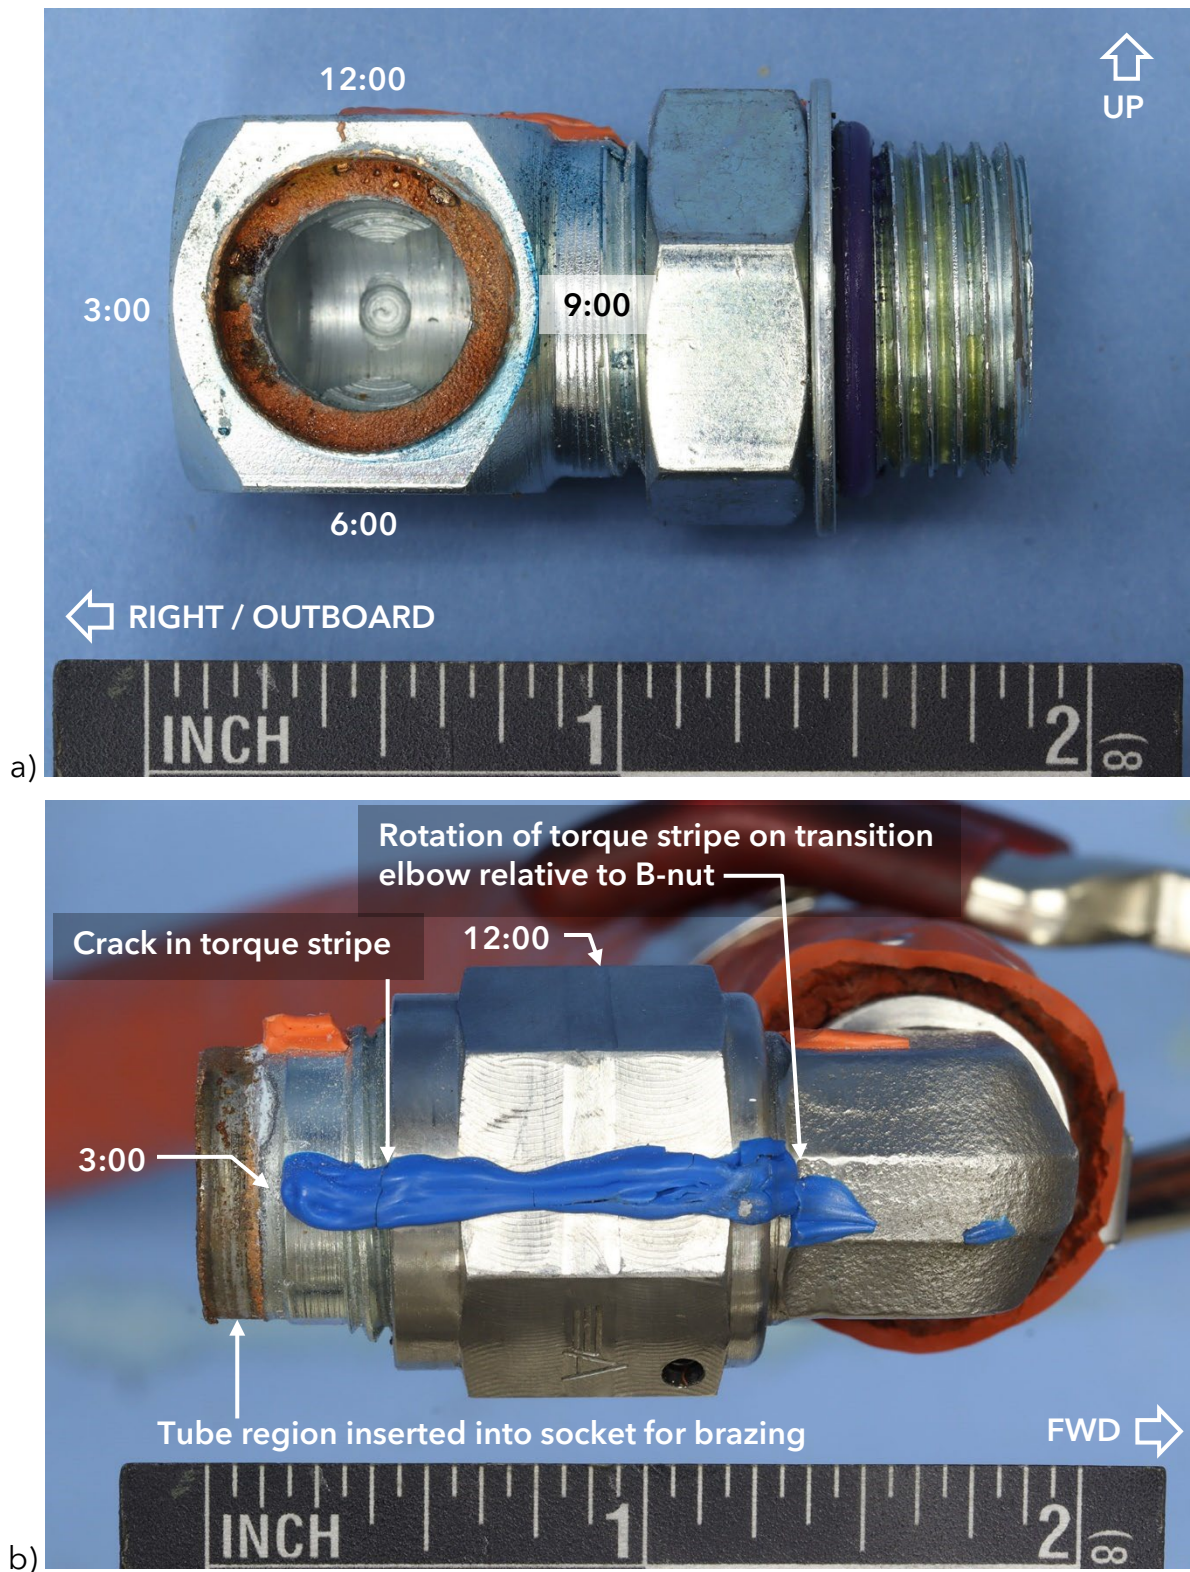
The fitting had separated into two pieces, as shown in figure 1. Visual examination indicated that the separation had occurred at a brazed joint as seen in figures 3a and 3b. The socket-side of the joint, shown in figure 3a, was on the segment connected to the boost pump inlet while the tube-side of the joint, shown in figure 3b, was on the segment connected to the B-nut. For convenience, the socket and tube were assigned clock positions as if the fitting and pump were installed on

the aircraft and were viewed from the aft direction looking forward, with 12 o'clock located at top-dead-center (see figure 2 for the orientation of the installed pump). As indicated in figure 3b, a blue adhesive torque stripe had previously been applied to the tube, B-nut, and fuel line transition elbow along the 3:00 position. The torque stripe had fractured in two locations: one at the transition from the tube to the B-nut, and the other at the transition from the B-nut to the transition elbow. As indicated in figure 3b, the torque stripe at the later location was displaced in the circumferential direction, consistent with a rotation of the transition elbow relative to the B-nut. The displacement, measured on a calibrated image was approximately 0.075 inch. The rotation, viewed from the forward direction looking aft, was in the counterclockwise direction or from the 9:00 position toward the 12:00 position in the clock coordinate system of the brazed joint. When viewed at higher magnification, a small rotational offset of approximately 0.006 inch was also observed at the crack between the B-nut and tube, with the B-nut similarly rotating in the counterclockwise direction (viewed forward looking aft).

**Figure 3.** Images of the separated fitting; a) socket side and b) tube side with cracked and rotated blue torque striping.

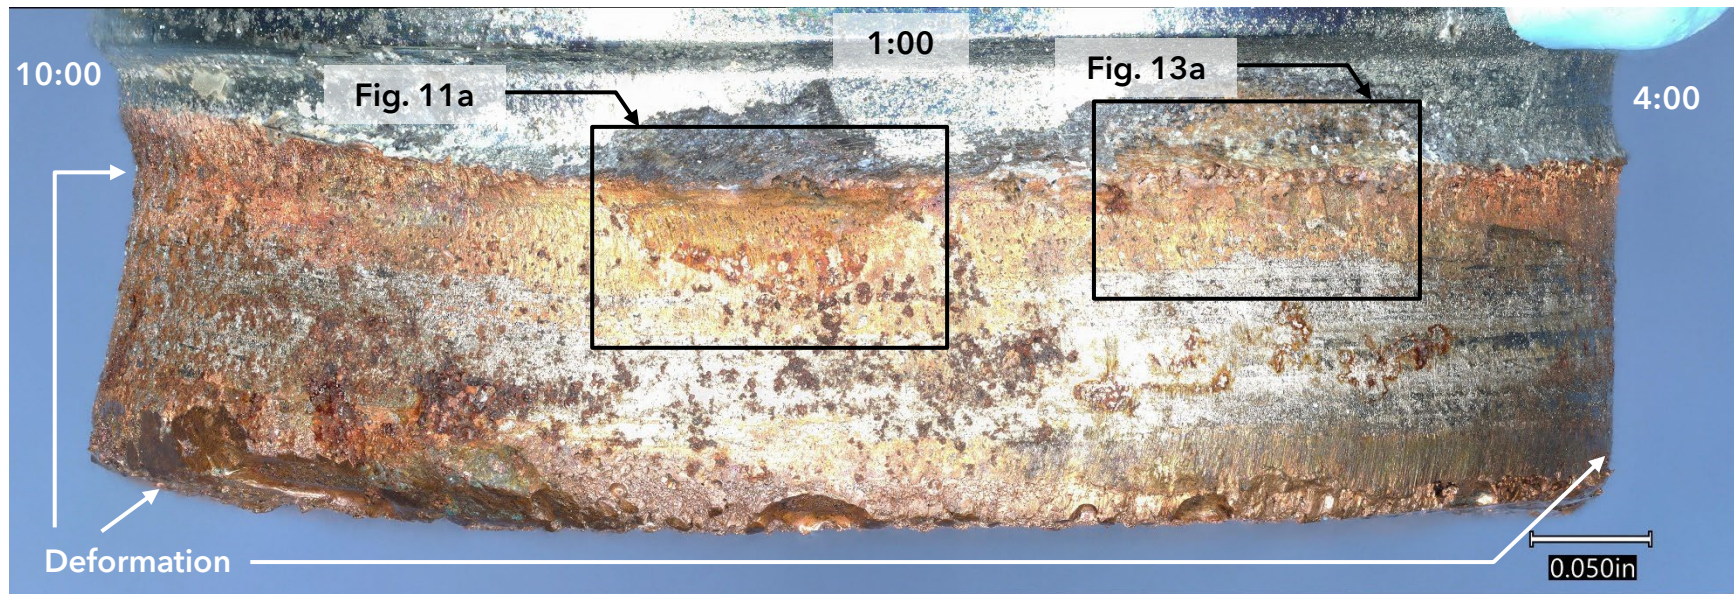
Both sides of the joint exhibited plastic deformation consistent with an applied moment causing the tube to lever out of the socket, with the pivot point at approximately the 10:00 position. At that position and near the butt-end of the joint, the tube material was deformed axially upward and outward, as indicated in figures 4 and 5, respectively. At the same clock position but at the top opening to the joint, the tube material was similarly displaced axially upward but was deformed radially inward. At approximately the 4:00 position (180° around the circumference of the tube) the sidewall was deformed radially inward (a comparatively small amount) near the butt-end of the tube. On the socket-side, the braze metal at the base of the joint exhibited a comparatively flattened and smeared appearance over an approximately 70° angle that was centered nominally about the 10:00 position, as indicated by the yellow-dashed region shown in figure 6. Centered about the same clock position, the sidewall at the opening to the socket was deformed as shown in figure 7.

The separated fitting from the accident aircraft exhibited similar features on the sidewall of the socket and tube, with some apparent copper-colored and some bare-steel regions, as seen in figures 7 and 4, respectively. Similarly, braze metal was generally observed covering the base of the socket and the butt-end of the tube, seen in figures 3a and 5, respectively, except near the 3:00 position, where a gap in coverage was observed.

**Figure 4.** Image showing the sidewall of the brazed portion of the tube at approximately the 1:00 position. The tube was deformed in the axial direction at approximately the 10:00 position (upward in the image) and was deformed radially outward, also at the 10:00 position, at the butt-end of the joint. The tube was deformed radially inward near the butt-end of the joint at the 4:00 position and at the opening to the joint around the 10:00 position. Staining was also observed at two locations on the zinc-plate and copper braze surfaces.

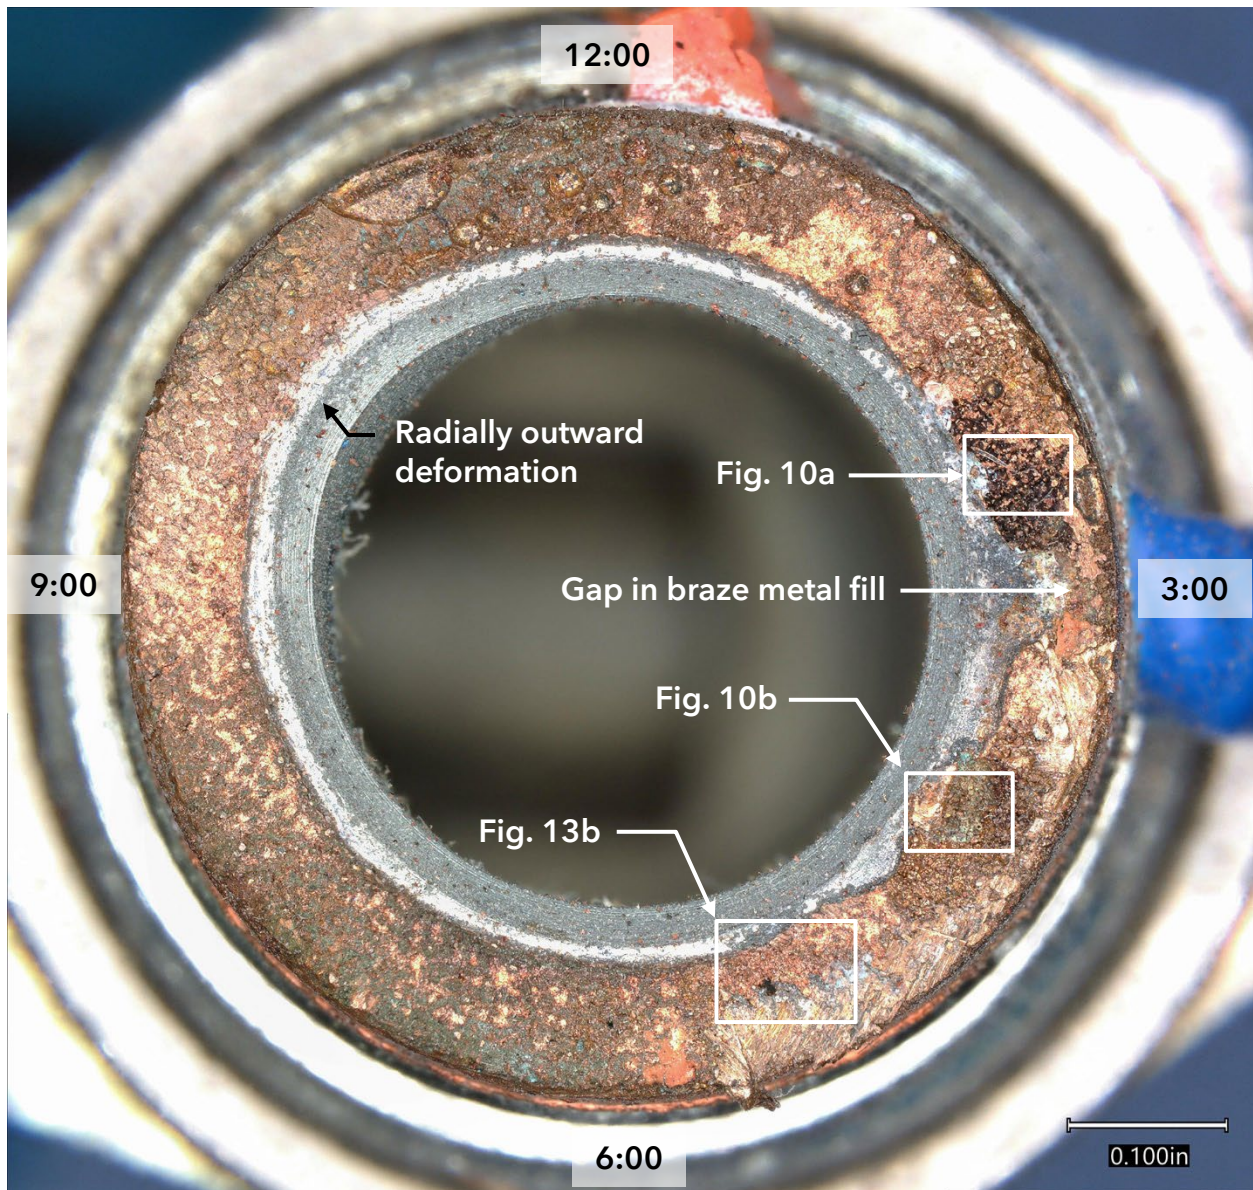
Anomalies were observed on the separated joint. As indicated in figure 5 and shown by scanning electron microscope in figures 10a and 10b, at the 2:00 and 4:00 positions, the braze metal between the butt-end of the tube and the base of the socket exhibited a porous, unconsolidated appearance. In between these regions, at the 3:00 position, was a region without copper braze metal fill, indicated in figure 5. As seen in figure 4, the zinc plated surface outside the joint and near the 1:00 position exhibited dark staining at two locations.<sup>1</sup> Thumbnail-shaped regions of staining were also observed within the joint space adjacent to the surface staining. A backscatter electron image of one of those locations is shown in figure 11a. The thumbnail-shaped region had a dark appearance in the backscatter image. A higher magnification image near the bottom edge of the thumbnail region (a region furthest from the opening of the joint) is shown in figure 11b, also indicated in part a. The dark-colored material appeared to be deposited over the light-colored regions, which exhibited a smeared appearance. The compositions of the dark- and light-colored regions were examined by energy-dispersive X-ray spectroscopy (EDS), as shown in figures 12a and 12b, respectively. The spectrum from the dark-colored region consisted primarily of iron (Fe), copper (Cu), zinc (Zn), and oxygen (O). By comparison, the spectrum from the light-colored region consisted primarily of Fe and Cu. Zinc and oxygen were detected by EDS at two additional locations: One location was in an adjacent stained region, shown in figures 4 and 13a, and the second

location was observed on the end face of the tube near the 5:00 position, as shown in figures 5 and 13b.

**Figure 5.** Image showing the brazed end of the tube.

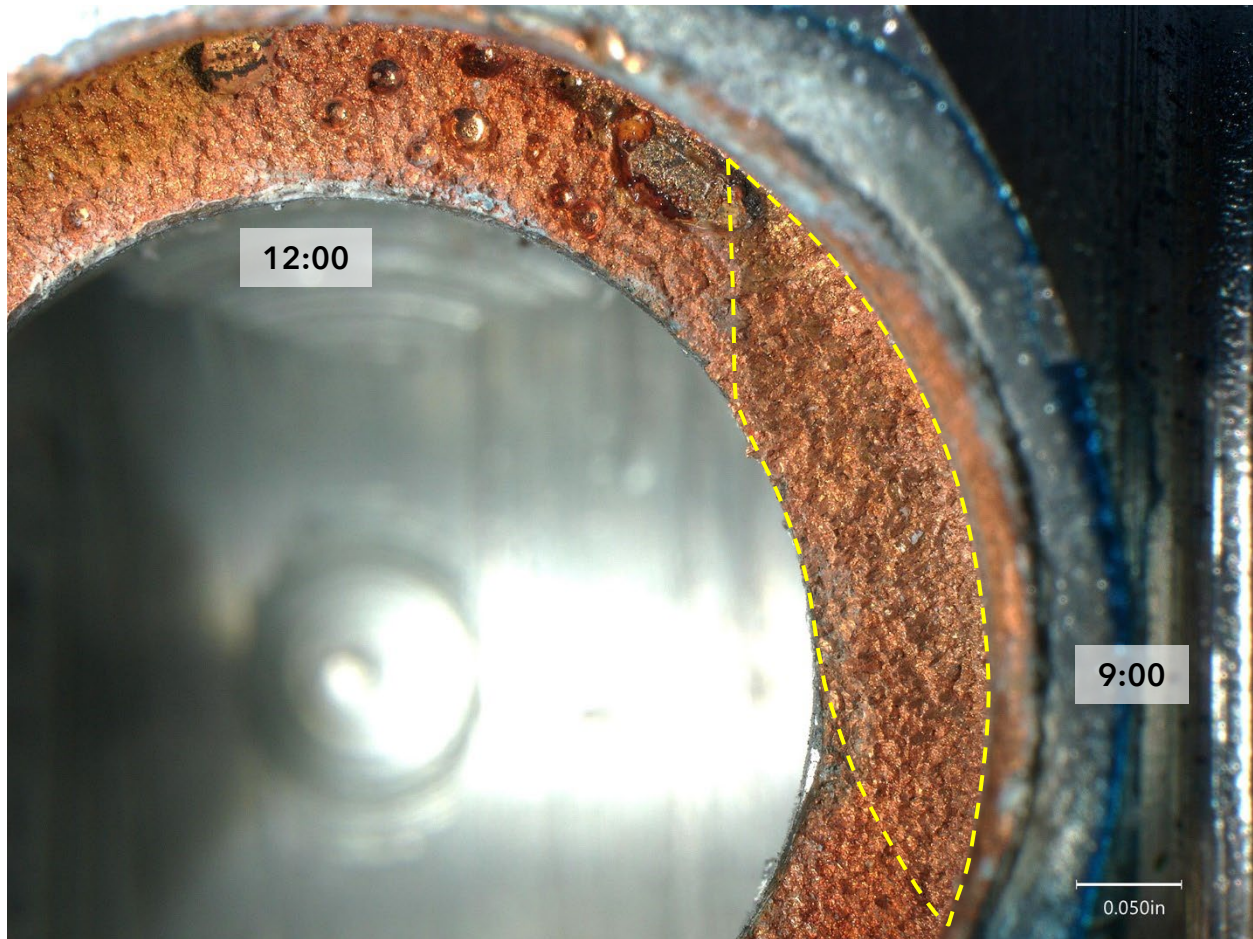
**Figure 6.** Image of the socket base between the 9:00 and 12:00 positions. A region of the base is indicated by the yellow dashed line where the braze metal surface was comparatively flattened and smeared. The region spanned an approximately 70° arc centered nominally about the 10:00 position.

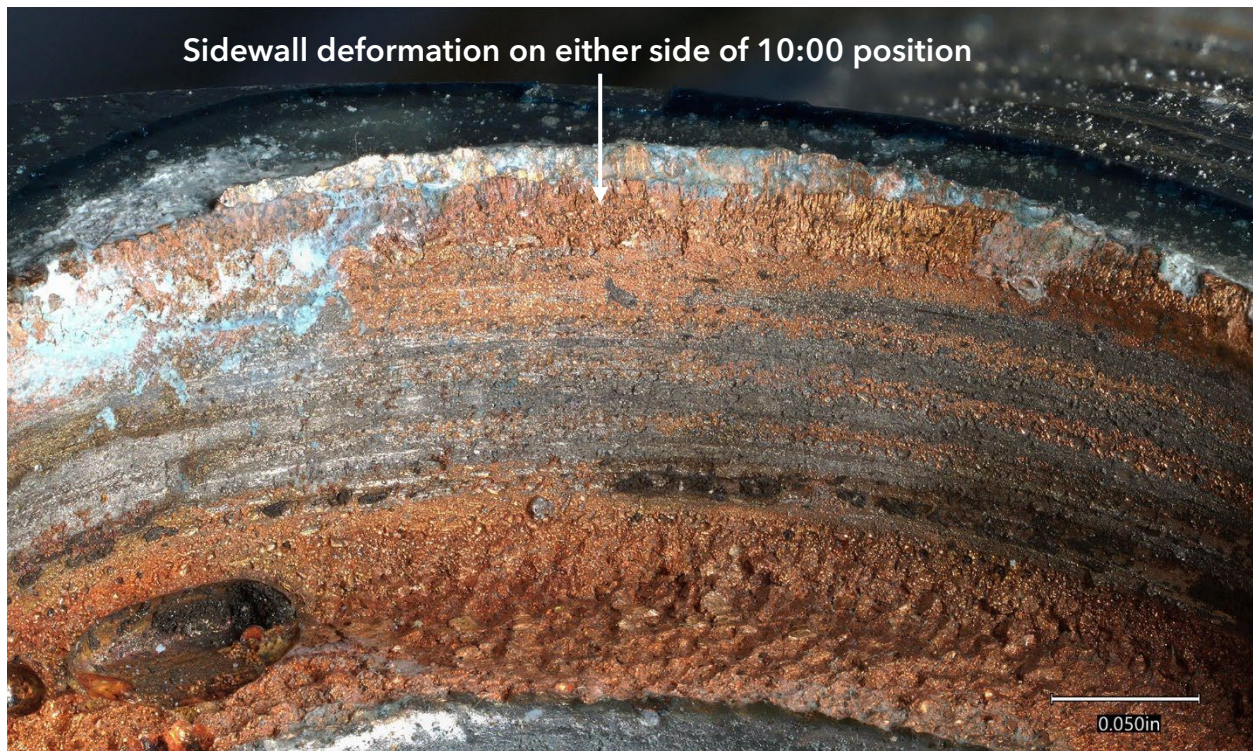
**Figure 7.** Image of the socket sidewall centered about the 10:00 position with an indicator pointing to deformation of the sidewall edge at the entrance to the joint.

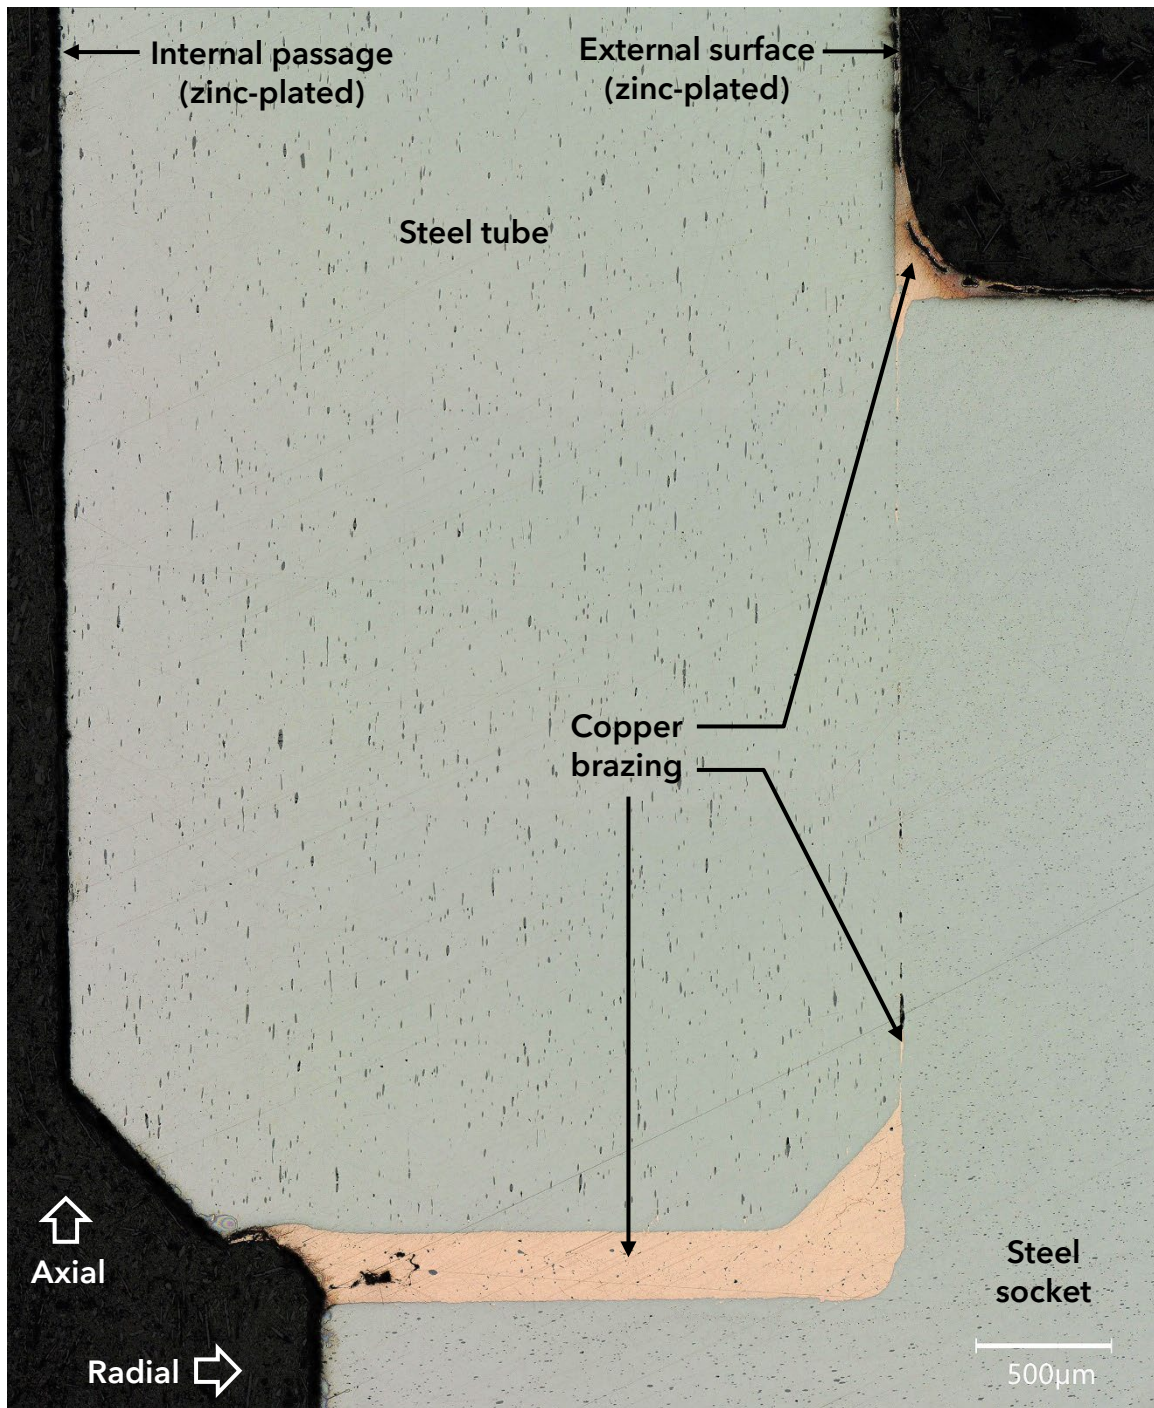
The brazed joint on the separated fitting was compared to a similar joint taken from an exemplar boost pump. The exemplar fitting was sectioned in the radial axial plane of the tube, passing through the 10:00 and 4:00 positions. One of the sectioned sides was mounted in diallyl phthalate resin, ground using silicon carbide papers, and polished on a cloth loaded with a 3 µm diamond suspension. The resulting cross section through the joint at the 4:00 position is shown in figure 8. The socket was approximately 0.146-inch deep and the tube extended approximately 0.136 inch into the socket. The gap between the end of the tube and the base of the socket was filled with copper braze metal. A region of porosity in the braze metal, approximately 0.013 inch in width, was observed close to the internal passage. The rest of the braze metal appeared to be well-consolidated. A fillet of braze metal was also observed along the external surface where the tube entered the socket. The

sidewall between the base and opening of the socket exhibited regions where the socket and tube surfaces were in direct contact with one another, with no apparent gap or braze metal in between. Elsewhere along the sidewall, small gaps between the tube and socket were observed, the widest of which measured approximately 0.0005 inch across. Some of the gaps were filled with braze metal while others were not.

**Figure 8.** Cross section through exemplar fitting at approximately the 4:00 position.

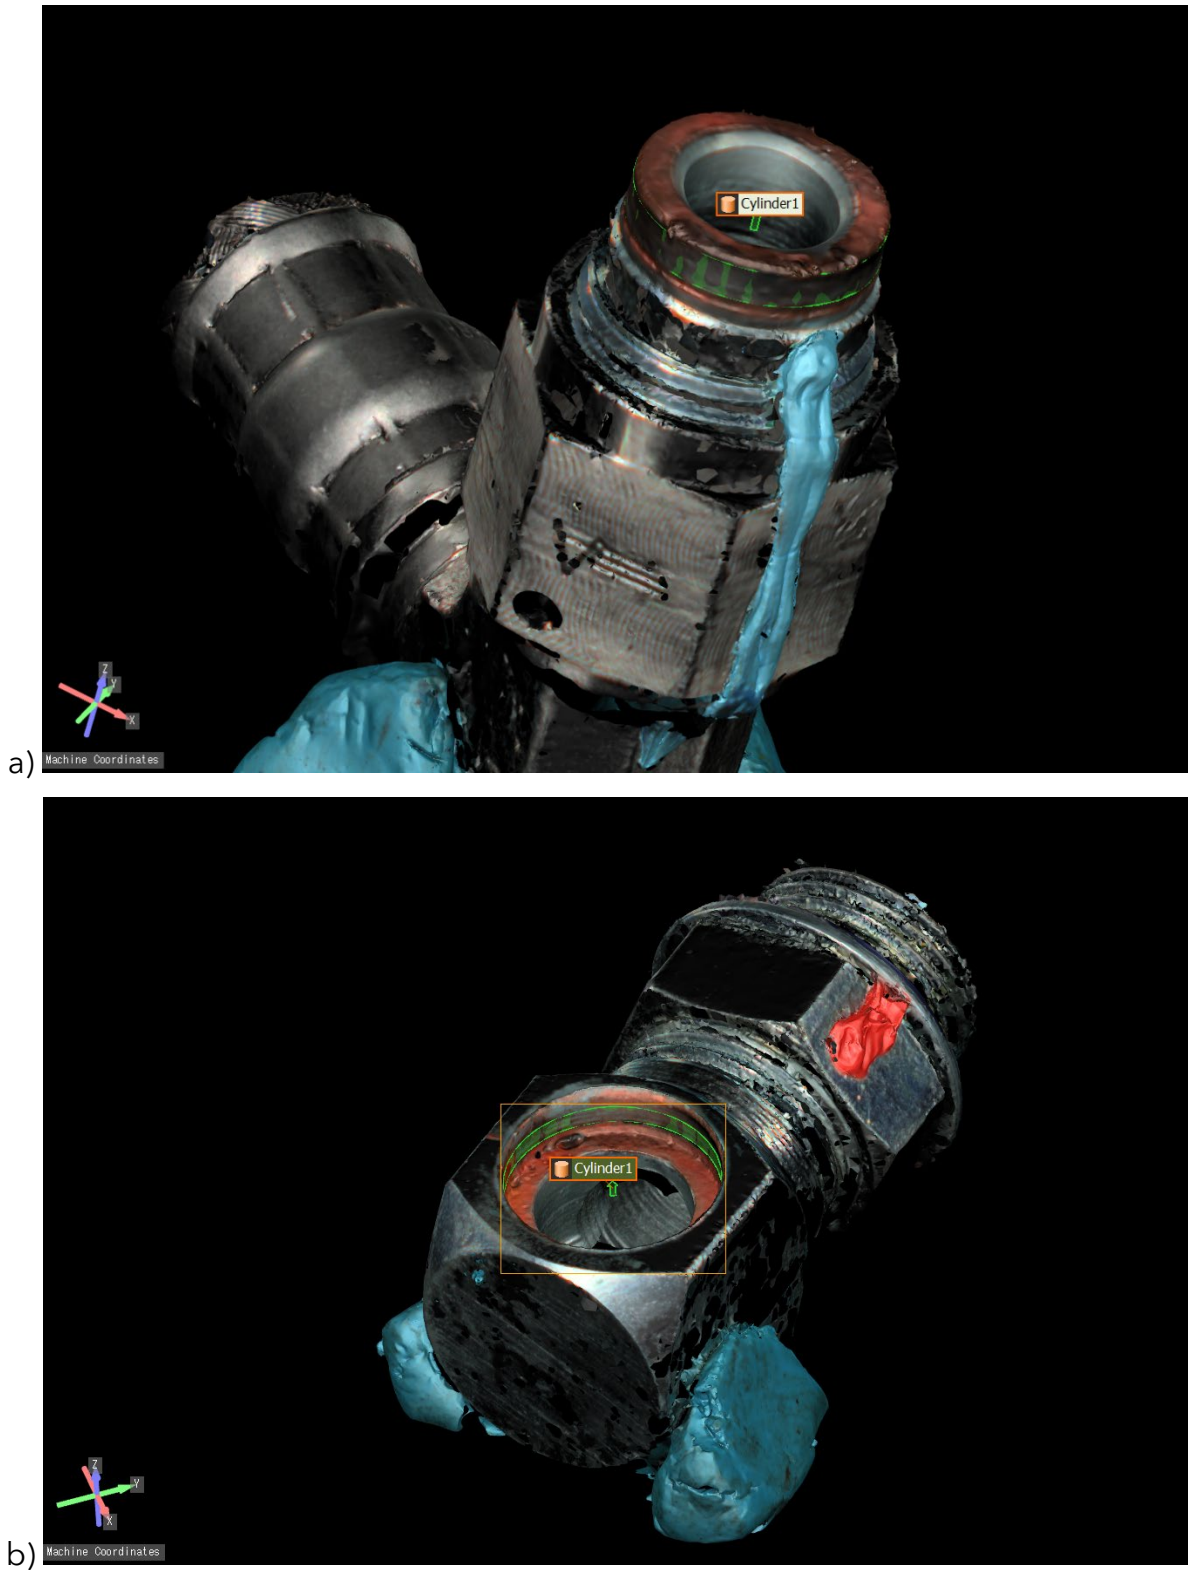
The tube- and socket-sides of the joint were scanned using a structured-light 3D scanner and the models were used to estimate their outer- and inner-diameters, respectively, as shown in figures 9a and 9b. Regions that exhibited plastic deformation were excluded from the diameter measurements. The tube and socket both measured 0.626 inch for the outer- and inner-diameter, respectively.

**Figure 9.** 3D models generated using a structured-light 3D scanner; a) tube-side of joint and b) socket-side of joint.

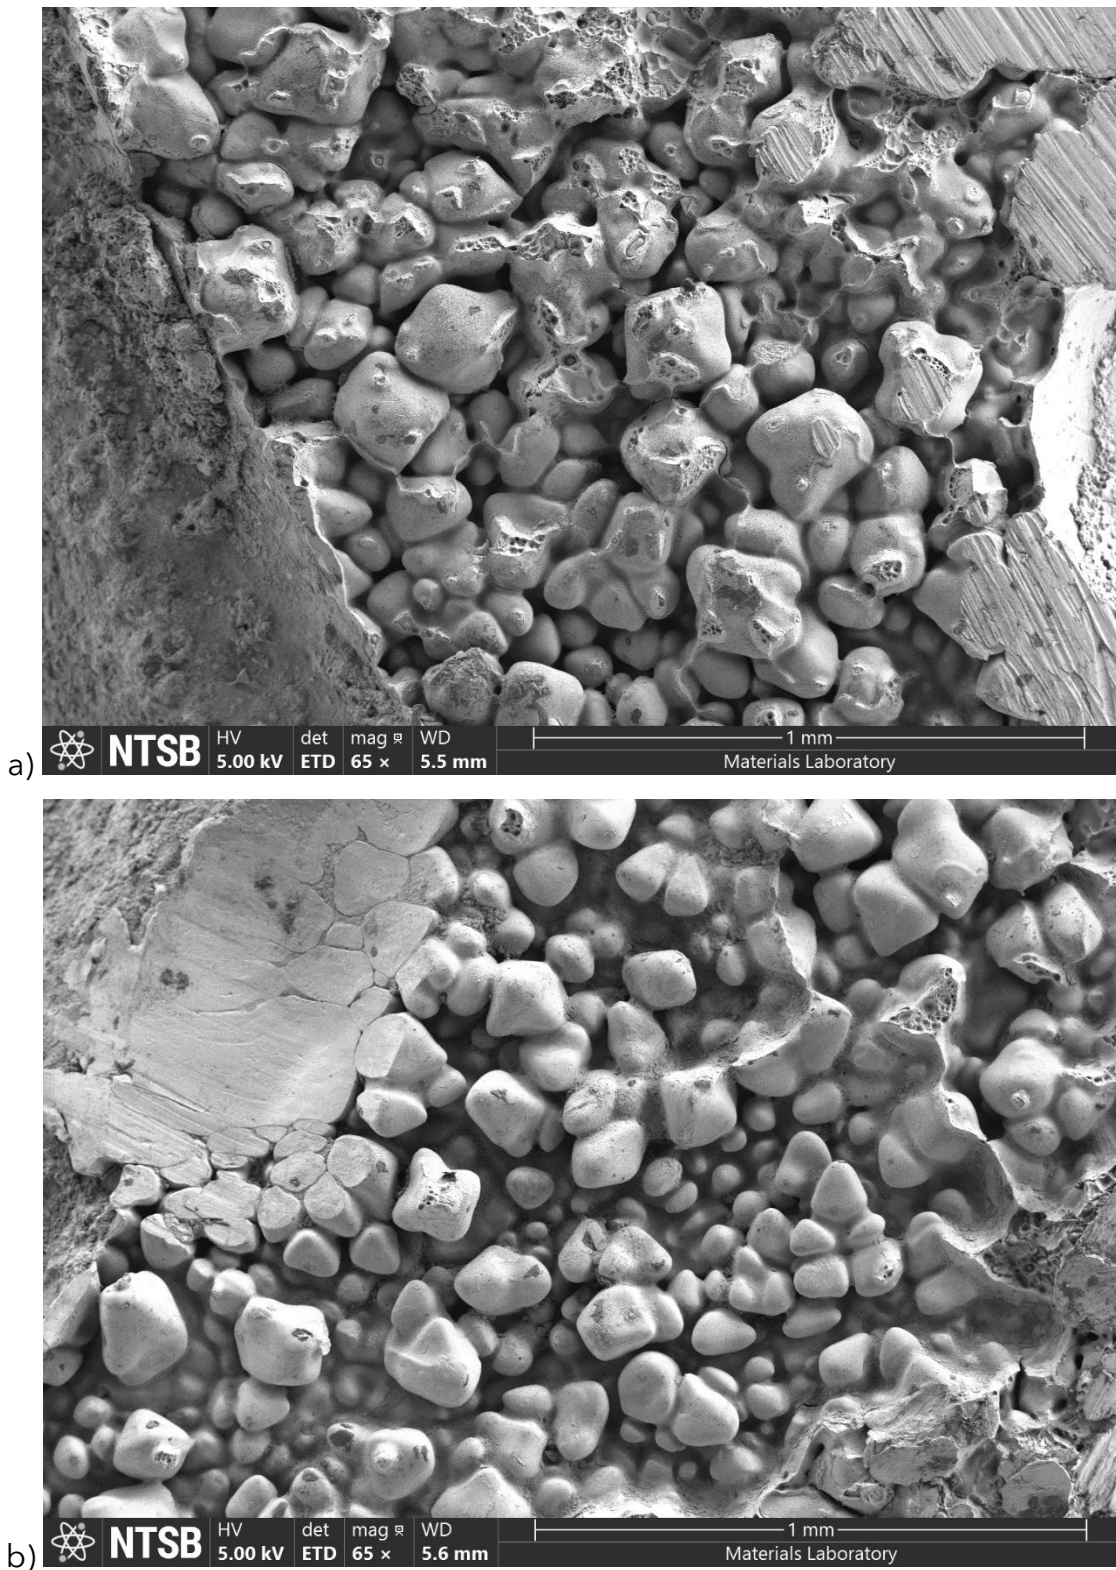
**Figure 10.** End face of brazed tube showing unconsolidated copper braze metal. See figure 5 for clock positions; a) near the 2:00 position and b) near the 4:00 position.

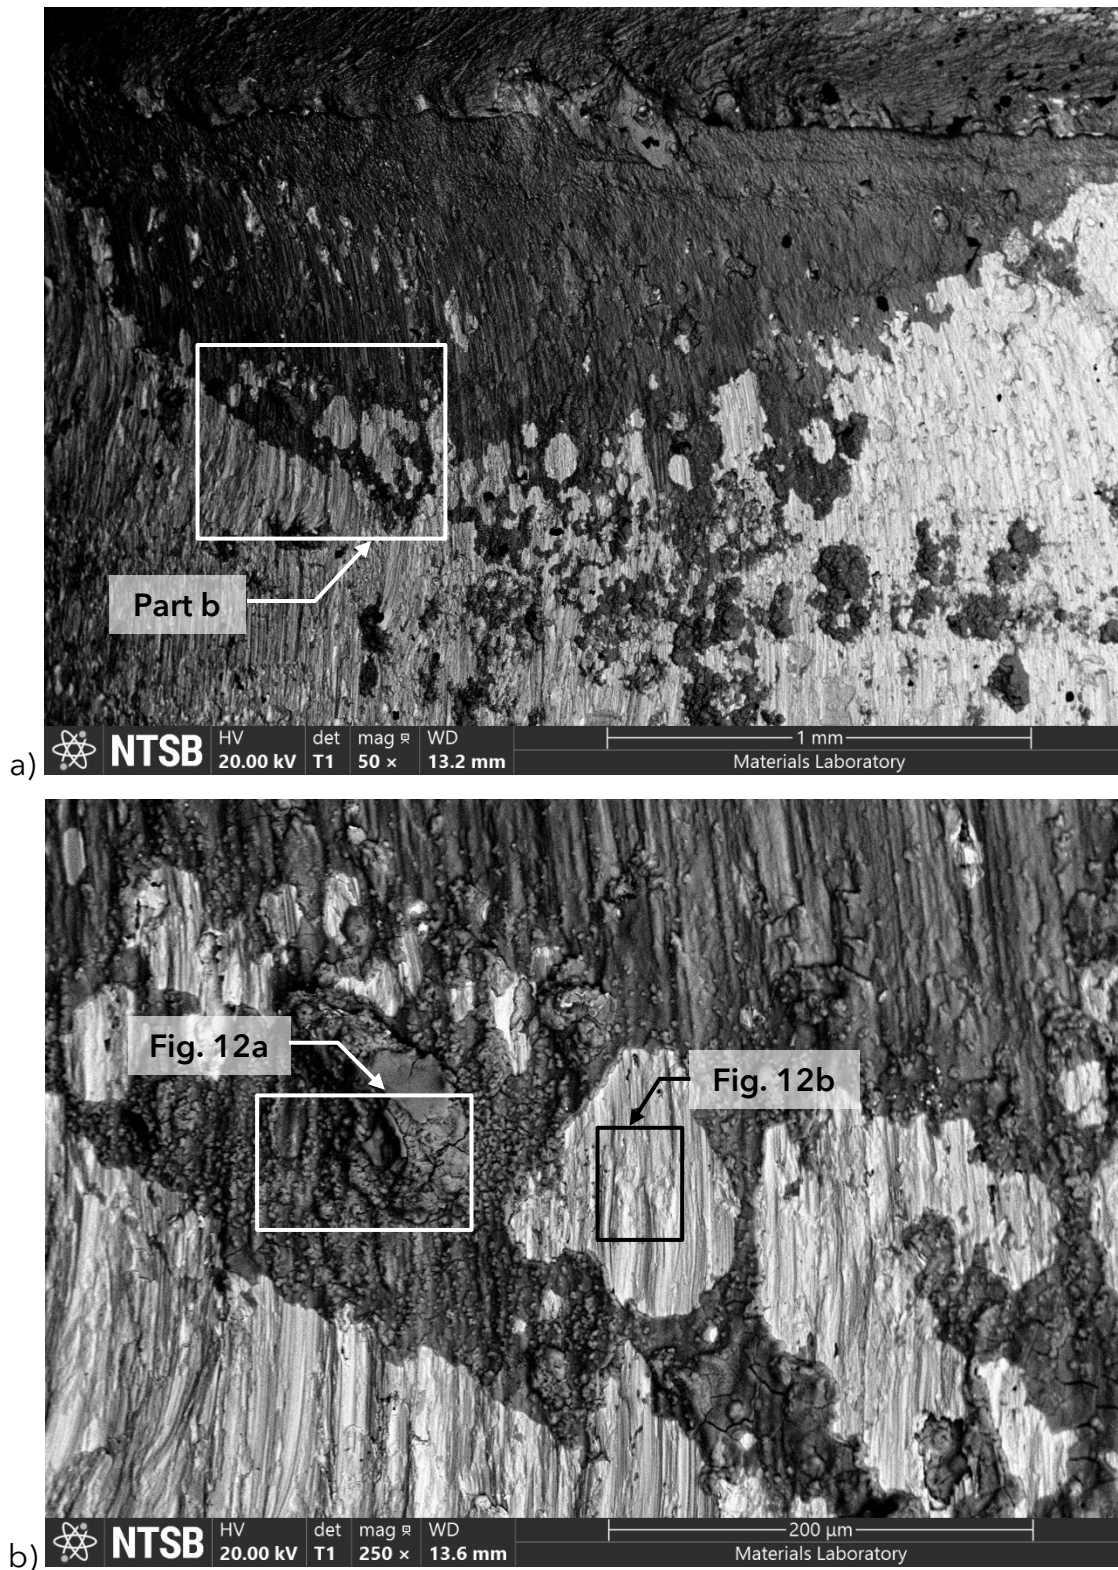
**Figure 11.** Backscatter electron images on the sidewall of the brazed tube near the 1:00 position and at the opening to the joint. See figure 4; a) Low magnification image of a thumbnail-shaped region and b) higher magnification image at the location indicated in part a.

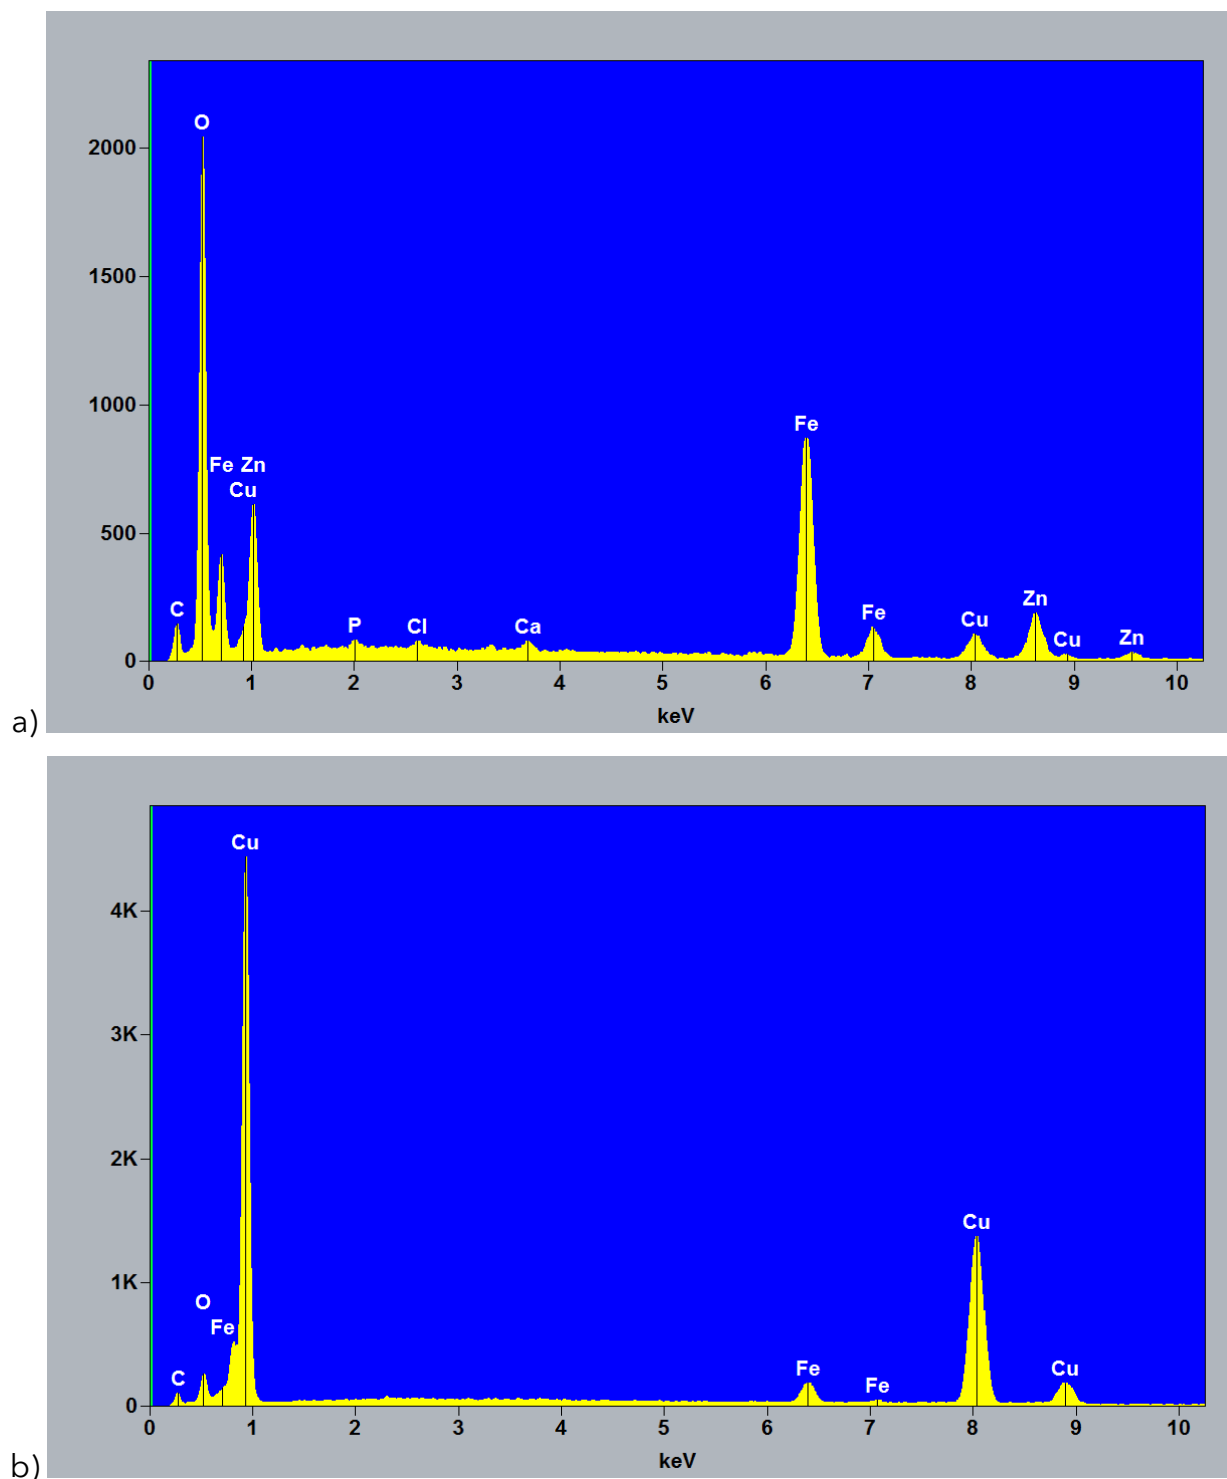
**Figure 12.** EDS spectra from the regions indicated in figure 11; a) spectrum for dark-colored region exhibiting primarily iron (Fe), copper (Cu), zinc (Zn), and oxygen (O) and b) spectrum from the light-colored region exhibiting primarily Fe and Cu.

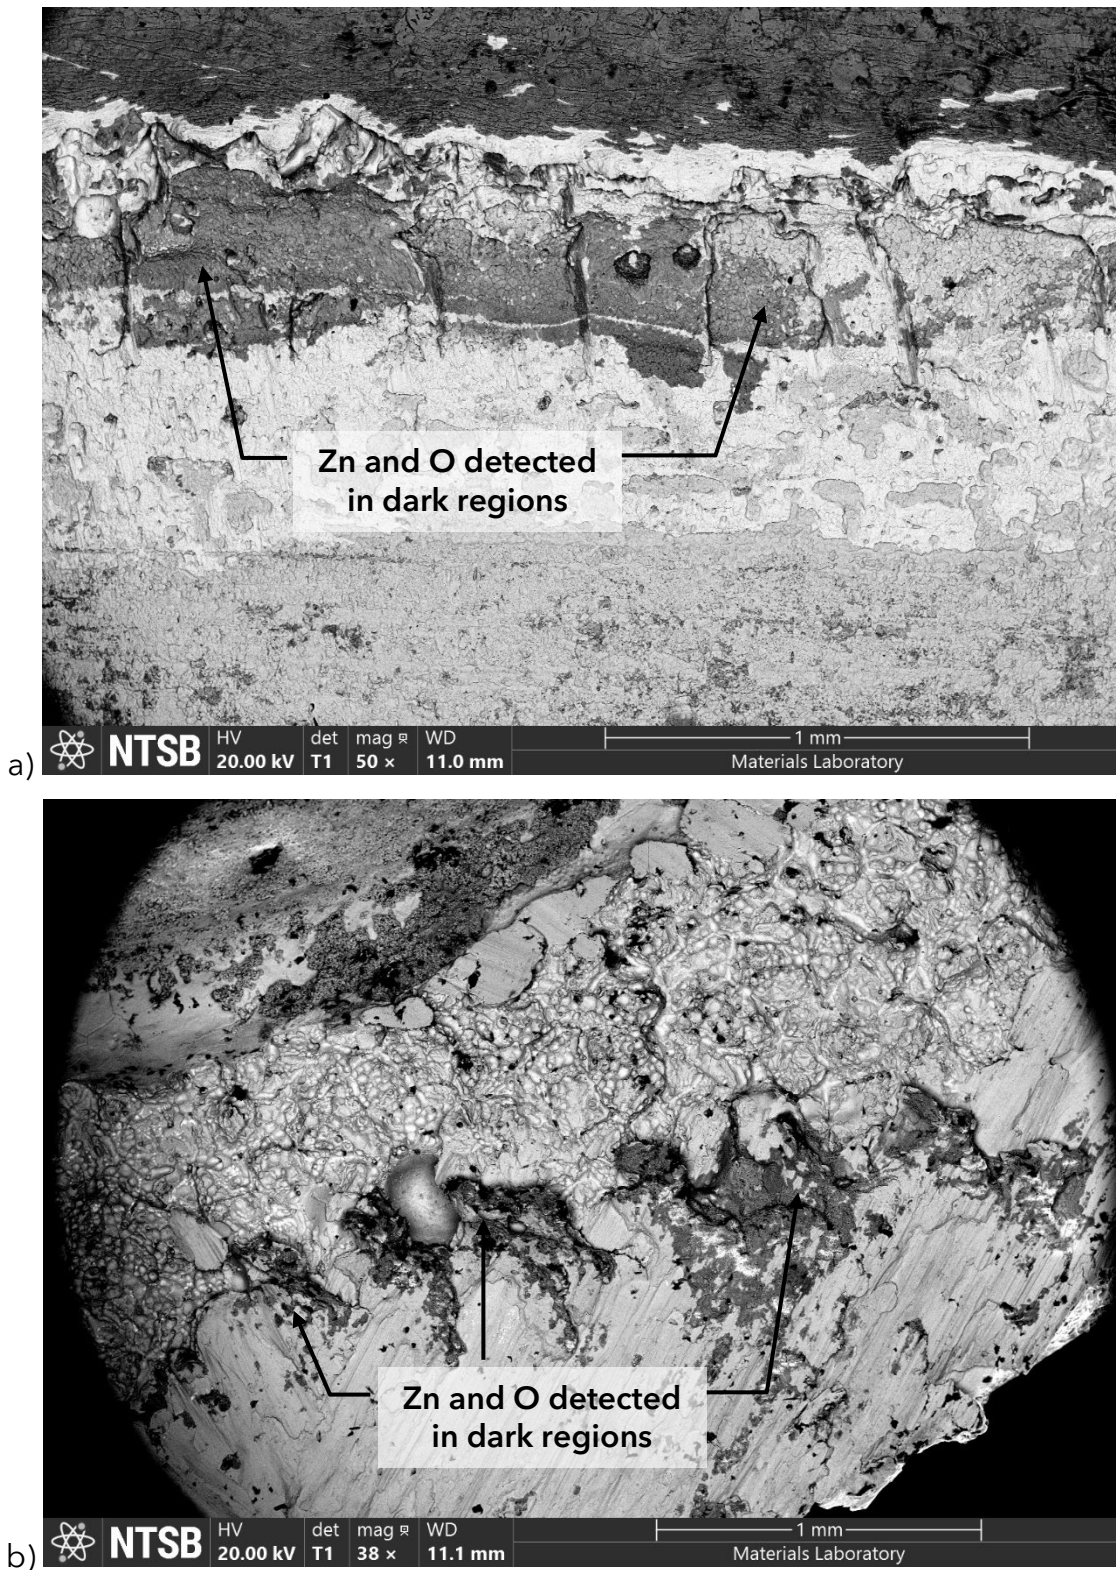
**Figure 13.** Images of additional regions exhibiting Zn and O in EDS spectra; a) region along sidewall of tube at opening to joint near 1:00 position (see fig. 4) and b) region on end-face of tube near the 5:00 position (see fig. 5).

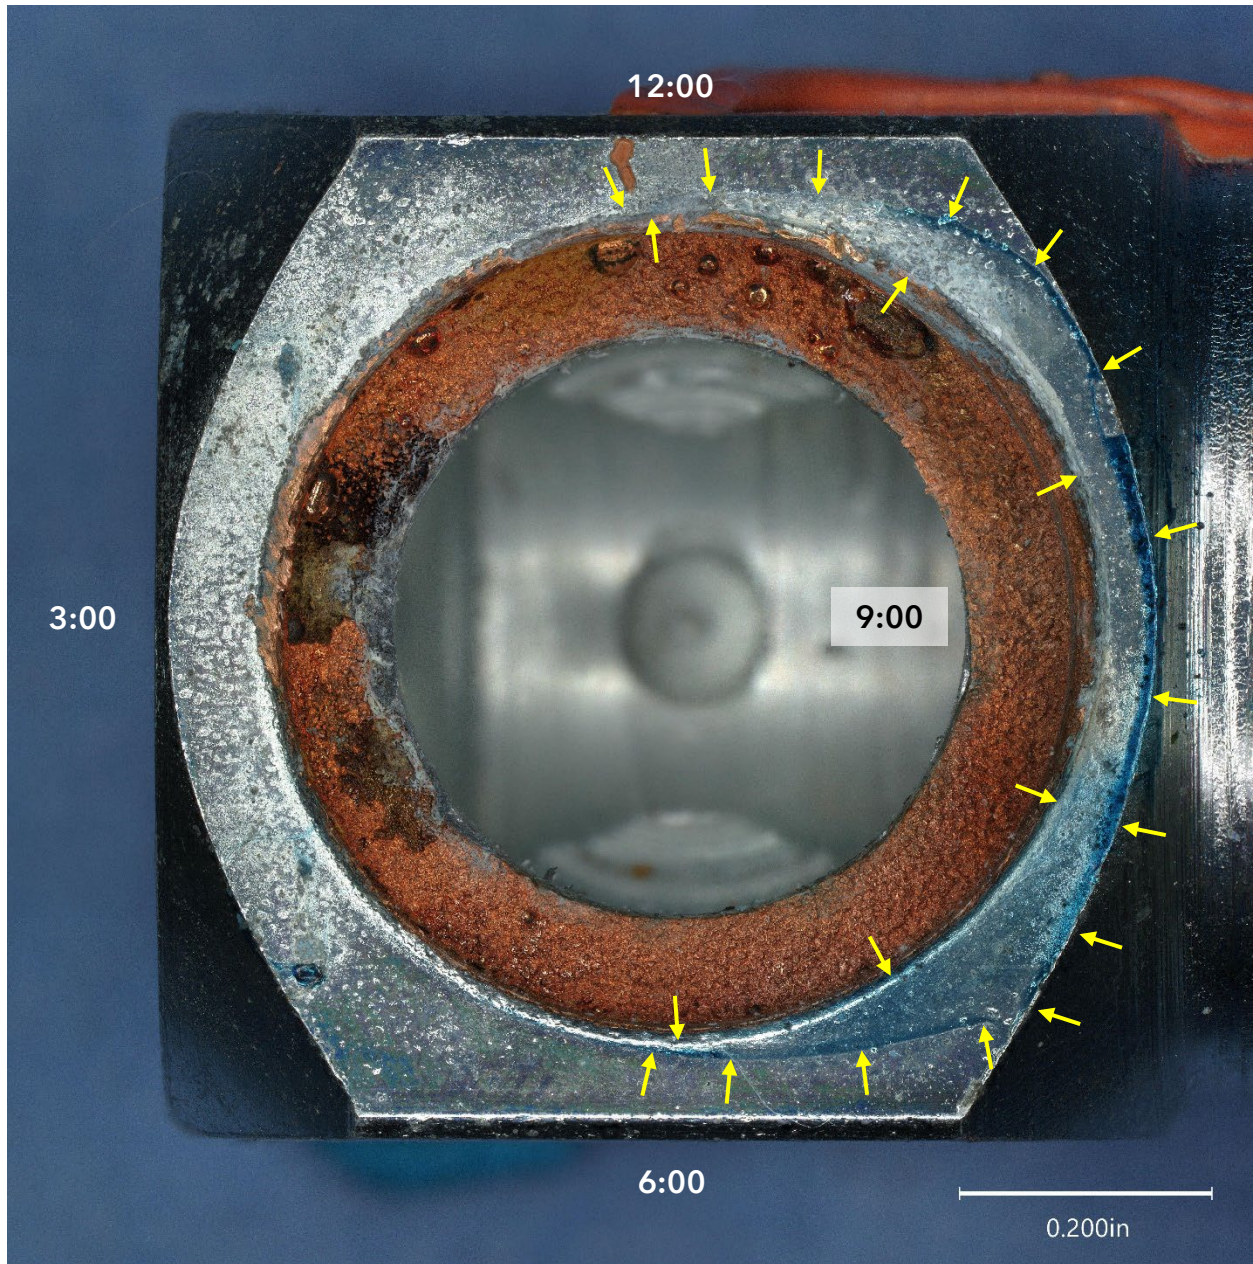
Visual examination of the separated fitting's socket-side revealed a residual film of unknown origin. The film was observed on the flat face of the socket near the opening to the joint, as indicated in figure 14. Yellow arrows in the figure demarcate the boundary of the film, which extended from the 12:00 position to the 6:00 position by way of 9:00. The film was clear toward 12:00, but exhibited a blue tint, consistent with fuel dye, toward the 6:00 position. An excerpt from a photo taken during the wreckage exam, seen in figure 15 and showing the socket-side of the joint, indicated the film was present at that time. Multiple spots of blue dye were also observed on that part of the fitting. Within the boundary of the film, the spots of dye exhibited comparatively discrete boundaries as compared to their condition at the time of the lab examination.

**Figure 14.** Image of the socket with yellow arrows indicating the extent of a translucent film on the flat face around the entrance to the joint. The film extended from approximately the 12:00 position to the 6:00 position by way of the 9:00 position.
