# National Transportation Safety Board

CEN22FA405

## **MATERIALS LABORATORY**

Factual Report 22-069

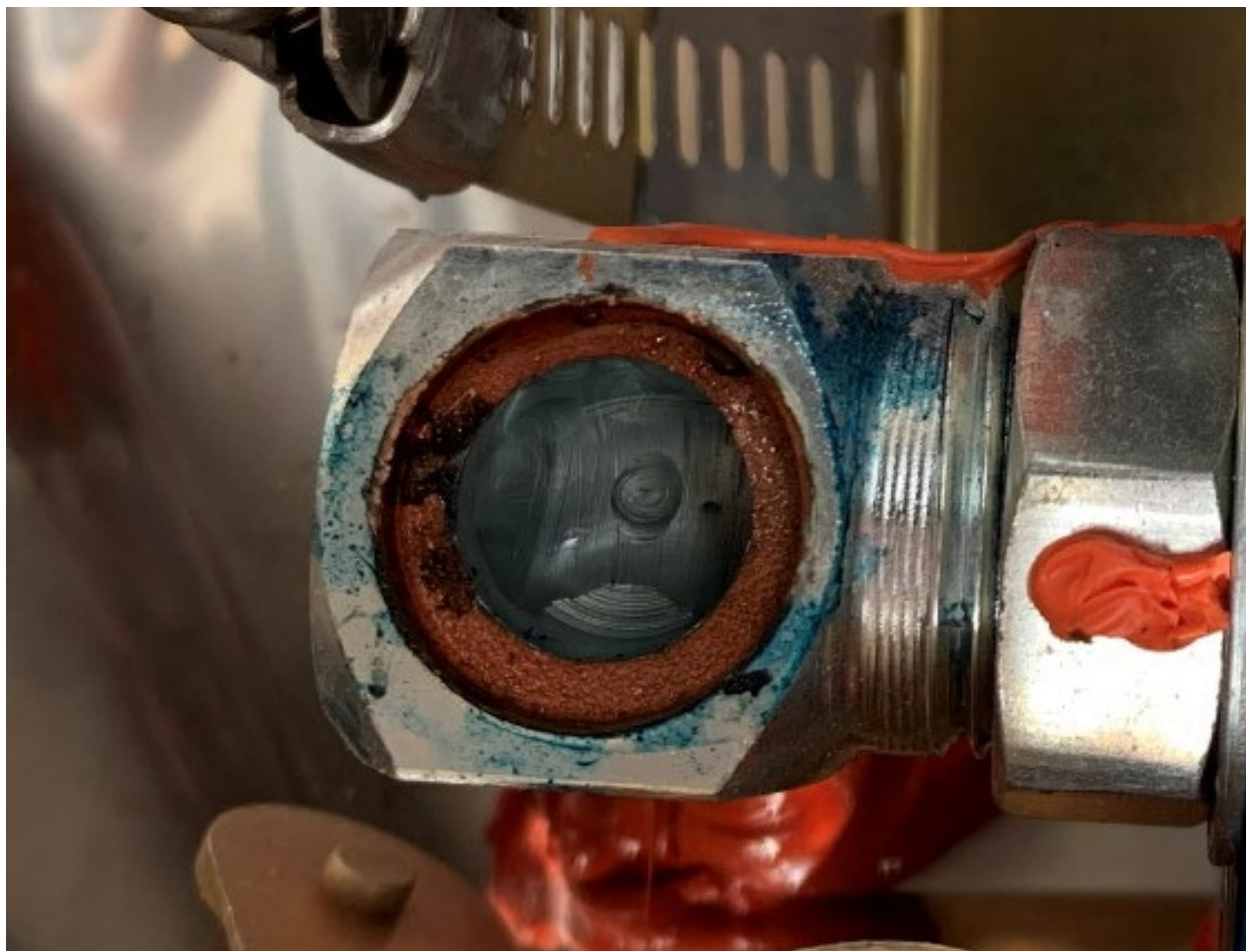
**Figure 15.** Excerpt of a photo taken during the wreckage exam showing the condition of the socket and surrounding surfaces at that time. Image courtesy of the investigator-in-charge.

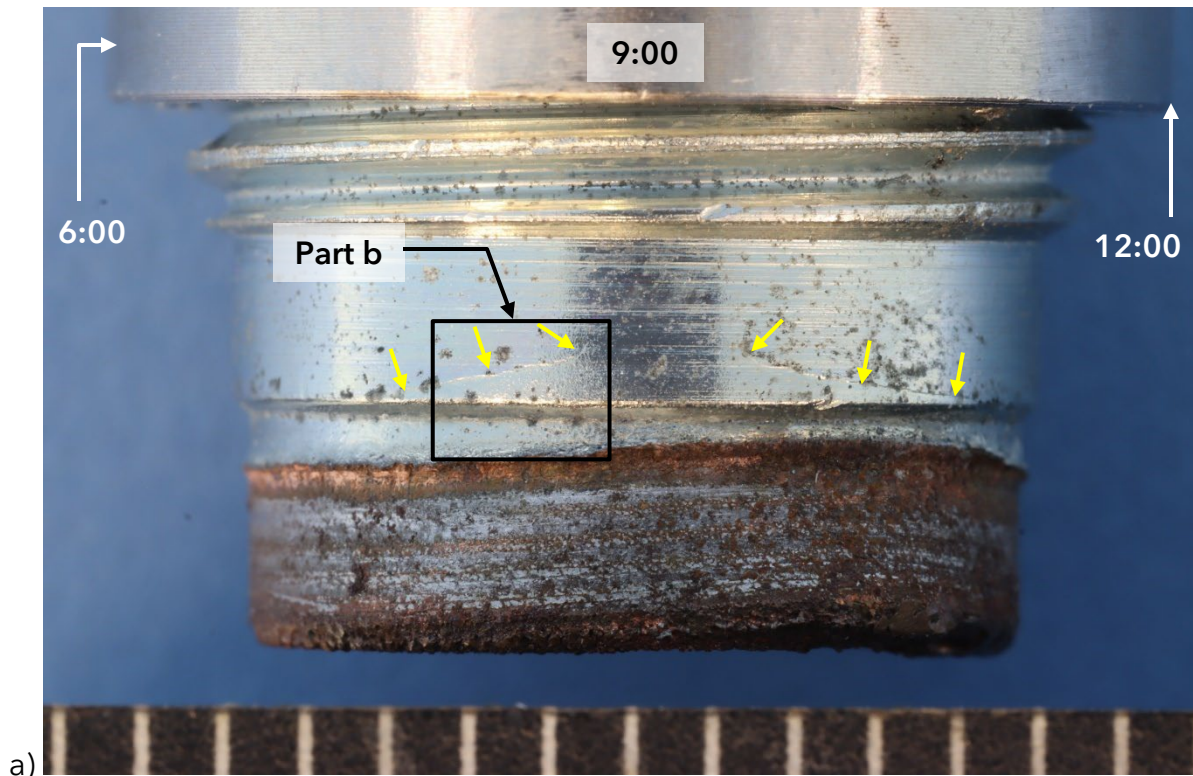
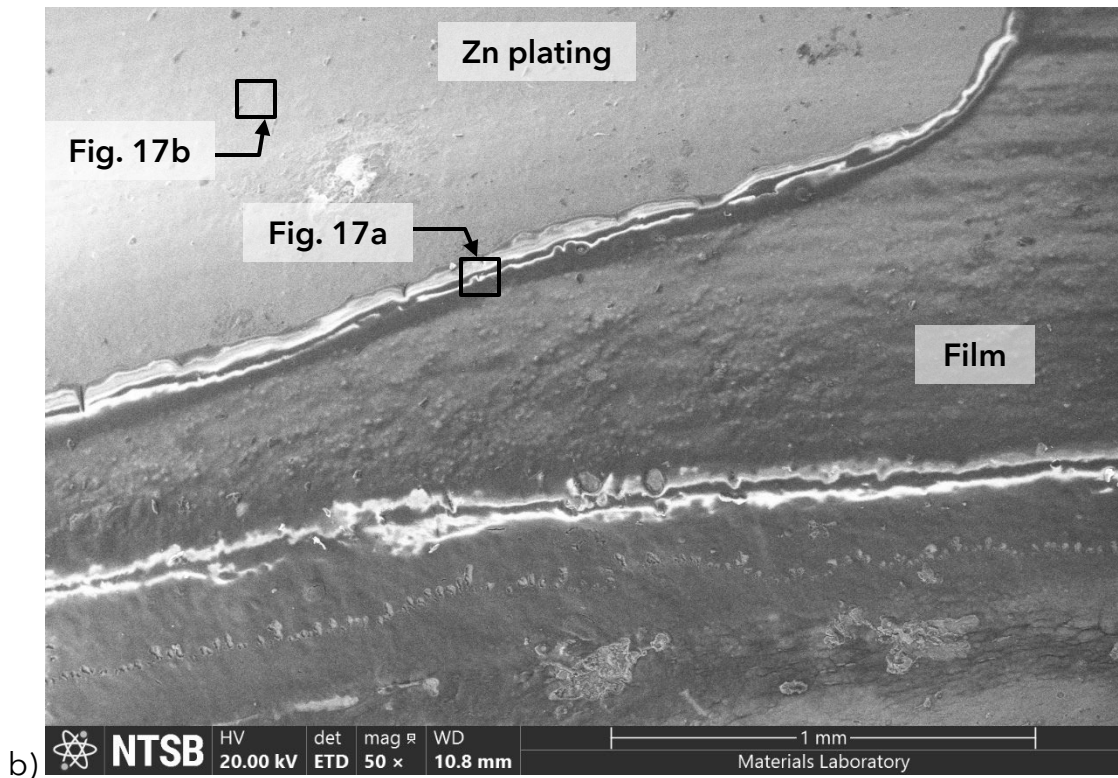
The tube-side of the joint was examined and a clear film was observed on the zinc-plated sidewall adjacent to the joint opening, also centered about the 9:00 position, but with no blue staining from fuel dye. The boundary of the film is indicated by yellow arrows in figure 16a and a region of the film is shown in the scanning electron microscope image in figure 16b. The chemical composition of the film was identified by EDS. As shown in figure 17a, a spectrum from a region at the edge of the film consisted primarily of silicon (Si), oxygen (O), and carbon (C), consistent with a silicone-based material, along with a trace of Zn and a possible trace of lead (Pb). A spectrum taken outside the boundary of the film, shown in figure 17b, consisted primarily of Zn, Fe, Cr, O, and C with traces of additional elements. An EDS spectrum from the film on the socket-side of the fitting (not shown) produced a similar spectrum as shown in figure 17a, consisting primarily of Si, O, and C.

**Figure 16.** a) Image of the tube at the 9:00 position with the boundary of the translucent film indicated by yellow arrows and b) SEM image as indicated in part a showing the film boundary.

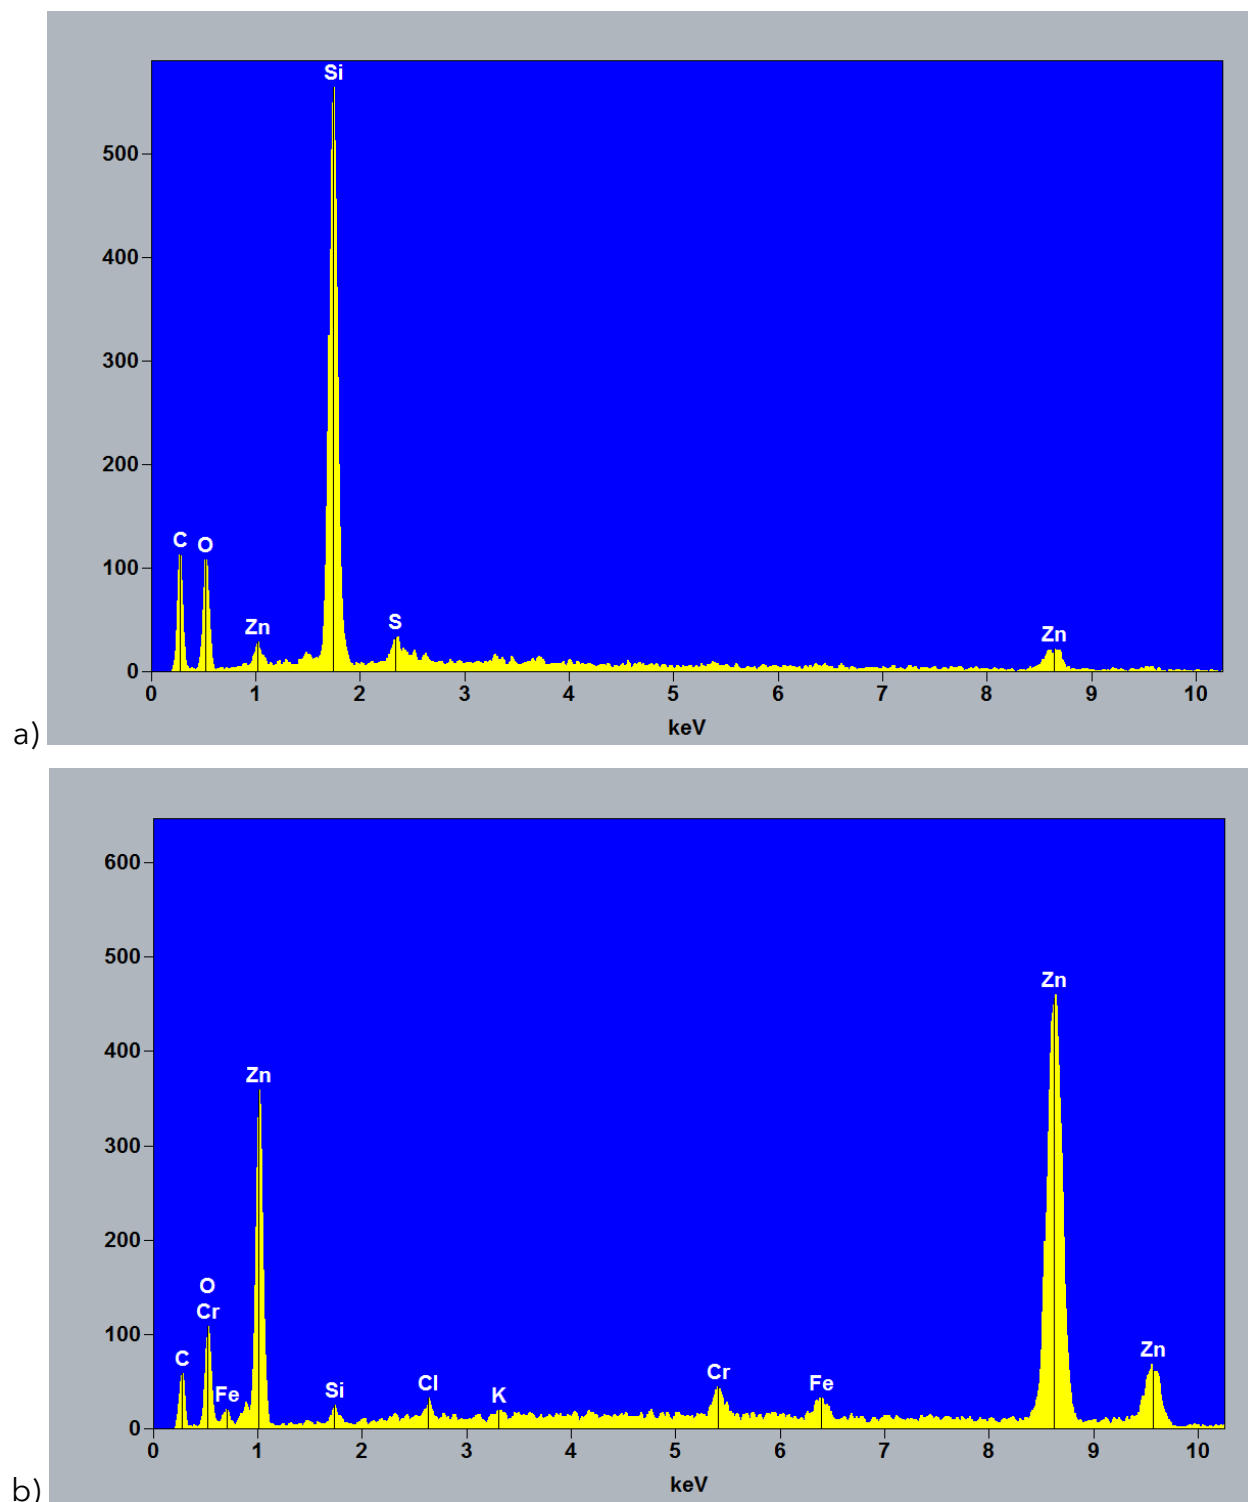
**Figure 17.** EDS spectra at the locations indicated in figure 16b; a) spectrum at the edge of the film exhibiting silicon (Si), oxygen (O), and carbon (C) with a trace of zinc (Zn) and b) spectrum outside the film exhibiting primarily Zn, iron (Fe), chromium (Cr), O, and C.
