**Number:** SA23-06R1  
**Issued:** 25 Apr 2023  
**Revised:** 02 May 2023

**SUBJECT:** AmSafe Seat Belt Inspection

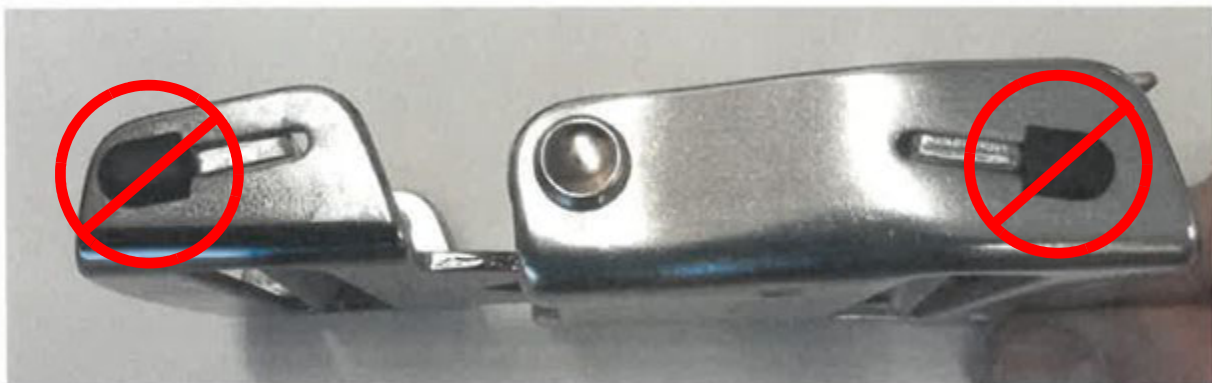
**Figure 2**  
**Incorrect Installation**

Cirrus has been made aware of a condition where the anti-rattle plug in the AmSafe seat belt buckle may have been installed incorrectly, potentially allowing the belt to loosen under load.

**WARNING:** Affected seat is inoperative and must not be used until condition is resolved. Incorrect installation of anti-rattle plug may result in seat belt web load bar not functioning correctly, potentially allowing the belt to loosen under load.

- A. If all plugs are installed correctly, no further action required. (See Figure 1)
- B. If any of the four plugs are installed incorrectly, seat must be marked inoperative. (See Figure 2)
  - (1) Secure both halves of the buckle together using cable ties or equivalent.
  - (2) Attach placard to the buckle stating "INOP".
  - (3) Contact Cirrus for disposition.
