# National Transportation Safety Board

CEN22FA405

## **FLIGHT TESTING SUMMARY**

Location: Tomball, Texas  
Date: September 1, 2022  
Time: 1707 central daylight time  
Airplane: Cirrus Aircraft SR22, s/n 8750, registration No. N420SS

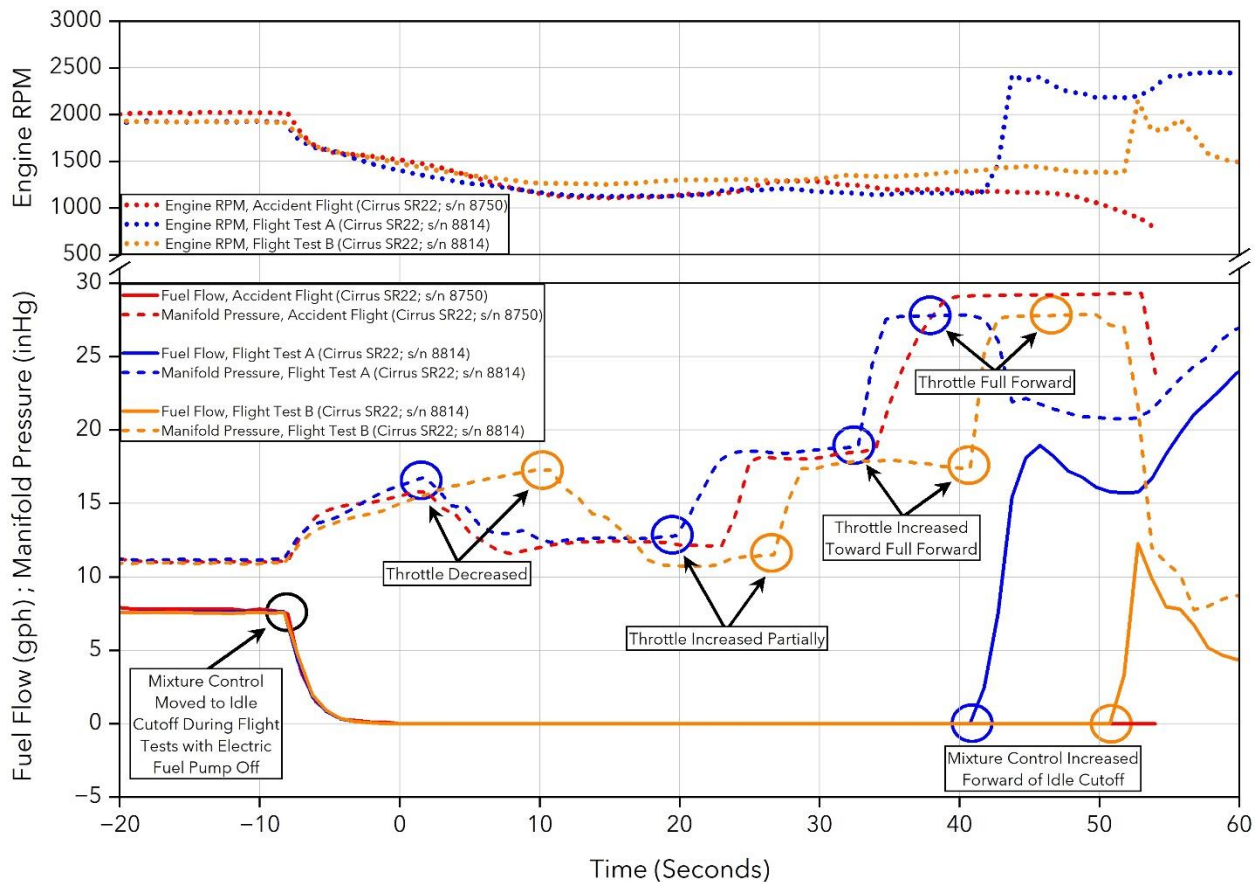
Flight testing revealed that when the mixture control was moved full aft to the idle cutoff position with the electric fuel pump off, the decrease in fuel flow closely matched the recorded data from the accident flight, as shown in Figure 1. The fuel

flow decreased from 7.6 gph to zero in 8-9 seconds. During the flight test, the throttle initially remained unmoved when the mixture control was placed in the idle cutoff position, but after a small rise in manifold pressure, the test pilot made one throttle reduction followed by two throttle advances to match the recorded accident data. Normal fuel flow and engine operation were restored when the mixture control was increased forward of the idle cutoff position.

**Figure 1** - A plot comparing accident data with flight test data. The flight test scenario was the placement of the mixture control to the idle cutoff position with the electric fuel pump off. The plotted parameters include engine speed, fuel flow, and manifold pressure. The flight test data is time-aligned with the accident data to depict the loss of fuel flow at the same time.

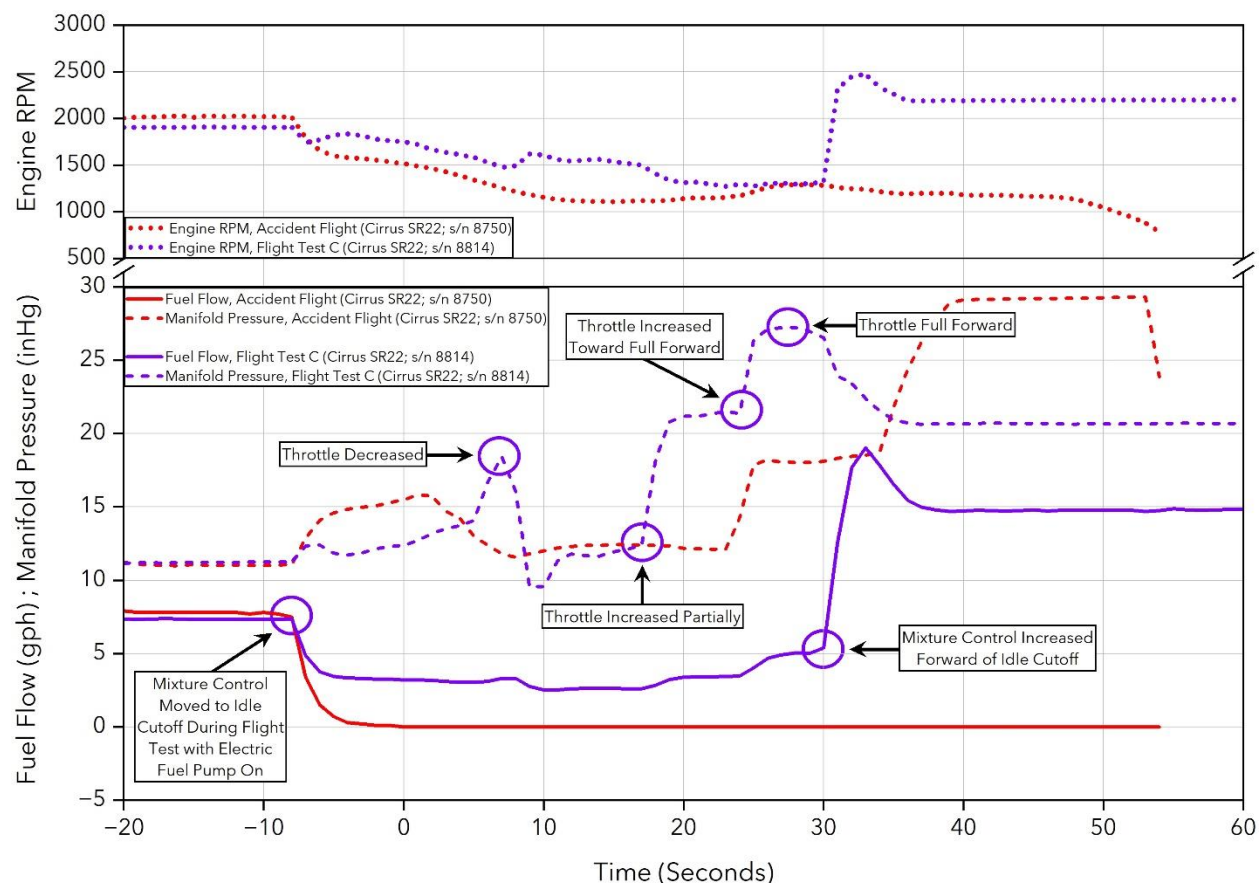
Flight testing revealed that when the mixture control was moved full aft to the idle cutoff position with the electric fuel pump on, the decrease in fuel flow did not match the recorded data from the accident flight, as shown in Figure 2. Notably, the fuel flow did not decrease to zero; the fuel flow was 2.5 gph to 5.0 gph, depending on the throttle position. The test pilot noted that the engine continued to operate with

noticeable roughness while the mixture control was in the idle cutoff position with the electric fuel pump on. Normal fuel flow and engine operation were restored when the mixture control was increased forward of the cutoff position.

**Figure 2** - A plot comparing accident data with flight test data. The flight test scenario was the placement of the mixture control to the idle cutoff position with the electric fuel pump on. The plotted parameters include engine speed, fuel flow, and manifold pressure. The flight test data is time-aligned with the accident data to depict the loss of fuel flow at the same time.

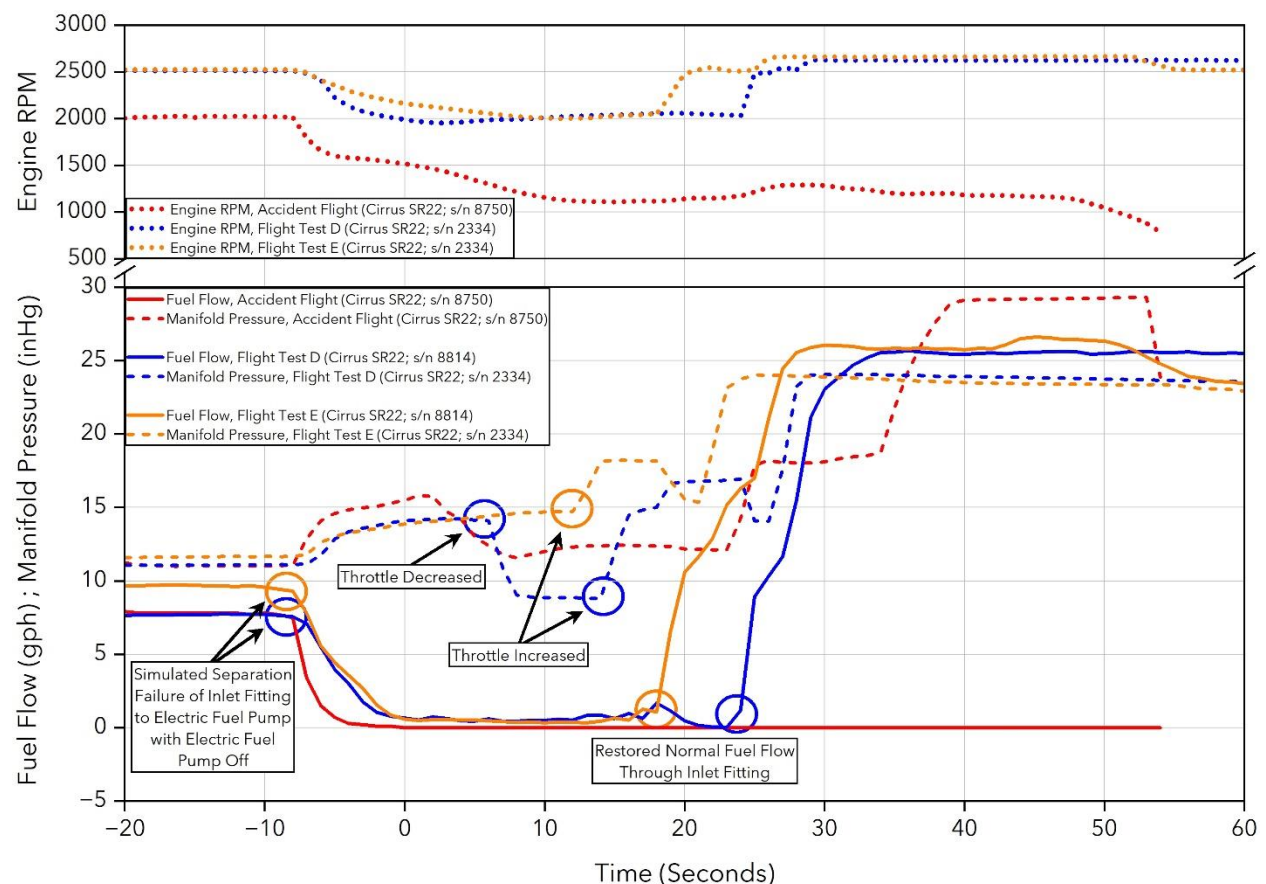
The modified test airplane was flown to altitude before the test pilot entered a descent with engine power settings similar to the accident flight. During the descent with the electric fuel pump off, the electronic fuel valve was activated to simultaneously shutoff access to the fuel line and vent the electric fuel pump inlet to ambient air. The results of two similar tests did not replicate the total loss of fuel flow recorded during the accident flight, as shown in Figure 3. Notably, the fuel flow did not immediately decrease to zero, rather there was a slower decrease of fuel flow that extended past 25 seconds. In one test, the fuel flow eventually decreased to 0.02 gph about 30 seconds after the electronic fuel valve was activated. Normal fuel flow and engine operation were restored when the test pilot selected the electronic fuel valve to draw fuel from the fuel line instead of being vented to ambient pressure.

**Figure 3** - A plot comparing accident data with flight test data. The flight test scenario was a simulated separation failure of the 90° elbow inlet fitting to the electric fuel pump with the electric fuel pump off. The plotted parameters include engine speed, fuel flow, and manifold pressure. The flight test data is time-aligned with the accident data to depict the loss of fuel flow at the same time.

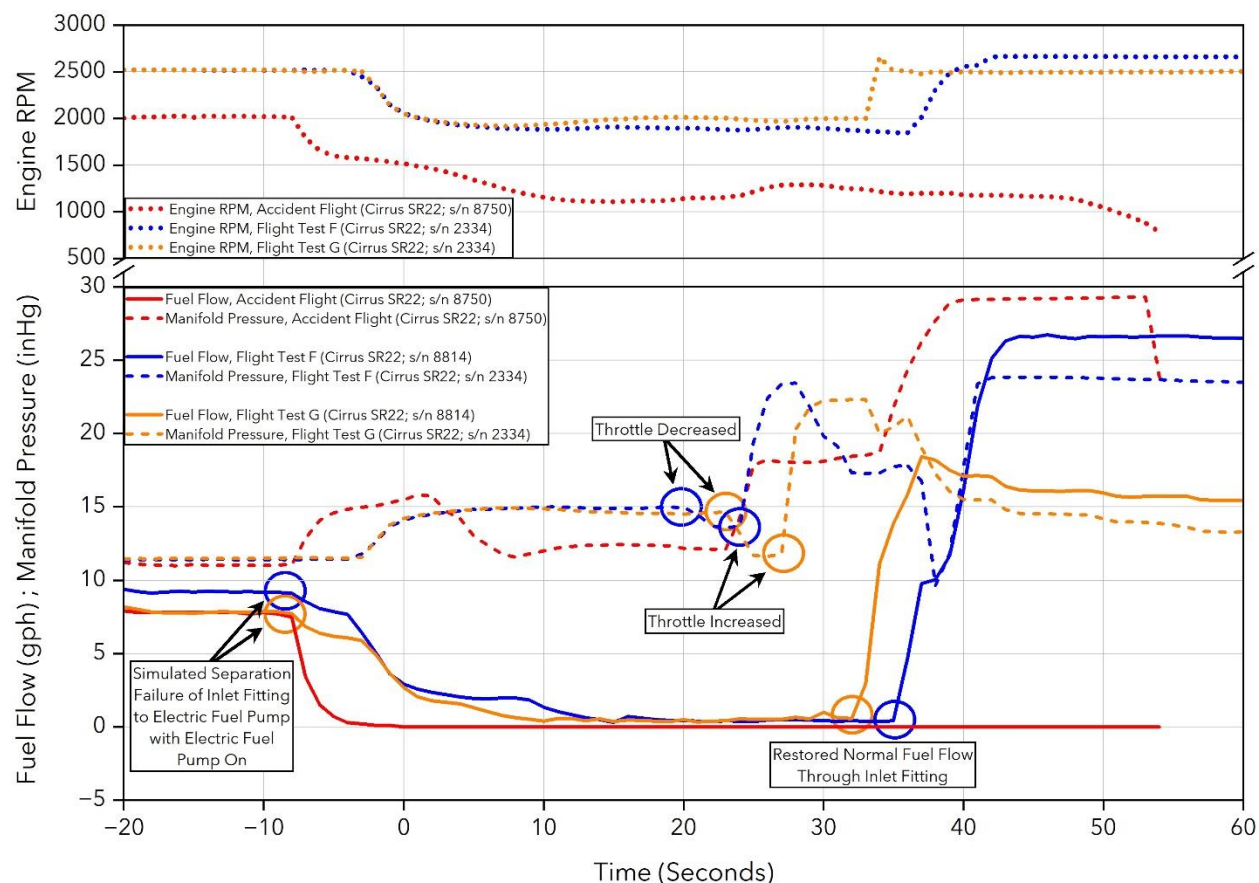
Further flight testing was conducted to determine what affect an operating electric fuel pump had during a simulated separation failure of the electric fuel pump inlet fitting. The flight test data showed that the fuel flow did not immediately decrease to zero, rather an initial 20 second decrease toward a low fuel flow rate ( $< 0.5$  gph) that continued another approximately 20 seconds before the test pilot restored normal fuel flow and engine operation by selecting the electric fuel valve to draw fuel from the fuel line instead of being vented to ambient pressure, as shown in Figure 4.

**Figure 4** - A plot comparing accident data with flight test data. The flight test scenario was a simulated separation failure of the 90° elbow inlet fitting to the electric fuel pump with the electric fuel pump on. The plotted parameters include engine speed, fuel flow, and manifold pressure. The flight test data is time-aligned with the accident data to depict the loss of fuel flow at the same time.
