## **NATIONAL TRANSPORTATION SAFETY BOARD**

### **Specialist's Factual Report**

## **HUMAN PERFORMANCE**

CEN22FA405

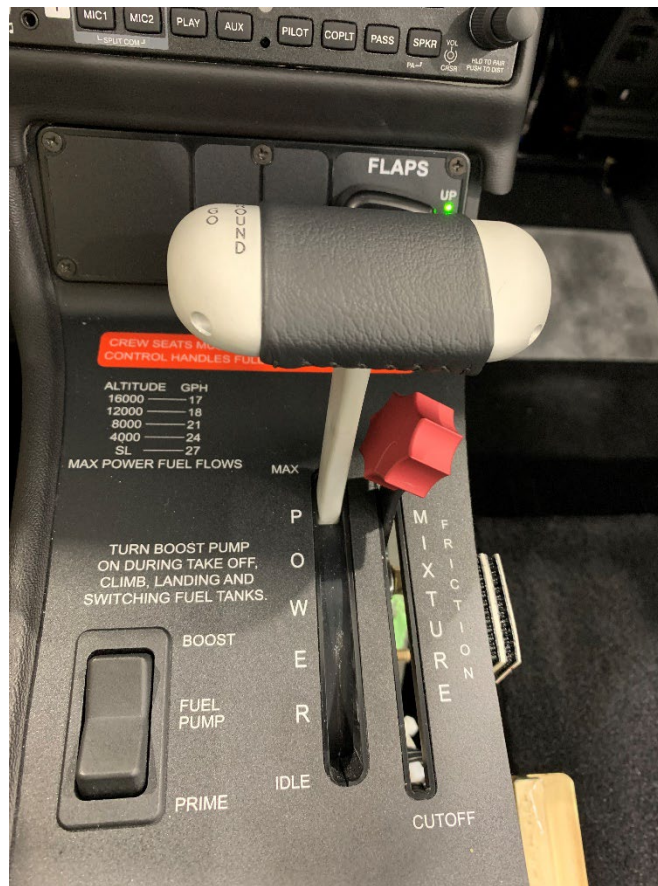
Figure 3: Throttle quadrant and fuel mixture control lever

indication was a decrease in engine noise. There are no discreet aural warnings for a loss of fuel flow pertaining to the fuel mixture control lever being in the cutoff position. It must be noted that during the simulator run the IIC (seated in the left seat of the sim) inadvertently moved the fuel mixture control lever aft while cycling through throttle positions. The IIC's inadvertent movement of the mixture was due to his hand/finger placement on the throttle's T-handle, and the throttle had to be moved to the full idle position to inadvertently move the mixture control to the idle cutoff position. The Flight Training Development (FTD) Specialist serving as the simulator technician remarked that it was not something he had ever seen happen before. Additionally, the FTD specialist discussed and demonstrated alternative hand/finger positions that he typically uses to move the throttle that did not interfere with the mixture control.

When asked during the interviews, none of the flight instructors had ever witnessed a fuel mixture control lever inadvertently pulled completely to cutoff; however, one instructor stated that he witnessed the cord of a headset get wrapped around the fuel mixture control knob, which leaned out the mixture to the point that the engine started running rough. It was the rough running engine that alerted the instructor to the problem. Another flight instructor said that he had seen a cord close enough to the throttle and fuel mixture control lever to make him uncomfortable enough to move it, but that it did not directly interfere with the engine controls.
