# National Transportation Safety Board

CEN22FA405

## **SURVIVAL FACTORS**

Specialist's Factual Report

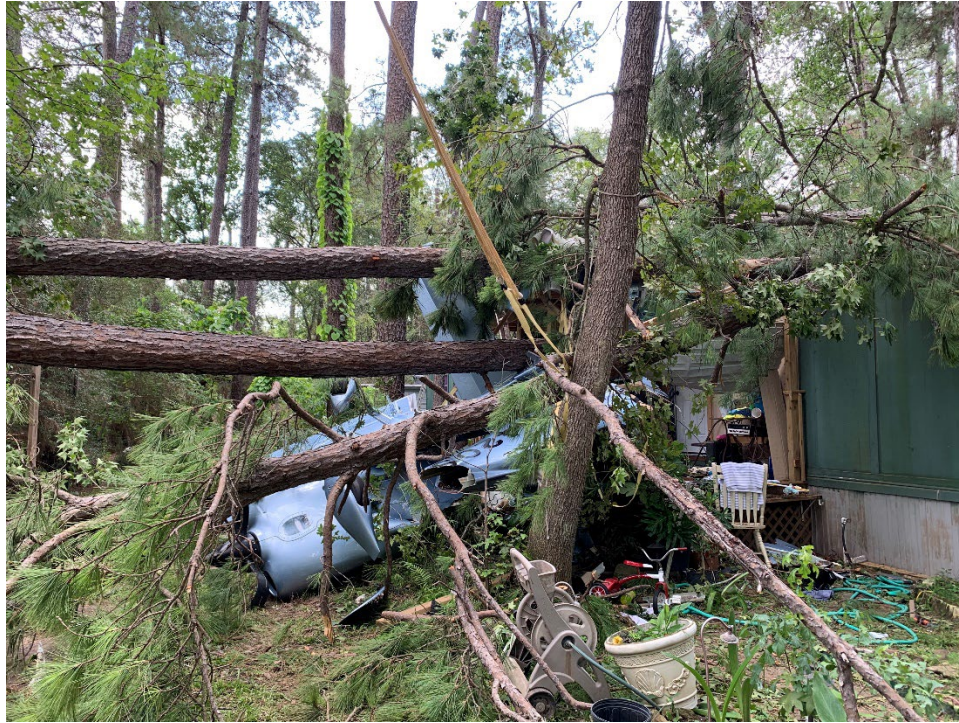
According to the NTSB investigator-in-charge, the accident site was in a wooded mobile home neighborhood and the airplane struck a group of 60-75 foot tall pine trees. Multiple pine trees were knocked over by the airplane and there were numerous tree branches scattered along the wreckage debris path and among the main wreckage. The main wreckage consisted of the main cabin, left wing, aft fuselage, empennage, engine, and propeller (see figure 2). The right wing separated from the fuselage at the wing root and was found on the opposite side of the mobile home. The left aileron was found adjacent to the right wing.

**Figure 2.** N420SS main wreckage as found at the accident site.

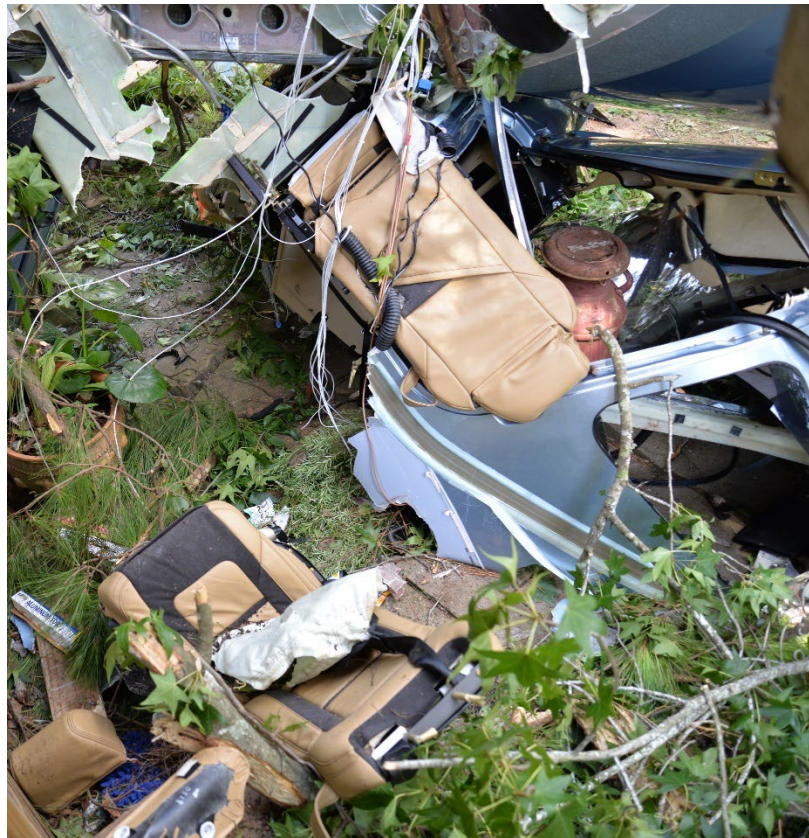
Overall, the front seats remained attached to their seat rails, however there was significant disruption of the supporting structure. The front left seat was still connected to fuselage structure, but the front right seat was found separated from the fuselage. It was sitting upright a short distance away (see figure 3). The rear seat, both bench and seat backs, remained attached to the supporting structure in the aft portion of the cabin (see figure 4).

**Figure 3.** Front seats as found at the accident site.

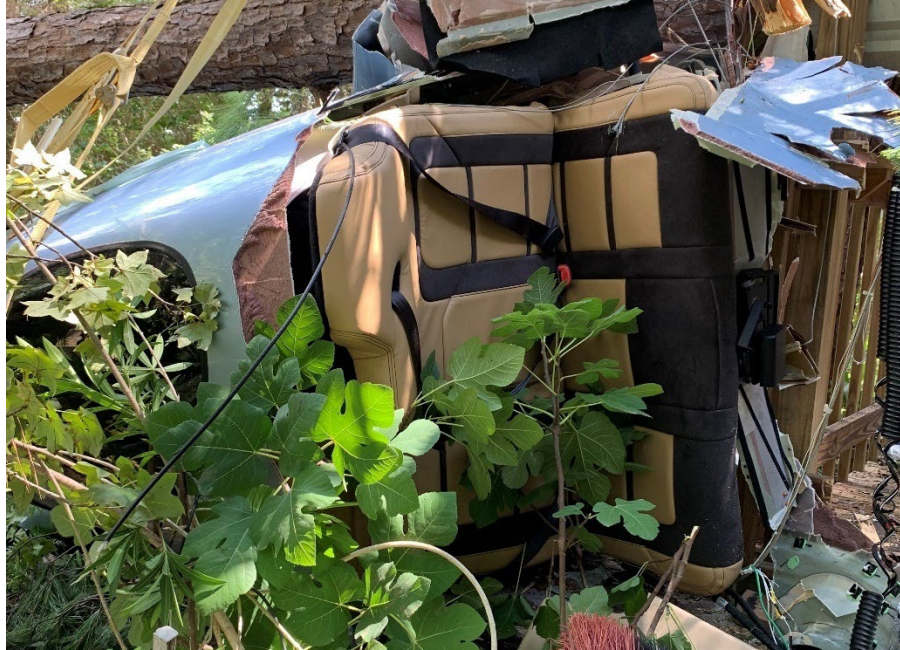
**Figure 4.** Rear bench seat.

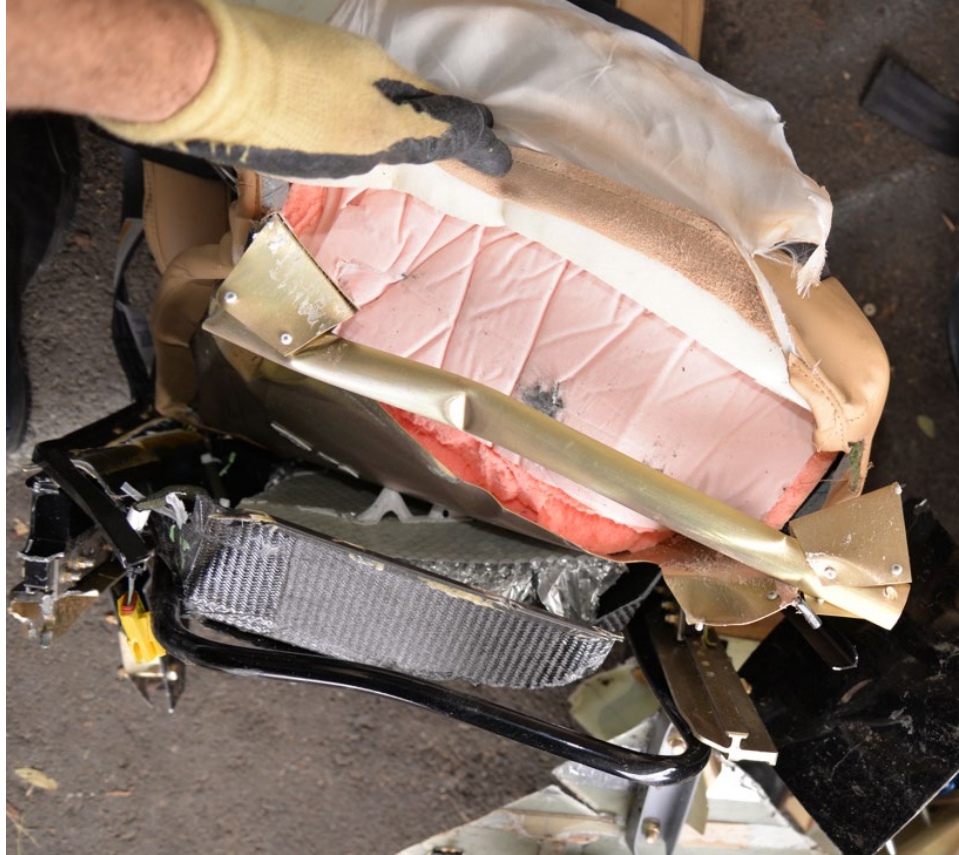
The front right crew seat was found outside of the fuselage at the accident site. The aluminum seat pan above the EAM was damaged, with dents and tears in multiple places. The EAM exhibited crushing damage at the front. The front right corner measured 2 inches, front left 2.75 inches, rear right 1.8 inches, and the rear left 2.75 inches thick. There was no label on the top surface of the EAM. The front cross tubes were deformed. The lower carbon fiber seat pan, outboard seat frame, and seat rails also had multiple fractures (see figure 5).

**Figure 5.** Front right seat pan.

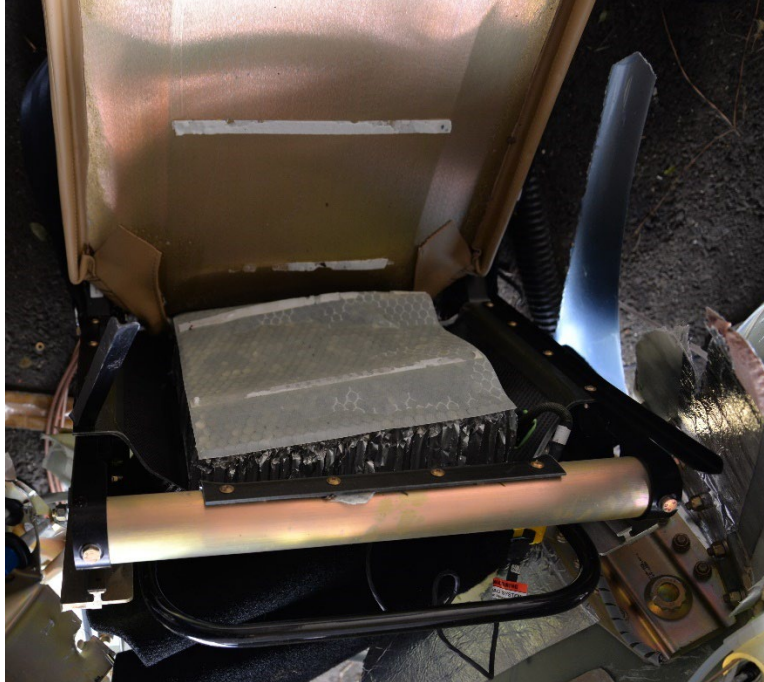
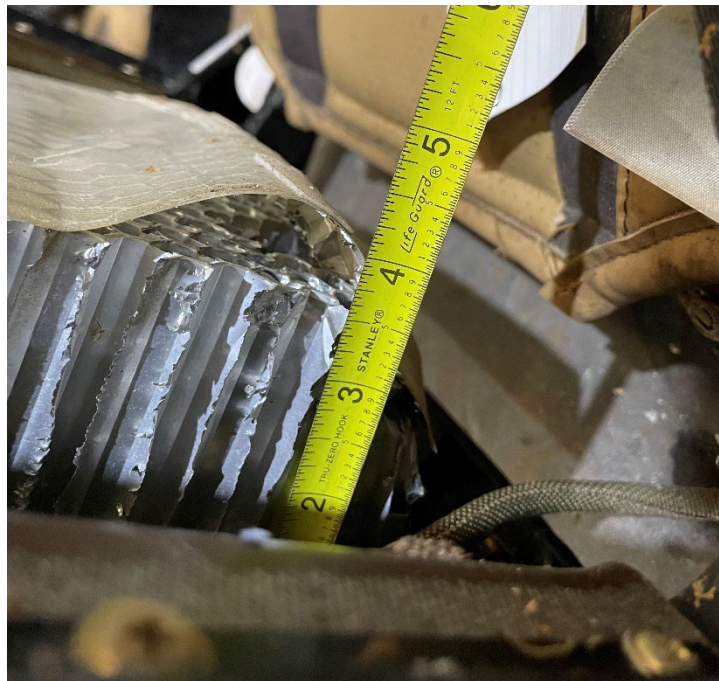
On-scene photographs indicated that the front left pilot seat was still connected to fuselage structure, however, it became separated during the recovery operation. The aluminum seat pan above the EAM was dented, but the cross tubes appeared undamaged. The EAM exhibited crushing damage across its leading edge. The front right corner measured 2.6 inches, front left 3.4 inches, rear right 3.1 inches, and the rear left 3.5 inches thick. (The rear left corner was measured to the top of the aluminum honeycomb as the top surface had become disconnected from the honeycomb during the event.) There was no label on the top surface of the EAM. The lower carbon fiber seat pan appeared undamaged (see figures 6 and 7).

**Figure 6.** Front left seat EAM, seat pan, and frame.

**Figure 7.** Left rear measurement of the EAM for seat 2.

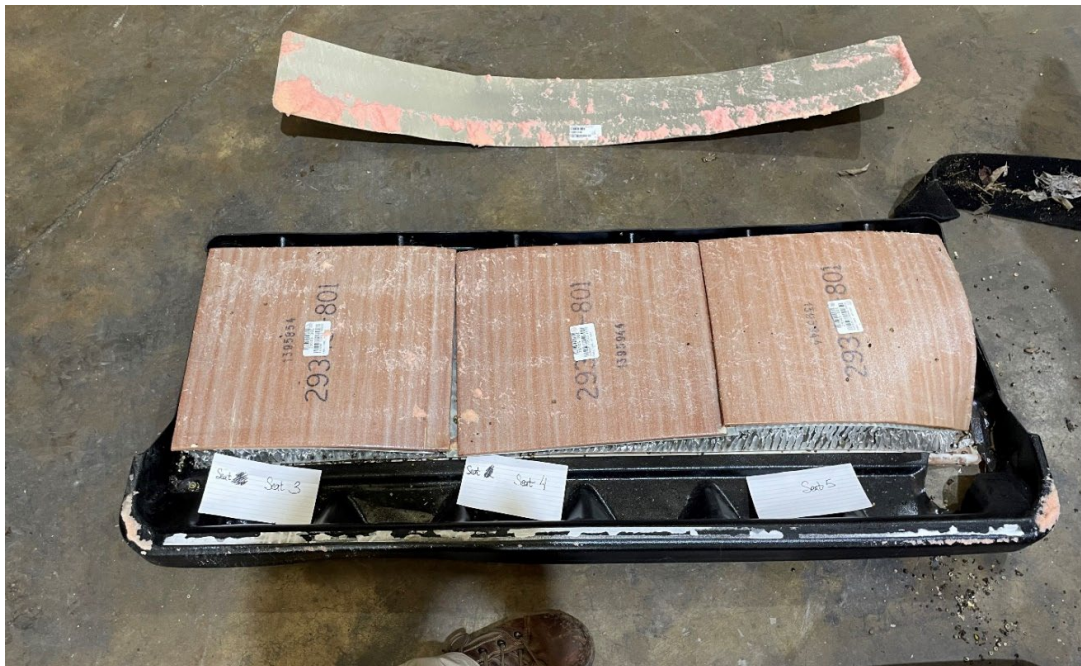
The rear seat remained attached to the aft fuselage. The bench was removed from the airframe and the leather cover and foam were removed to allow for documentation of the EAMs. The thin piece of aluminum on the leading edge was

also removed and measurements were taken from the bottom of the EAM to the lower surface of the PVC foam (see figure 8).

**Figure 8.** Rear seat with leather cover and foam removed.

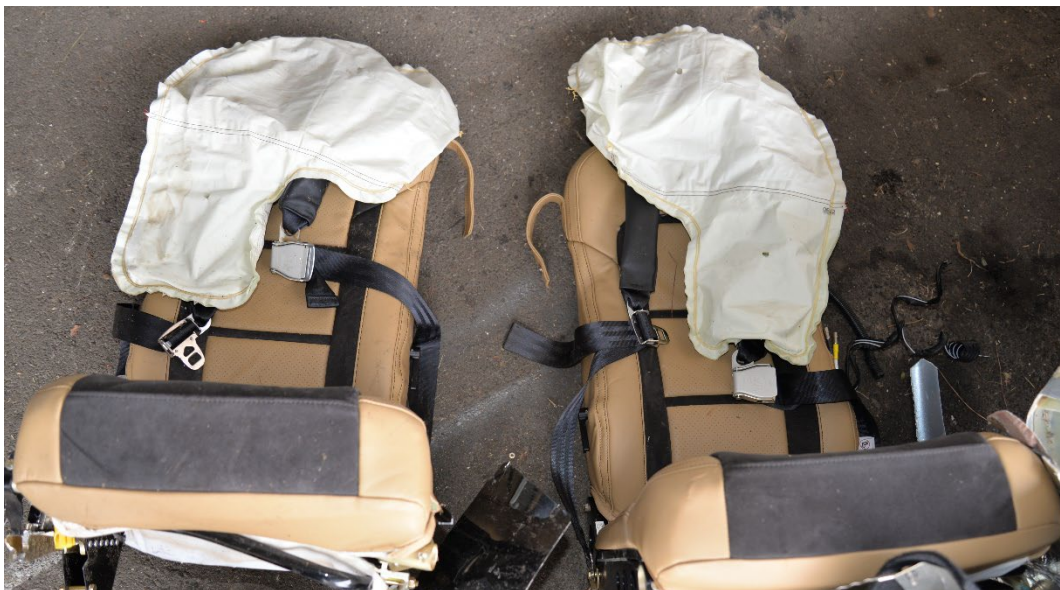
installed on the outboard shoulder harnesses and a lift latch buckle. The airbags were designed to deploy in front of the occupant when a deceleration event occurred, and both deployed in the accident (see figure 9).

**Figure 9.** Front crew seats with deployed airbags.

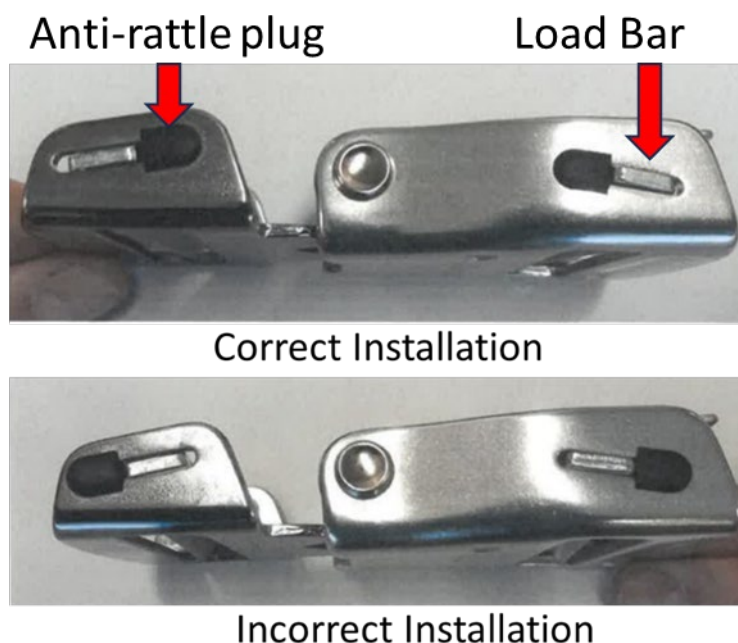
On April 24, 2023 AmSafe issued Service Letter (SL) 7041, Issue:1 for Cirrus Aircraft inflatable restraint assemblies. In the SL, AmSafe noted customers reported an in-service problem of incorrect or missing anti-rattle plugs found on the belt buckle assemblies (see figure 10). Cirrus issued the SL to describe the procedure for removing and correctly installing replacement buckle/connector anti-rattle plugs. Cirrus subsequently issued Service Advisory SA23-06R1 on April 25, 2023, to notify customers of the issue and describe how to conduct a visual inspection of the buckles. The advisory stated that incorrect installation of the plugs may result in the seat belt web load bar not functioning correctly, potentially allowing the belt to loosen under load. It also referenced the SL on how to correct the issue.

**Figure 10.** Photographs from the Cirrus service letter showing the correct (top) and incorrect (bottom) installation of the anti-rattle plugs.

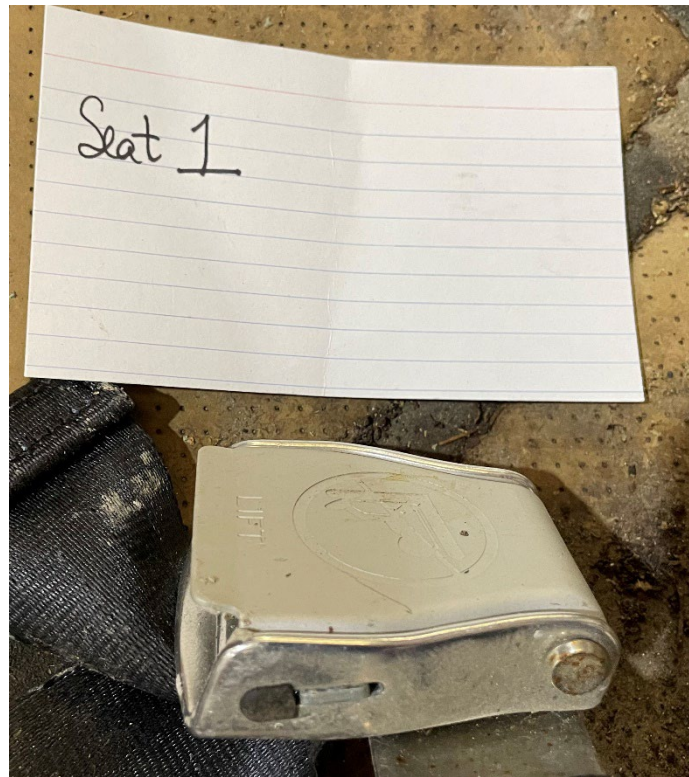
The front right crew seat restraint buckle anti-rattle plugs were in the incorrect position (see figure 11). The buckle tang had the plugs in the correct position. The left lap belt segment measured 23.8 inches from the webbing attachment to the center of the load bar. The webbing was almost completely pulled through and was twisted around the load bar (see figure 12). No witness marks indicating rubbing, discoloration or fraying was noted on the webbing. The right lap belt portion

**Figure 11.** Seat 1's buckle with anti-rattle plug in the incorrect position.

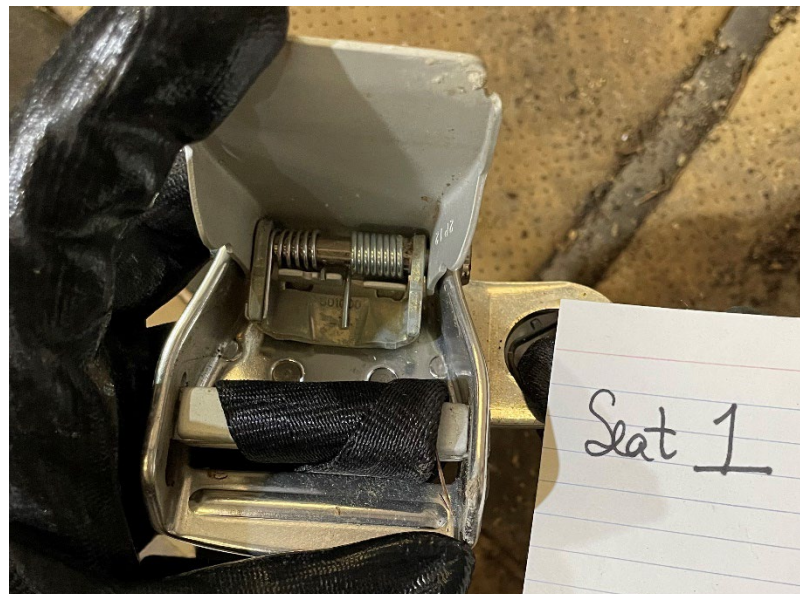
**Figure 12.** Seat 1's buckle with webbing twisted around the webbing load bar.

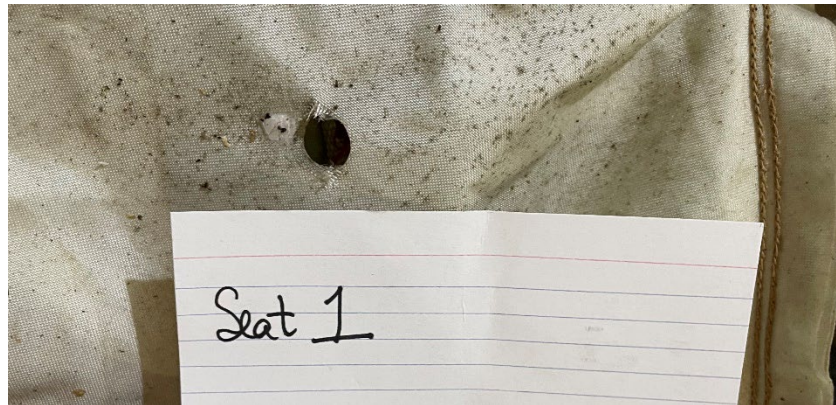
2396, ID# 3608241, conforms to FAA TSO-C114, rated 3000 pounds, to be repaired by AmSafe only). Squaring<sup>1</sup> was noted on the lower airbag vents (see figure 13), but not on the upper.

**Figure 13.** Seat 1's lower airbag vent with squaring.

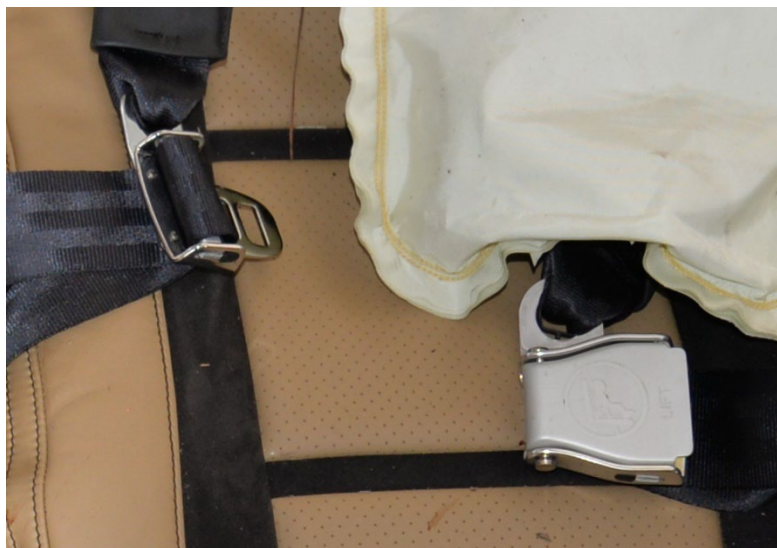
The front left crew seat restraint buckle anti-rattle plugs were in the correct position (see figure 14). The buckle tang also had the plugs in the correct position. The left lap belt measured 17.4 inches and the right measured 17.2 inches from the webbing attachment point to the center of the load bar. The buckle functioned and no anomalies or damage were noted.

**Figure 14.** Seat 2 showing plugs in the correct position.

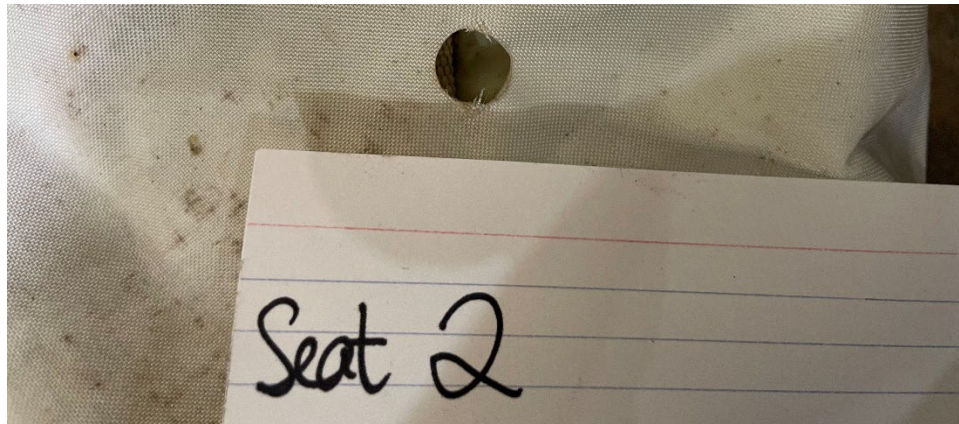
2396, ID# 36068231, conforms to FAA TSO-C114, rated 3000 pounds, to be repaired by AmSafe only). Squaring was noted on the lower airbag vents (see figure 15), but not on the upper.

**Figure 15.** Seat 2's lower airbag vent with squaring.

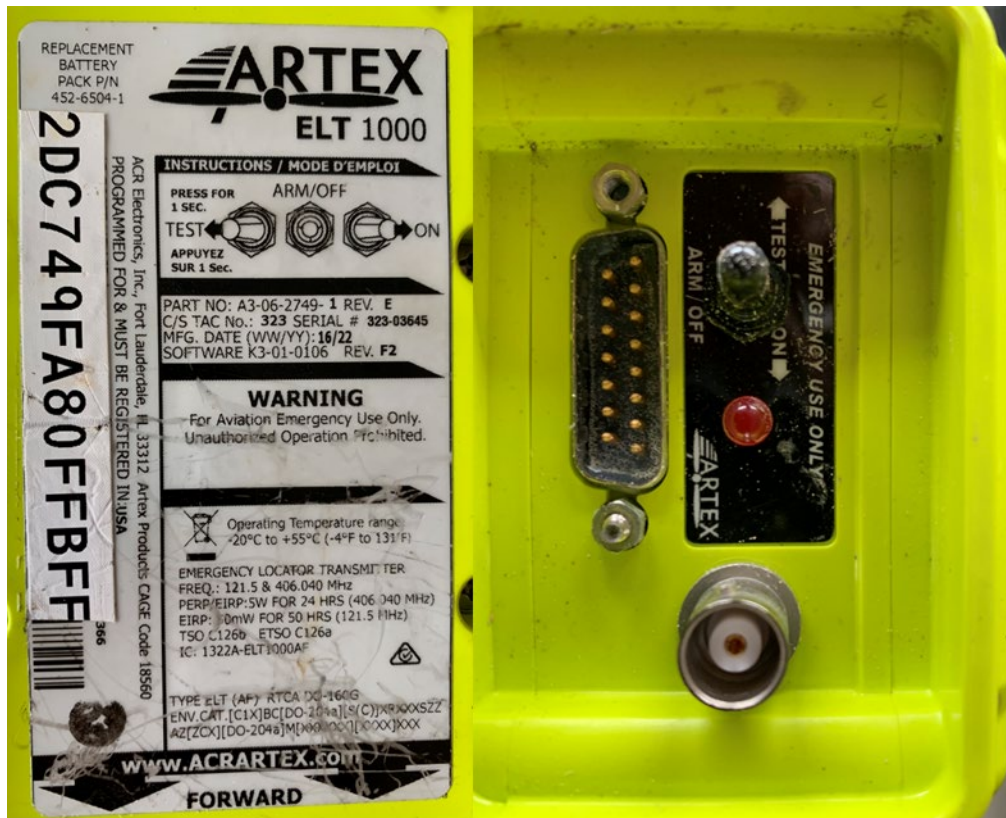
The airplane's Artex ELT 1000 was found by investigators still secured to the airframe in its cradle (although the cradle latch was undone) in the armed position (see figure 17). According to the National Oceanic and Atmospheric Administration's records the ELT activated during impact and an alert was received by the Air Force Rescue Coordination Center (AFRCC) at 22:07:51. AFRCC then "contacted the Fort Worth authorities who reported emergency services were already on scene." The coordinates of the first satellite detection were 30 04.9N, 95 33.4W which was approximately 0.09 miles from the accident site.

**Figure 17.** ELT information, including the ARM/OFF switch position.

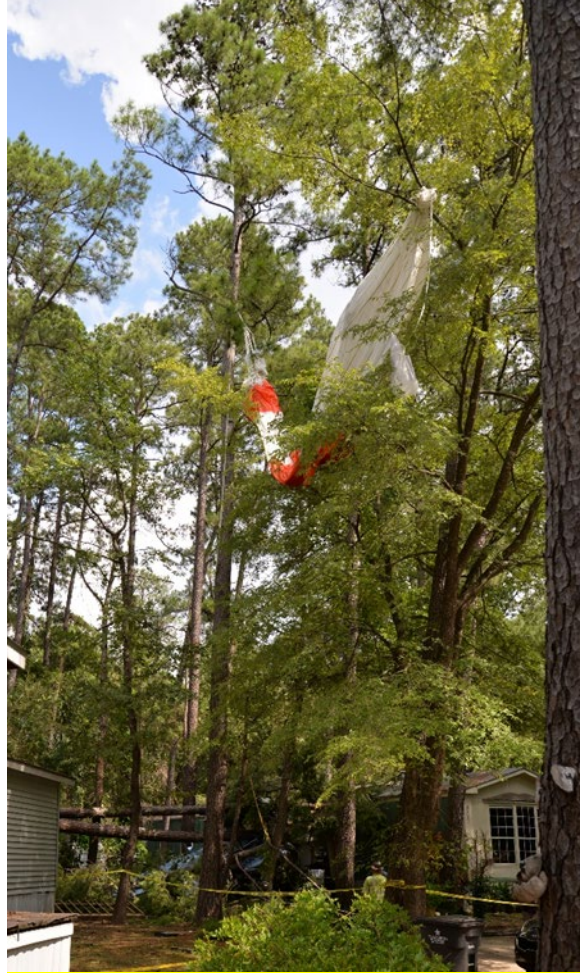
According to the NTSB investigator-in-charge, the CAPS rocket motor deployed upon ground impact, with the deployment bag and canopy found suspended in the surrounding trees. The parachute enclosure cover separated from the aft cabin and was found near the main wreckage. The parachute canopy did not inflate during deployment and was found stretched-out on a linear trajectory into the surrounding treetops (see figure 19).

**Figure 19.** The CAPS parachute as found at the accident site.
