# National Transportation Safety Board

CEN22FA405

## **ACCIDENT FLIGHT DATA SUMMARY**

Location: Tomball, Texas  
Date: September 1, 2022  
Time: 1707 central daylight time  
Airplane: Cirrus Aircraft SR22, s/n 8750, registration No. N420SS

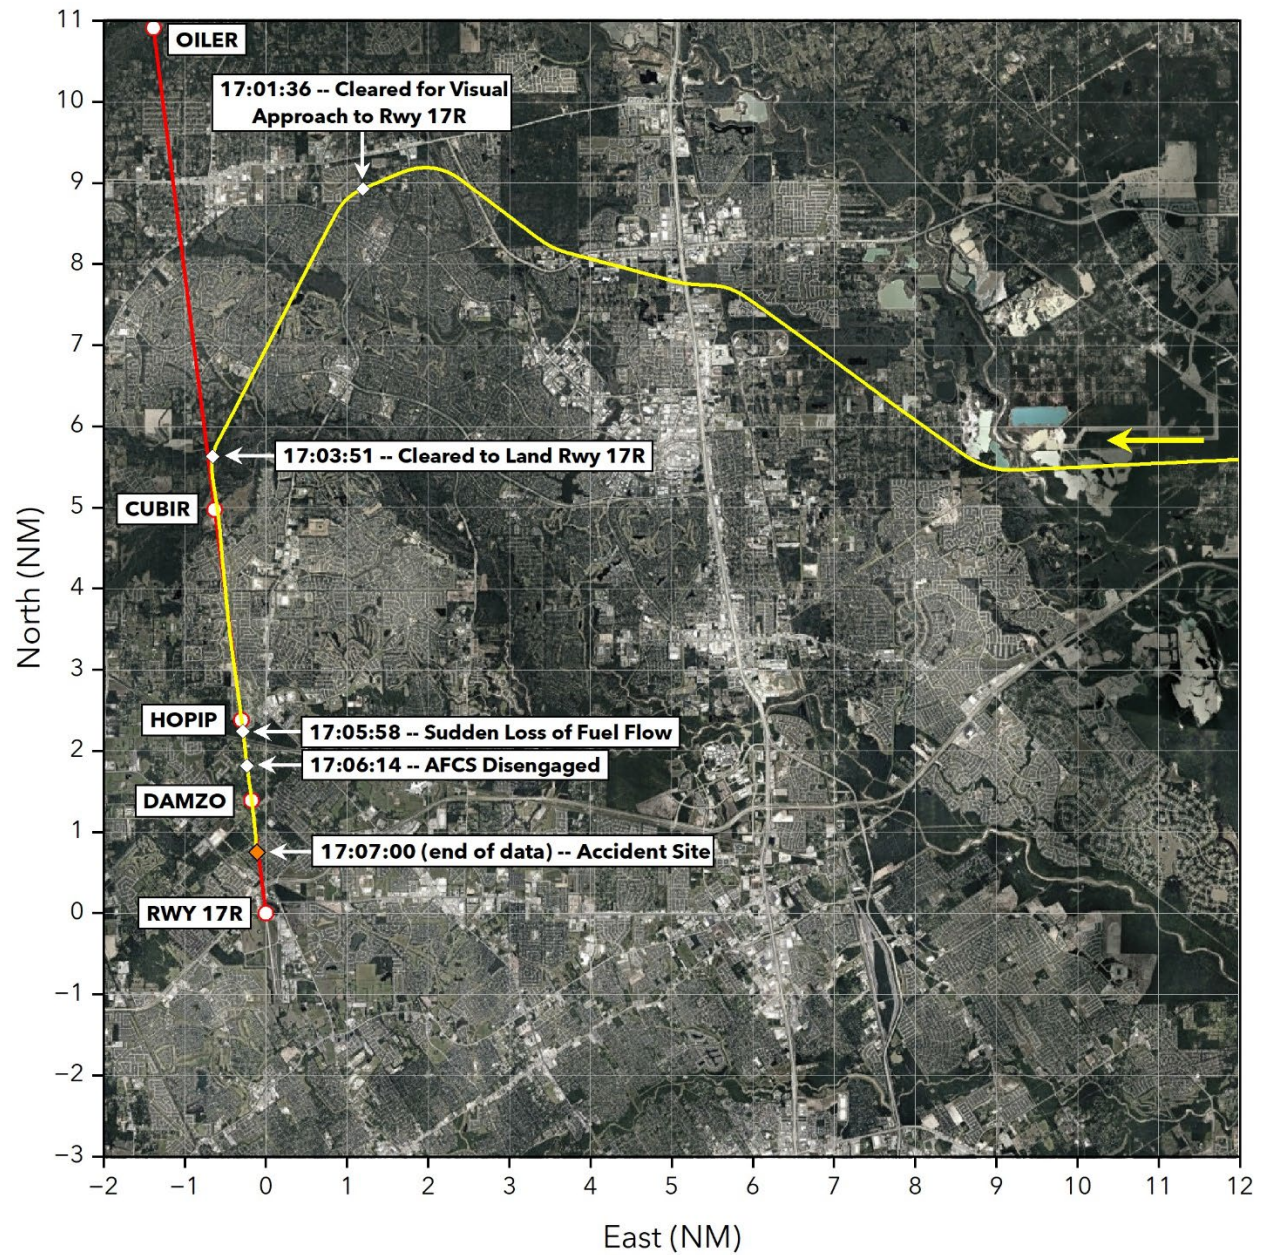
A review of recorded data downloaded from both the airplane's Cirrus Perspective+ system and Recoverable Data Module, along with recorded ATC communications, revealed that the flight received radar vectors to join the visual approach to runway 17R at DWH, as shown in Figure 1. At 1701:36, the flight was cleared for the visual approach and told to contact the DWH tower controller. At 1703:51, the tower controller cleared the flight to land on runway 17R. The airplane's automatic flight control system (AFCS) was engaged during the earlier portions of the approach, and the flight crew used vertical speed mode to descend to and level off at specified intermediate altitudes based on a lateral navigation only (LNAV) instrument procedure, as shown in Figure 2 and Figure 3. Additionally, according to the recorded data, there were several engine power changes (increases/decreases) made during the approach. The recorded data concluded at 1707:00, when the airplane was about 200 ft north of the accident site and about 76 ft above ground level (agl).

**Figure 1** - Plot of the airplane ground track.

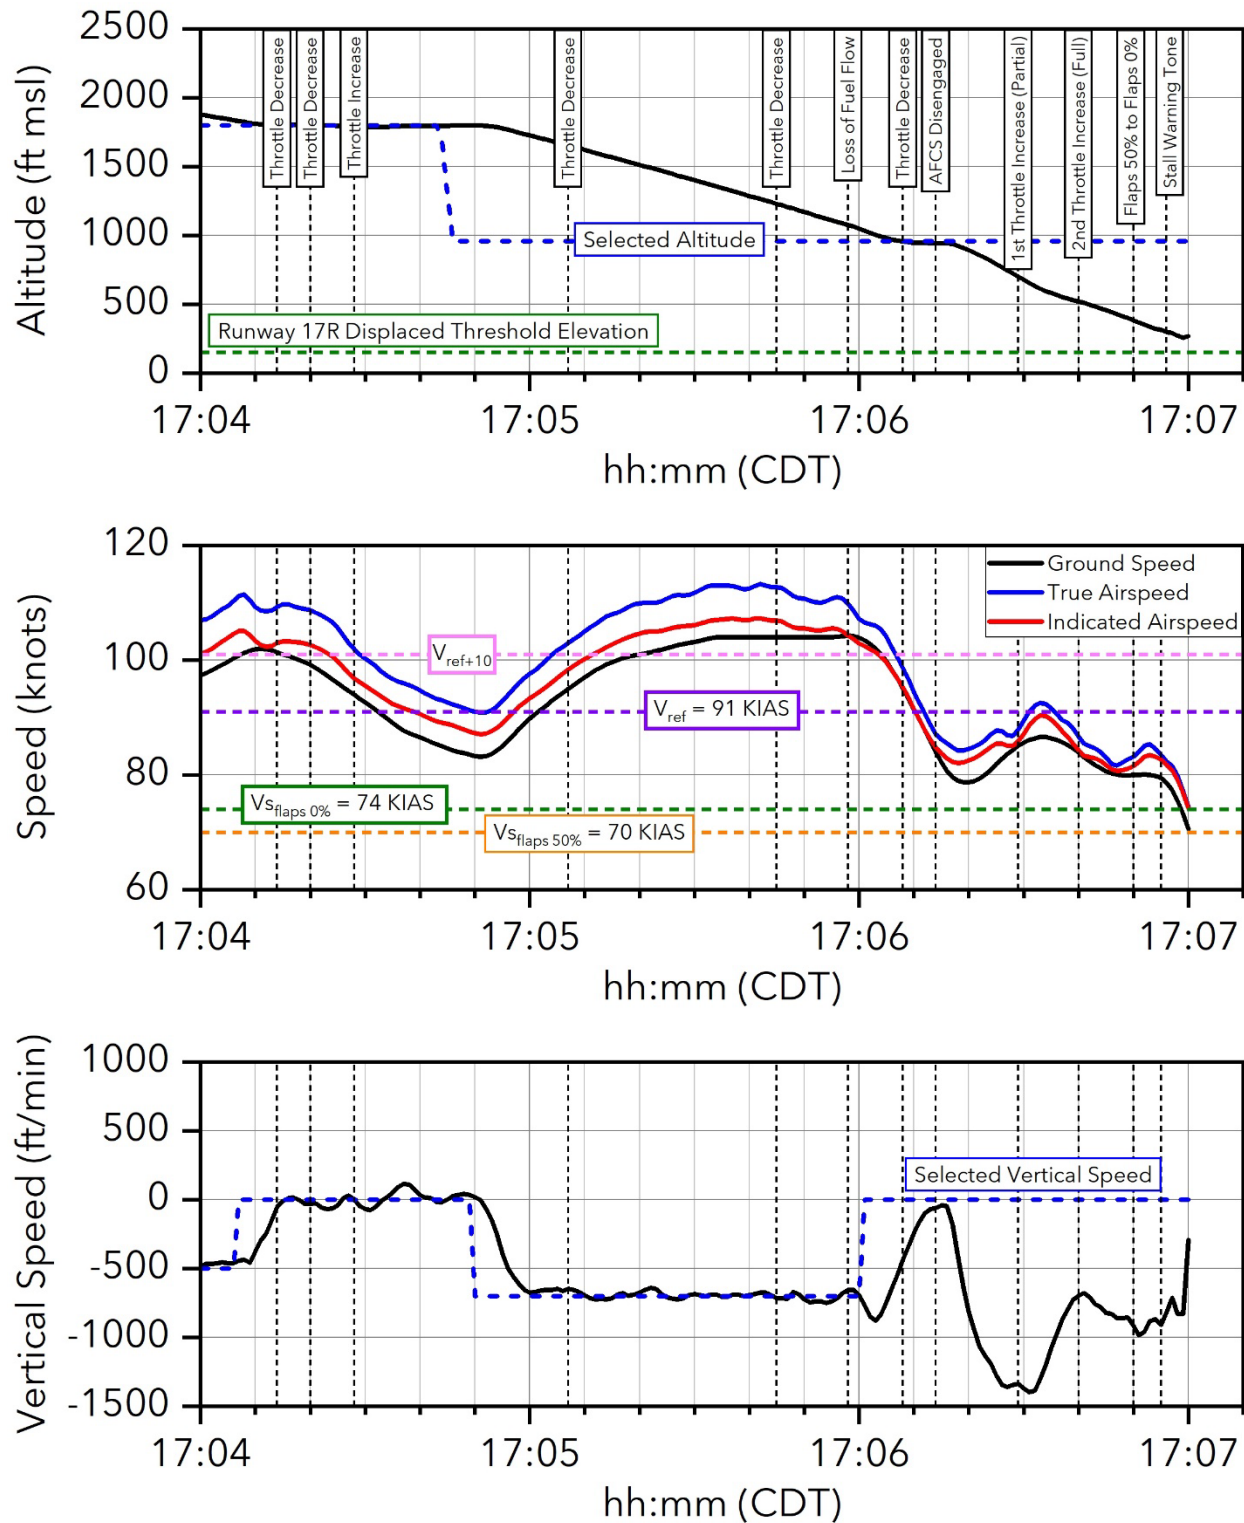
**Figure 2** - Plot of airplane altitude, ground speed, true airspeed, indicated airspeed, and vertical speed.

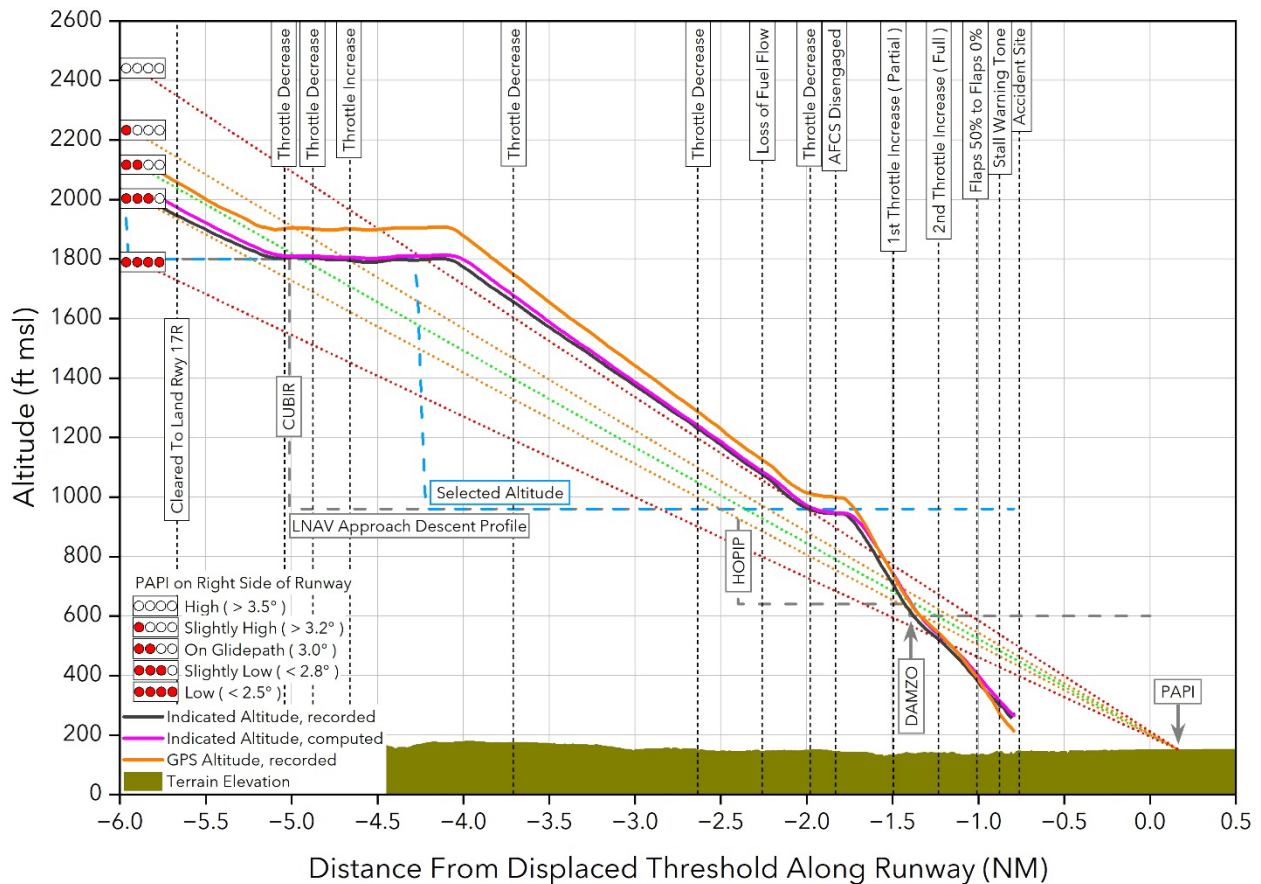
**Figure 3** - Plot the airplane's descent profile during the visual approach.

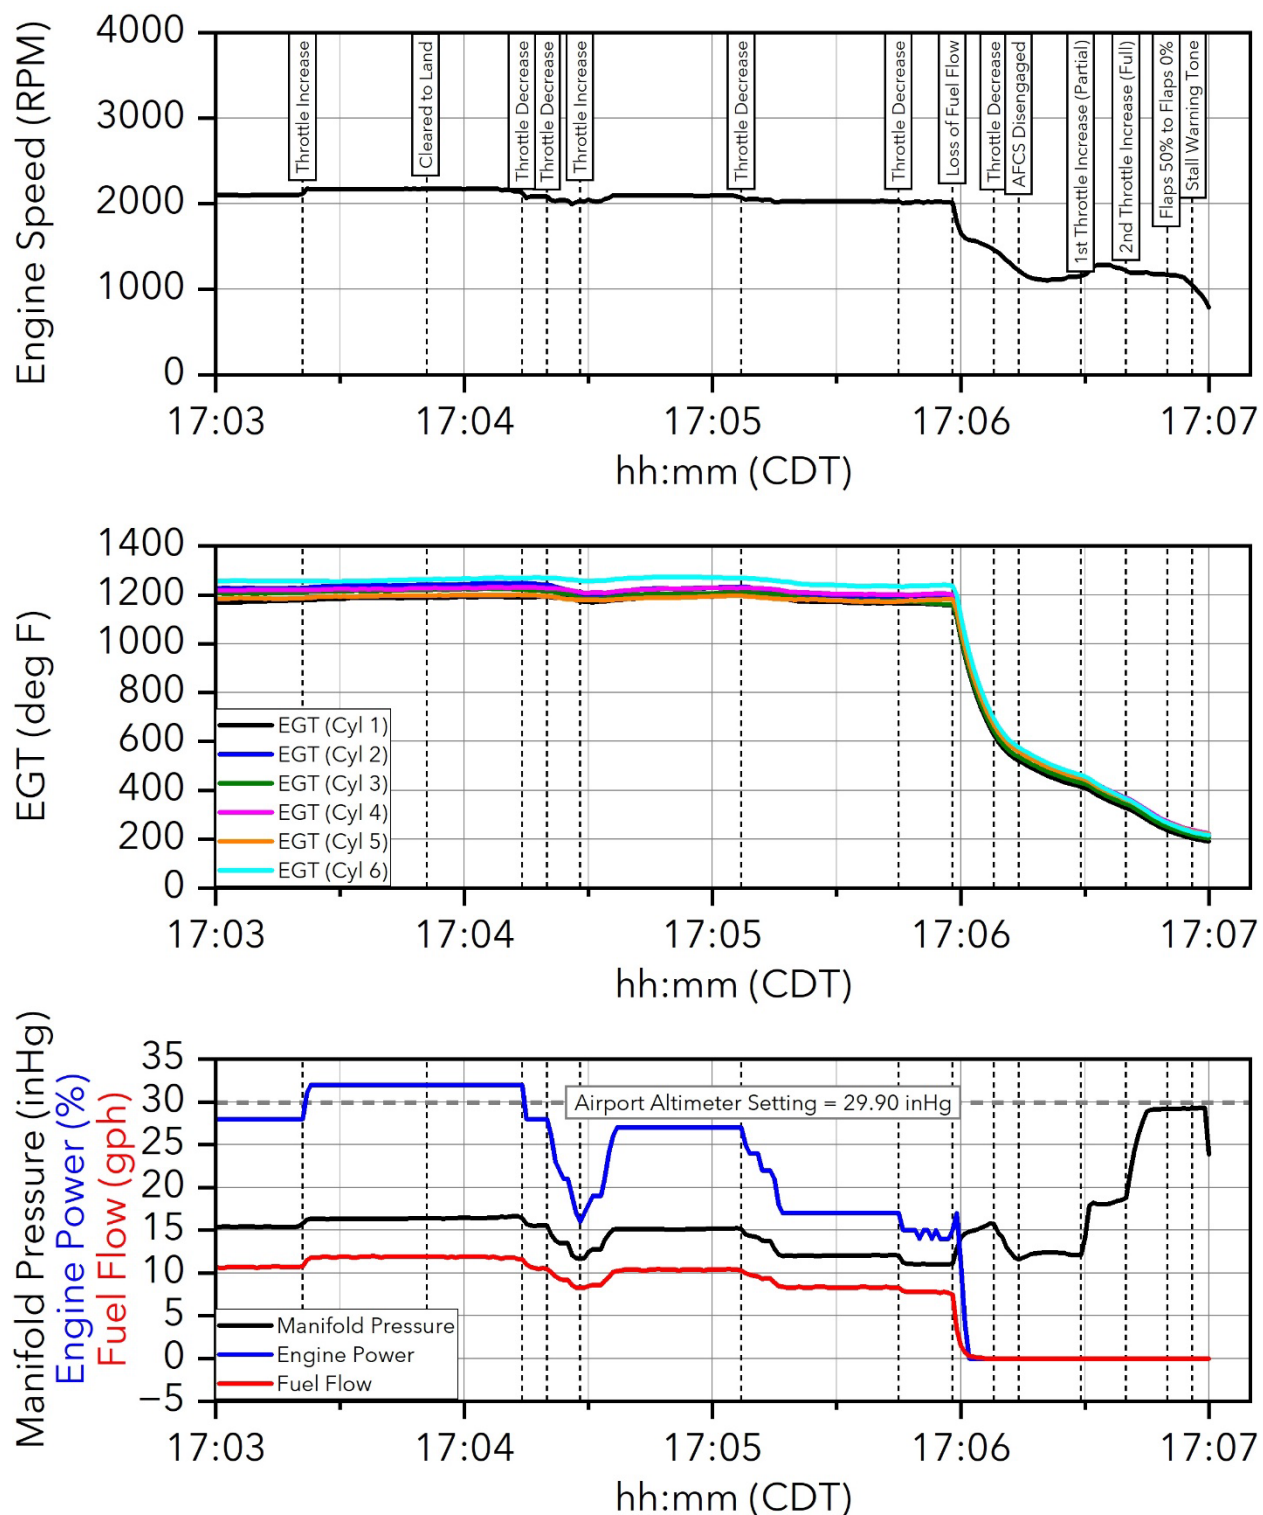
Based on recorded data from the airplane, beginning at 1705:58, there was a loss of fuel flow to the engine, as shown in Figure 4 and Figure 5, as the airplane continued in a descent toward runway 17R in visual meteorological conditions. At that time, the airplane was about 1,126 ft msl (988 ft agl) and 2.26 nm from the runway 17R displaced threshold, as shown in Figure 6. About 16 seconds after the loss of engine power, the AFCS was turned off and remained off for the remainder of the flight. With the AFCS disengaged, the flight crew continued the descent toward the runway under manual flight control.

**Figure 4** - Plot of engine speed, EGT, manifold pressure, engine power, and fuel flow during the visual approach.

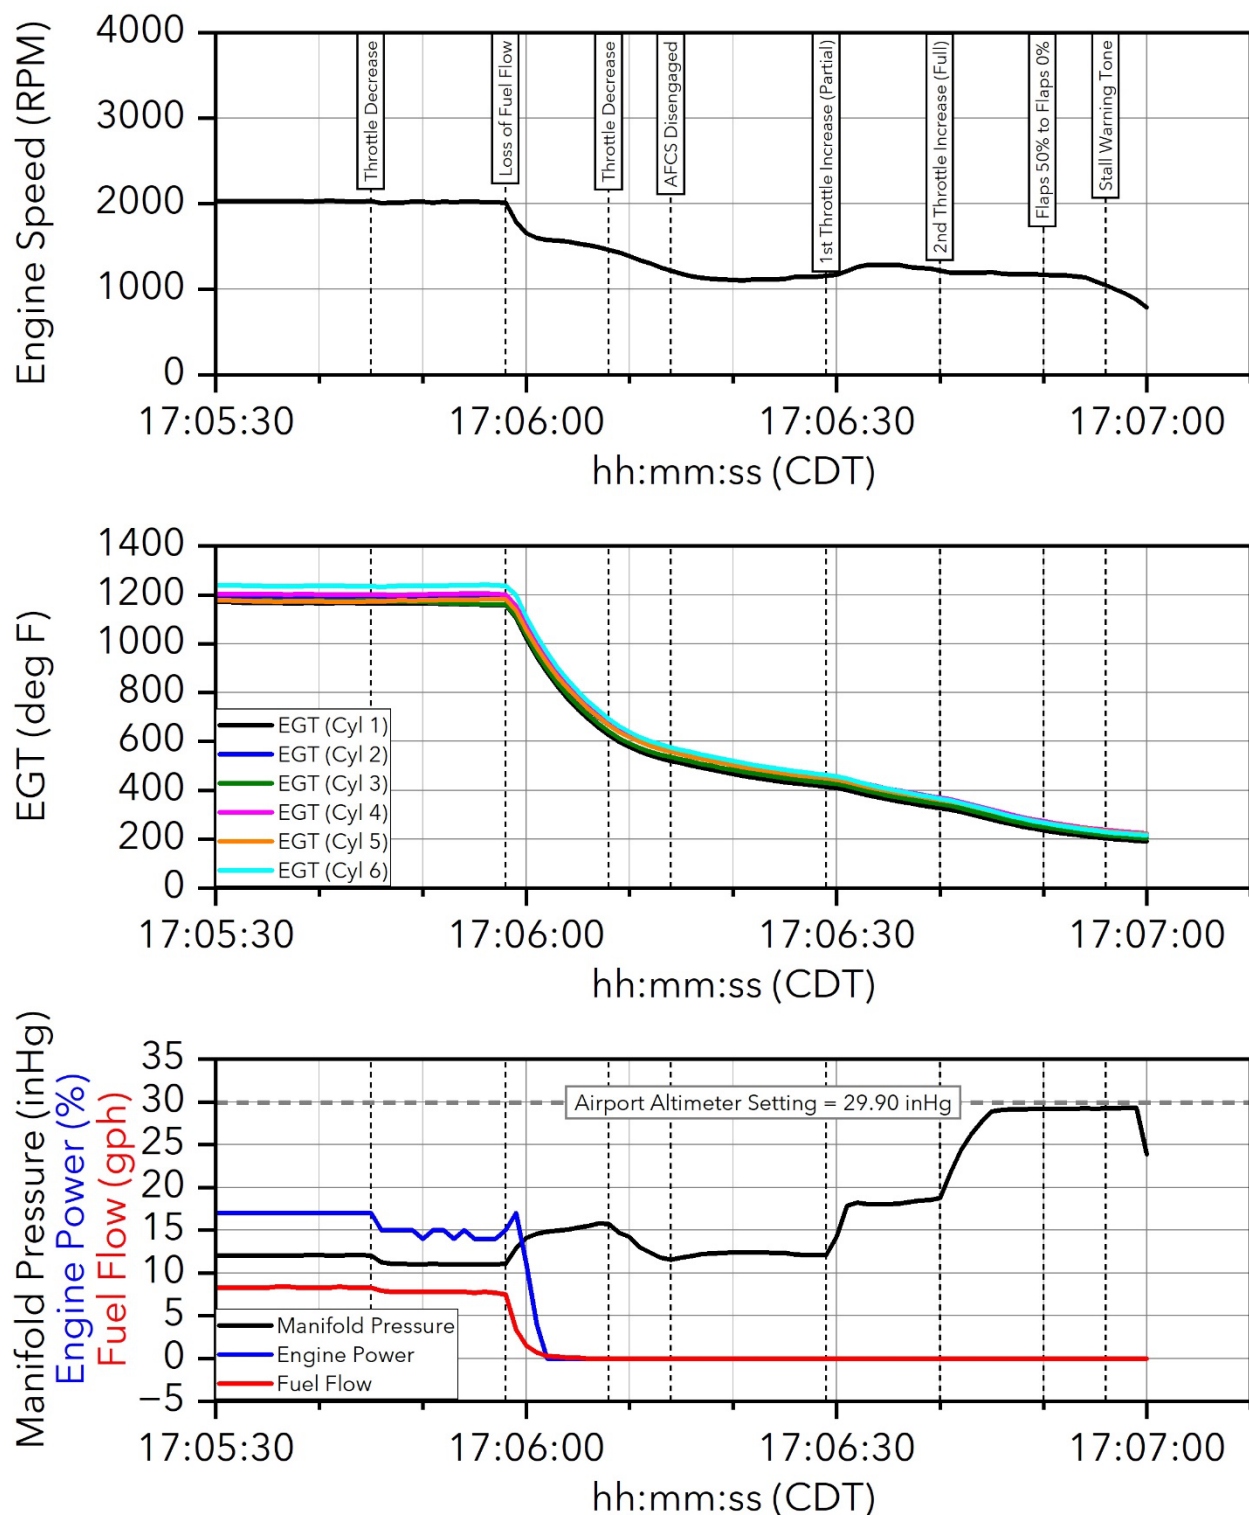
**Figure 5** - Plot of engine speed, EGT, manifold pressure, engine power, and fuel flow at the end of the flight.

Based on recorded engine manifold pressure values after the total loss of fuel flow to the engine, the power (throttle) lever was decreased once and then increased twice. The first, partial, increase of throttle began at 1706:29 as the airplane descended through 738 ft msl (602 ft agl) about 1.49 nm from the runway 17R displaced threshold. About 11 seconds later, the second throttle increase, likely to the full throttle position, occurred as the airplane descended through 544 ft msl (407 ft agl) about 1.23 nm from the displaced threshold.

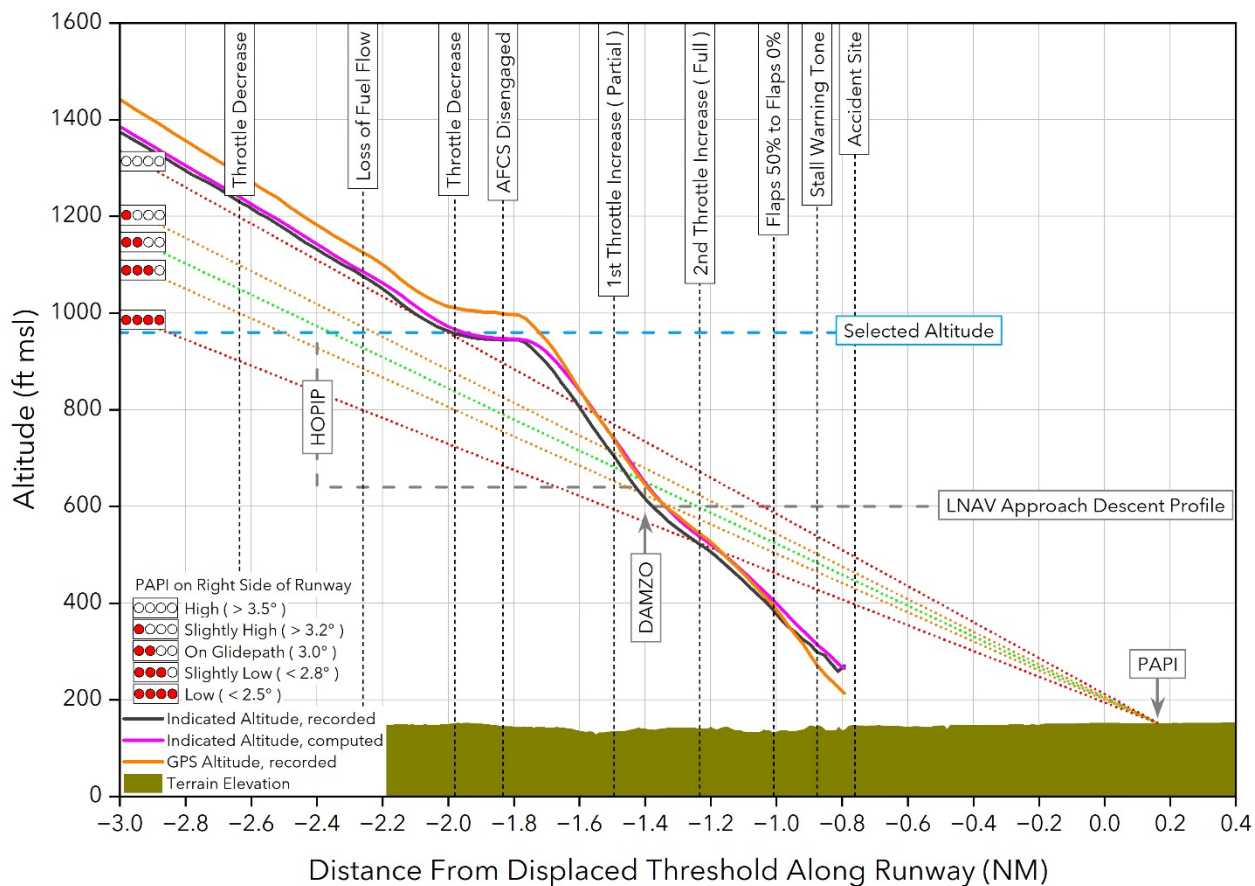
**Figure 6** - Plot of the airplane's descent path at the end of the flight.

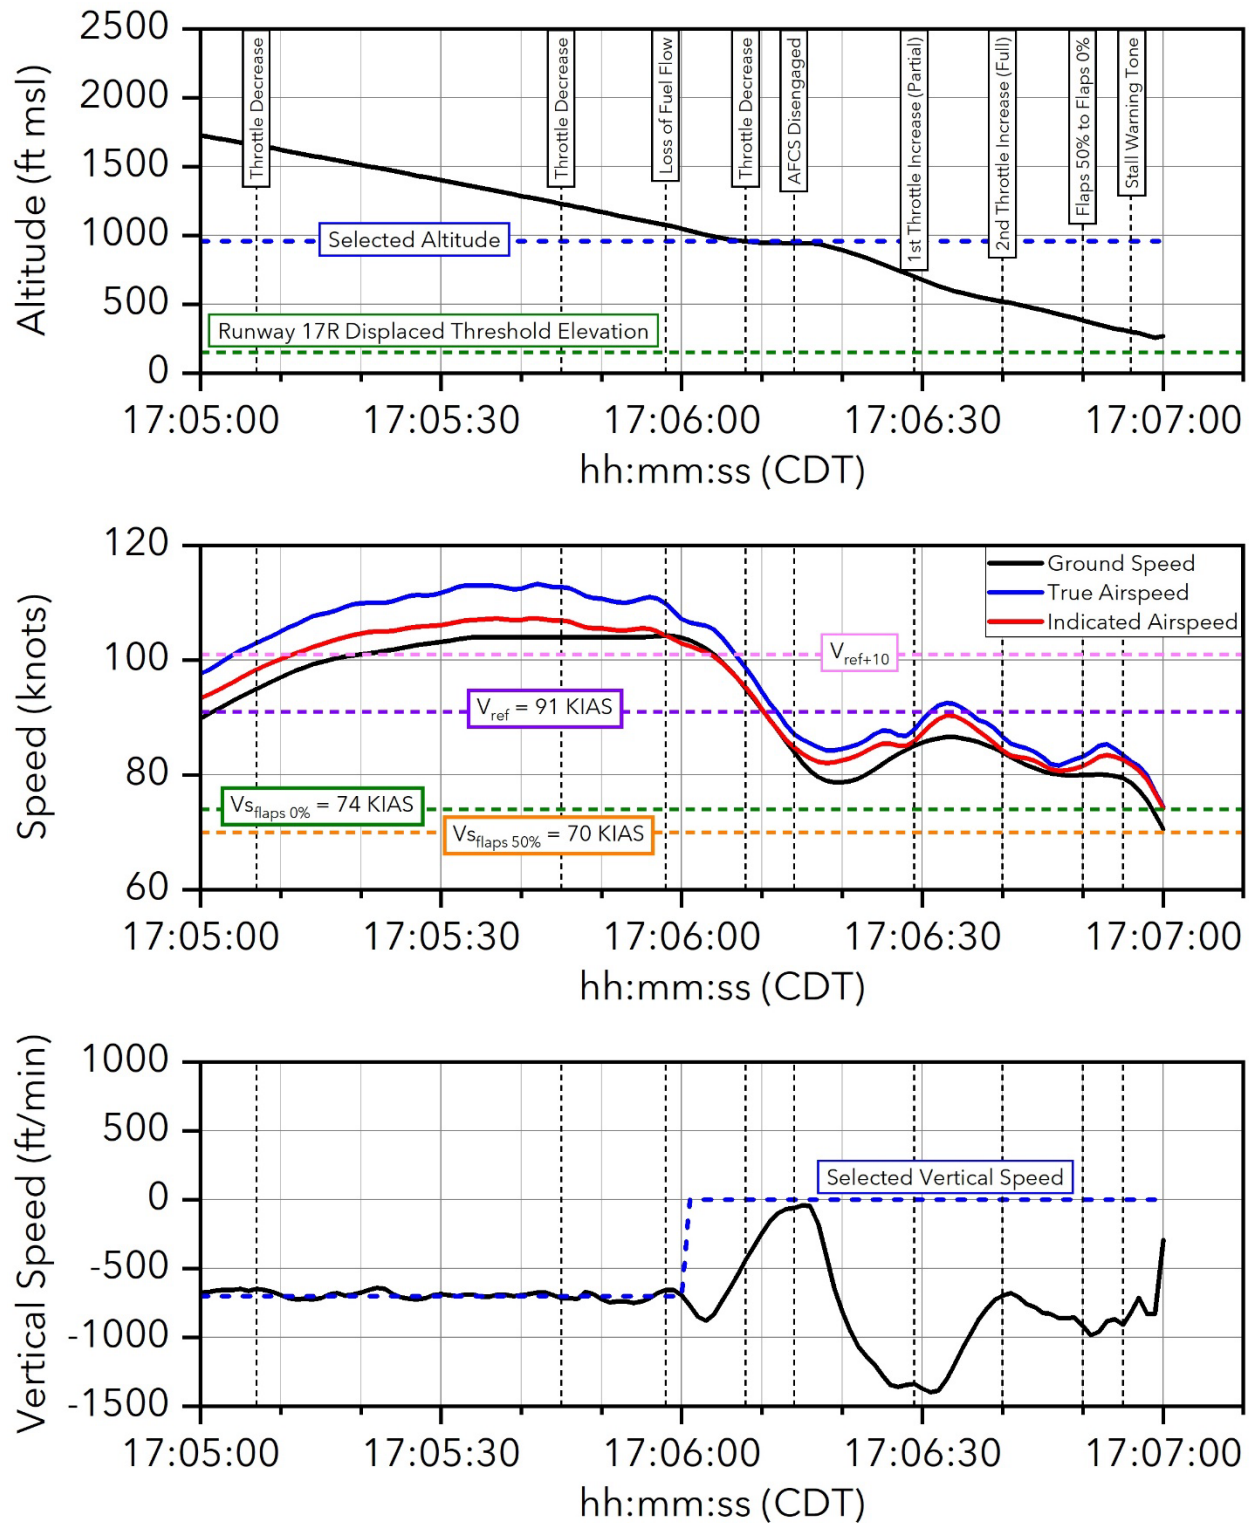
According to the recorded data, at 1706:50, about 394 ft msl (258 ft agl) and 1.01 nm from the displaced threshold, the wing flaps were retracted from 50% to 0%. About 6 seconds later, the stall warning tone activated as the airplane decelerated below 82 knots indicated airspeed (KIAS). At 1707:00, the final recorded data, indicated that the airplane had descended to 214 ft msl (76 ft agl) and decelerated to 74 KIAS, as shown in Figure 7. According to the Cirrus SR22 Pilot Operating Handbook (POH), the airplane's wings-level aerodynamic stall at maximum gross weight is 74 KIAS. The airplane subsequently impacted trees and terrain about 0.76 nm from the runway 17R displaced threshold.

**Figure 7** - Plot of airplane altitude, ground speed, true airspeed, indicated airspeed, and vertical speed at the end of the flight.
