# The National Transportation Safety Board

Office of Aviation Safety  
Central Region  
Memorandum for the Record  
Accident Site and Aircraft  
Exam CEN22FA416  
Waller, Texas  
September 12, 2022

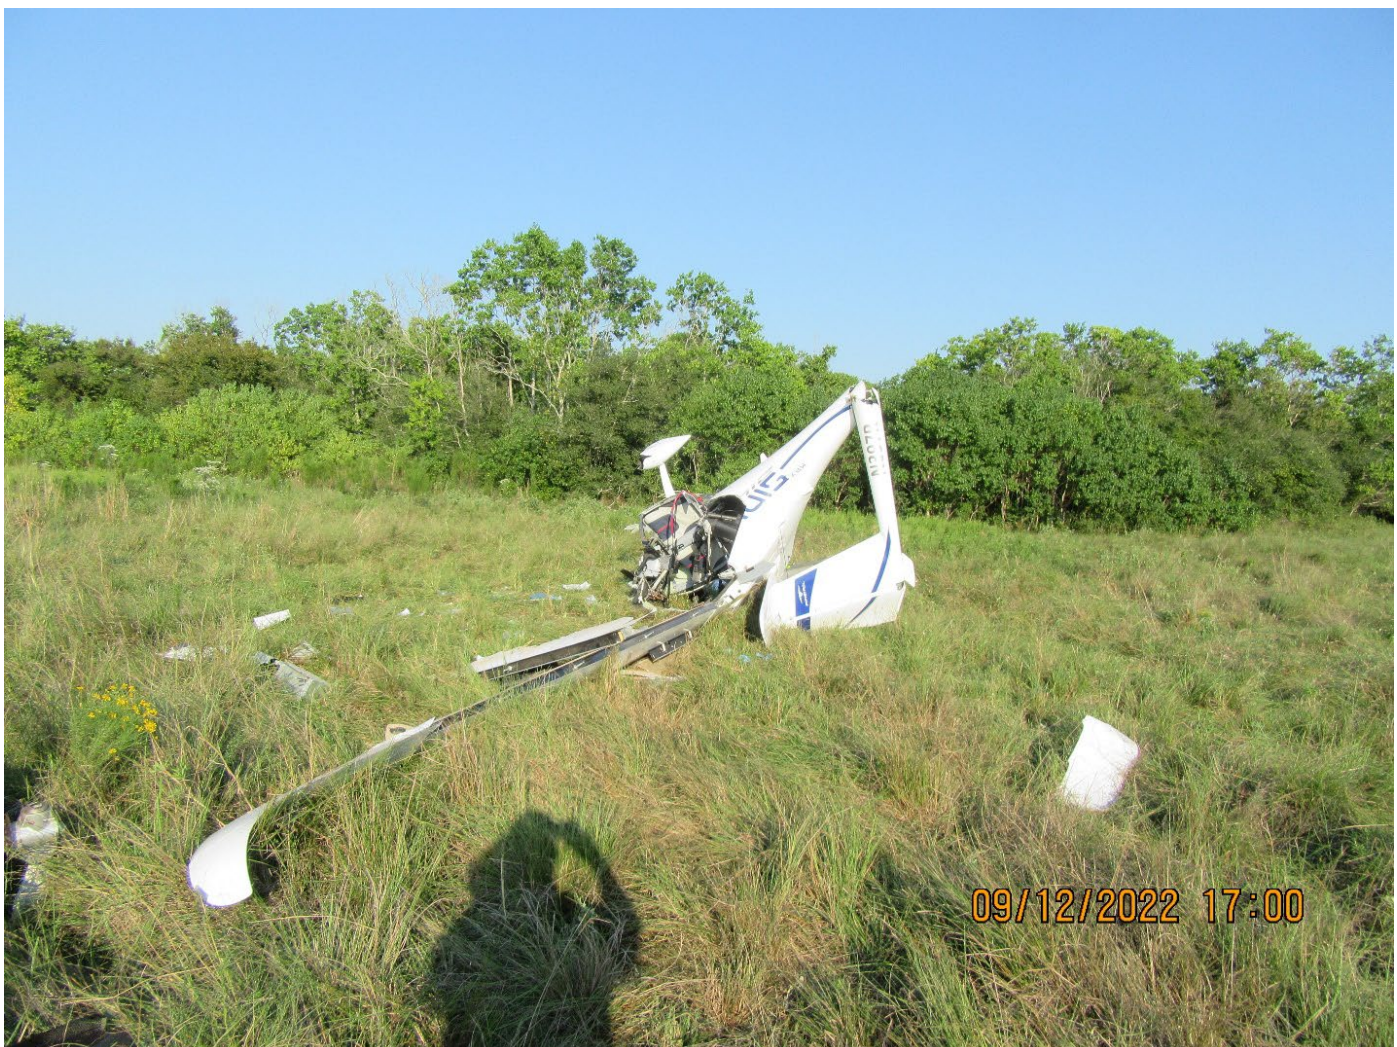
Photo 1. Accident Site and Wreckage

The accident occurred on airport property, adjacent to the approach end of runway 35. The runway and surrounding area were grass covered. Examination of the wreckage at the accident site showed that it impacted the ground in a left wing down, nose-low attitude. The orientation of the wreckage was consistent with a low-energy, impact. The wreckage debris was scattered about 75 feet from the initial impact point. The on-board ballistic recovery system (BRS) was found stowed and not deployed. The aircraft's collision with the ground was consistent with a low altitude stall. See photo 1.
