## **NATIONAL TRANSPORTATION SAFETY BOARD**

### **Aircraft Examination and Accident Site Summary**

**CEN22FA424**

Location: Longmont, Colorado  
Date: September 17, 2022  
Aircraft: Cessna 172S & Sonex Xenos  
NTSB IIC: Michael Folkerts

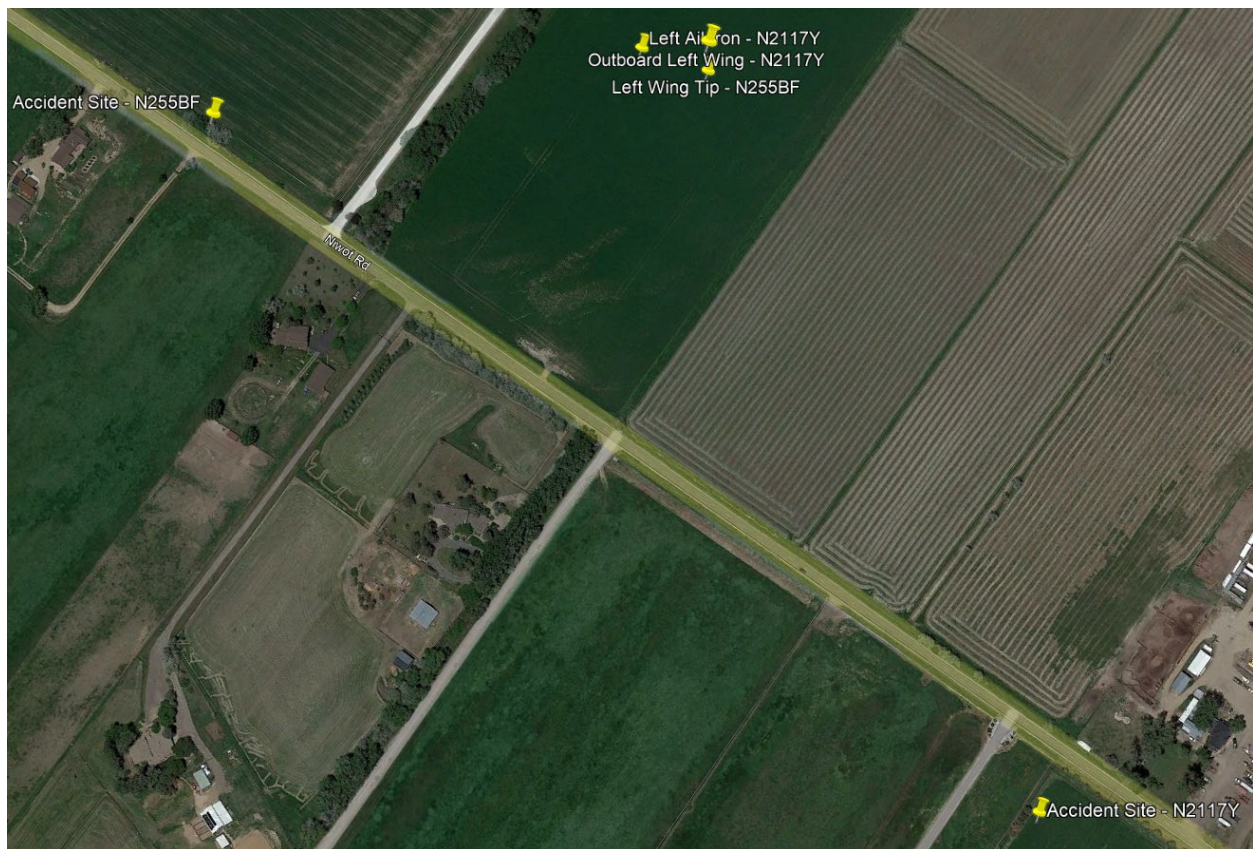
Figure 1. Overhead View of Accident Sites

The two aircraft collided over a rural farm area. Examination revealed a 5 ft section of the left wing and aileron had separated from the Cessna 172 (N2117Y) and a 2 ft long section of the left wing tip had separated from the Sonex Xenos (N255BF).

The wing fragments of both aircraft were found in a field. The Cessna 172 was located about 1,800 ft southeast of the wing fragments; the Xenos was about 1,100 ft southwest of the wing fragments (see Figure 1).

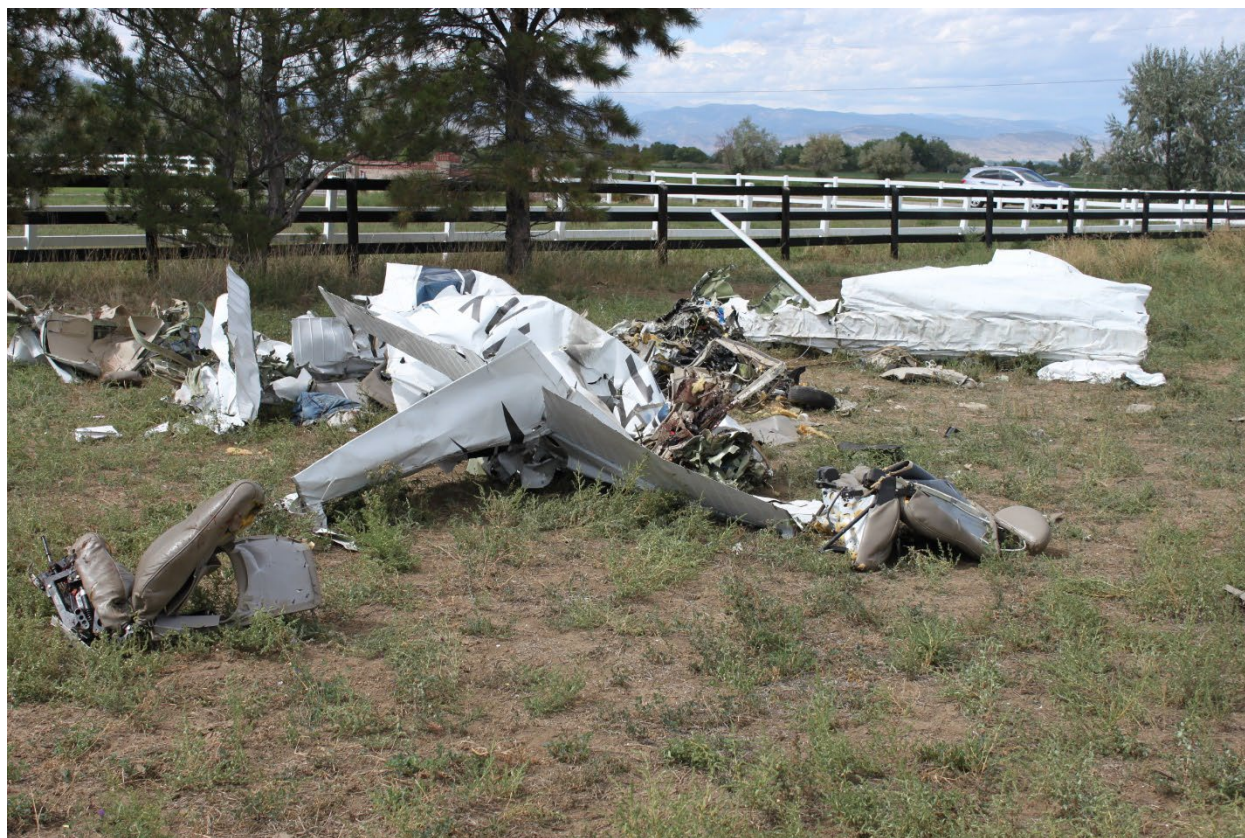
Figure 2. Cessna 172S Wreckage at Accident Site.

The Cessna impacted an open, rural field with a near vertical, nose-down attitude (see Figure 2).

The right wing tip was fractured into multiple small pieces and the right wing leading edge skin was crushed. The right aileron and right flap remained attached to the right wing. The center wing portion of the forward wing spar remained attached to the right wing. The leading edge of the left wing exhibited deformation and compression damage. The aft fuselage exhibited significant deformation and compression damage. The tail remained attached to aft fuselage. The vertical stabilizer and both horizontal stabilizers were crushed; the rudder and elevators remained attached. Flight control cable continuity was not established due to fragmentation and deformation.

The left main landing gear strut remained attached to the aircraft. The left main tire and wheel assembly had separated from the left gear strut and was found about 150 ft east of the fuselage. The right main landing gear strut and wheel assembly separated from the fuselage and were found approximately 50 ft south of the fuselage. The nose wheel assembly sustained ground impact damage and was found next to the engine and instrument panel. The propeller was twisted and exhibited leading edge polishing and rotational scoring near the spinner.

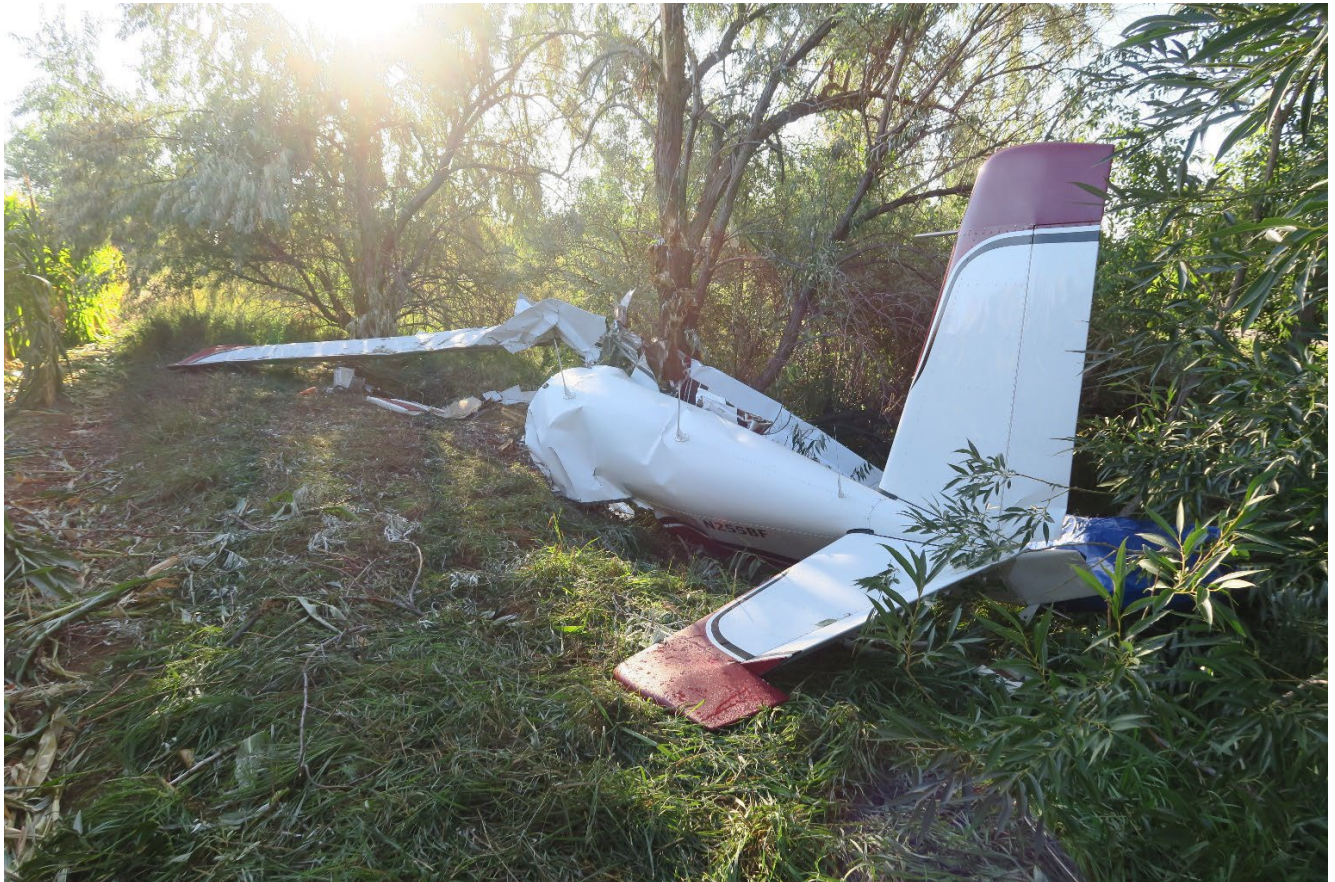
Figure 3. Sonex Xenos at Accident Site

The Sonex Xenos, a light sport experimental aircraft, impacted terrain between a corn field and Niwot Rd (see Figure 3).

The aircraft struck a tree in a near vertical descent and came to rest inverted on the edge of the roadway drainage ditch.

The right wing remained attached to the fuselage and sustained ground impact damage to the leading edge skin. The right wing tip and aileron remained attached. The left wing remained attached to the fuselage. The left wing was fractured near mid-span and was bent downward. The left wing tip and about 2 ft of the outboard left wing skin located near the leading edge of the left wing was impact separated from the aircraft when it struck the Cessna 172S. The left aileron remained attached to the wing; there did not appear to be any damage to the outboard end of the left aileron.

The aft fuselage was found separated from the forward cabin. The lower portion of the fuselage sustained tree impact damage and was torn in multiple locations. The V-tail remained attached to the aft fuselage and did not appear to be damaged.

The engine and propeller were embedded in the soil at the base of a tree. The forward fuselage and cockpit were crushed. The instrument panel was fragmented; instrument readings and switch positions were unreliable.
