# National Transportation Safety Board

CEN22FA433

Specialist's Fire Factual Report

Location: Yankton, South Dakota  
Date: September 27, 2022  
Vehicle: Airgyro AG915  
Investigator: Michael Hodges  
AS-CEN

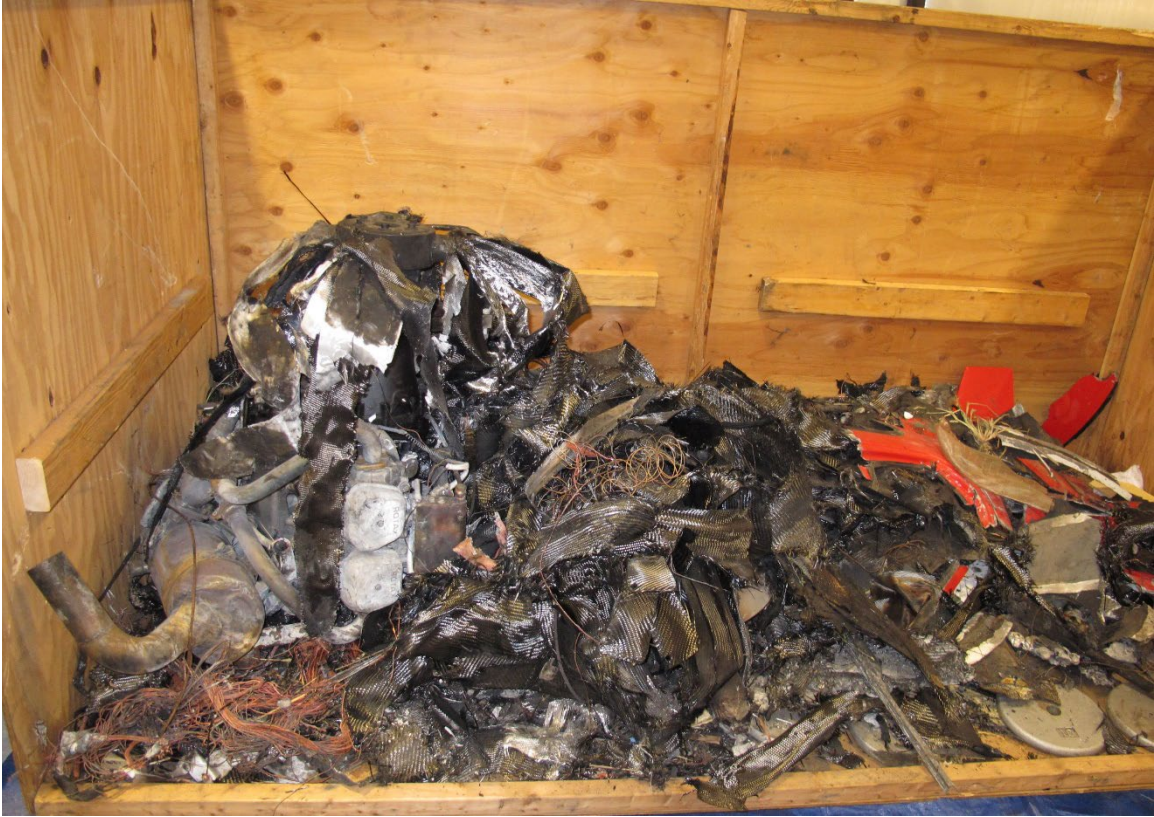
The majority of the carbon composite aircraft was damaged or destroyed (resin burned away leaving only the carbon fiber mat) by postcrash fire and impact. A photograph of the recovered wreckage in the storage crate is shown in Figure 1. Several sections of fuselage and empennage and the main rotor mast were found a significant distance from the impact point. The composite components exhibited signs of thermal damage that did not appear to be related to a postcrash fire. On-scene photographs of these components showed no evidence of a ground fire. These components are shown in Figures 2 and 3.

**Figure 1.** Wreckage in storage crate

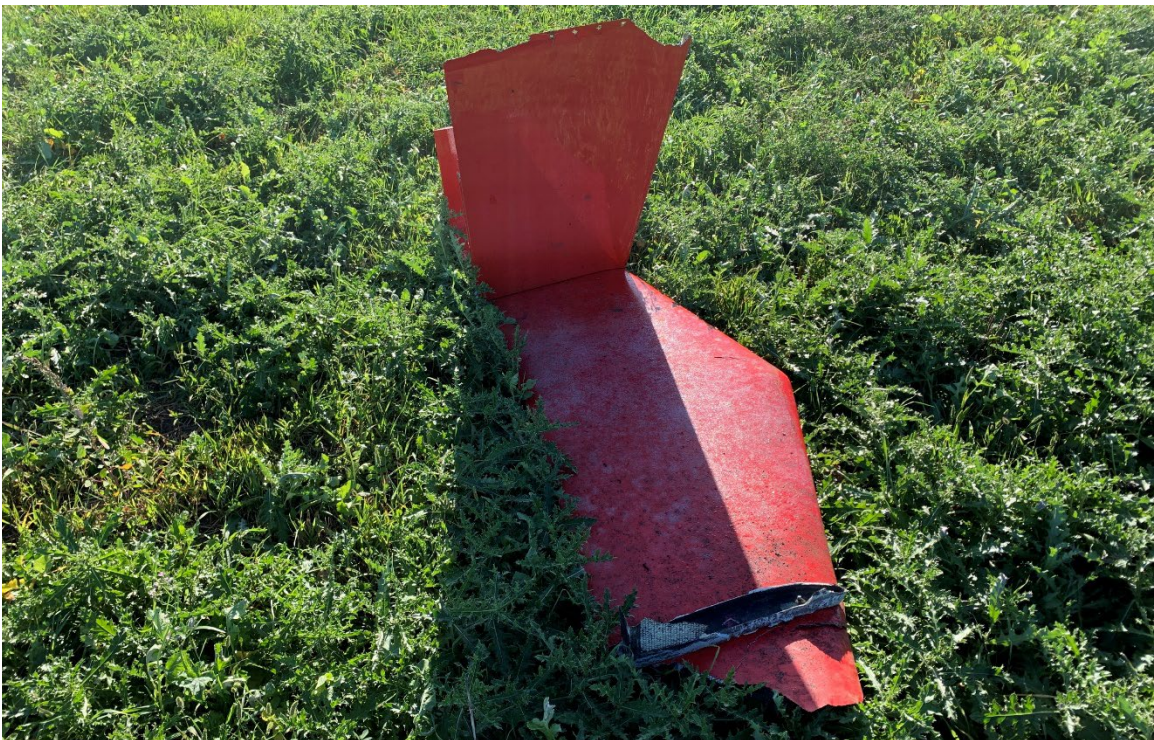
**Figure 2.** Empennage on scene

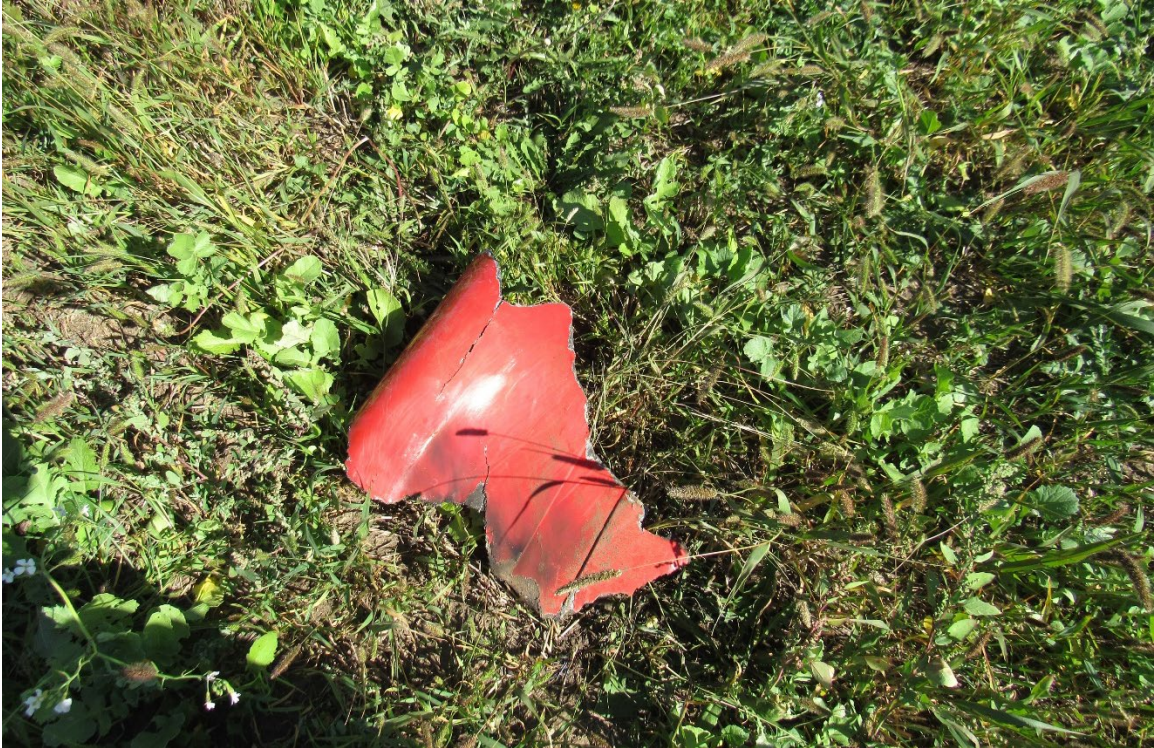
**Figure 3.** Piece of fuselage on scene

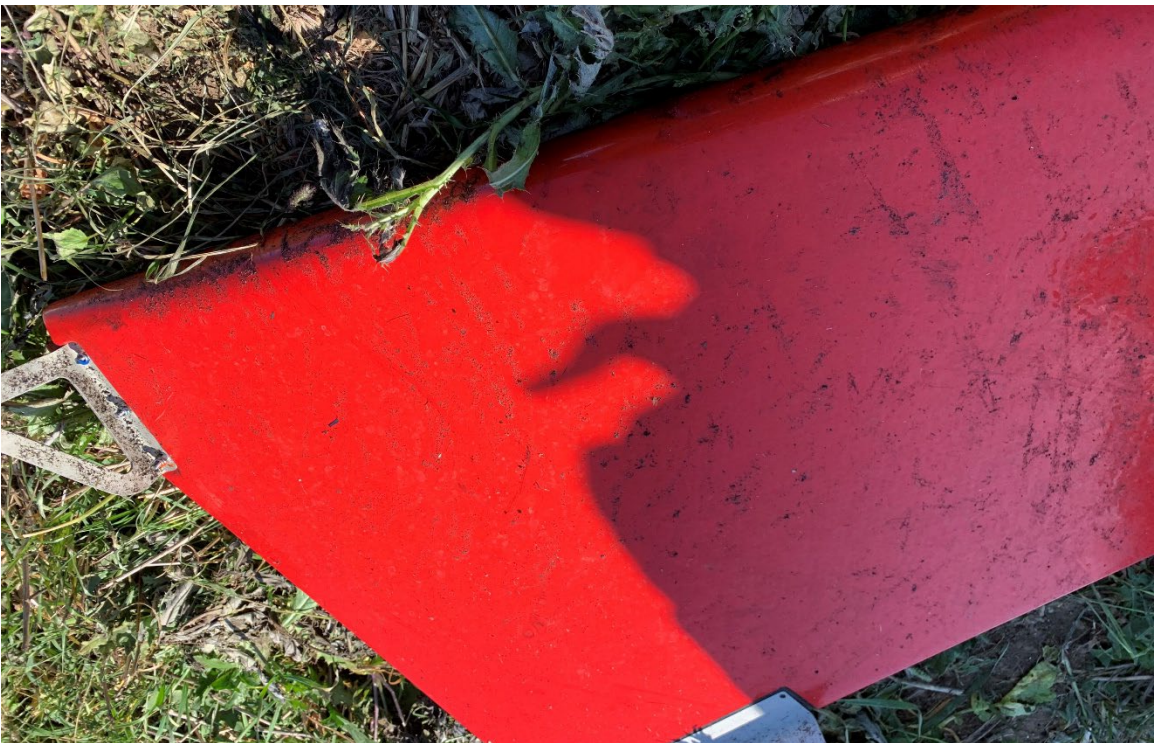
In addition to the thermal damage, there was also evidence of fluid consistent with oil, on both the interior and exterior on several fuselage and empennage pieces. The fluid on the exterior surfaces appears to be airflow driven patterns indicating that this occurred in flight. The spray patterns are shown in Figures 4-7.

**Figure 4.** Fluid on exterior of aircraft

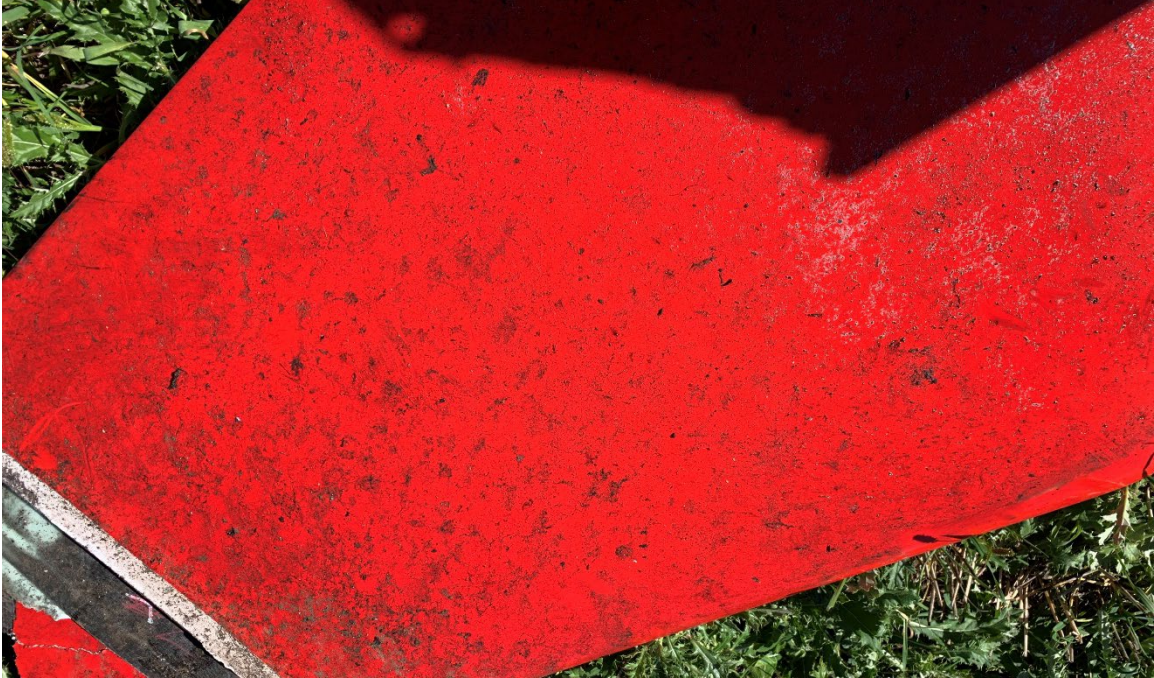
**Figure 5.** Fluid on exterior of aircraft

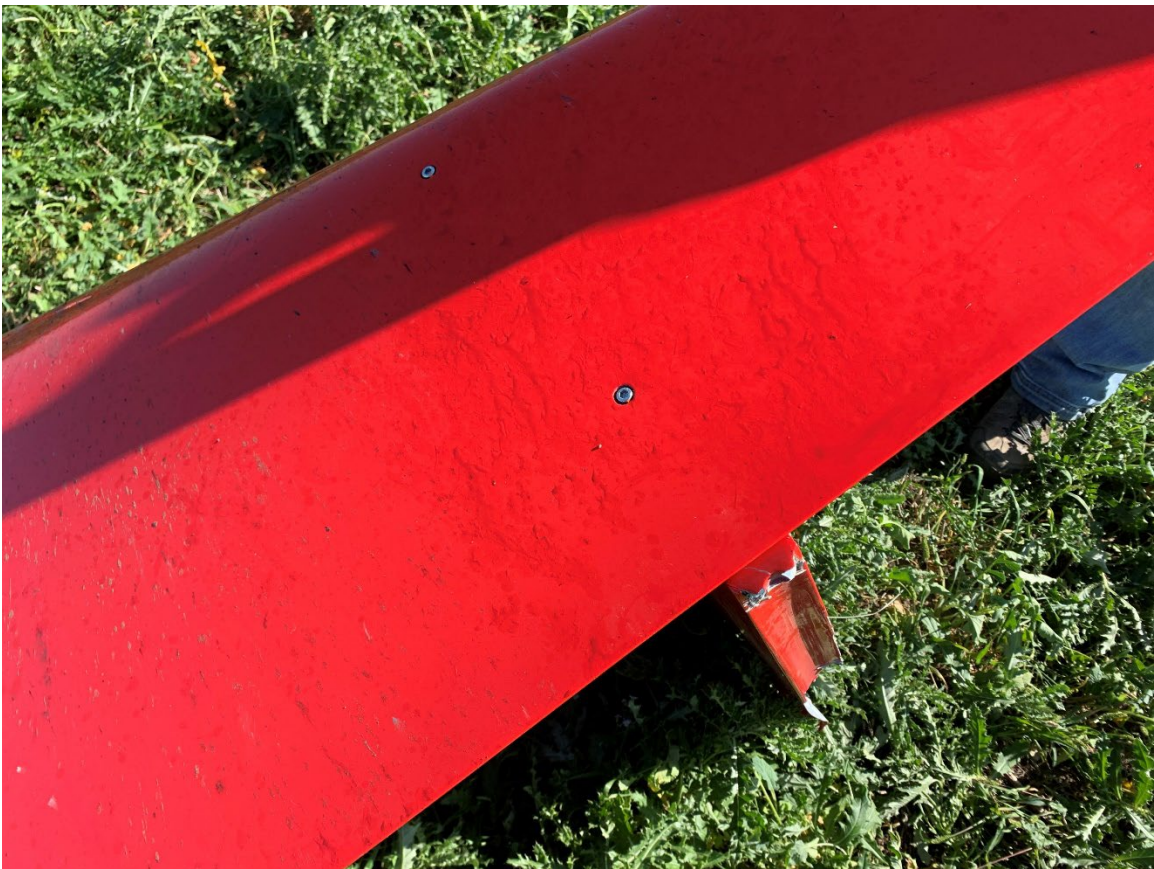
**Figure 6.** Fluid on exterior surface of aircraft

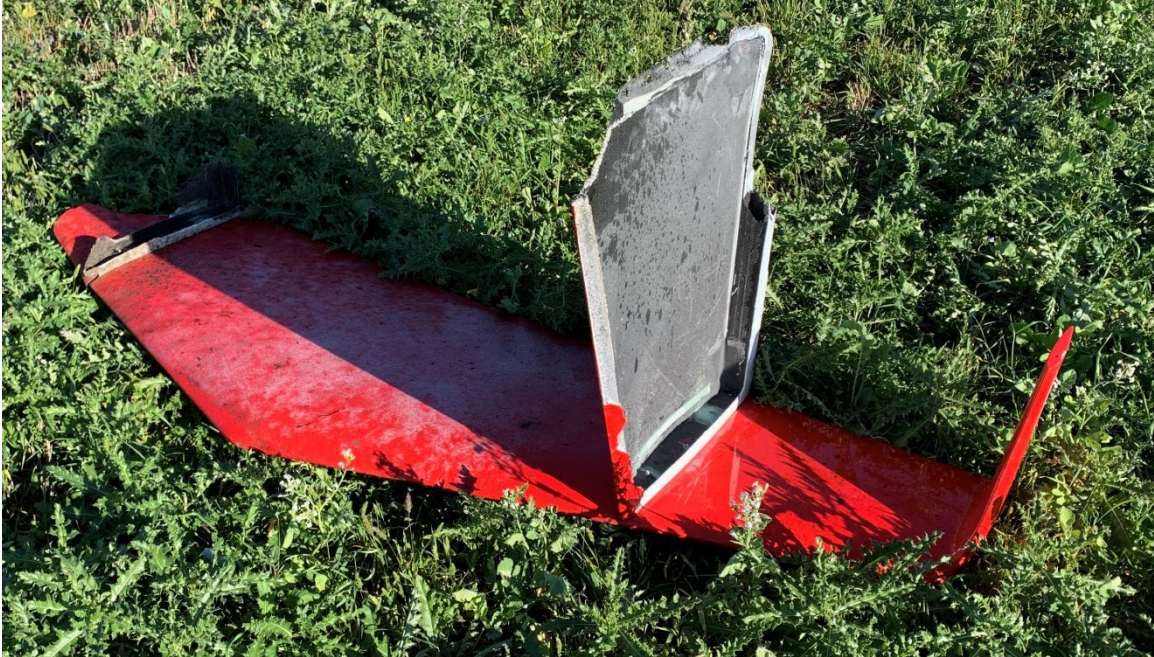
**Figure 7.** Fluid spray on interior of empennage.

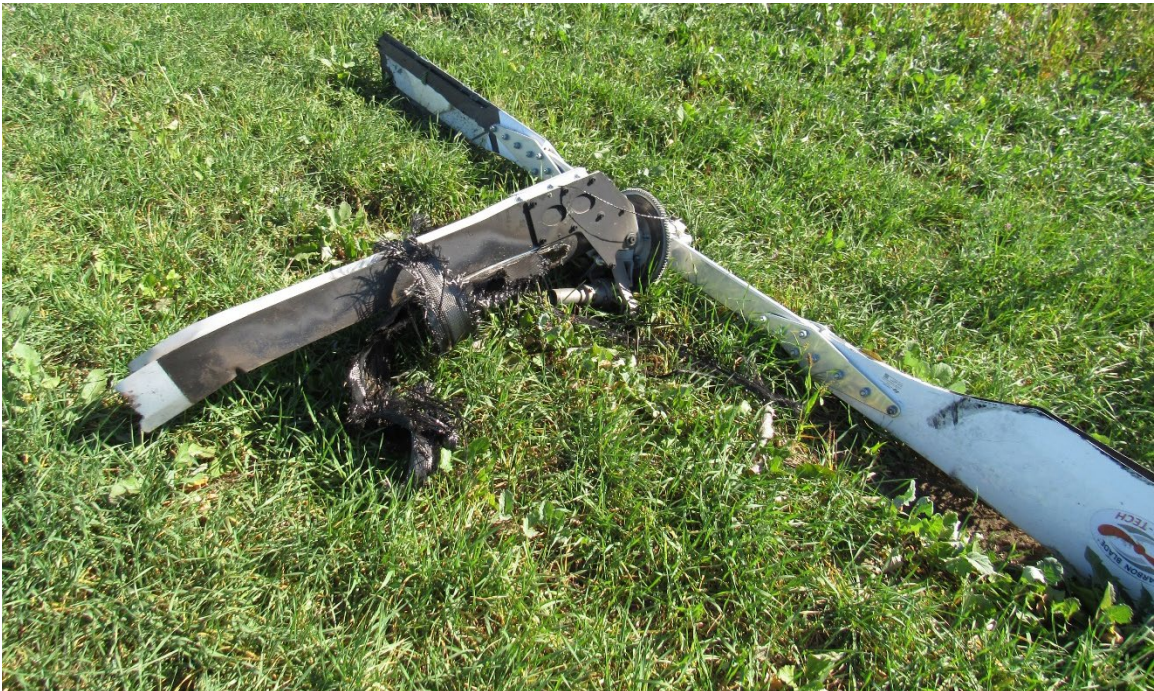
The main rotor mast exhibited thermal discoloration and heavy sooting up to and including the swash plate. This is shown in Figures 8 and 9. The remaining rotor blade sections show no thermal damage or sooting.

**Figure 8.** Main rotor mast on scene

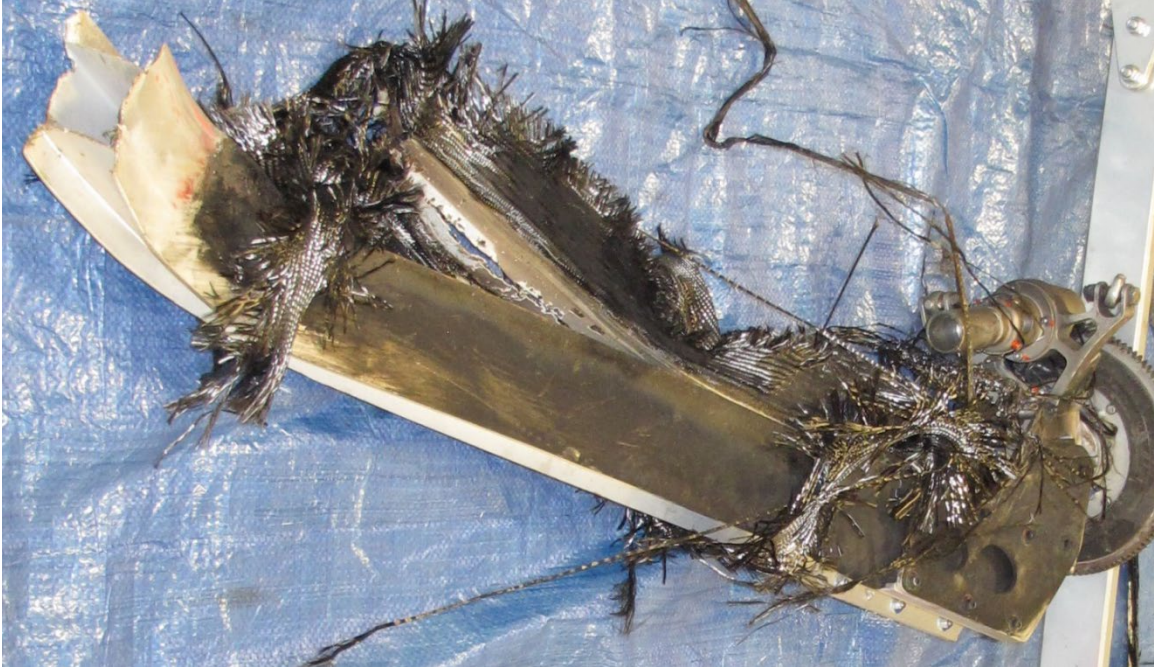
**Figure 9.** Close up photograph of thermal damage to rotor mast.

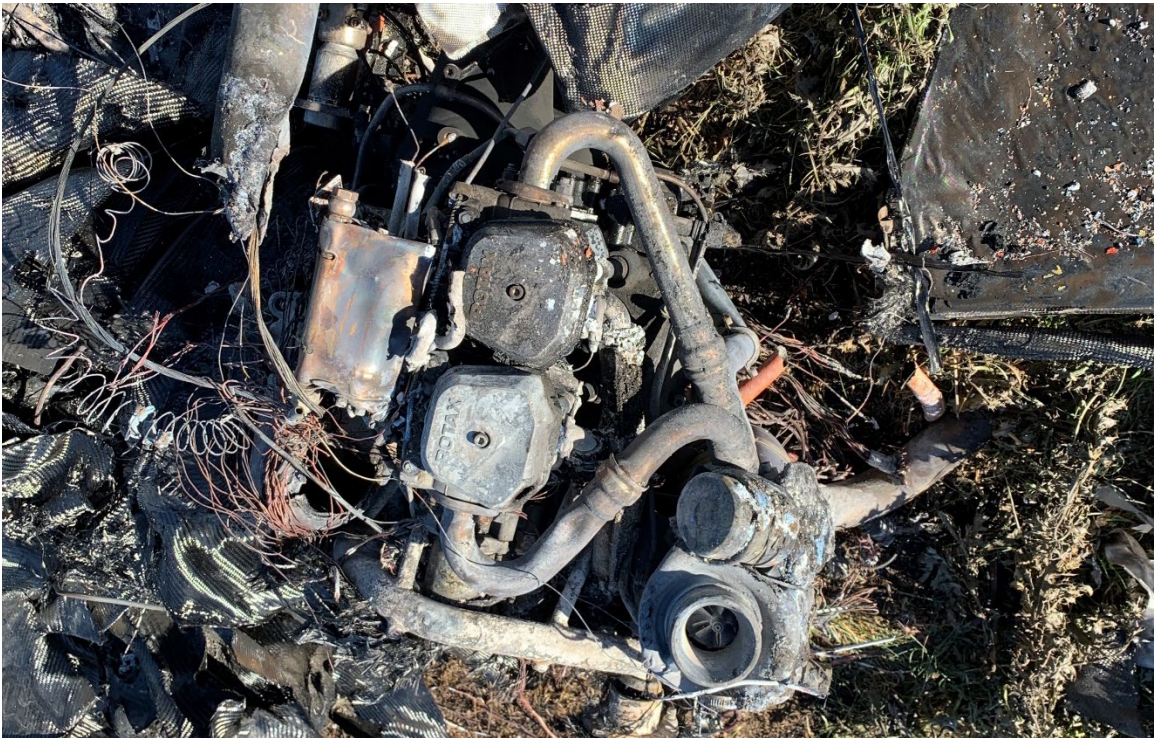
The engine was found on scene in the impact area and near the postcrash fire. The gyrocopter was equipped with a Rotax Aircraft Engines 915 series engine. A photograph of the engine at the accident site is shown in Figure 10. Upon examination, the engine had oil coating over a large area of the exposed surfaces. The governor pad was heavily coated in oil with an area of coagulated oil directly beneath it as shown in Figure 11. The governor oil pressure feed line banjo bolt-a normally torqued fitting- was found finger tight. There was no evidence of torque paint/markings on the surface of the fitting or the adjacent area of the engine block. However, the torque paint may have been damaged or destroyed as a result of thermal exposure.

**Figure 10.** Engine on scene.

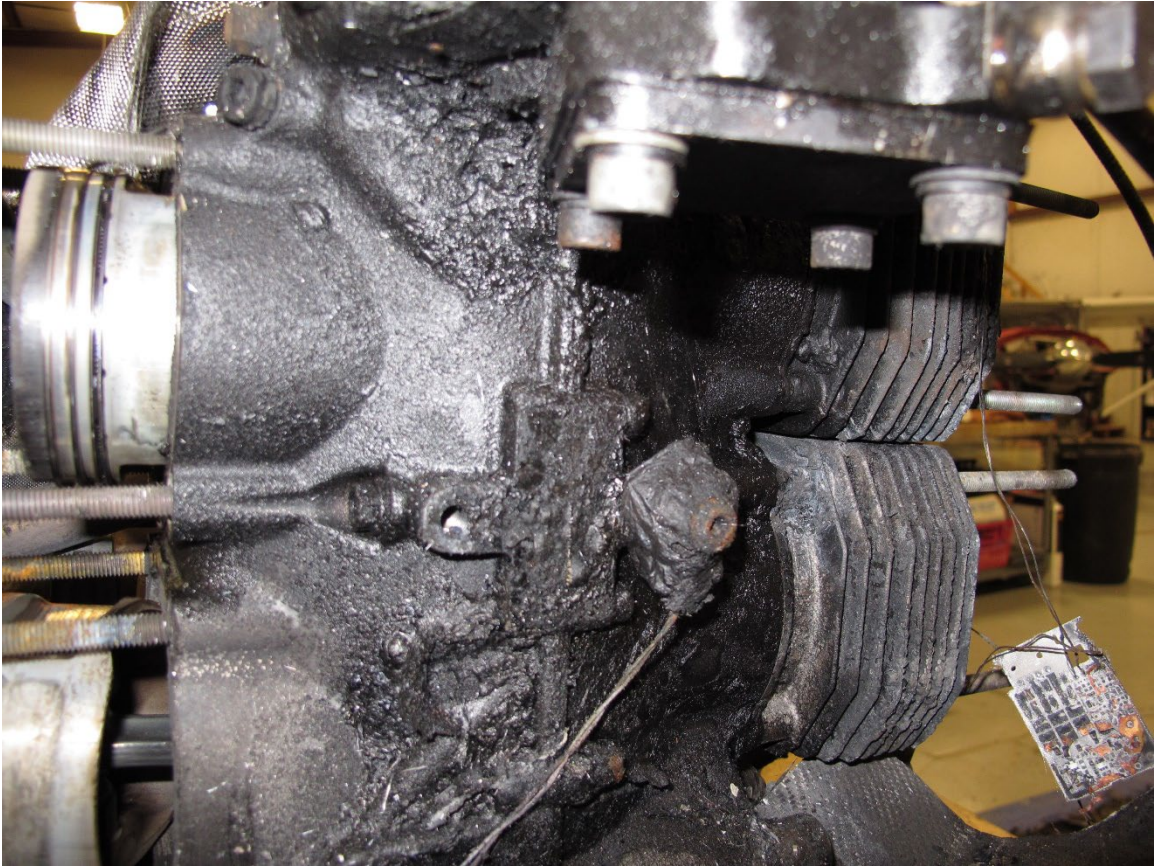
During the examination, it was observed that a governor had not been installed on the governor pad and the governor pad plate cover was still in place. According to the Rotax installation manual, the governor pad plate cover was

intended for shipping purposes only and may not be used in operational condition. However, it also stated that if the aircraft original equipment manufacturer (OEM) considered the cover plate as part of the hydraulic governor system, its usage and functionality may be subject to the aircraft manufacturer's responsibility, which in this case was the pilot. The cover plate bolts were found to be only finger tight, possibly a result of thermal exposure. According to the manufacturer's examination report, Rotax does not provide a specific torque specification for the cover plate bolts, and a general torque specification was applied based on the size of the bolts.

**Figure 11.** Area of engine block under governor pad.

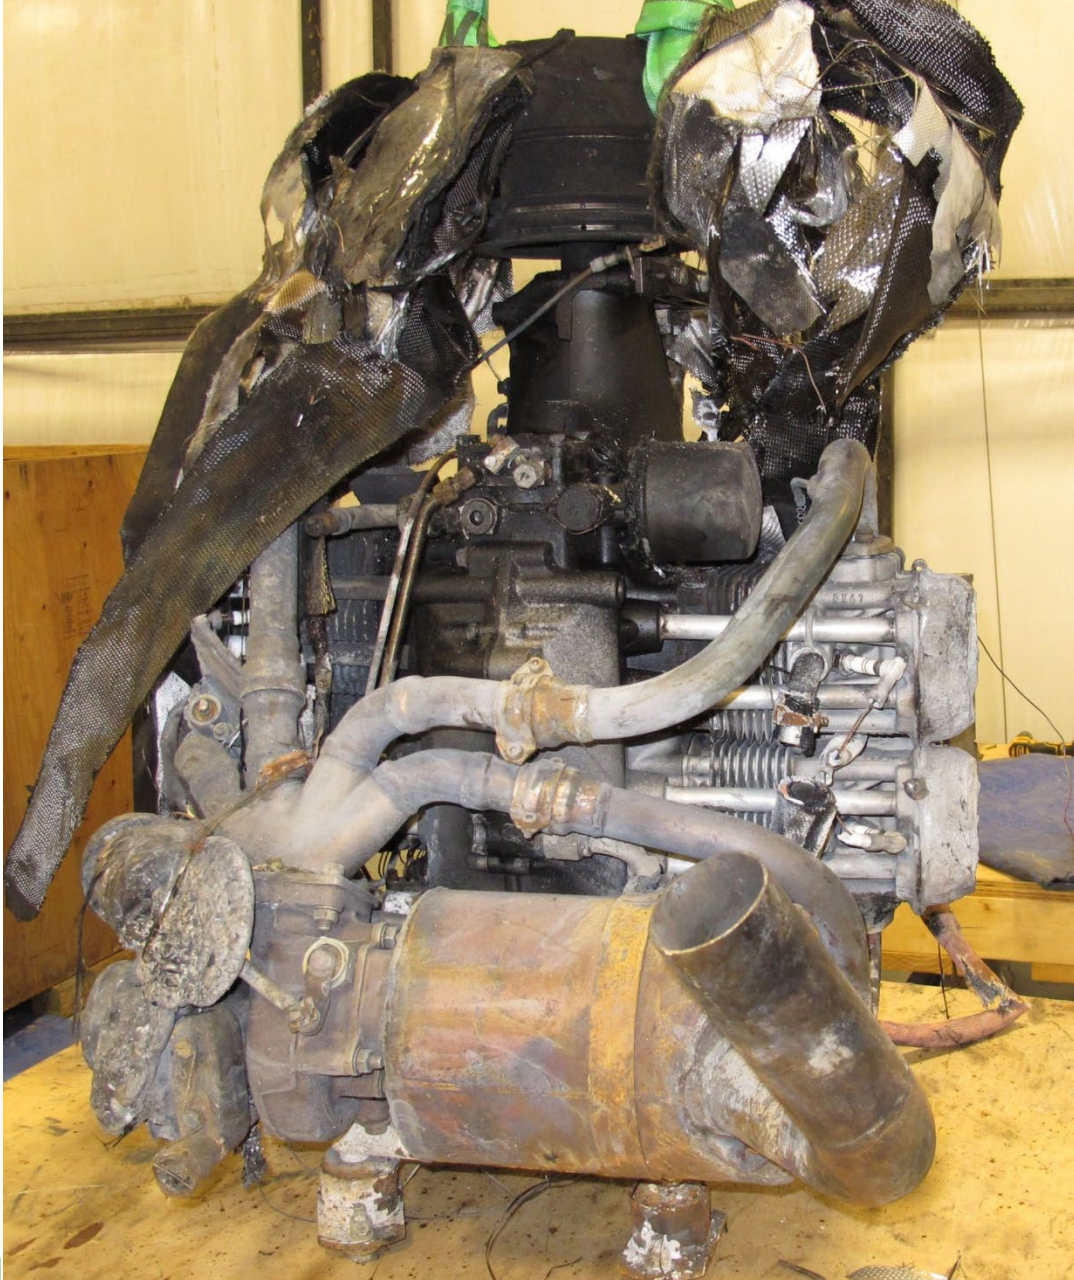
The only area not covered with oil was near the turbocharger and two of the exhaust ducts. This area also exhibited thermal discoloration as shown in Figure 12. Two aluminum valve covers (Cylinders 2 and 4) collocated in this area were melted along the bottom edge of the covers with evidence of dripping and material flow. This is shown in Figure 13. The flow direction of the melted areas indicate that the material was in an upright (inflight position) at the time the material started to flow as shown in Figure 14. Hoses and lines located in this area were either missing/presumed destroyed or thermally damaged. The oil return connection frange on the engine block located above the turbocharge exhibited thermal damage with melting on the threads. This is shown in Figure 15. The connector from this frange was found separated from the engine. There was resolidified aluminum on the connector as shown in Figure 16. The connector and frange are shown in the installed configuration in Figure 17. The cold side of the turbocharger and other aluminum engine components were also melted as shown in Figures 18 and 19. No other damage was observed.

**Figure 12.** Lower surface of engine and turbocharger.

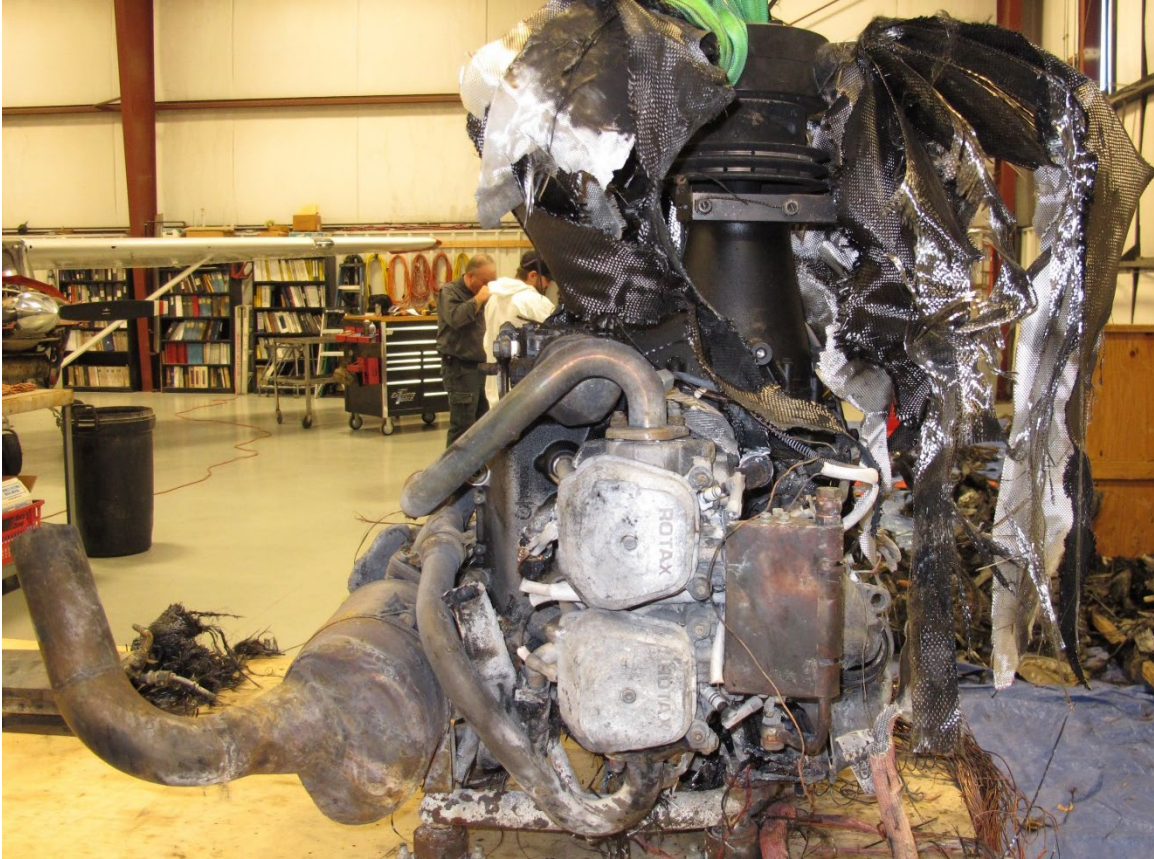
**Figure 13.** Left side of engine (Cylinders 2 (upper) and 4 (lower))

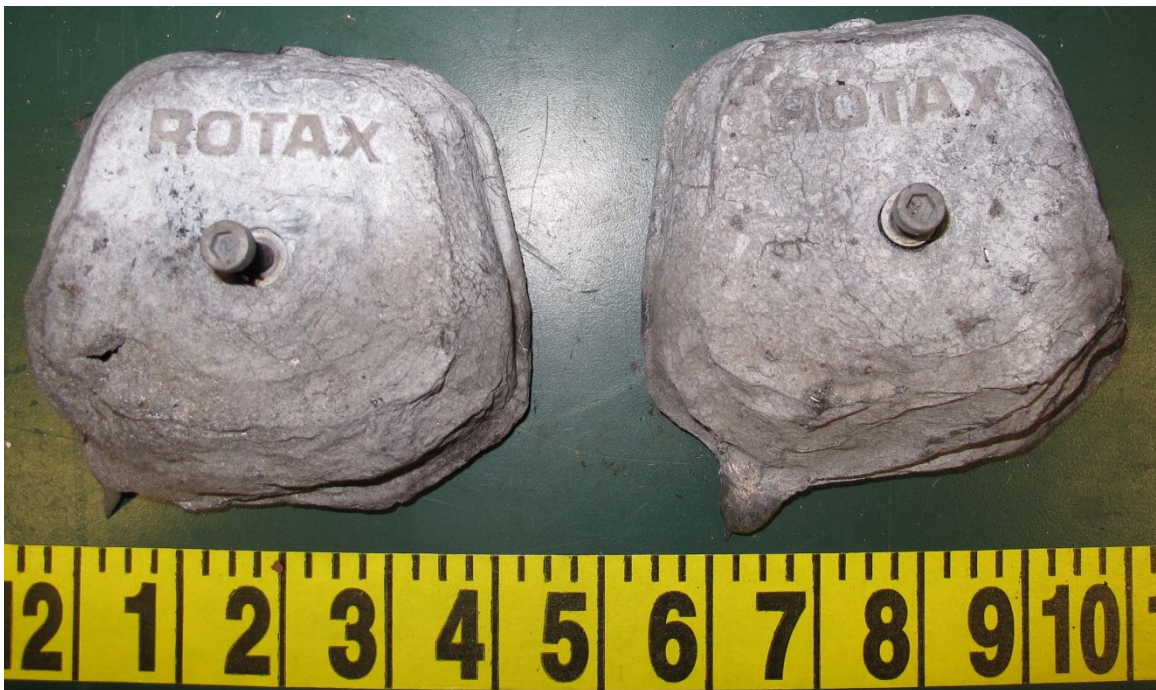
**Figure 14.** Cylinder covers for Cylinder 4 (left) and Cylinder 2 (right).

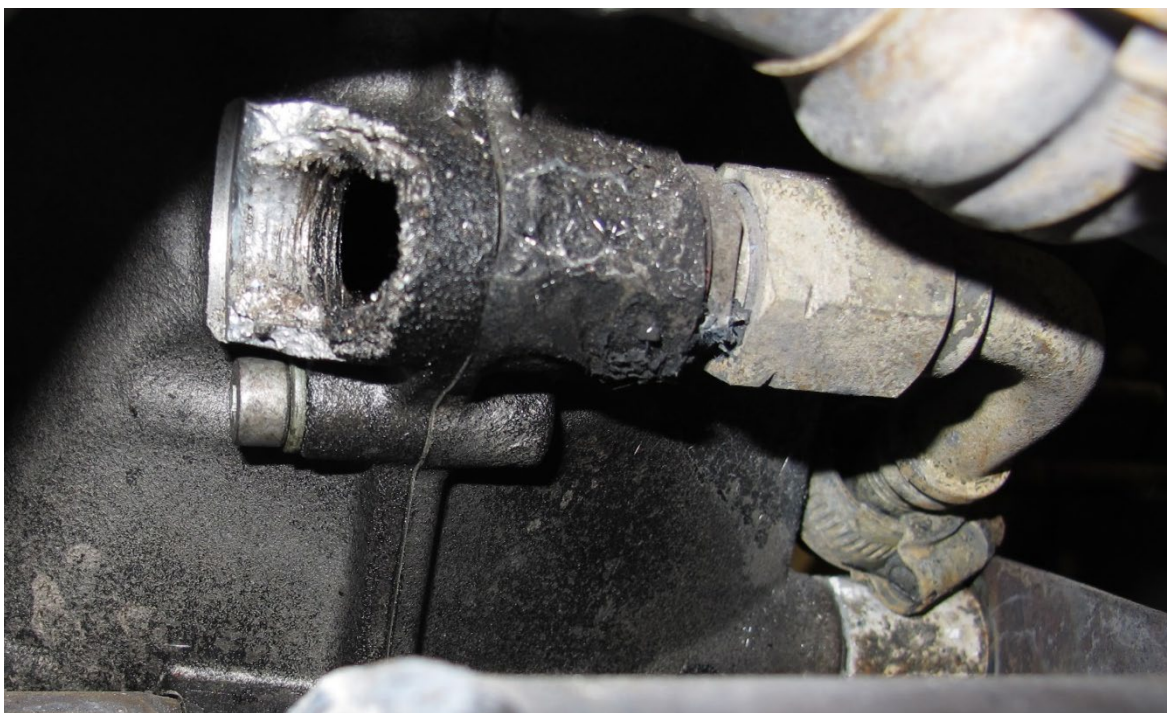
**Figure 15.** Closeup of frange connection on engine block.

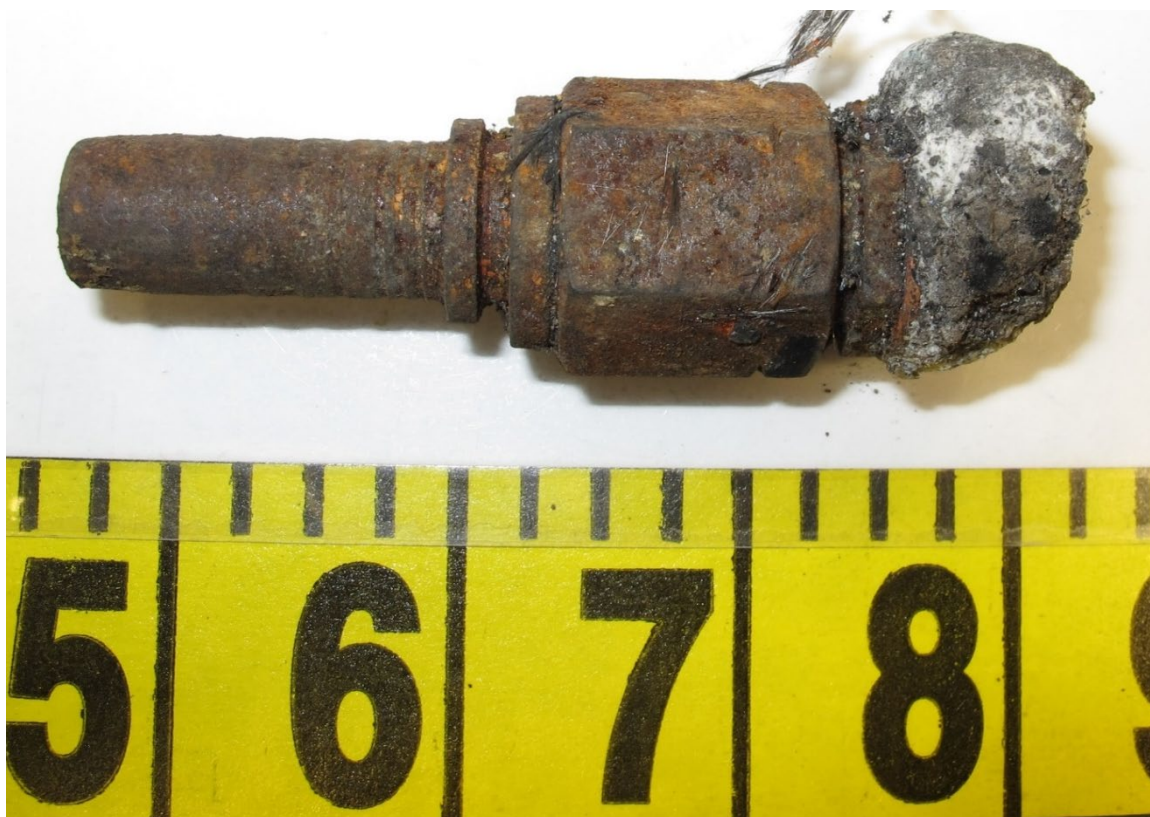
**Figure 16.** Separated frange connector.

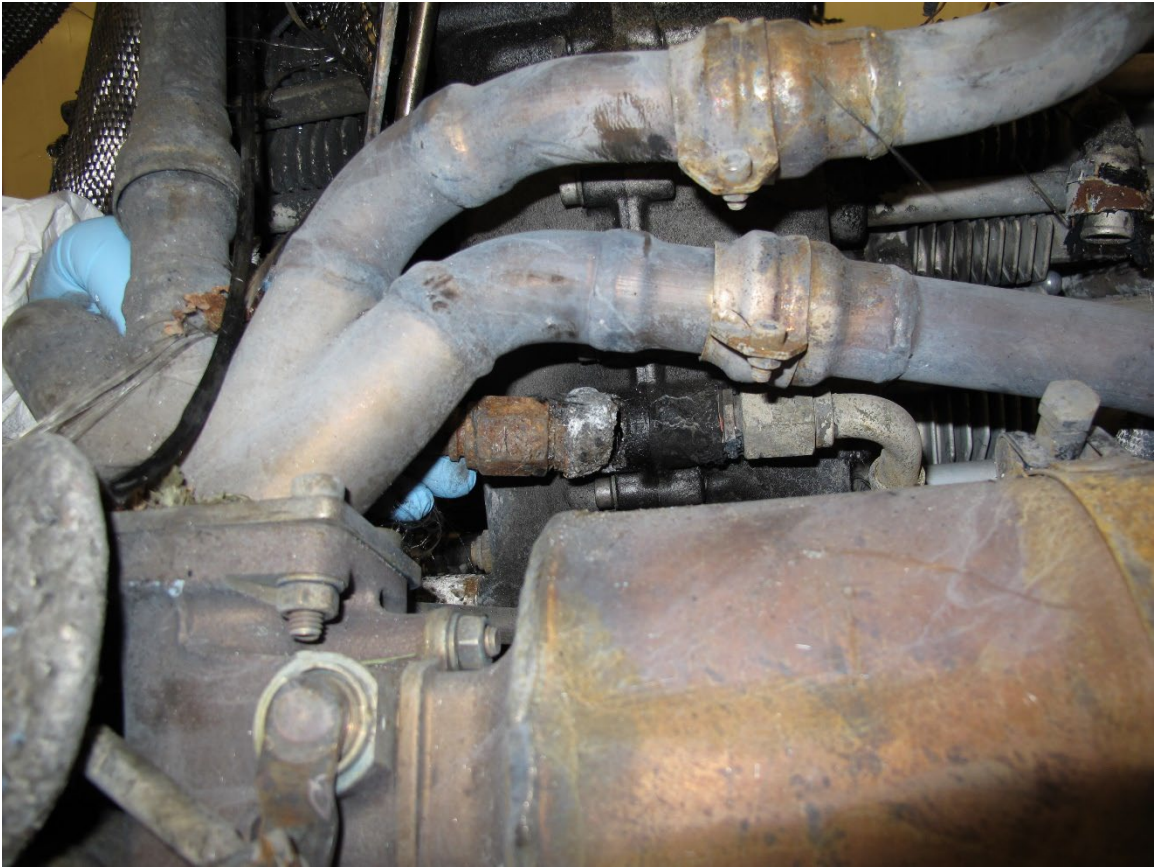
**Figure 17.** Oil frange connector with separated fitting.

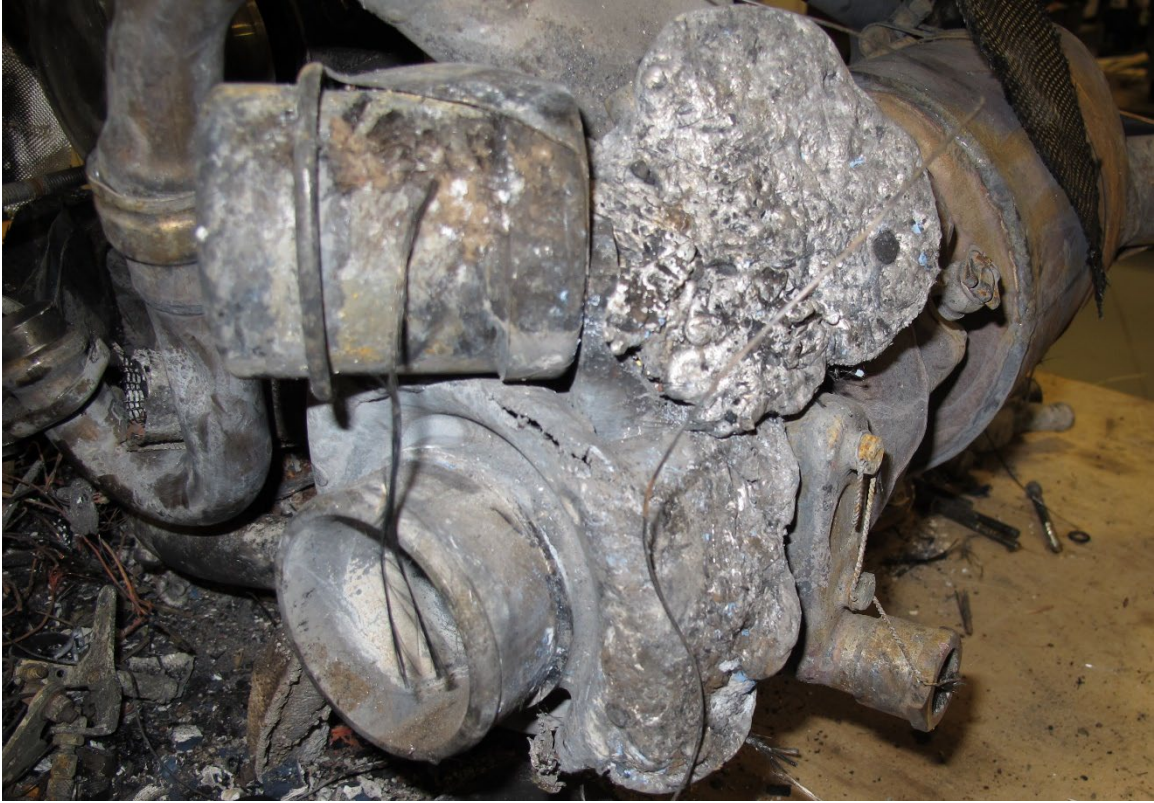
**Figure 18.** Turbocharger intake ("cold" side).

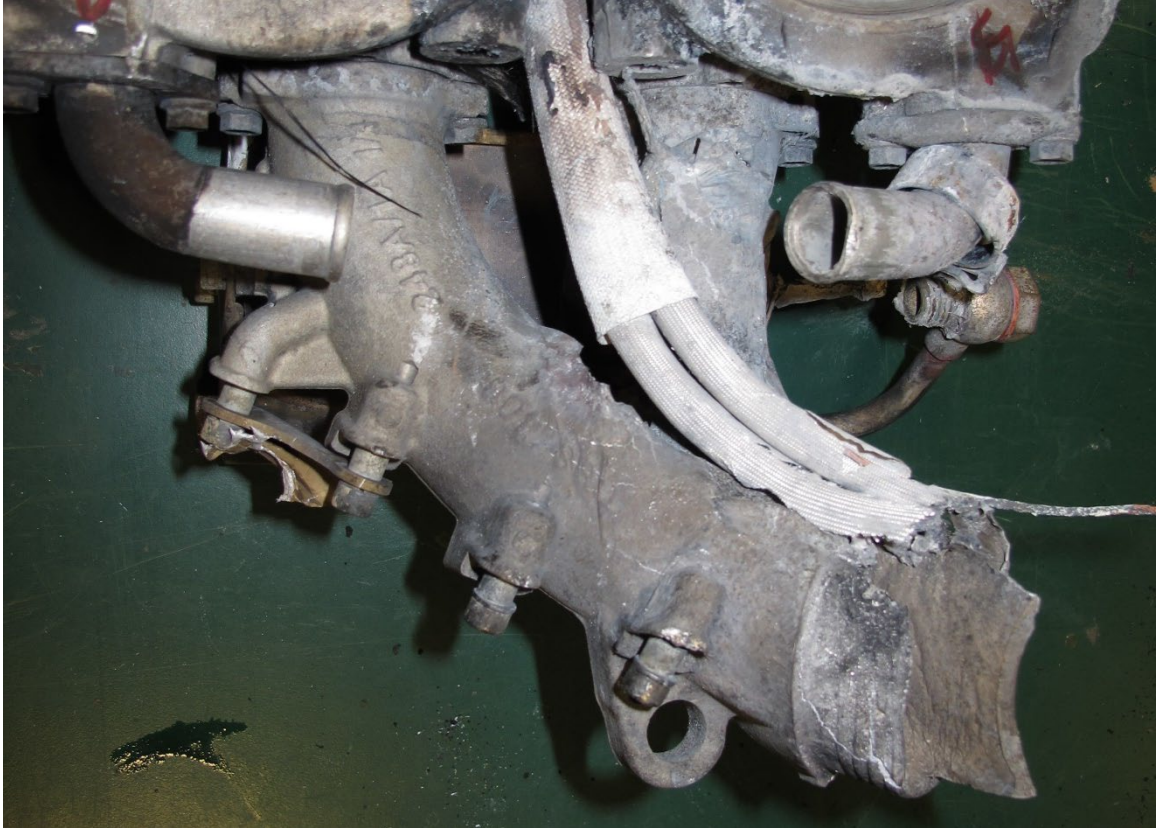
**Figure 19.** Melting on engine exhaust duct.
