## **INVESTIGATION REPORT**

| <b>Date of accident:</b> | September 27 <sup>th</sup> 2022 | <b>NTSB file number:</b> | CEN22FA433 |

| <b>Aircraft Make:</b> | Air Gyro | <b>Aircraft registration:</b> | N499AG |

| <b>Engine Type:</b> | Rotax 915 iS3 | <b>Engine TTSN</b> | 37.8 hrs TTSN |

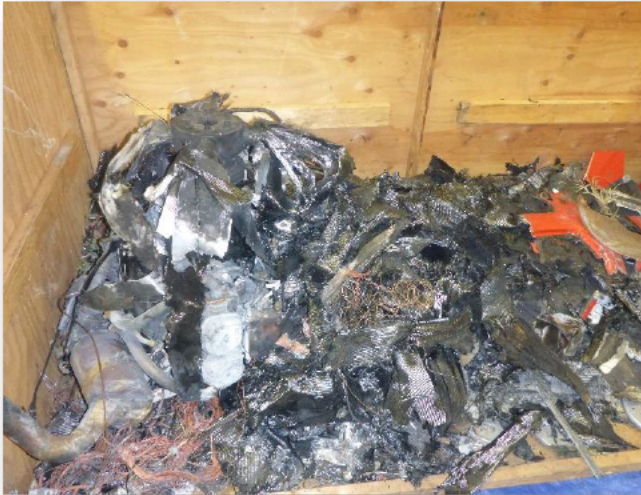
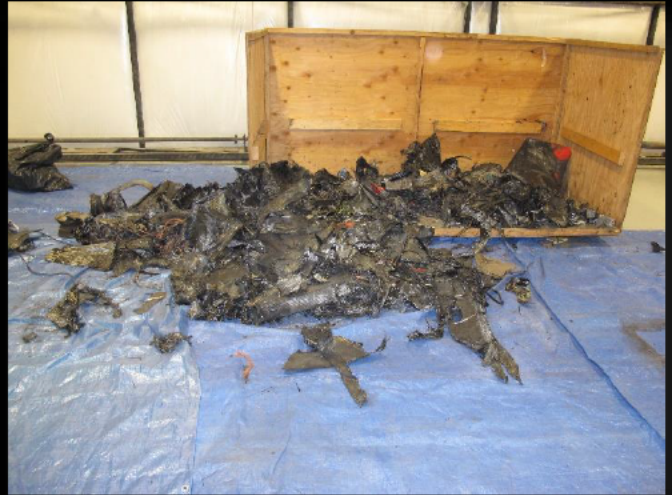
On February 7<sup>th</sup>, 2023, an engine examination took place at Whistler Aviation in Seward, NE. The aircraft wreckage was stored in a hangar and kept within a wooden box. The aircraft incurred significant damage due to the impact and subsequent fires that transpired before and after the impact.

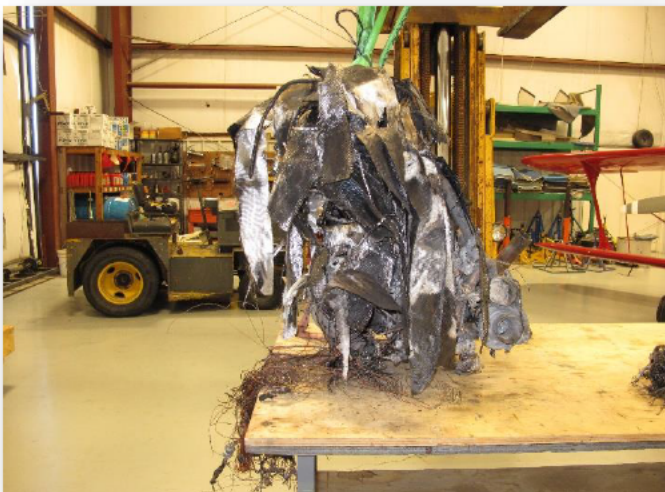
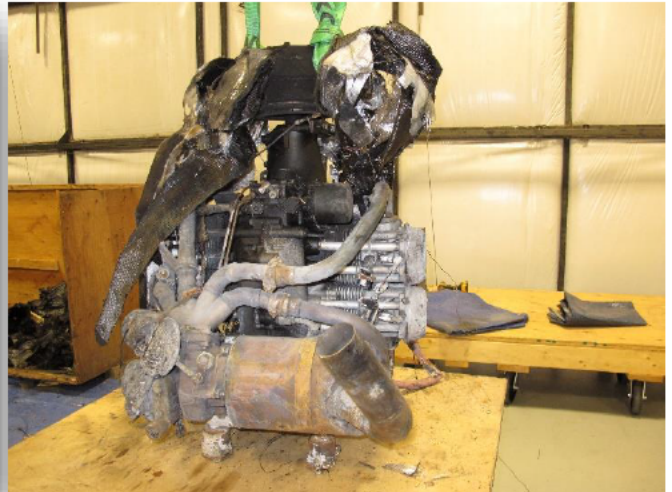
Upon inspection, it was evident that the engine had suffered significant thermal damage, resulting from the fire that occurred both before and after the impact. Notably, a considerable portion of the exposed surfaces exhibited a coating of engine oil.

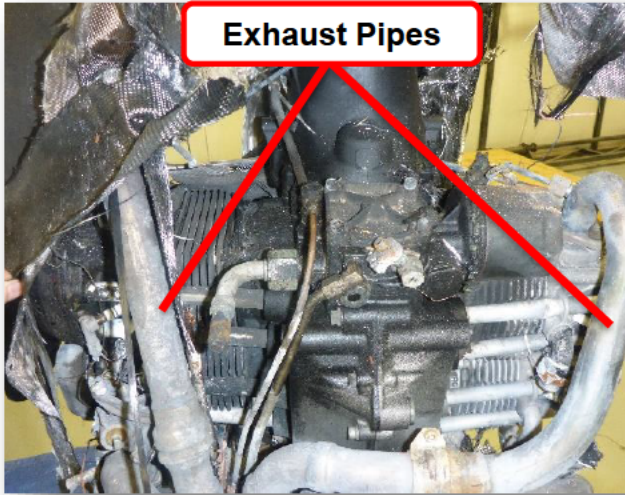
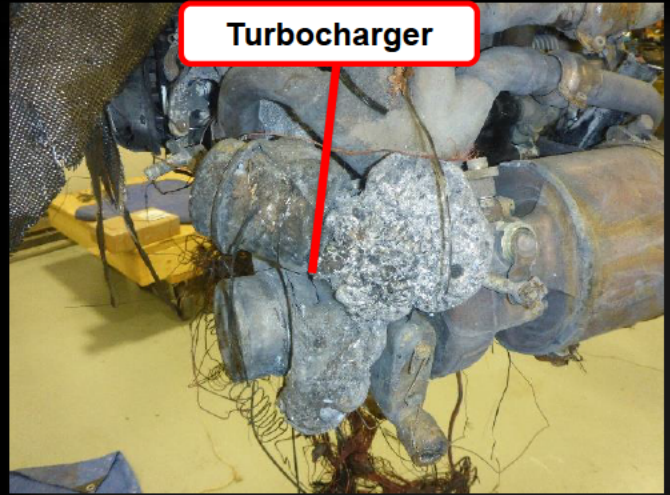
The only area that did not have oil coating was the region near the turbocharger and two of the exhaust pipes.

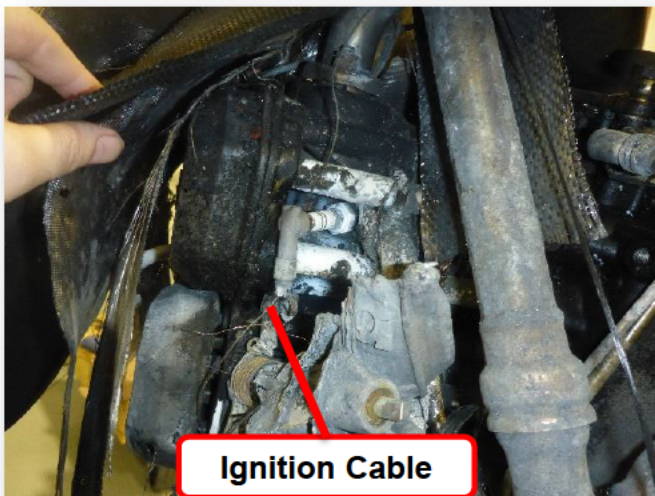
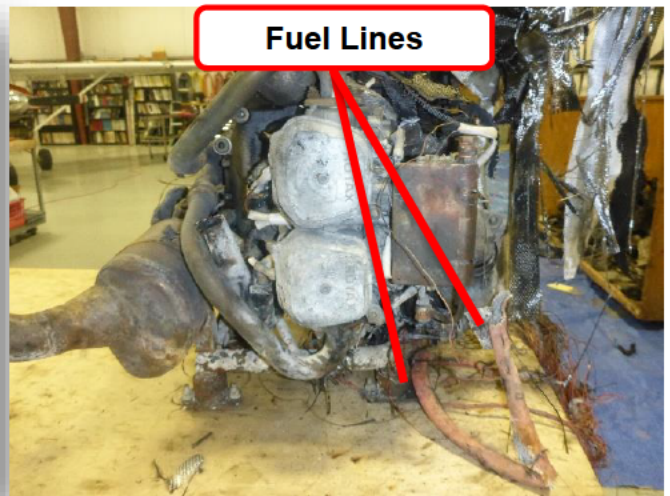
The turbocharger showed signs of thermal damage, indicating exposure to high temperatures during the fire. Additionally, the fire caused destruction to numerous oil, coolant, and fuel lines, as well as various engine system components. The electrical and ignition system of the engine was particularly affected and suffered significant damage, with most of it consumed by the fire.

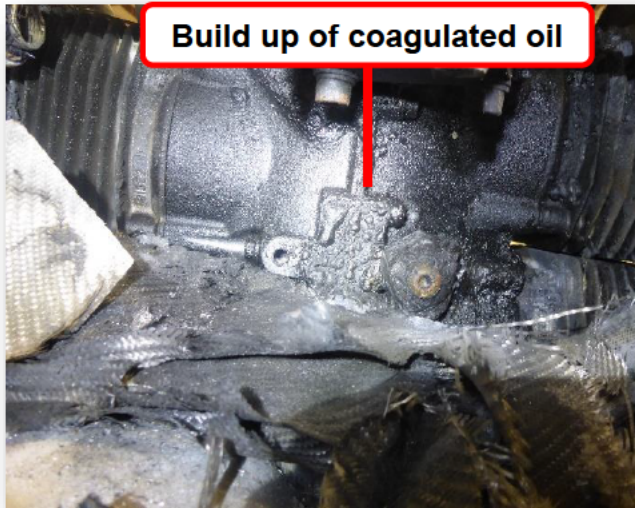
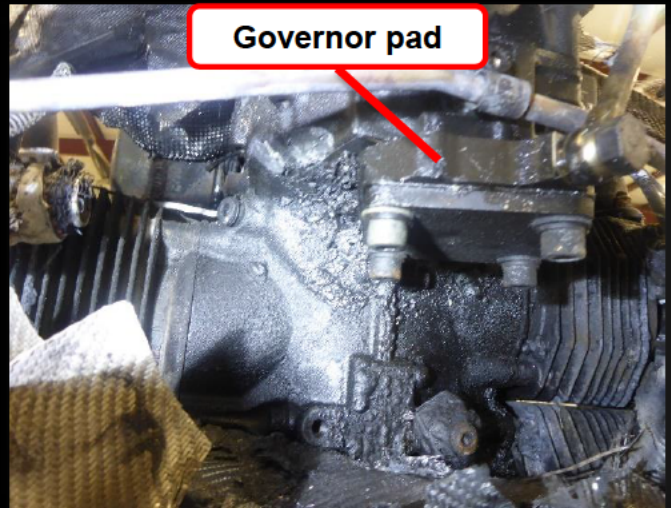
The governor pad exhibited a significant amount of coagulated oil directly underneath it. The feed line banjo bolt comes from the Rotax factory with torque seal paint on the bolt head. However, this marking was not observed on the banjo bolt of the engine involved in the accident. The absence of torque seal paint could also be attributed to the thermal damage inflicted upon the engine during the fire.

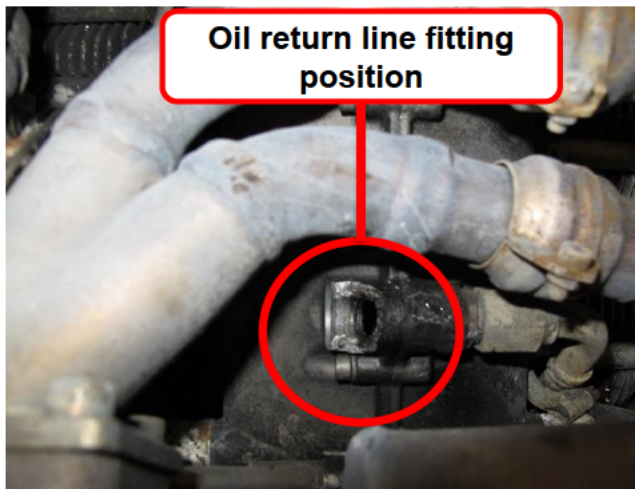
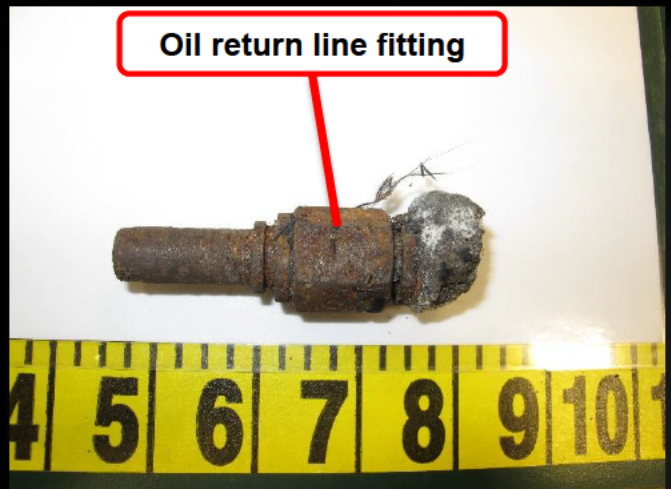
The oil return line fitting, positioned at the bottom of the crankcase and located above the turbocharger, was displaced and exhibited indications of thermal damage, including partial melting in the threads.

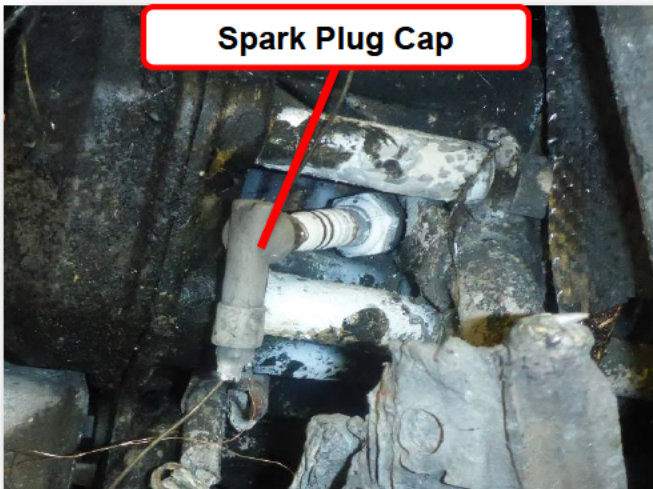
**Spark Plug Cap**

**Spark Plugs, Plug caps and Ignition cables:** During the investigation, all spark plugs, except for the #4 top spark plug, were successfully removed from the engine. These spark plugs were placed in a holding tray for further examination. It was determined that all the spark plugs installed on the engine were Rotax P/N 297656, and no abnormalities were detected during the inspection process. However, it was observed that the spark plug caps had suffered damage as a result of the fire. Additionally, the post-impact fire had caused the destruction of the spark plug cables.

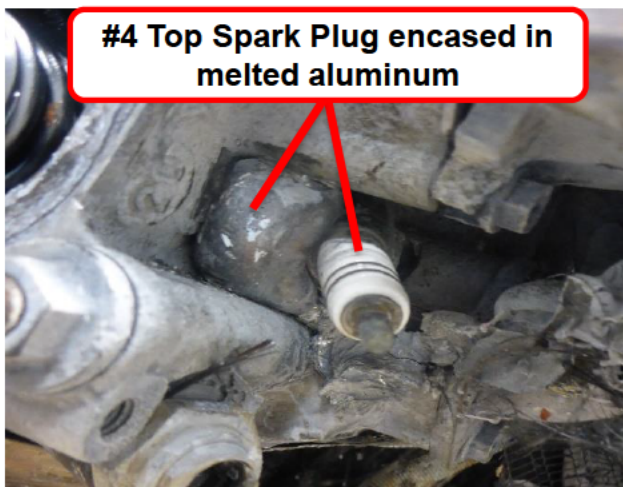
Due to melted aluminum encasing the #4 top spark plug, it was not possible to remove it during the initial investigation. Access to the top of the plug was hindered by the melted aluminum. Only after the #4 cylinder was removed, was it possible to examine the spark plug in situ.

**#4 Top Spark Plug encased in melted aluminum**

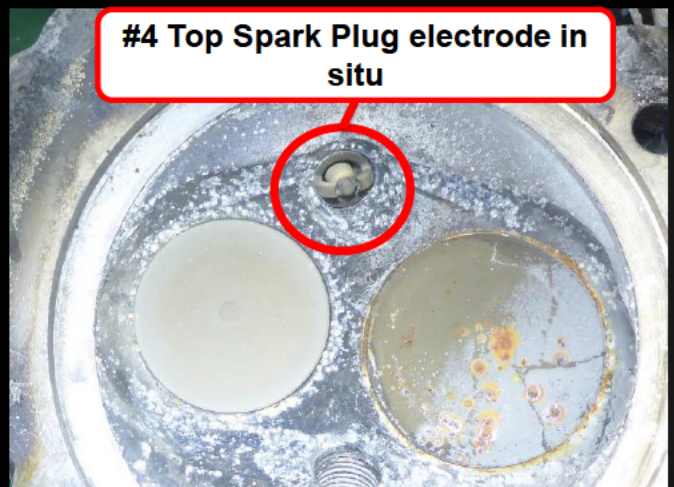
**#4 Top Spark Plug electrode in situ**

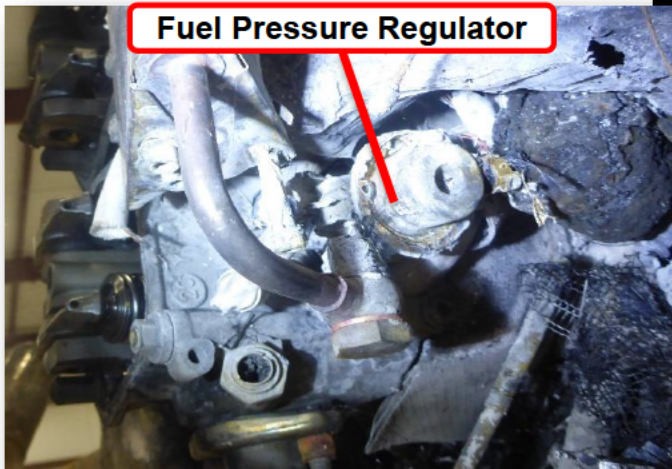
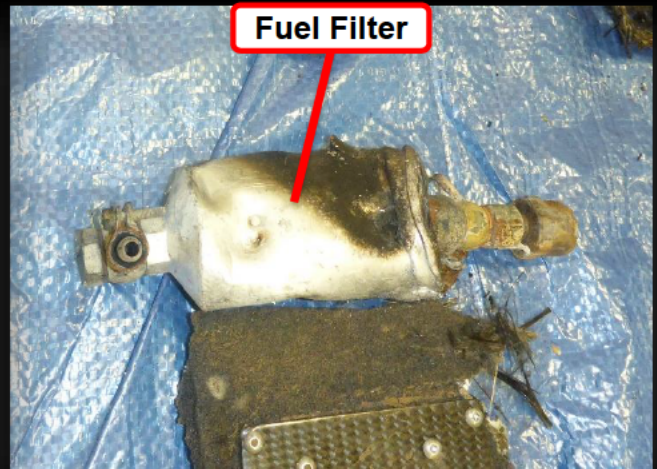
**Fuel System:** During the investigation, a comprehensive inspection of the fuel system was conducted. It was determined that the fire had caused extensive damage to the fuel lines, excluding the stainless fuel line assembly installed on the engine. Additionally, the fuel pressure regulator sustained significant fire-related damage. Furthermore, the fuel filter, although found separated from the wreckage, showed visible signs of fire-induced damage.

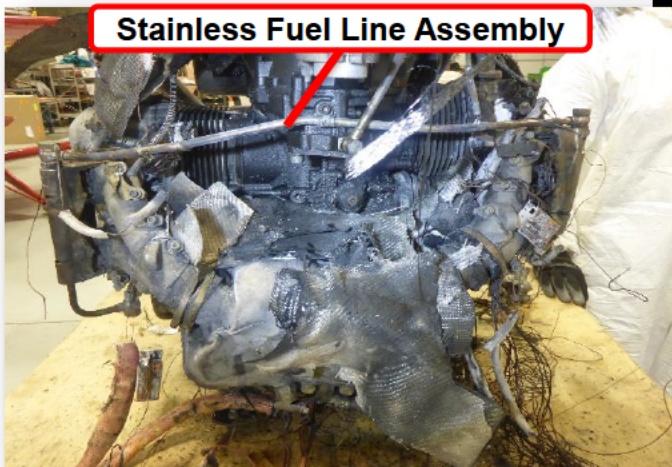
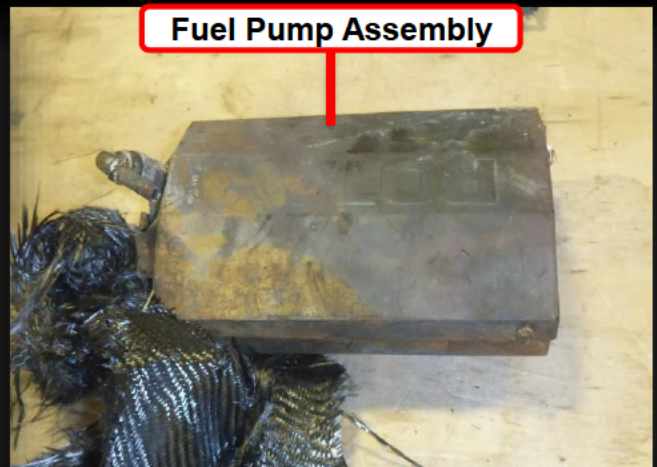
The fuel pump was located and still contained was noticeably damaged by the fire. Unfortunately, due to its condition, it was not possible to conduct a functional test on the fuel pump. Furthermore, it was not possible to obtain a fuel sample.

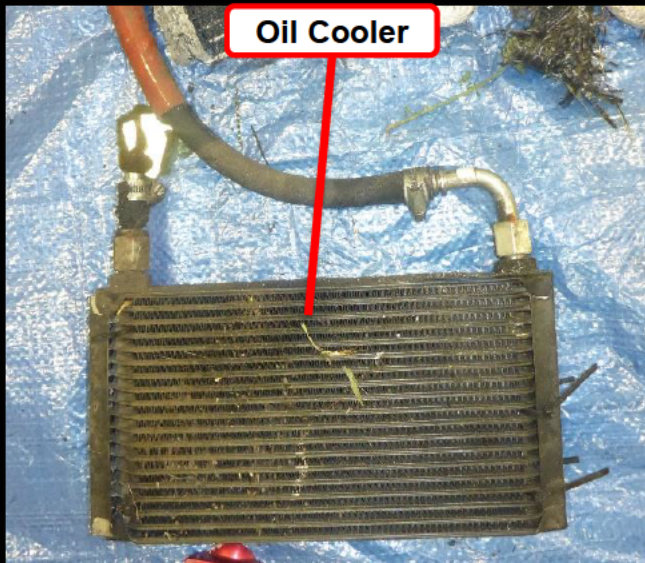
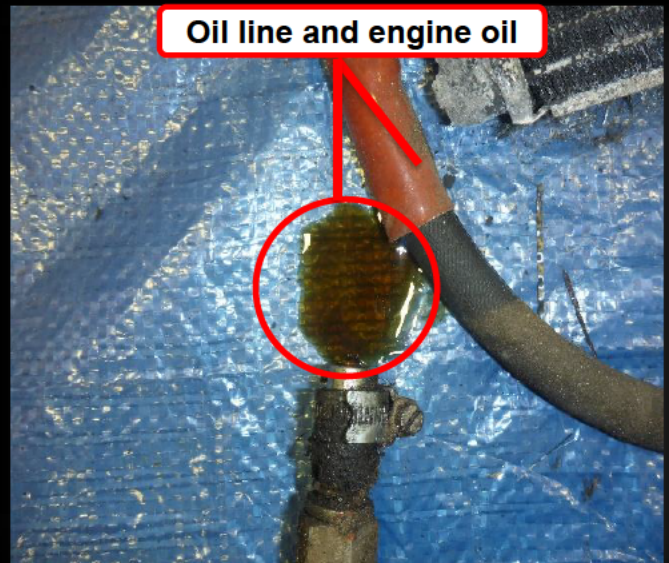
**Lubrication System:** During the investigation, an examination of the lubrication system was conducted. The oil lines showed partial damage by fire. However, the oil cooler remained mostly undamaged, and one oil line was still attached to it. The oil cooler still contained oil, which was carefully drained into a container and sent to the NTSB lab for further analysis.

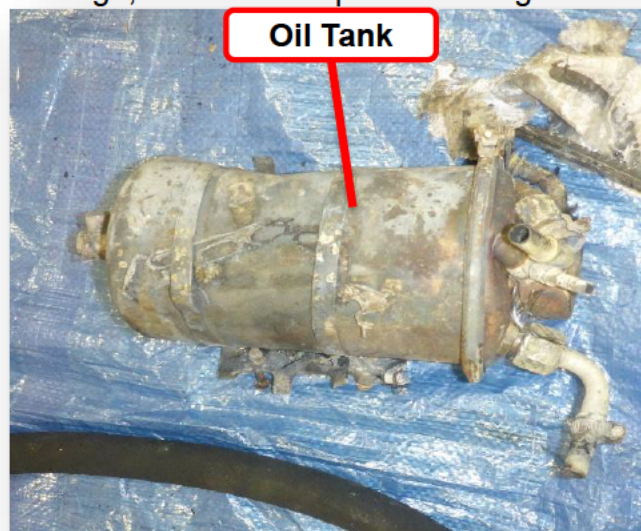
Unfortunately, the oil lines were consumed by the fire after the impact. The oil tank itself sustained some impact damage, and the oil cap was no longer attached.

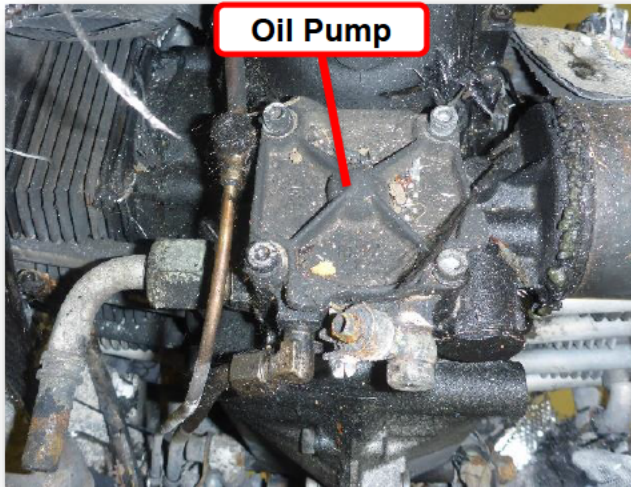
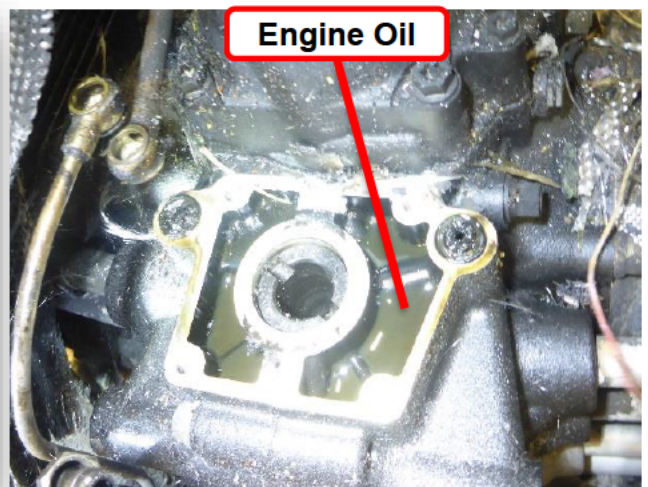
**Lubrication System (Continued)** The oil pump was removed from the engine for internal examination. During the inspection, it was discovered that the mounting bolts of the oil pump were found to be loose. However, the loosening of the bolts could have been a consequence of the extreme heat the oil pump endured during the fire.

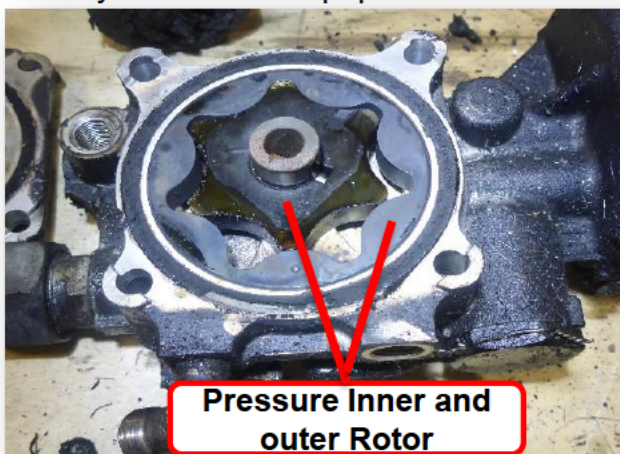
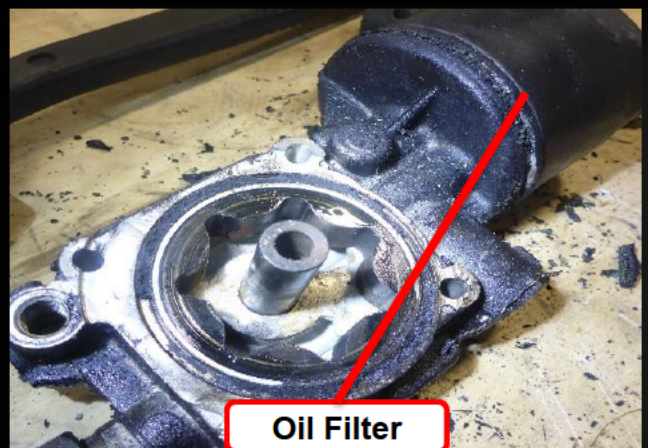
Although the oil line fittings remained attached to the oil pump, the rubber oil lines were completely consumed by the fire, leaving no trace for examination. Furthermore, the oil filter suffered damage as a direct result of the fire. The intense heat generated by the fire destroyed the internal paper elements of the

Despite the loosened bolts, no abnormalities were discovered during the examination of the oil pump itself. Engine oil was observed contained within the cavity located behind the oil pump.

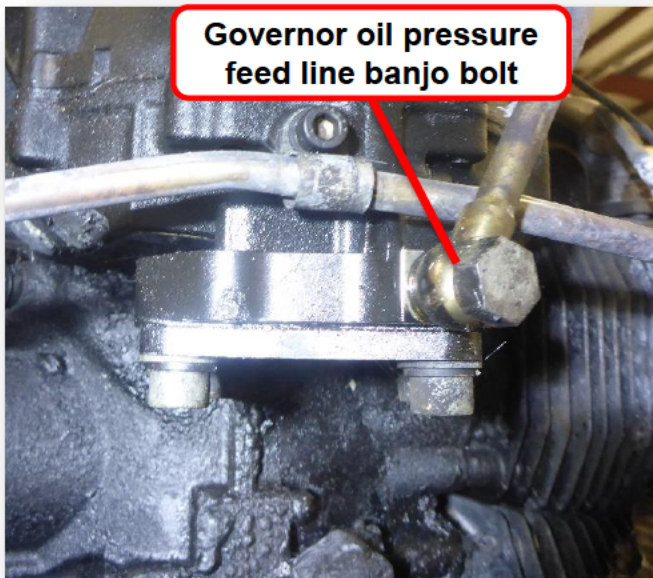
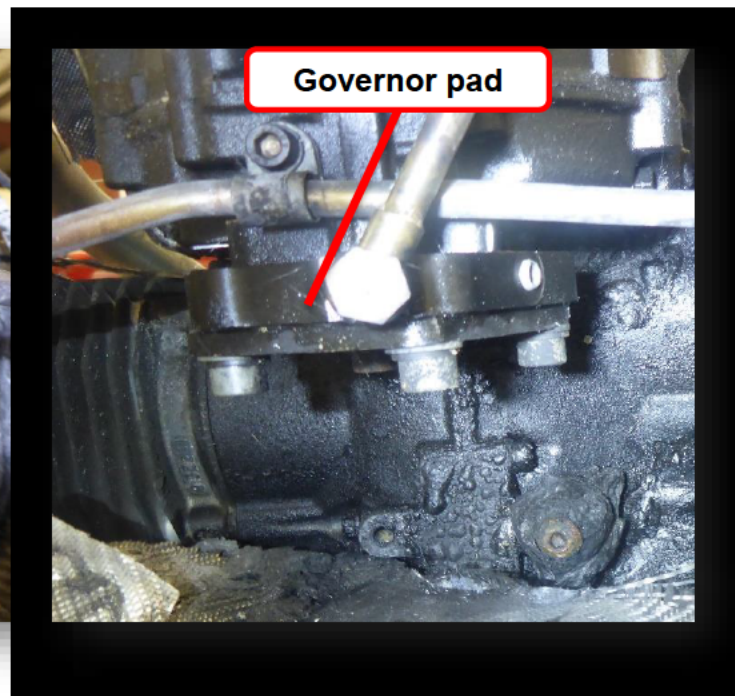
During the investigation, the governor pad on the engine showed a notable coating of oil, and there was a concentrated area of coagulated burnt oil directly beneath it. Further examination revealed that the governor oil pressure feed line banjo bolt was only finger tight and there was no indications of torque paint or markings were found on the fitting. The absence of torque seal paint and the loose bolt could potentially be attributed to the thermal damage sustained by the engine during the fire.

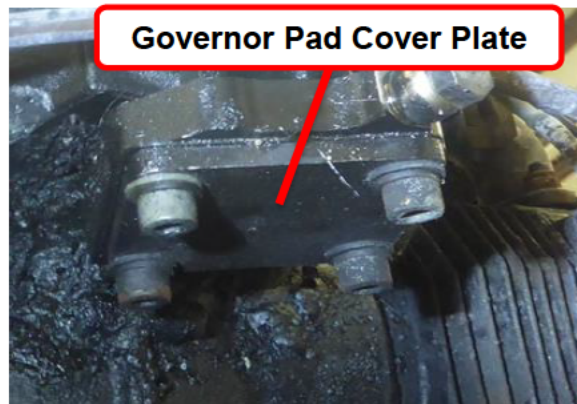
**Propeller Governor System (Continued):** During the examination, it was observed that a governor had not been installed on the governor pad, and the governor pad plate cover, intended for shipping purposes, was still in place. The cover plate bolts were found to be only finger tight, which may be attributed to the thermal damage incurred by the engine during the fire. It is important to note that Rotax does not provide a specific torque specification for the cover plate bolts, and a general torque specification is applied based on the size of the bolts.

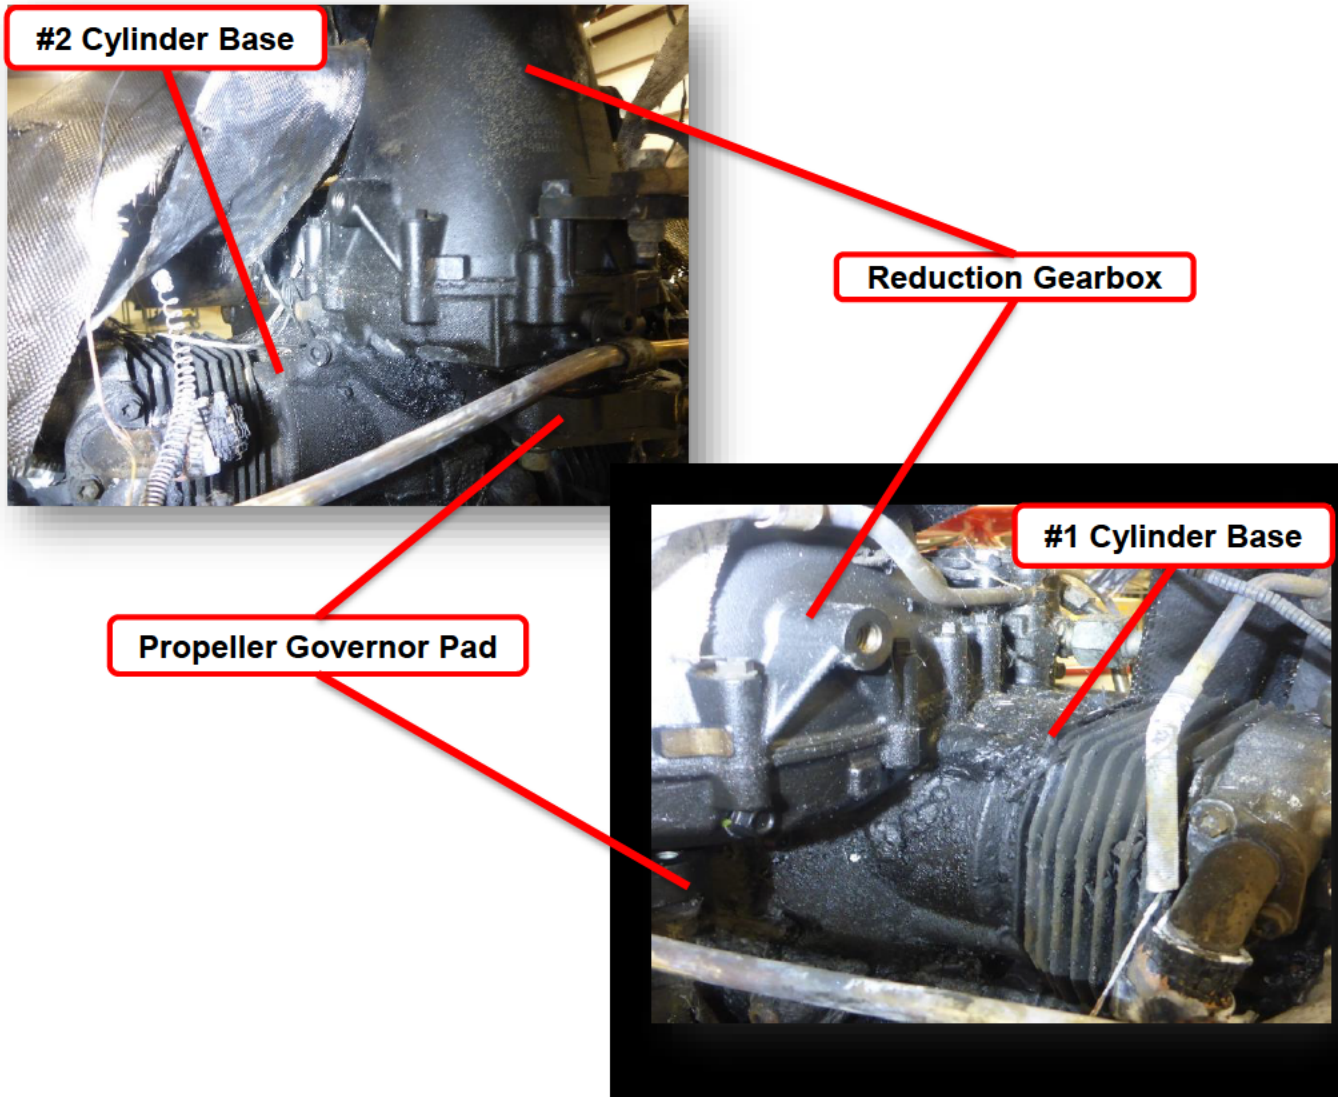
**Propeller Governor System (Continued):** Upon inspection, it became evident that the propeller governor pad assembly was the primary source of the oil leak. This conclusion was supported by the significant accumulation of congealed burnt oil found beneath the governor pad. However, due to the loose bolts on both the cover plate and the oil pressure feed line, it is challenging to determine the precise location of the oil leak with absolute certainty. It is worth noting that the loose bolts could potentially be a result of the thermal damage sustained by the engine during the fire.

The leaked oil was observed to have dripped down the engine crankcase, particularly near the #1 and #2 cylinder base. It is believed that this leaked oil made contact with the hot exhaust components, which subsequently ignited and resulted in the in-flight fire.

In conclusion, the investigation uncovered a significant finding of an oil leak originating from the governor pad assembly, which was determined to be the cause of the in-flight fire. However, the specific reason for the oil leak, whether it was due to the presence of the cover plate, loose cover plate bolts, or problems with the governor oil pressure feed line, could not be conclusively determined.

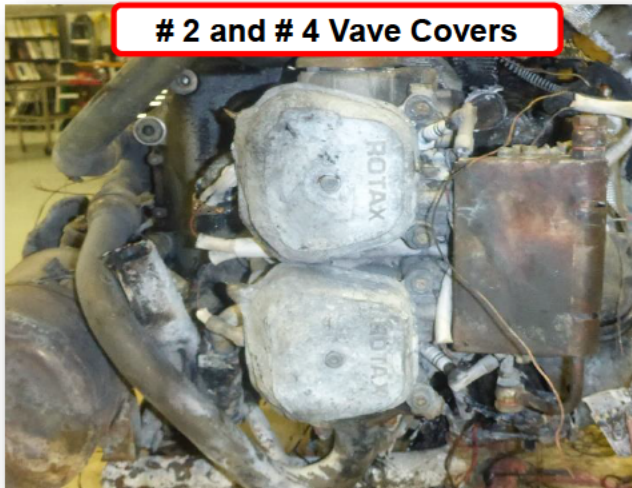
**# 2 and # 4 Vave Covers**

**Cylinder and cylinder head:** The cylinder head valve covers were removed to allow inspection of various cylinder head components. It was observed that the valve covers had been damaged by both the pre-impact and post-impact fires. Specifically, the valve covers for cylinders #2 and #4 showed signs of melting along the bottom edge, accompanied by evidence of dripping and material flow. The direction of the flow indicated that the material was in an upright position during the flight when it began to flow, as depicted in the diagram provided.

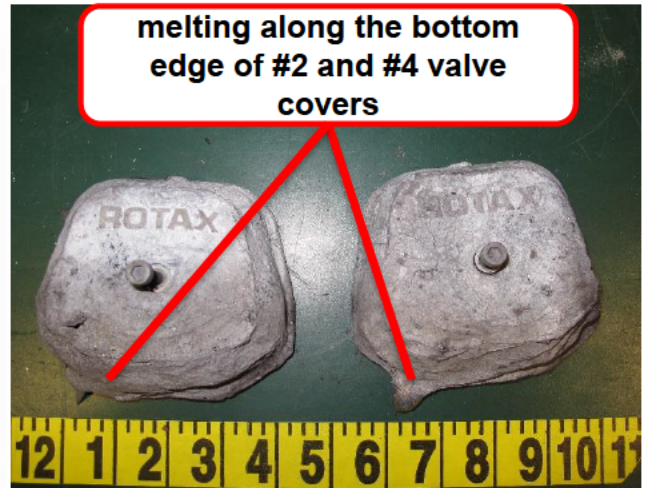
**melting along the bottom edge of #2 and #4 valve covers**

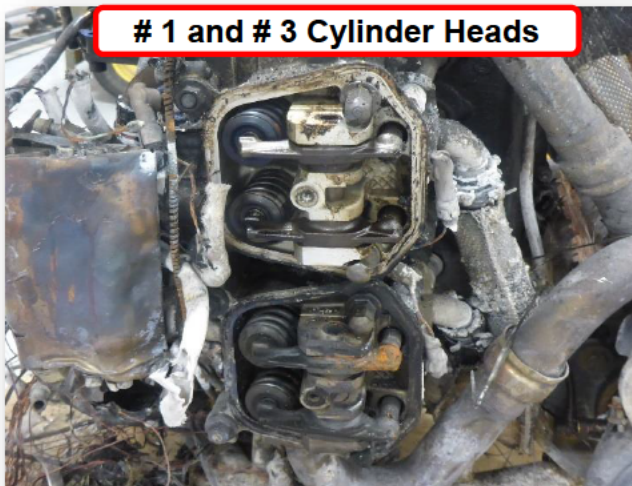
**# 1 and # 3 Cylinder Heads**

After the valve covers were removed, a thorough examination of the cylinder head components was conducted. No abnormalities or issues were found during the inspection of the rocker arms, rocker shafts, pushrods, valve springs, and valves. All these components were found to be in good condition, without any visible signs of damage or anomalies that could have contributed to the incident.

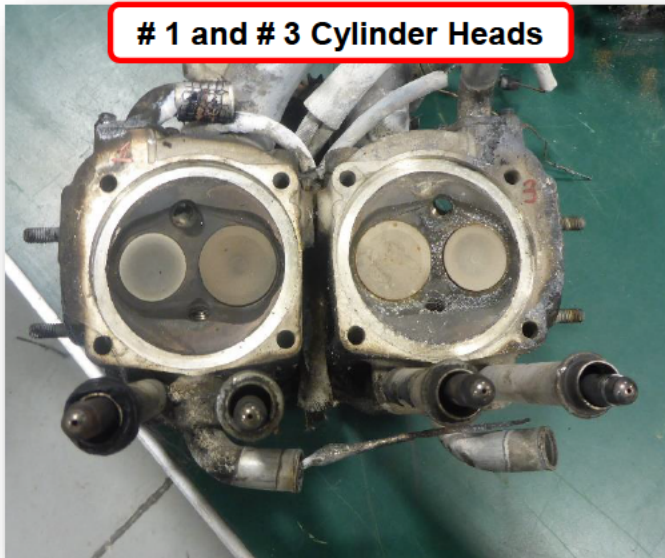
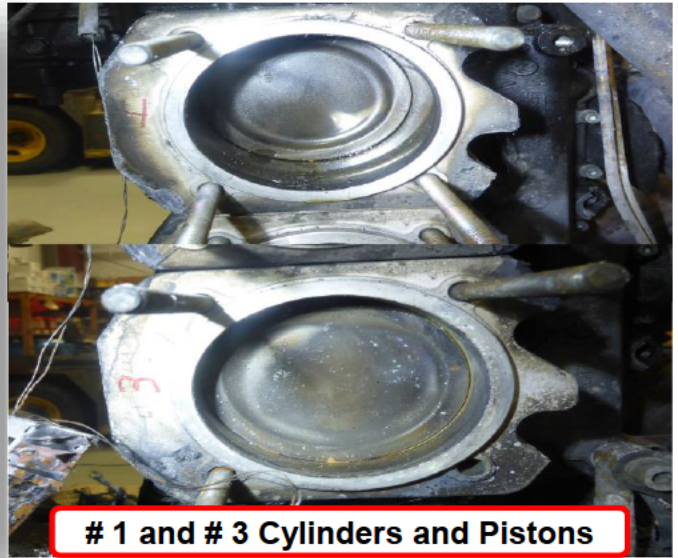
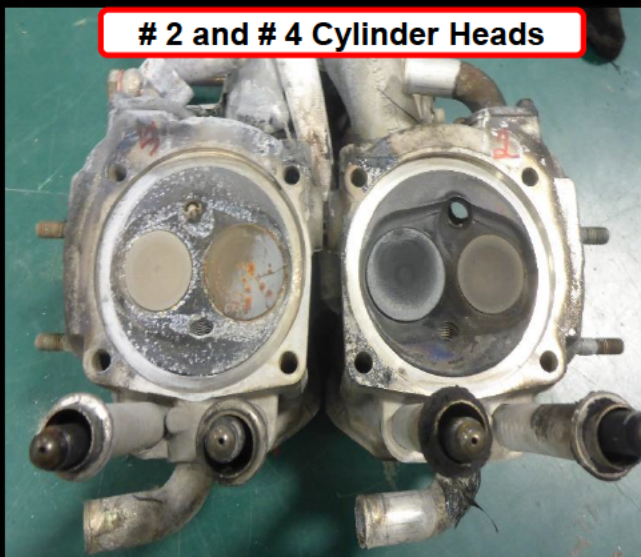
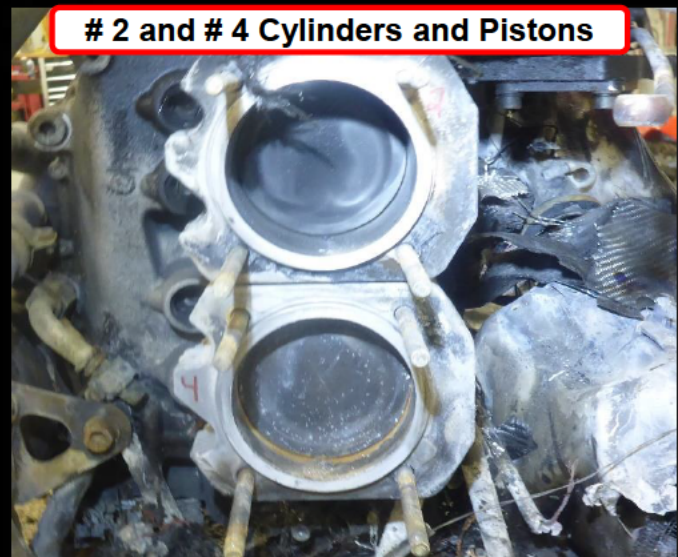
**Pistons and cylinder heads**: The cylinder heads were removed to provide a comprehensive inspection of the combustion chambers, intake valves, and exhaust valves. No anomalies or irregularities were discovered during the inspection that would impede the engine's normal operation. The examined parts were found to be in satisfactory condition.

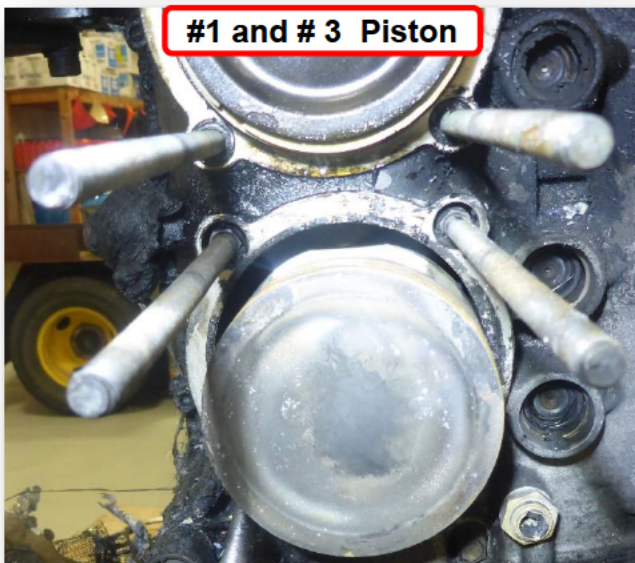
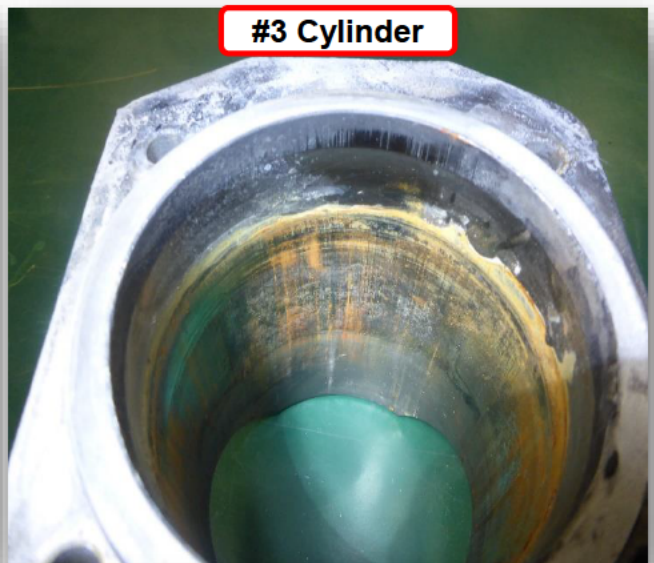
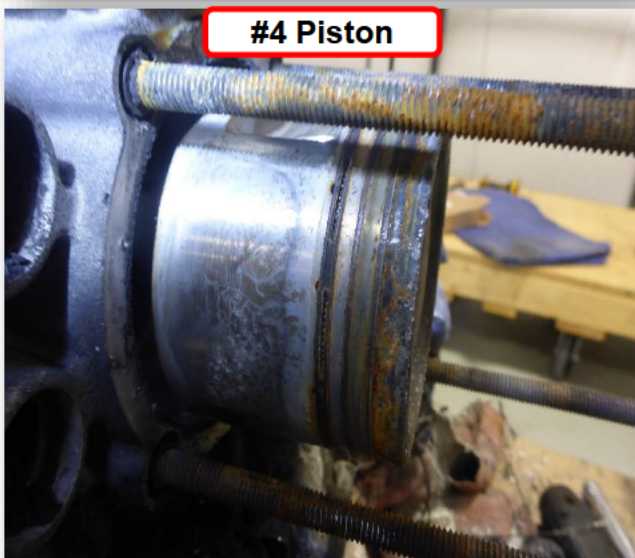
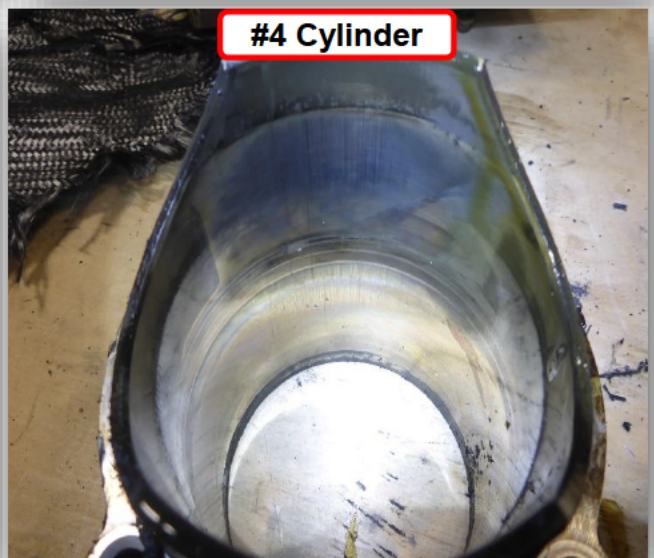
**Cylinders:** The cylinders were removed to allow for a thorough inspection of the piston rings and cylinder walls. No anomalies or irregularities were detected during the examination that would impede the normal operation of the engine. However, it is noteworthy that the #3 cylinder exhibited some rust on the side of the cylinder wall. This rust may be attributed to the fire extinguishing agent used to suppress the fire, exposure to the elements, or a combination of both factors. It is important to emphasize that this rust is a common occurrence when an engine has been exposed to extreme temperatures during an engine fire and does not indicate any underlying mechanical issues.

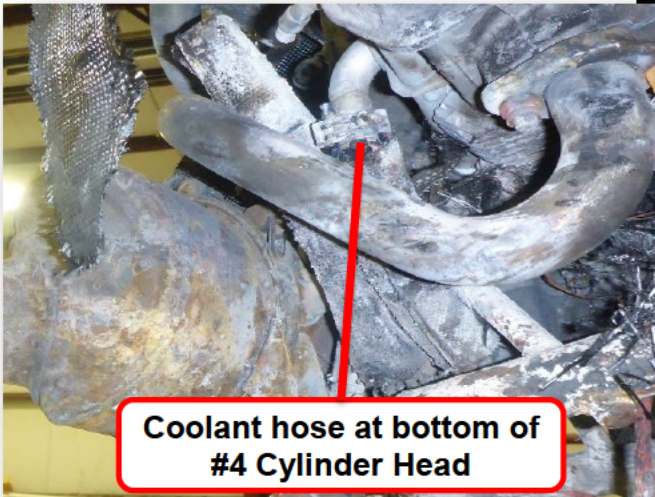
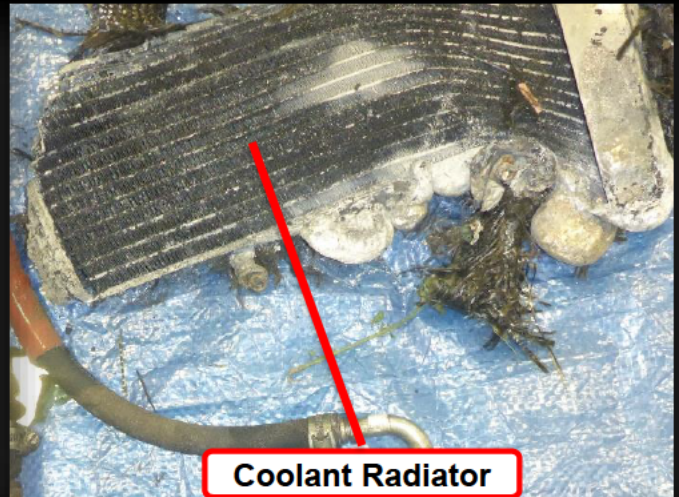
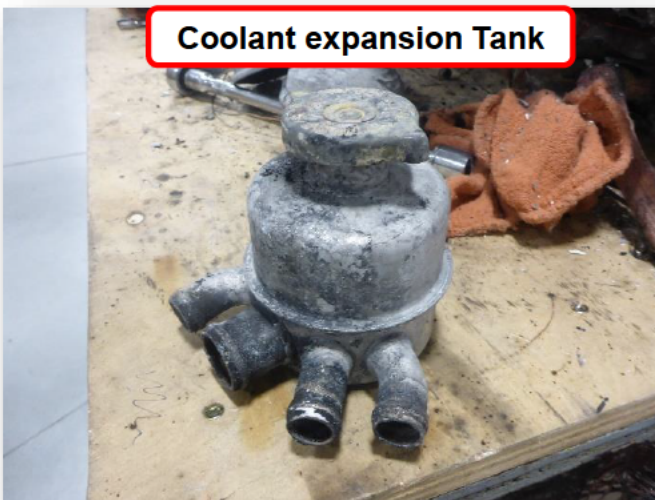
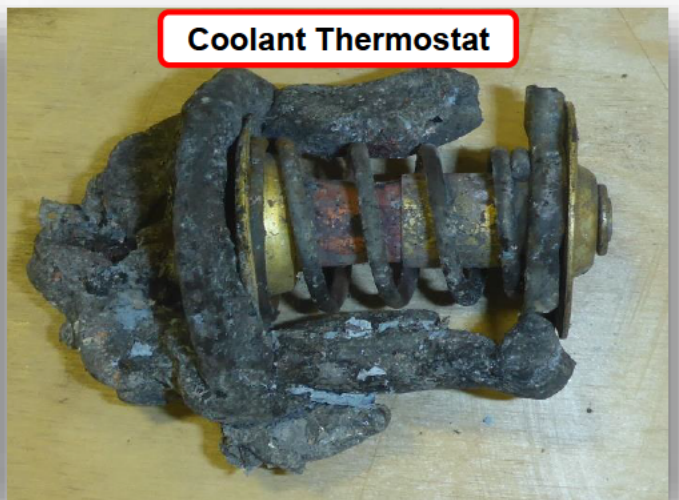
**Coolant system:** During the examination, it was determined that the fire had consumed the majority of the coolant system. However, some remnants of the coolant hoses, coolant radiator, coolant expansion tank, and thermostat were still present. Other than the significant damage caused by the fire, no anomalies were found with these remaining components.

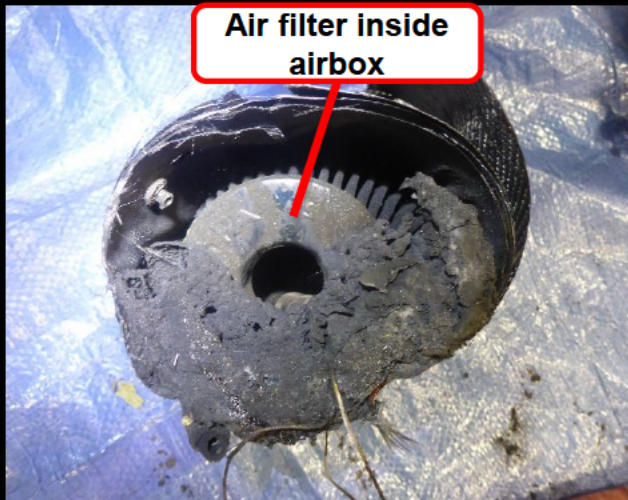
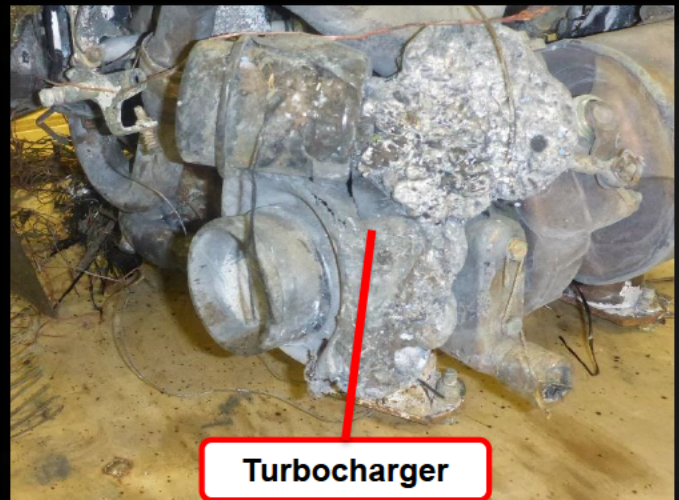
**Air Filtration:** During the examination, it was observed that the air filter was still contained within its airbox, but it was no longer attached to the inlet of the turbocharger. The air filter had sustained significant damage as a result of the fire. However, aside from the fire damage to the air filter, no other anomalies were observed.

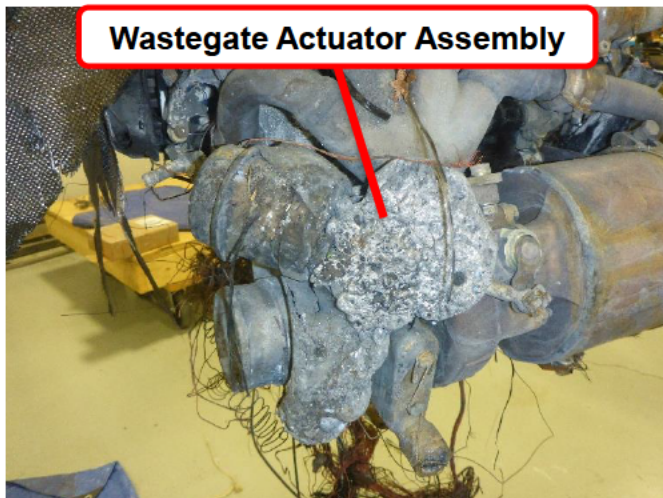
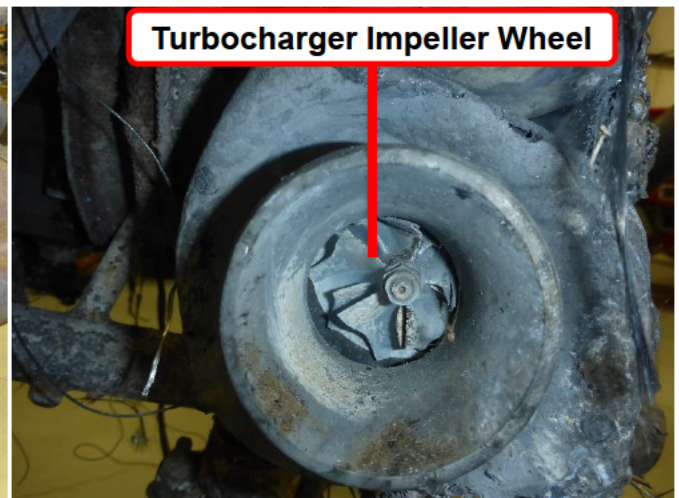
**Exhaust system and Turbocharger:** During the inspection of the exhaust system, it was found to be in good overall condition. However, certain components of the turbocharger, such as the cold section impeller wheel and the wastegate actuator assembly, had suffered substantial damage as a result of the fire. The material composition of these components, likely contributed to their vulnerability to fire damage.

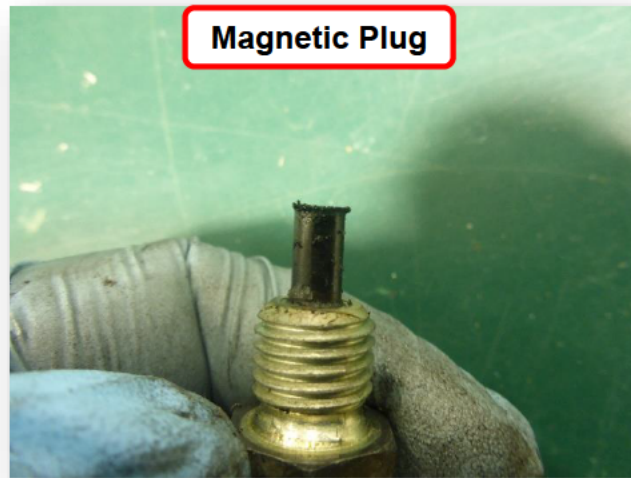
**Magnetic Plug:** The magnetic plug was removed and inspected. No unusual accumulation of metallic material was found attached to the magnet. This indicates that the engine and gearbox were not producing excessive internal metal debris, suggesting normal operation and minimal wear within the system.

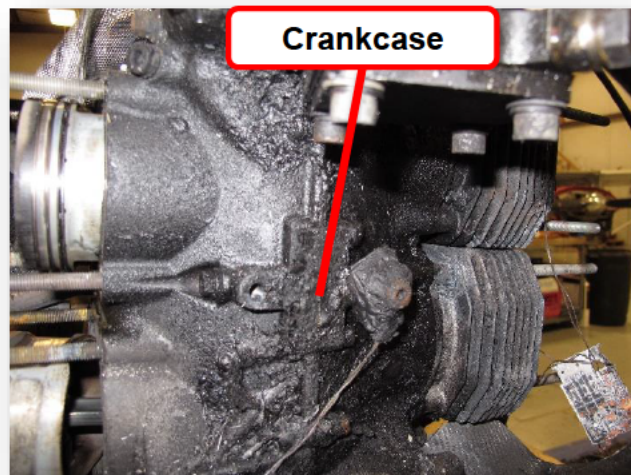
**Crankcase, Crankshaft and Camshaft:** The external inspection of the crankcase revealed that it was in good overall condition. However, due to the thermal damage caused by the fire, it was not possible to manually rotate the crankshaft and camshaft during the examination. Considering the thorough examination of other engine components and the suspected cause of the accident being an in-flight fire caused by an oil leak, it was determined that a physical examination of the crankshaft and camshaft was unnecessary for the purpose of this investigation.
