CEN22FA433

## INVESTIGATION PHOTOGRAPHS

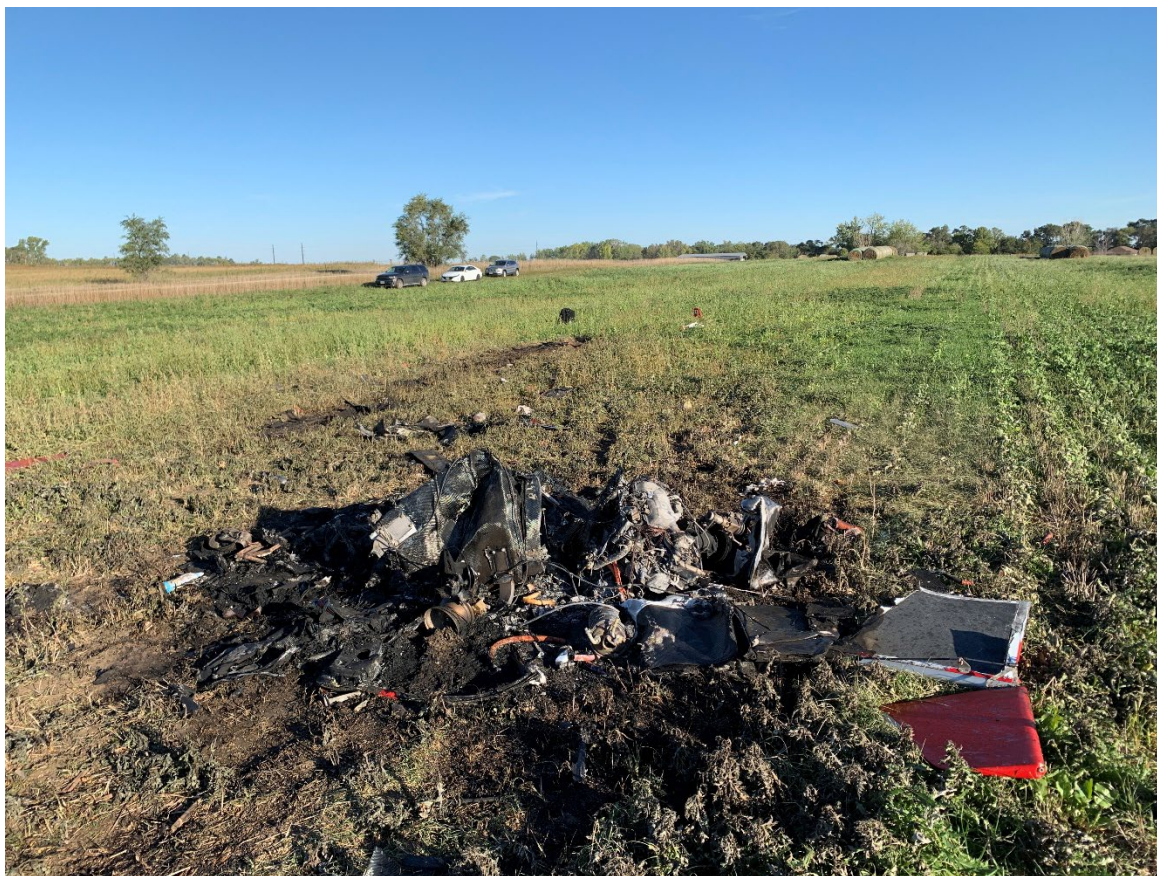
**Photograph 1 - View of the wreckage at the accident site.**

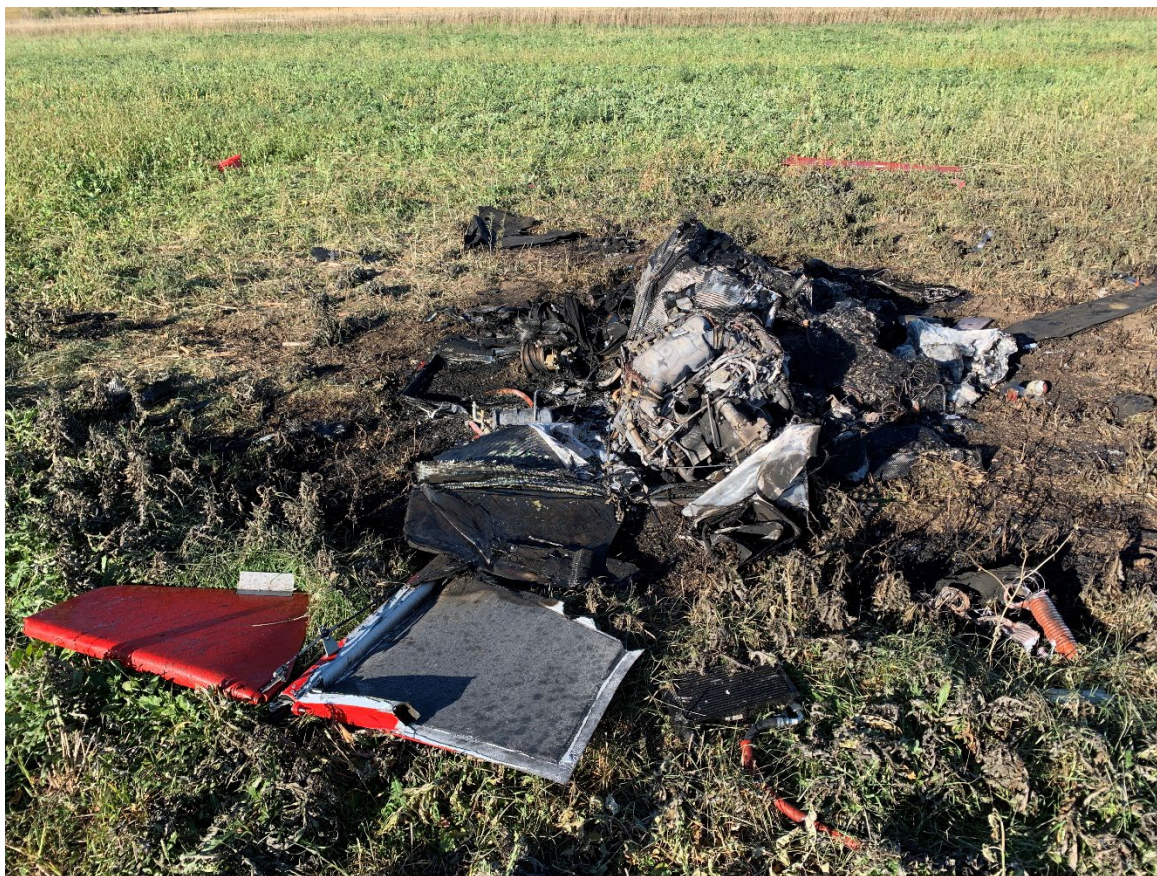
**Photograph 2 - View of the wreckage at the accident site.**

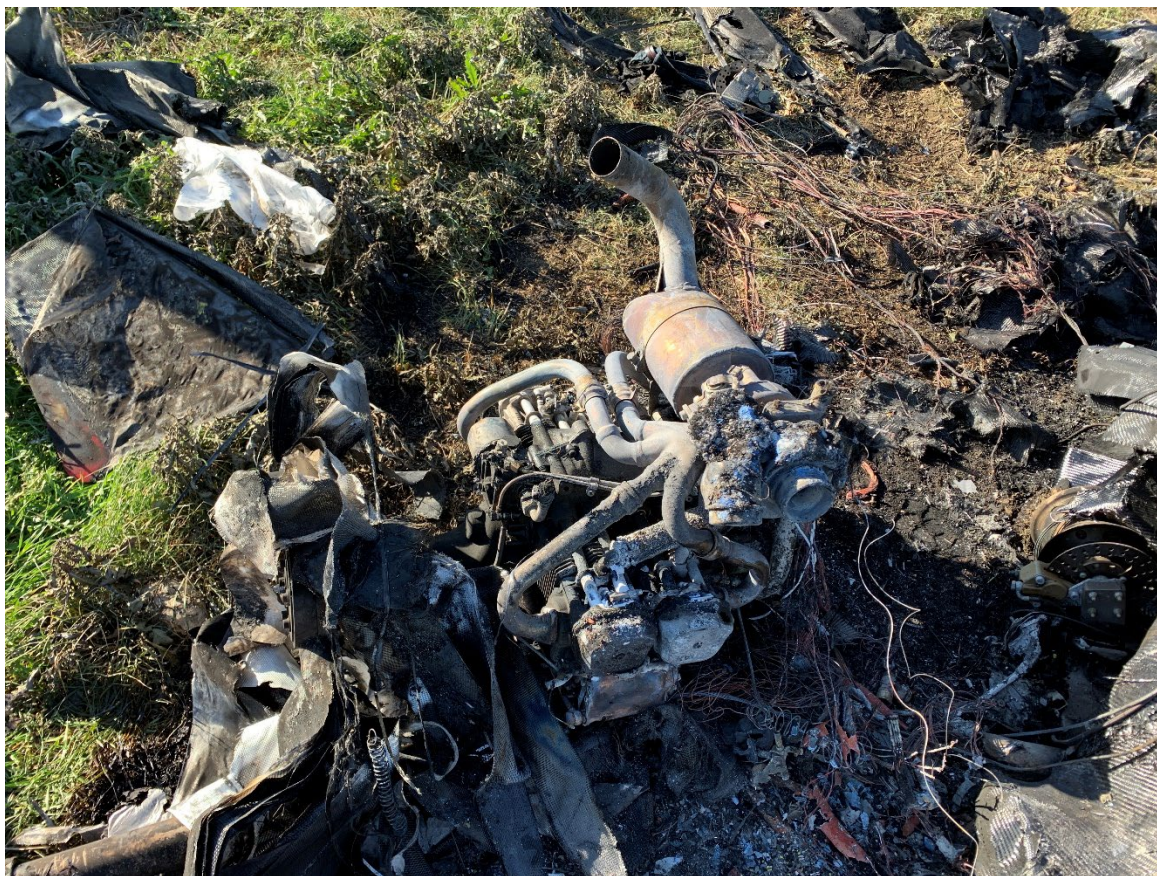
**Photograph 3 - View of the engine at the accident site.**

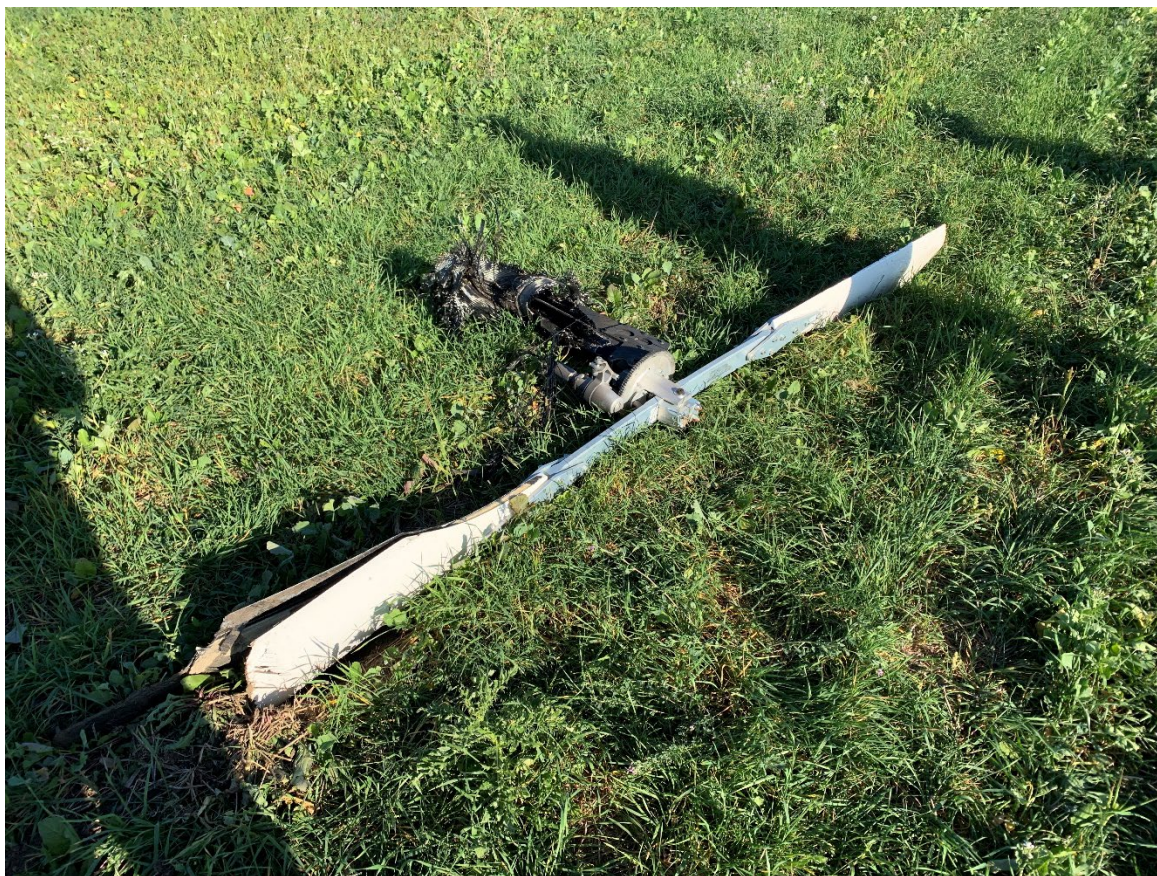
**Photograph 4 - View of the main rotor mast at the accident site.**

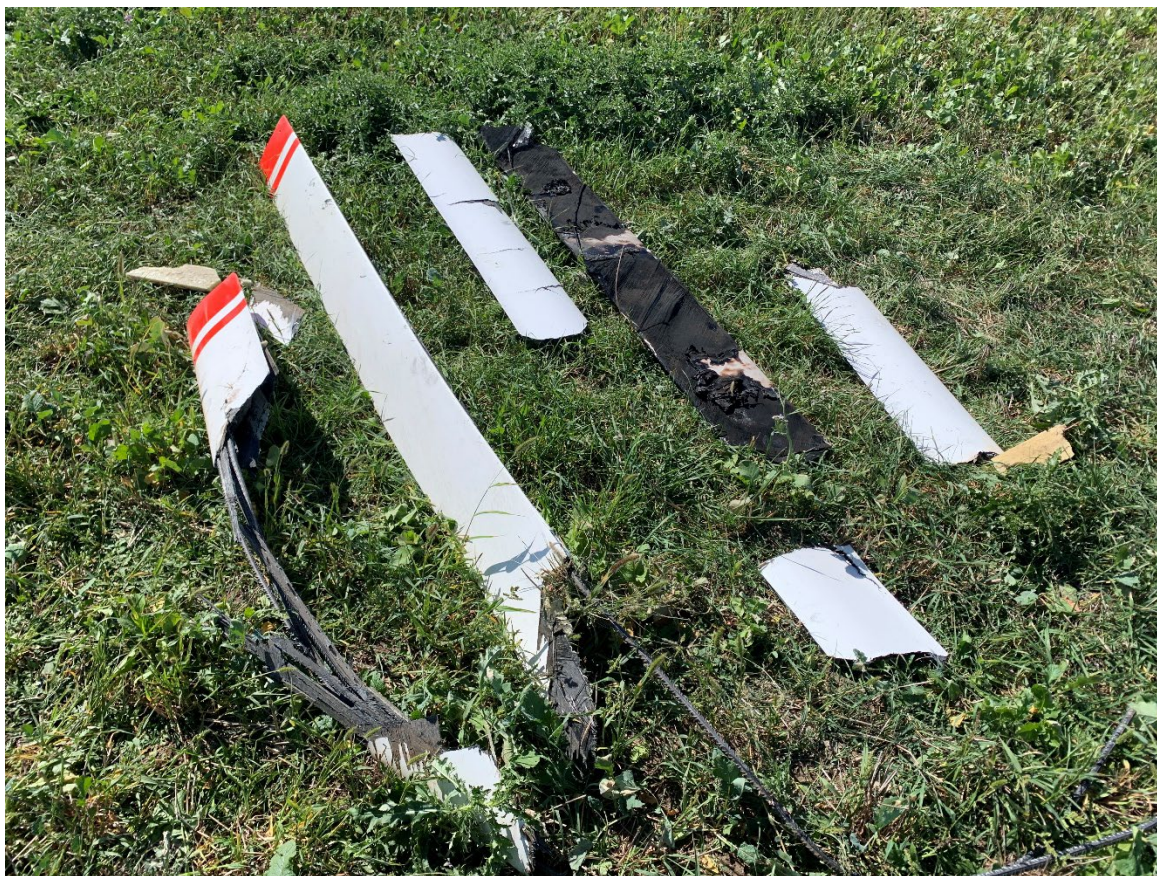
**Photograph 5 - View of the main rotor blades at the accident site.**

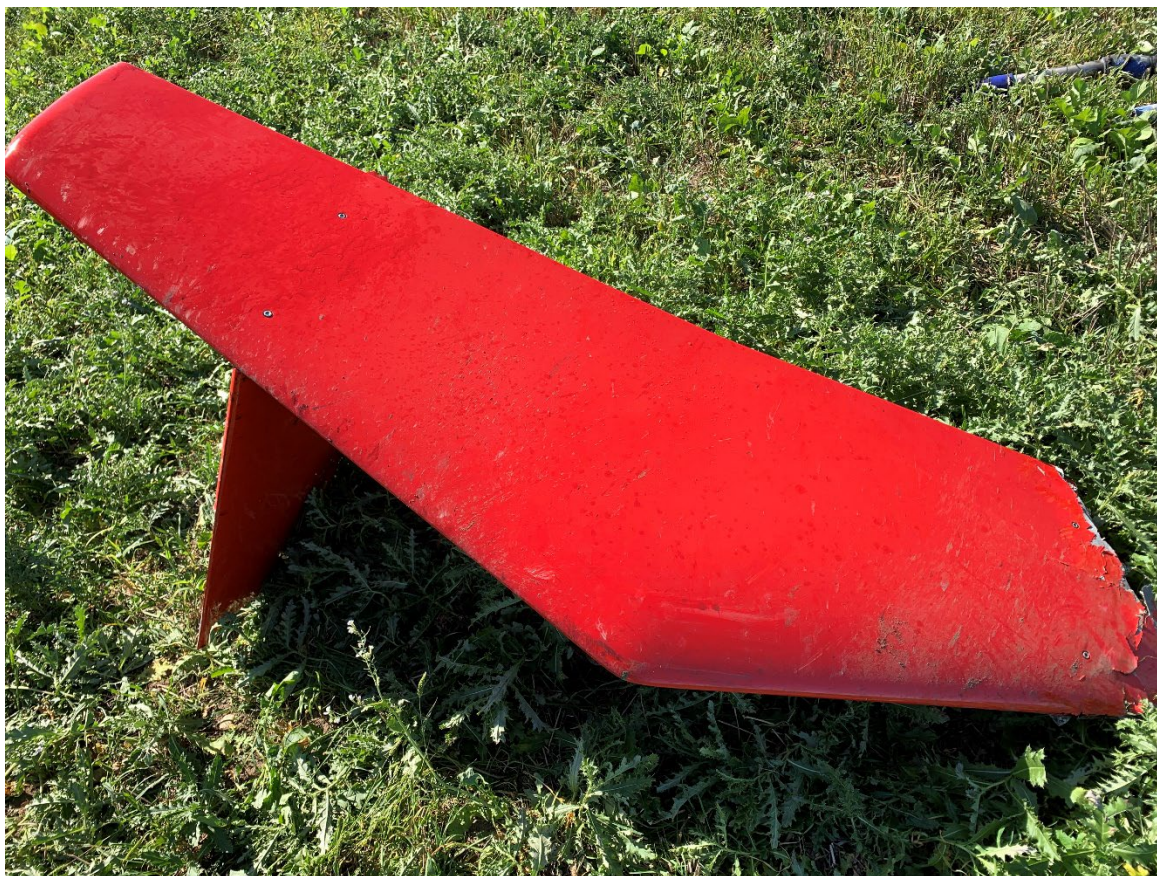
**Photograph 6 - View of the empennage with fluid spray at the accident site.**

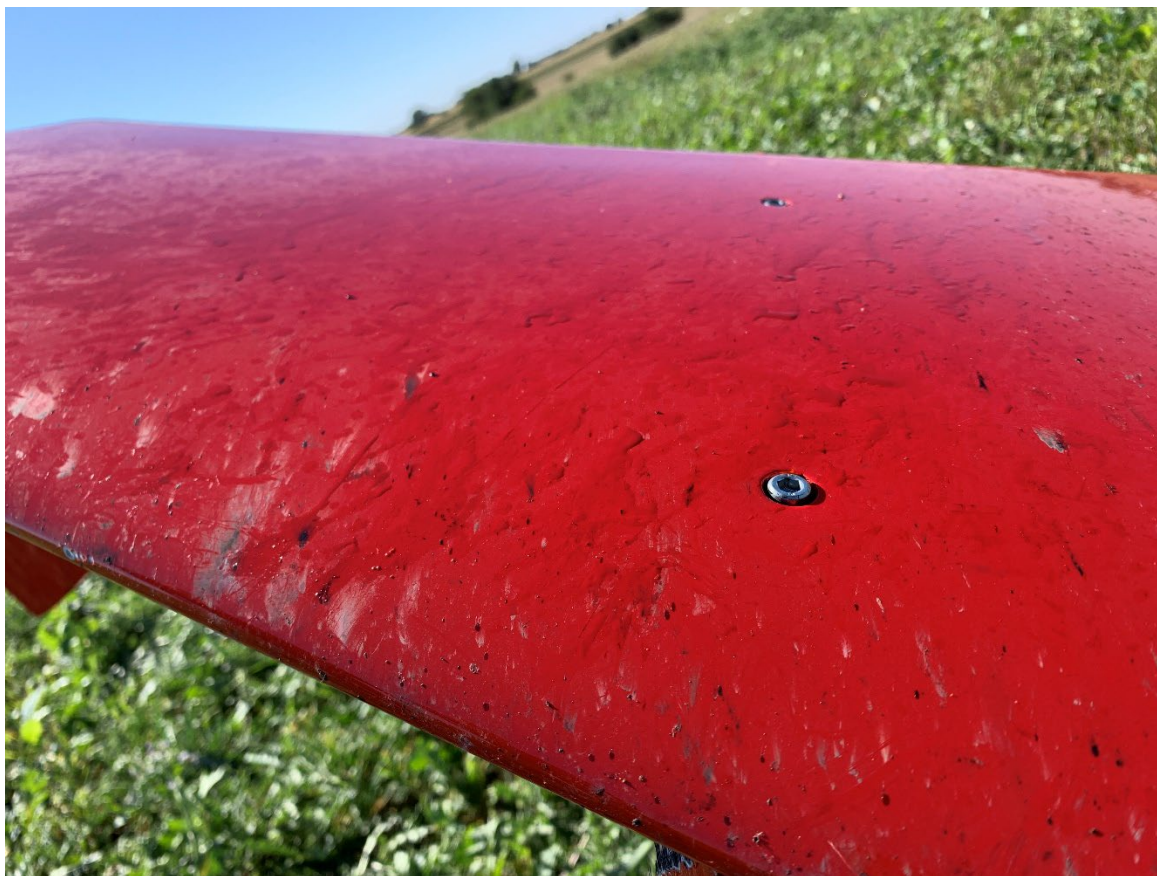
**Photograph 7 - View of the empennage with fluid spray at the accident site.**

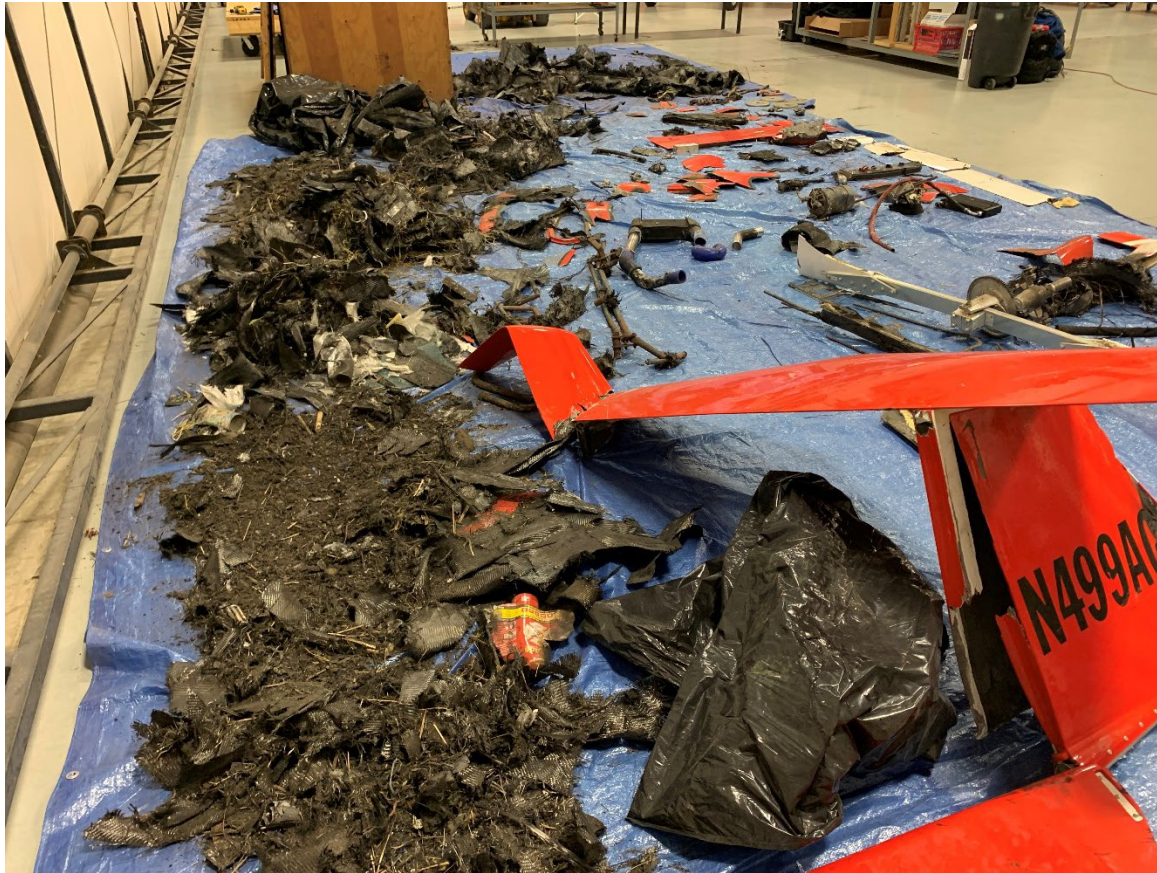
**Photograph 8 - View of the wreckage laid out at the salvage facility.**

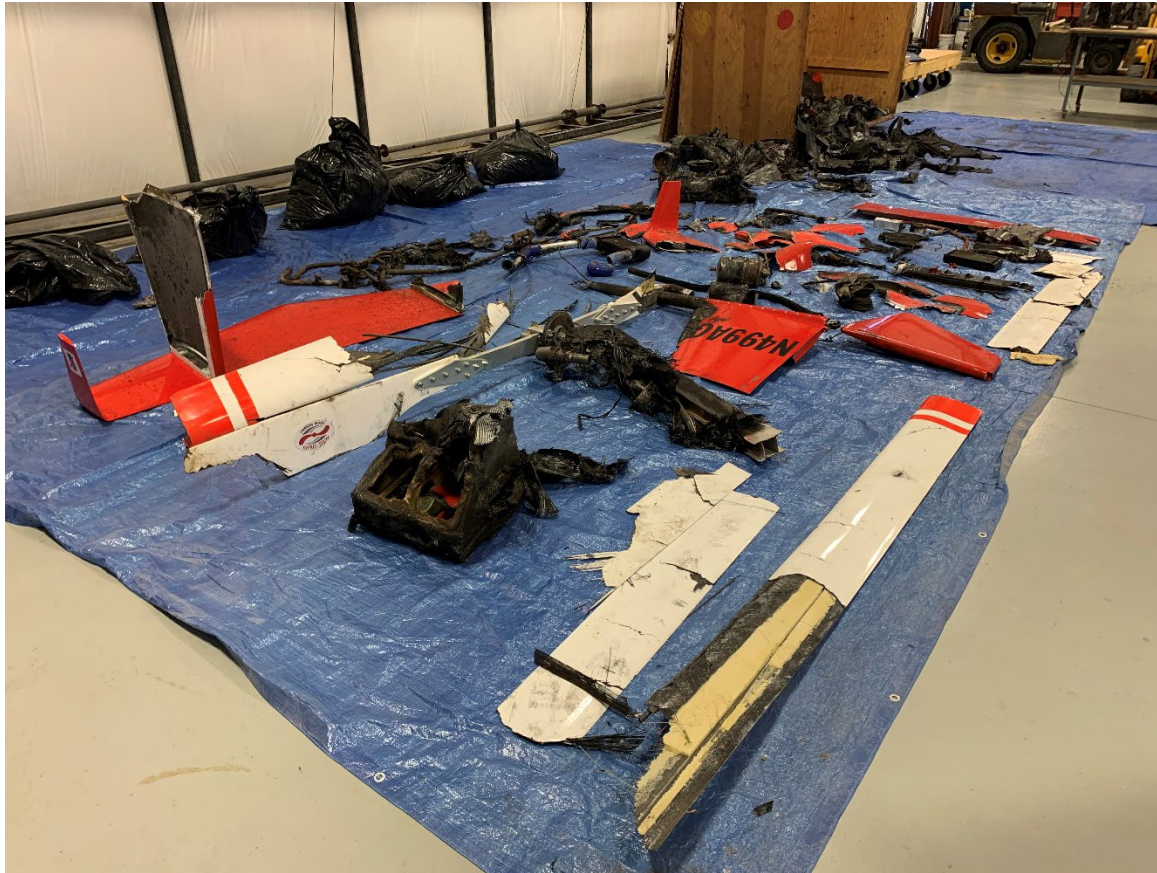
**Photograph 9 - View of the wreckage laid out at the salvage facility.**

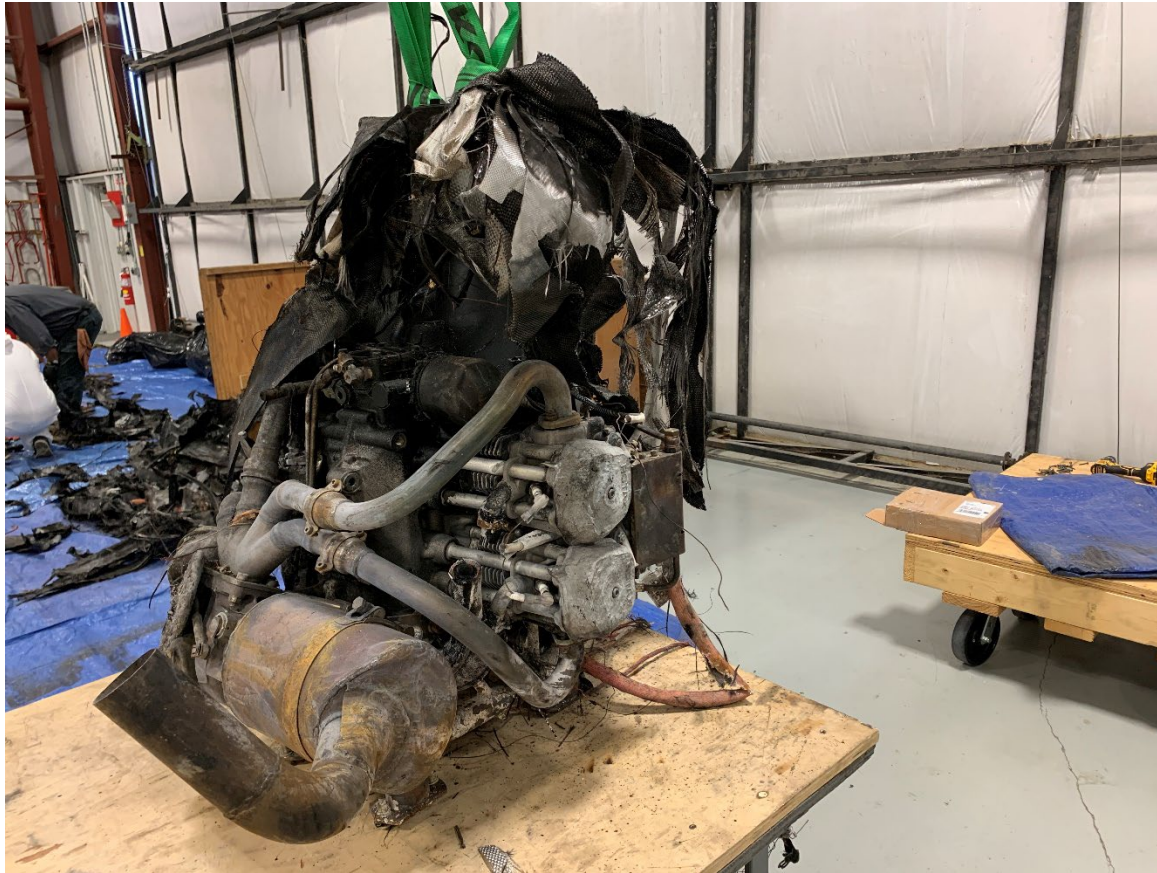
**Photograph 10 - View of the engine at the salvage facility.**
