# Aviation Investigation Final Report

| <b>Location:</b> | Allentown, Pennsylvania | <b>Accident Number:</b> | CEN22FA436 |
| <b>Aircraft:</b> | Piper PA-28-140 | <b>Aircraft Damage:</b> | Destroyed |
| <b>Defining Event:</b> | Loss of engine power (partial) | <b>Injuries:</b> | 1 Fatal, 1 Serious |

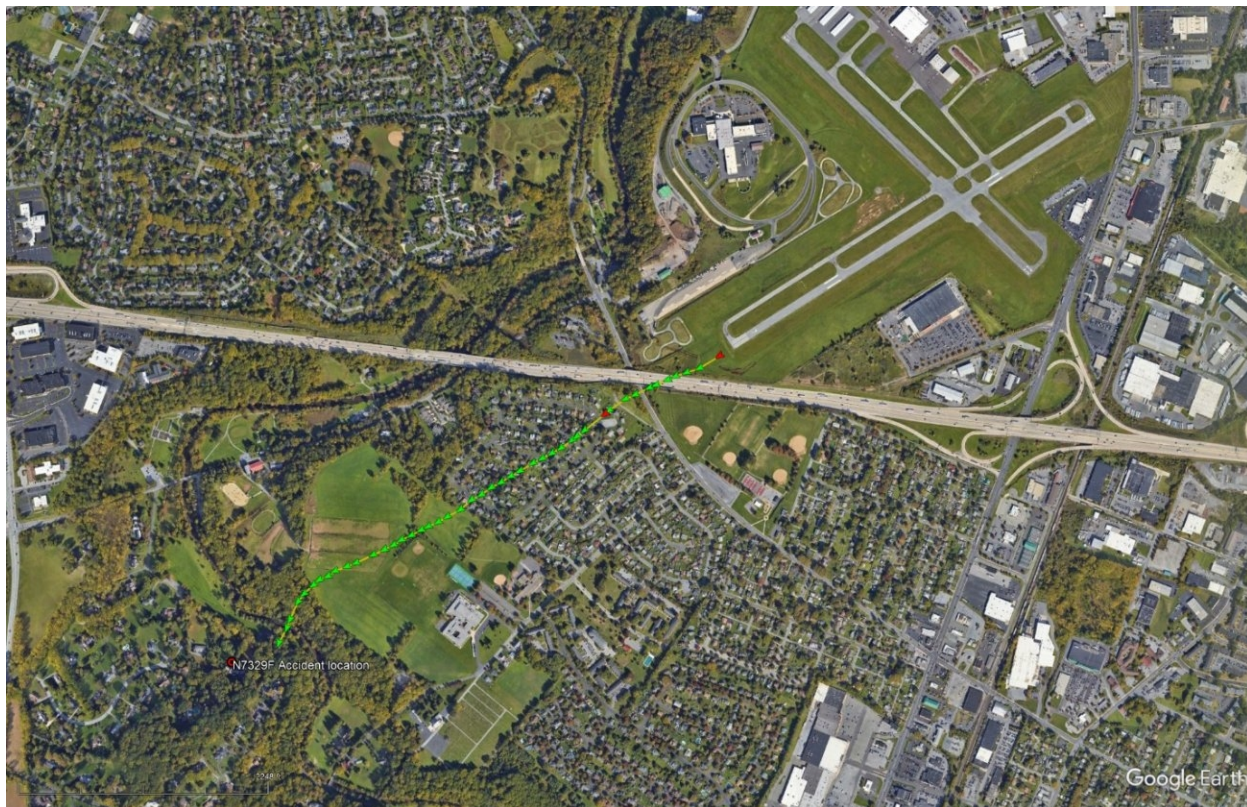
Recorded Automatic Dependent Surveillance-Broadcast (ADS-B) data showed that the airplane departed and continued for about 0.8 miles on runway heading, then made a slight left turn before the end of the data. The accident site was about 450 ft and 250° from the final recorded location. The reported wind at the departure airport was from 310° at 8 kts.

Examination of the data, taking into account the reported surface winds, showed that the airspeed during the final portion of the flight was below  $V_x$  but above the listed stall speed from the airplane owner's manual. The owner's manual listed a stall speed with 0° flap setting at maximum gross weight was 64 mph.

Figure 1. Overhead view of the accident flight path.
