## Carburetor Icing Probability Graph – CEN22LA002

Airplane: Beech A23

Accident Date: 10/2/2021

Accident Location: Lamesa, TX

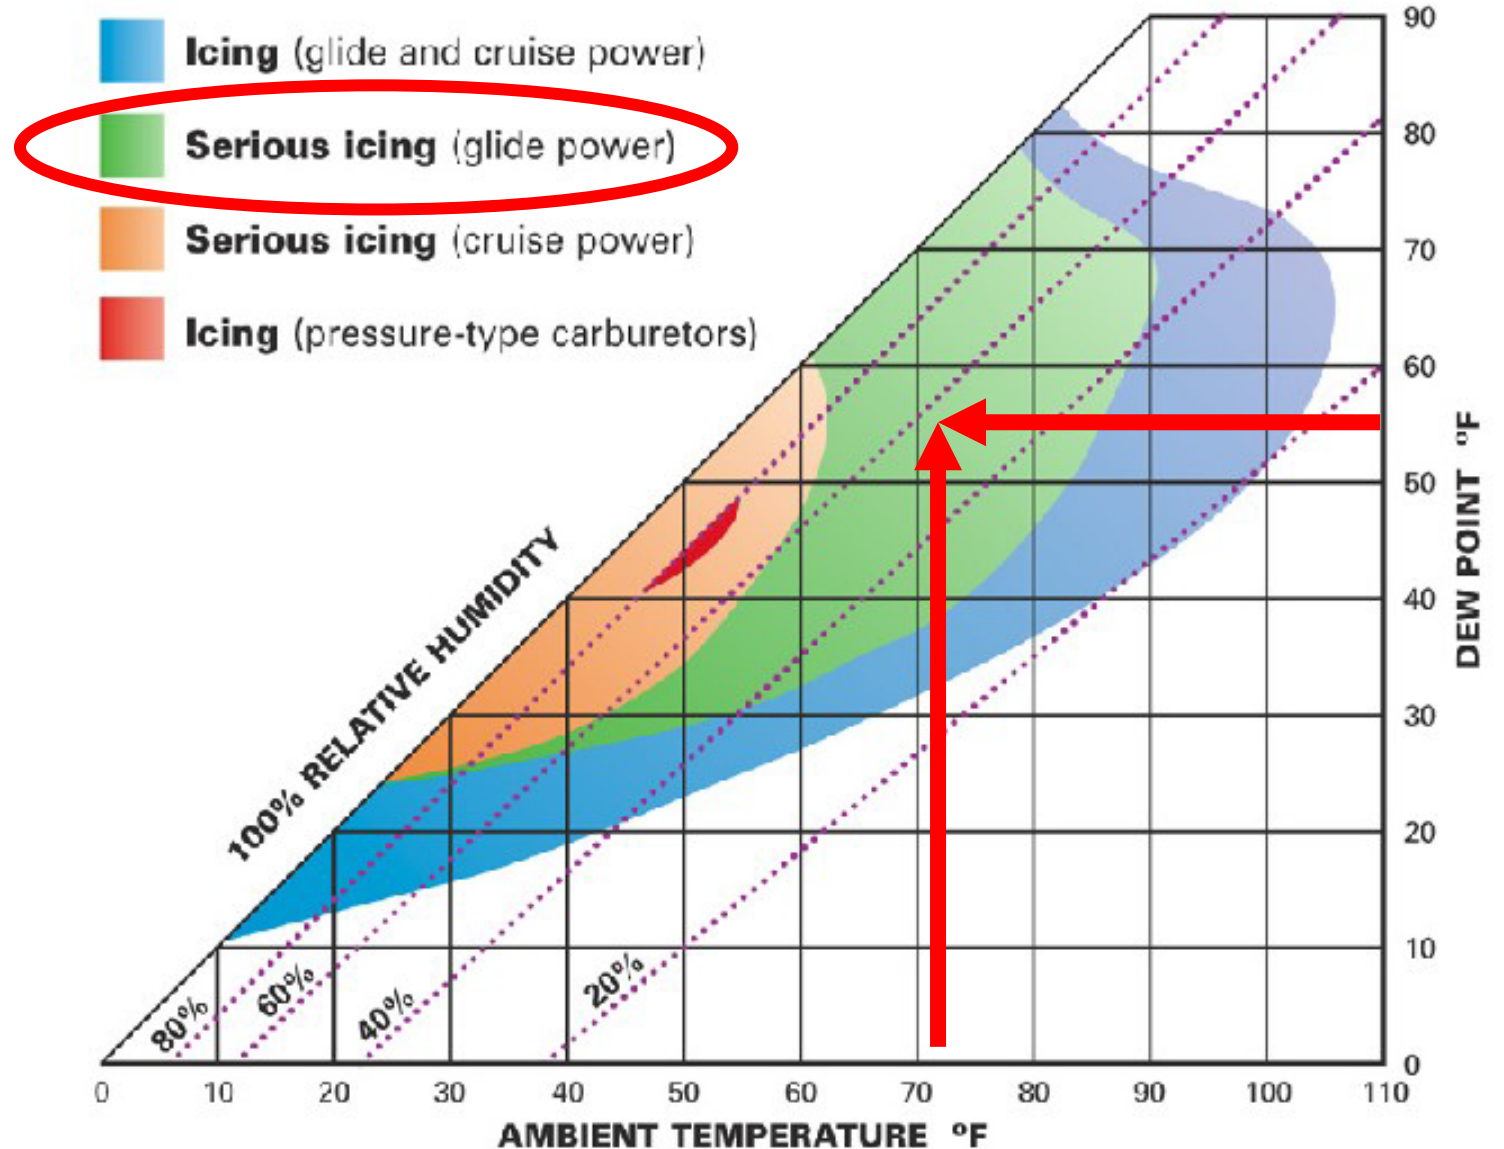
Weather: METAR KLUV 021735Z AUTO 00000KT 10SM  
22/13 A3019 RMK AO2=

Temperature, 22° C = 71.6° F

Dew Point, 13° C = 55.4° F

Carburetor Icing Prevention
