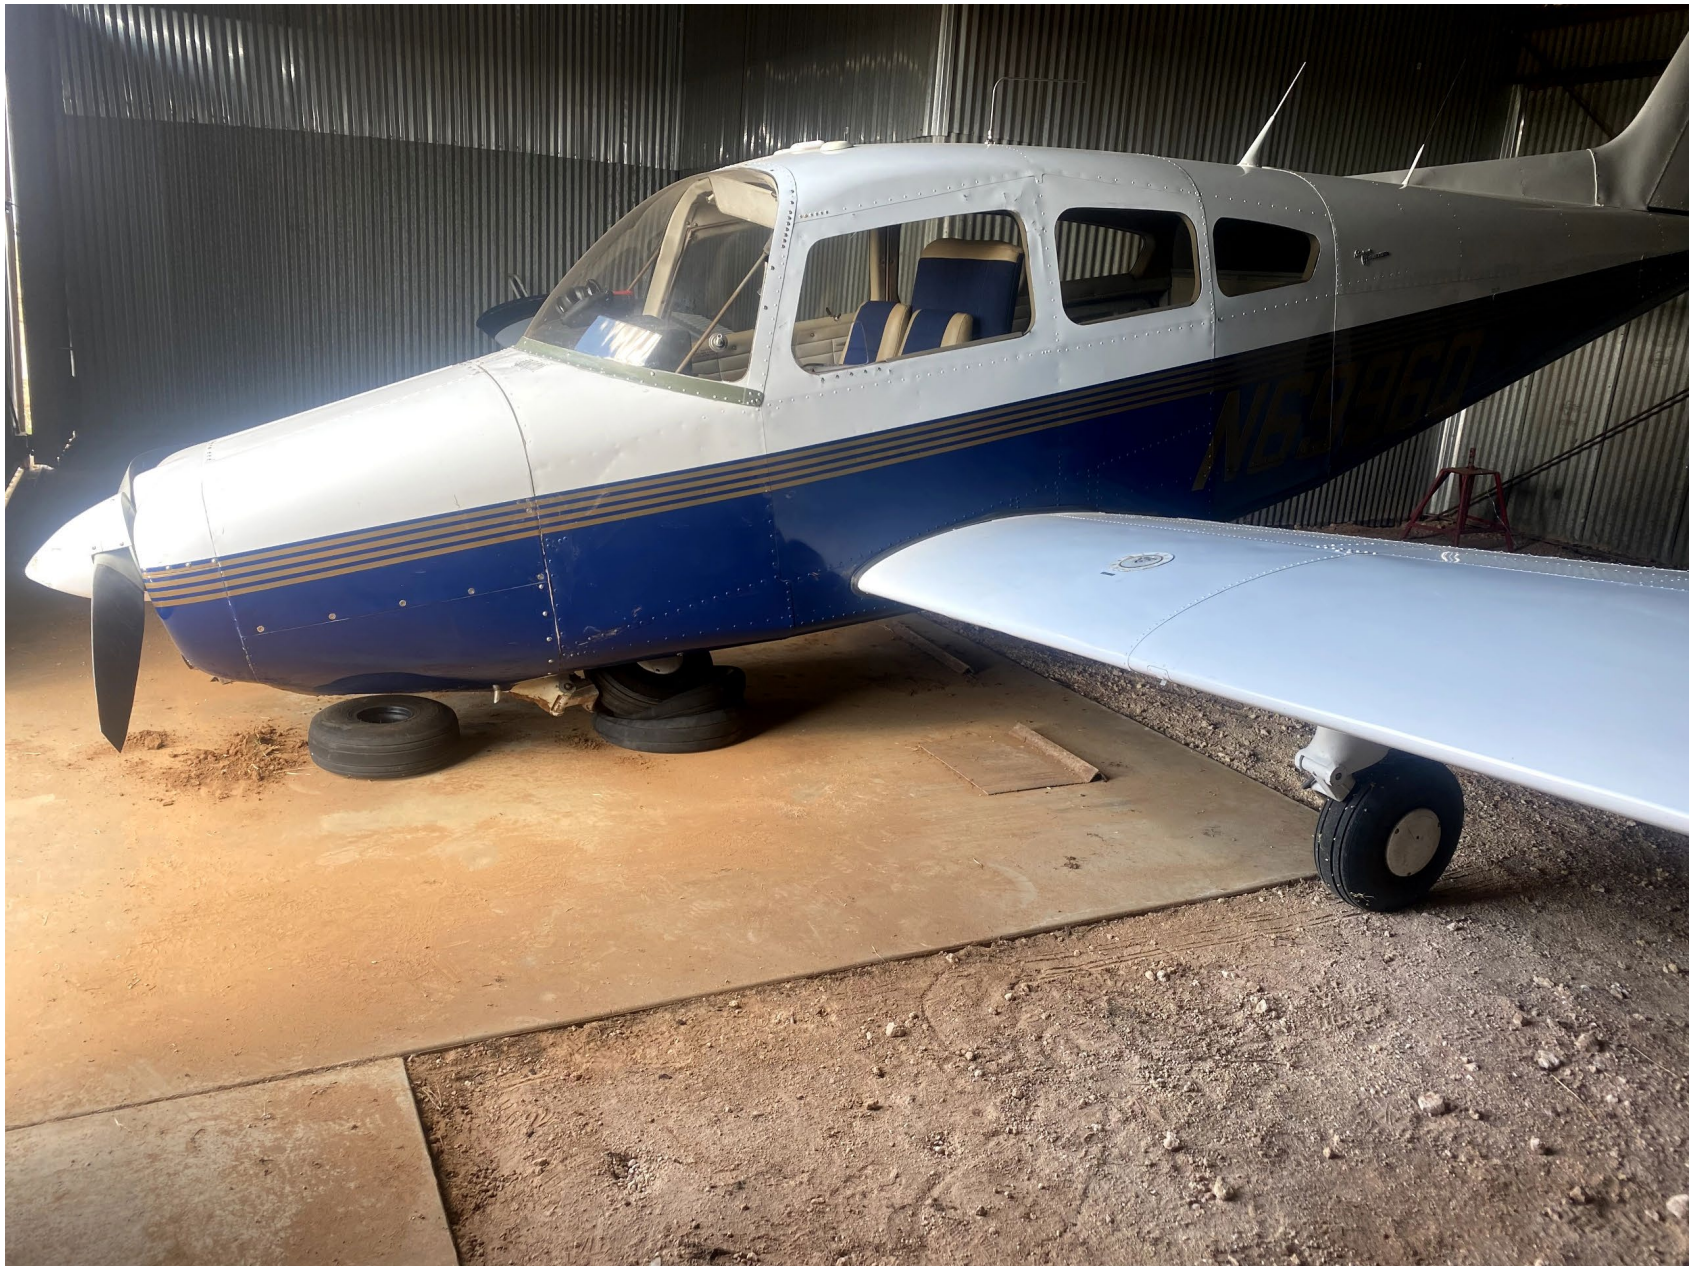
**Photo 1 – Left side view of airplane after recovery. (Photo provided by pilot)**

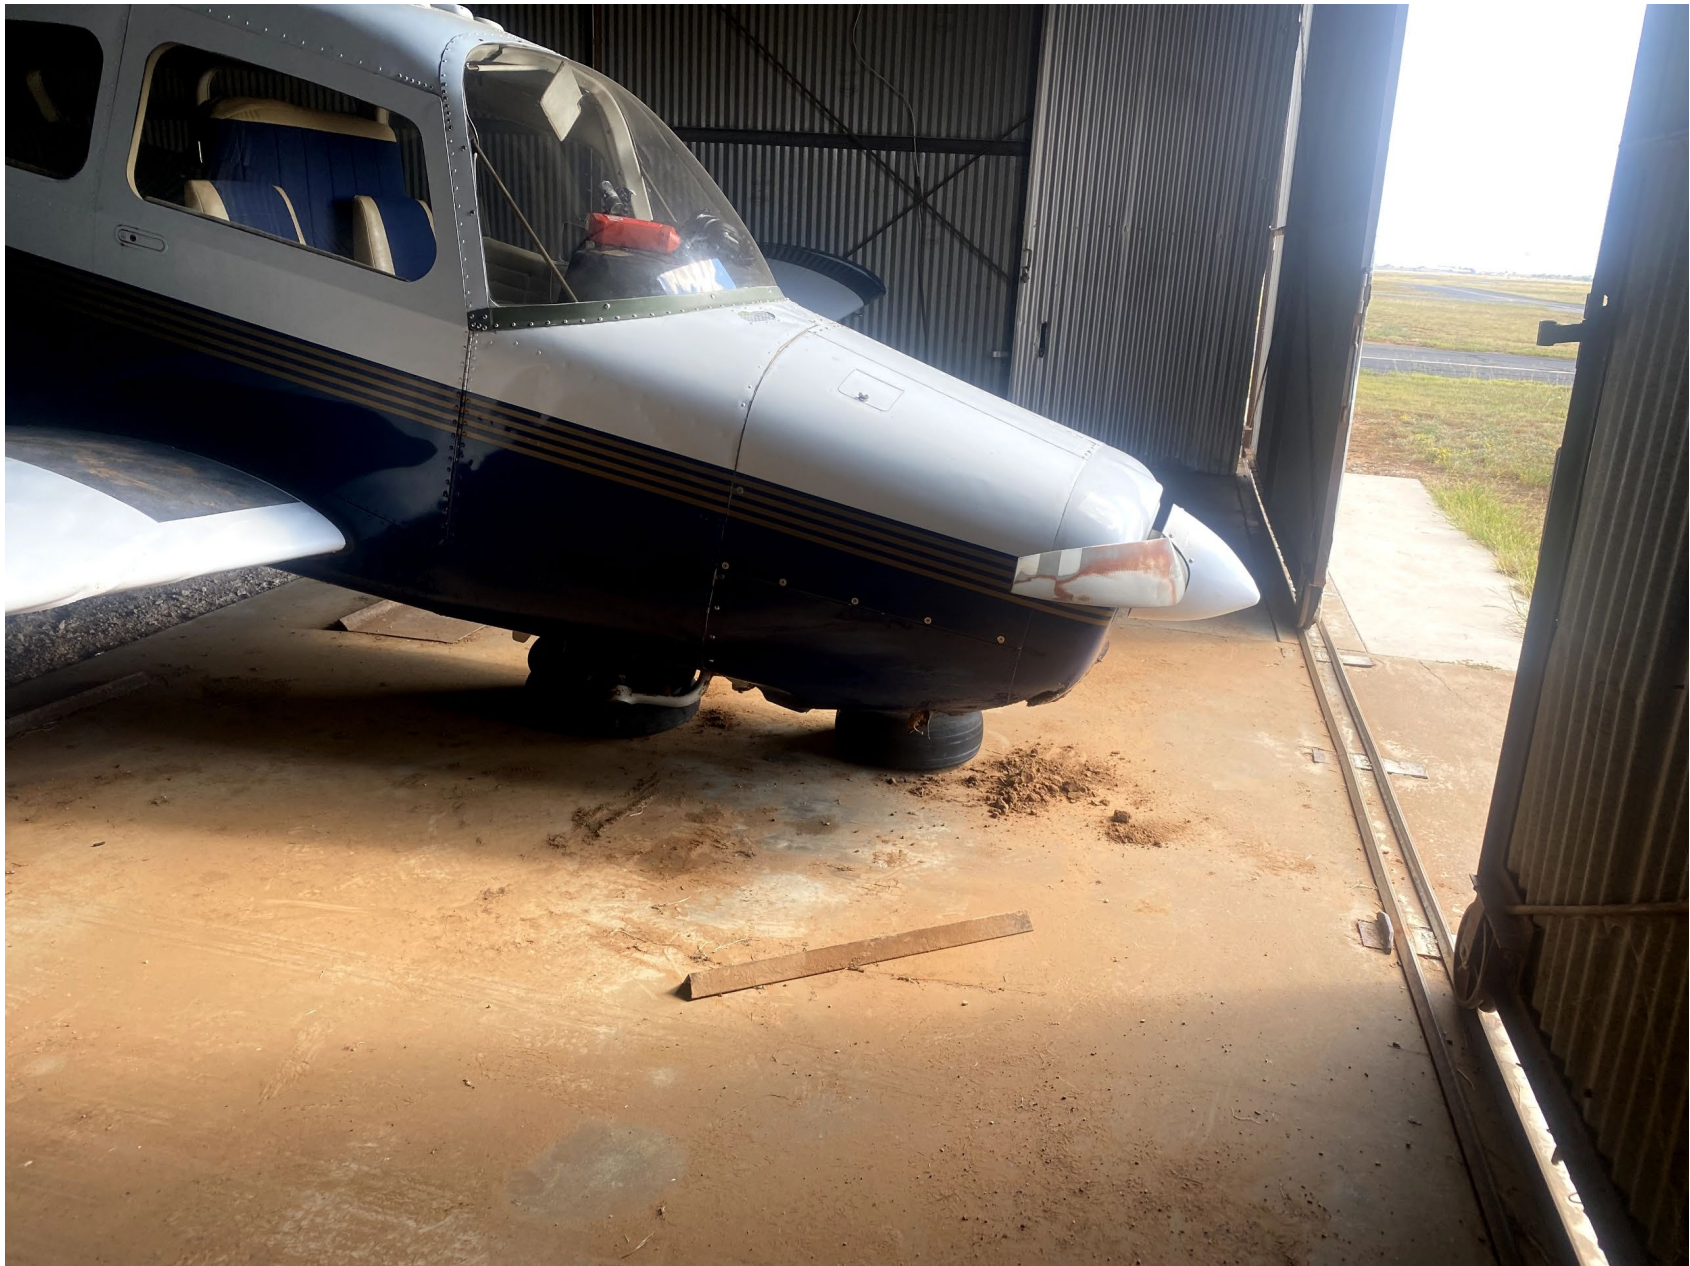
**Photo 2 – Right side view of airplane after recovery. Right wing leading edge wrinkled indicating internal damage to wing structure. Forward fuselage side wrinkled indicating substructure damage. (Photo provided by pilot)**

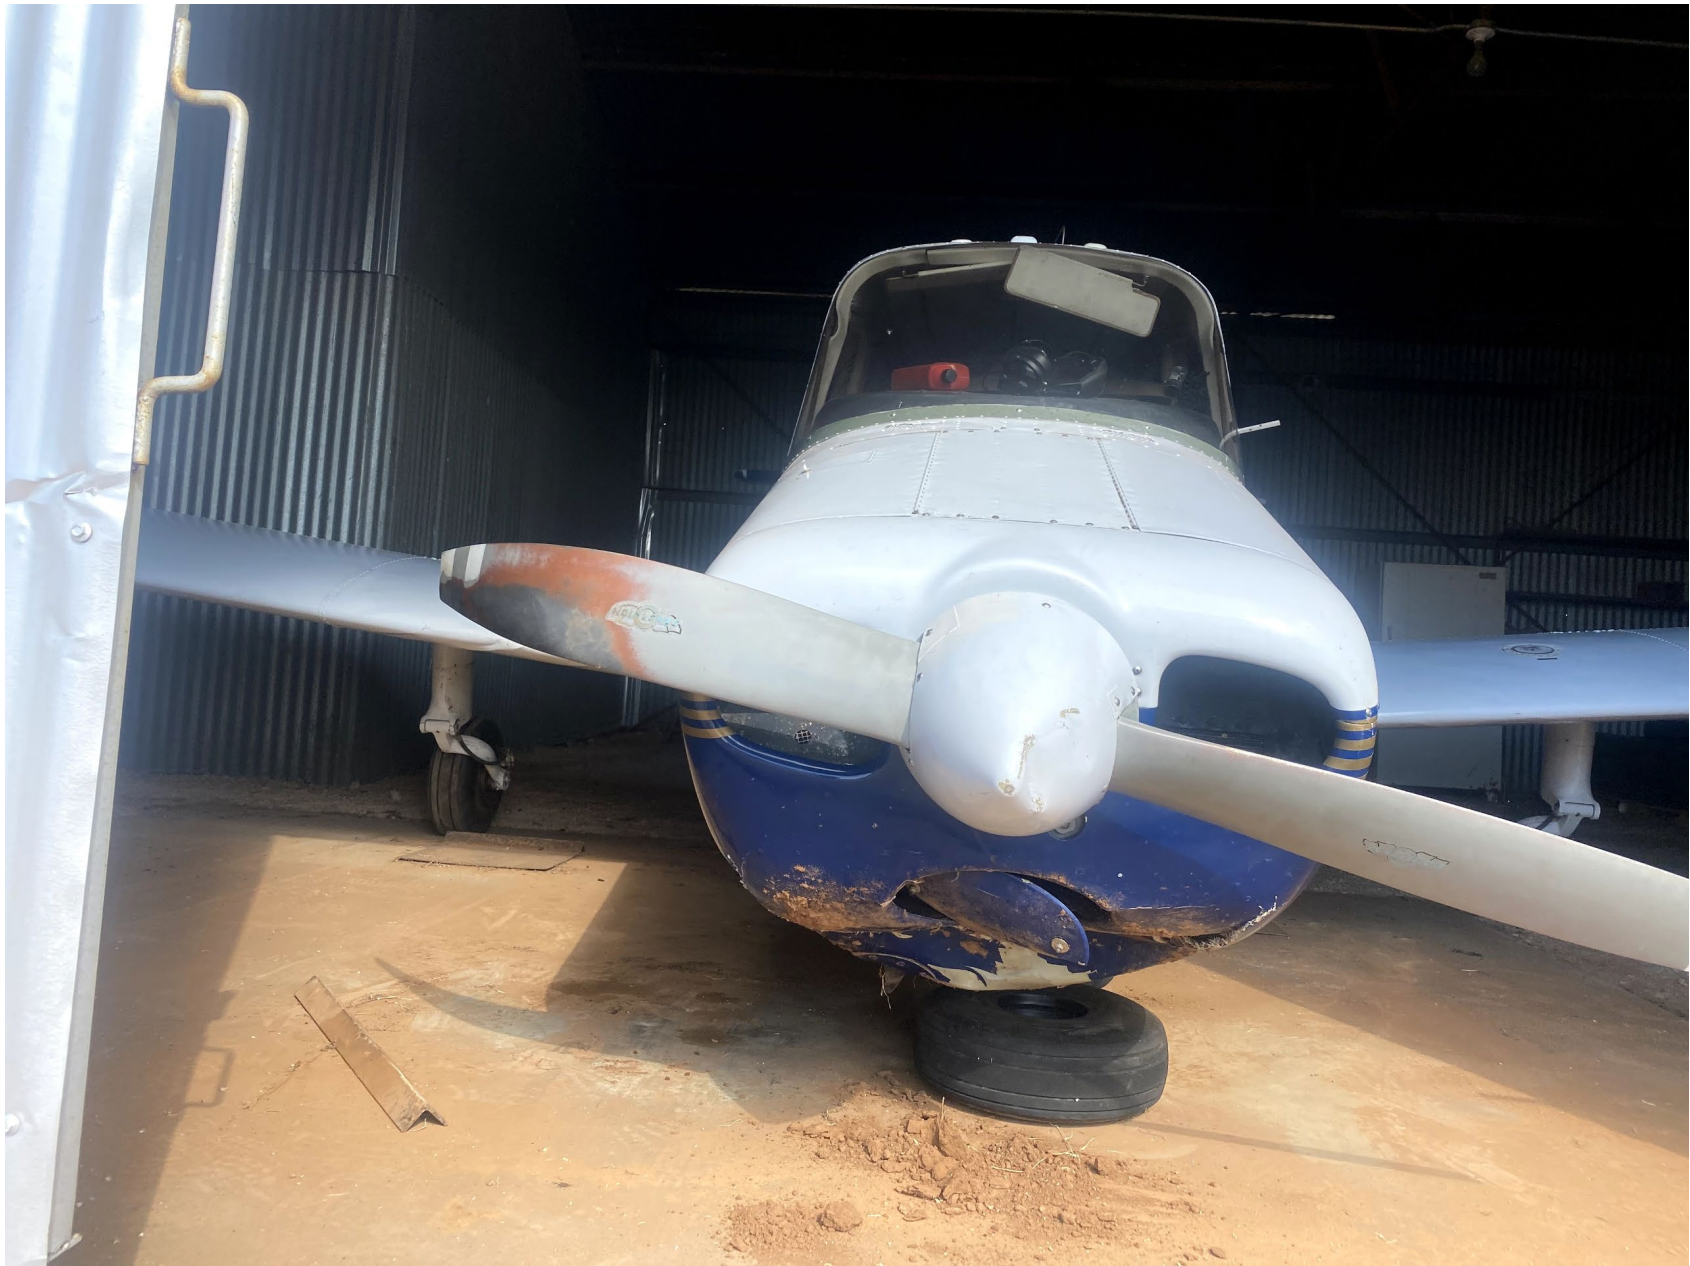
**Photo 3 – Front view of airplane after recovery. Right leading edge wrinkled indicating internal damage to wing structure. (Photo provided by pilot)**

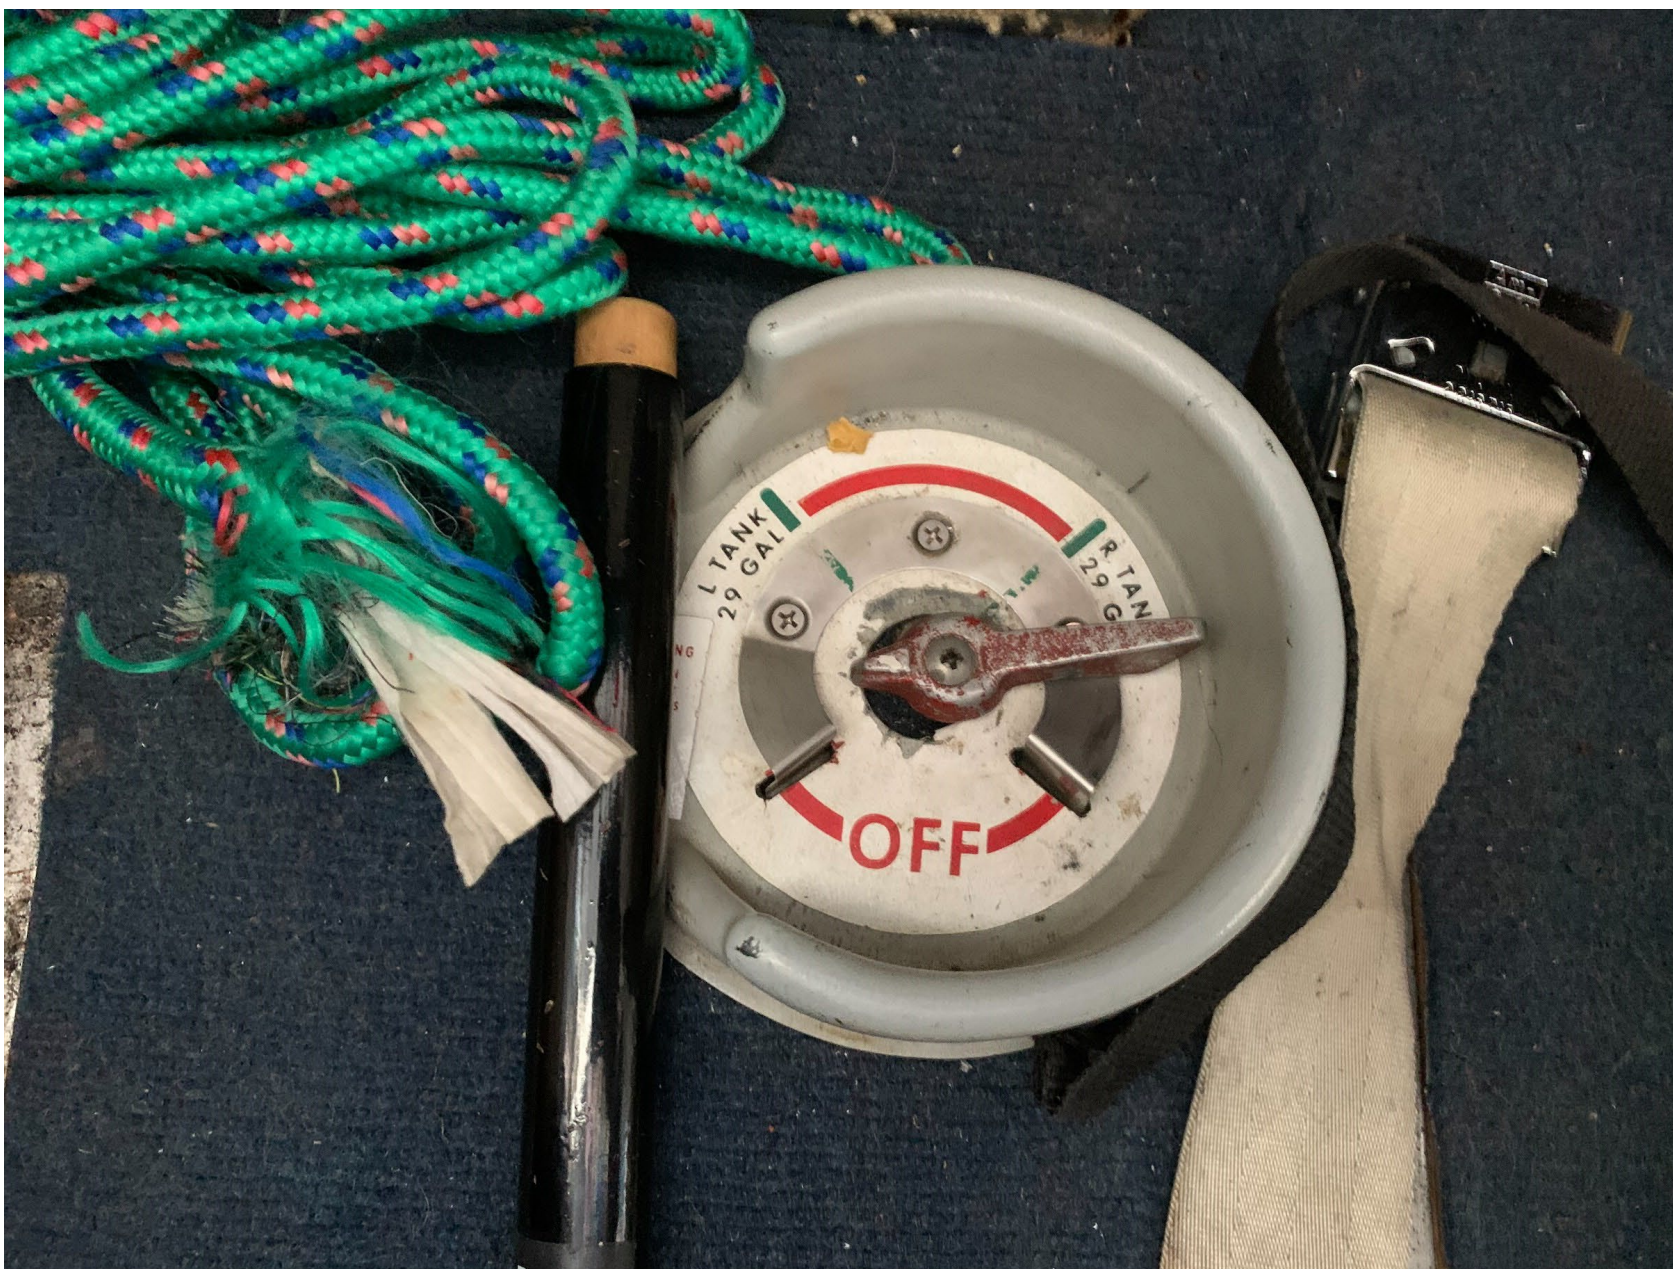
**Photo 4 – Fuel selector valve as found after the accident (FAA Photo)**
