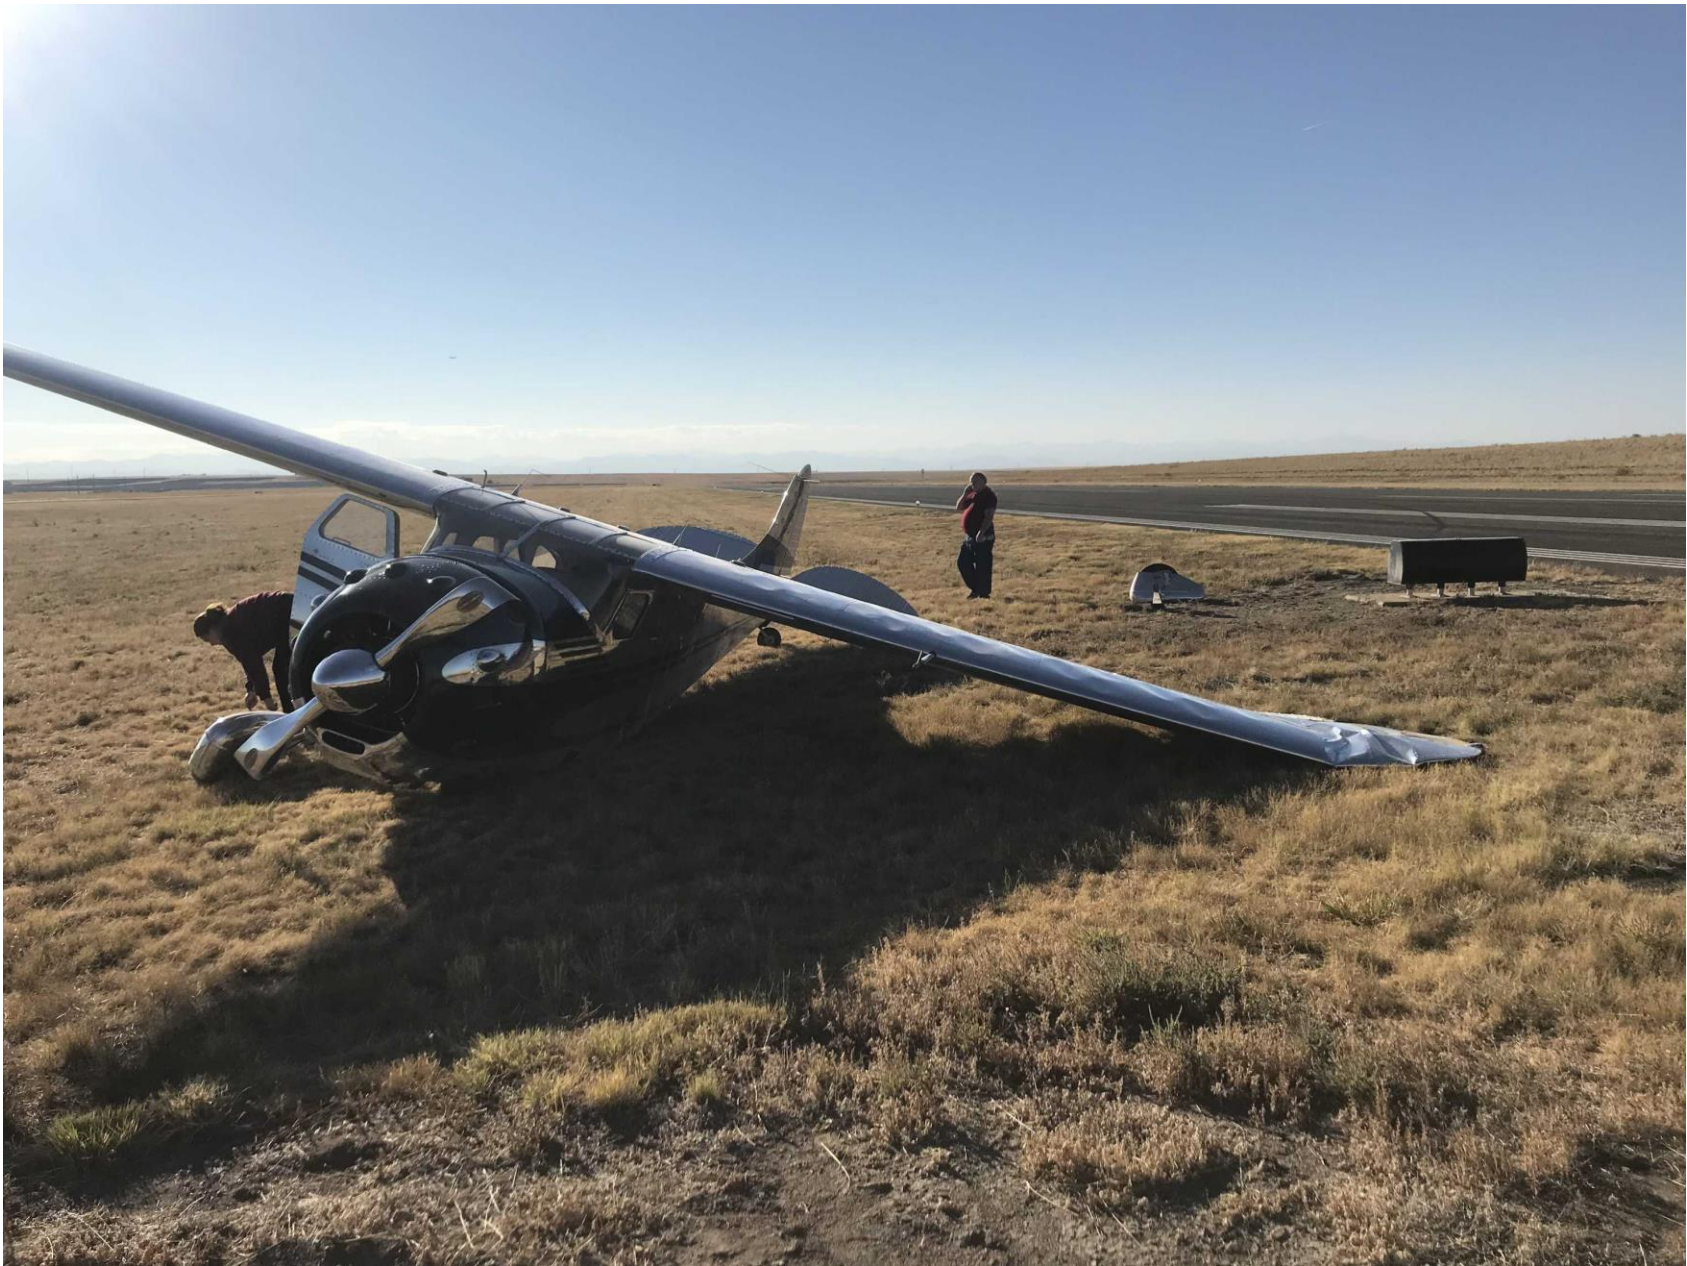
**Photo 1 – Accident Site Overview (Airport Operations Photo)**

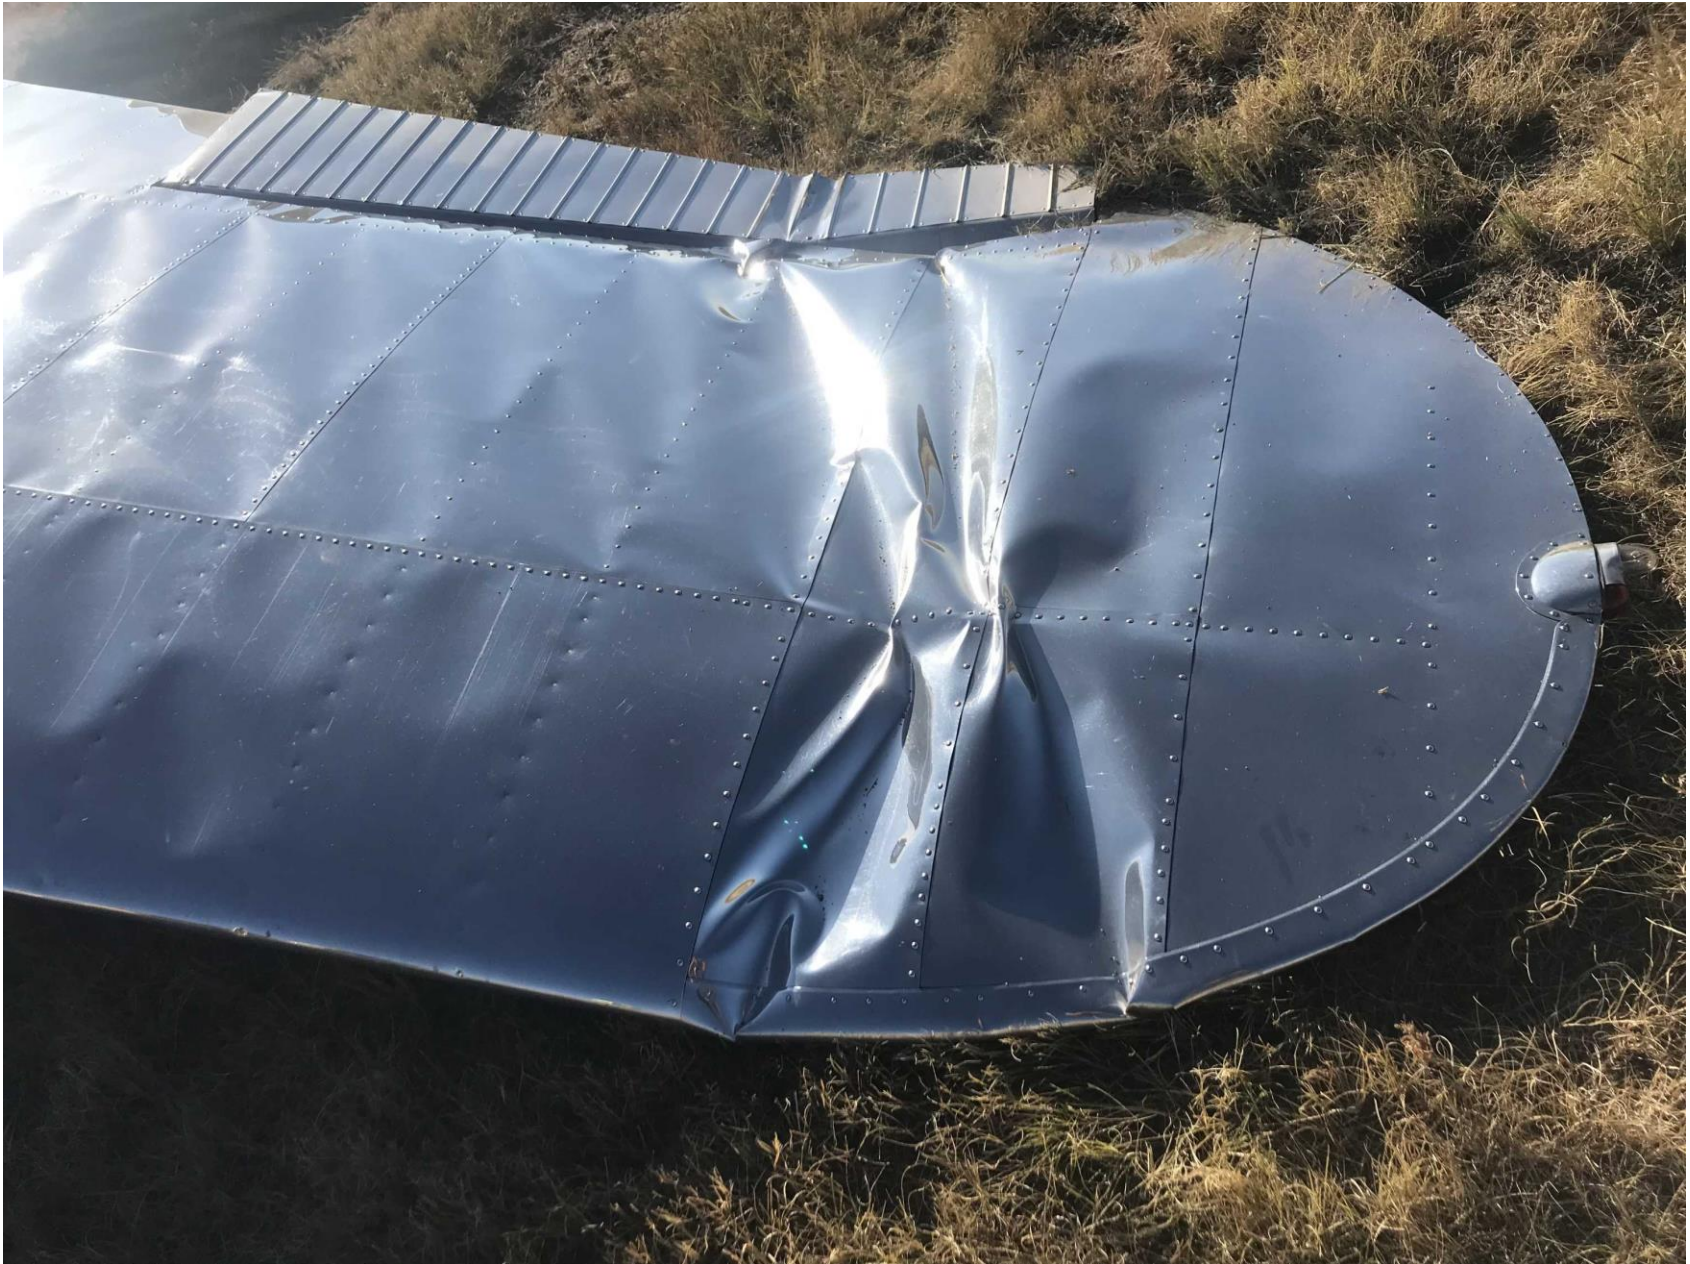
**Photo 2 – Left Wing Damage (Airport Operations Photo)**

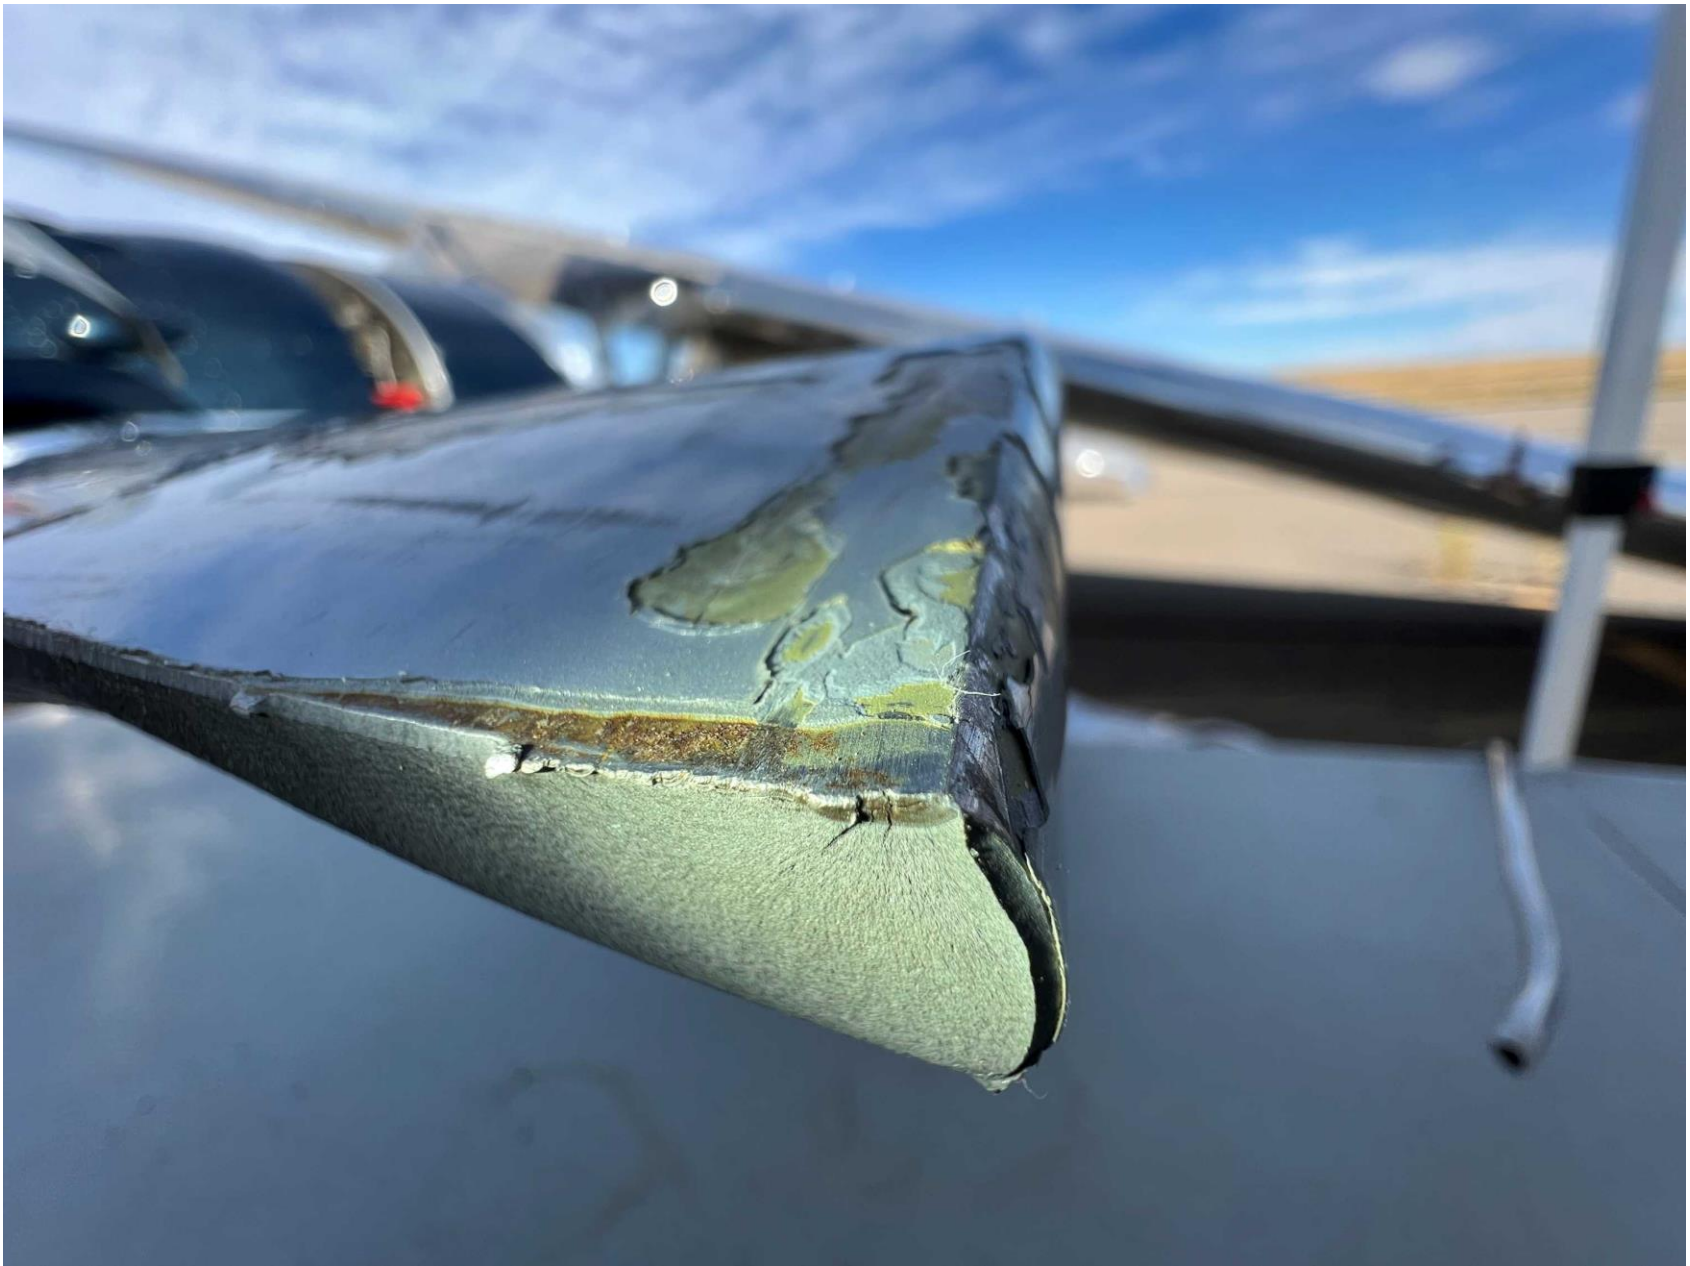
**Photo 3 – Left Main Landing Gear Spring Fracture (FAA Photo)**

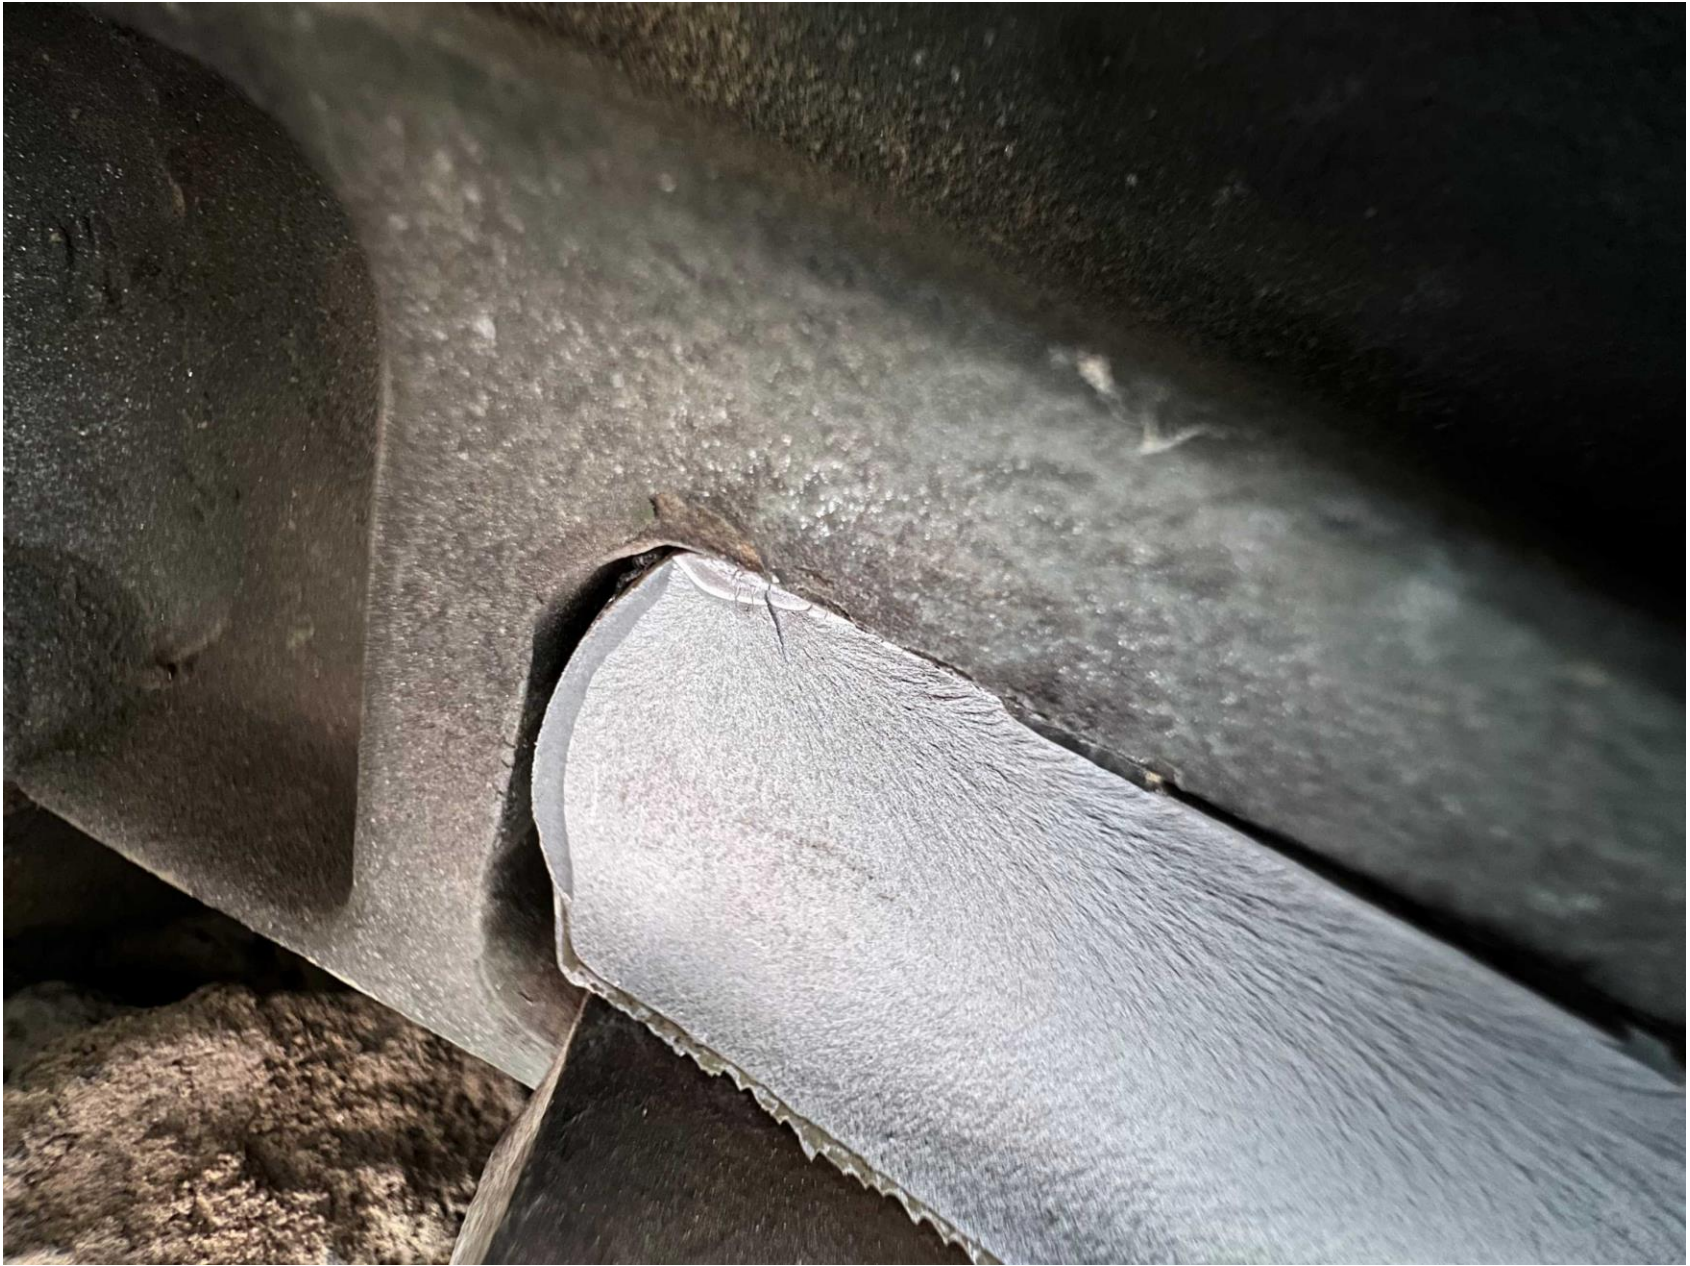
**Photo 4 – Left Main Landing Gear Spring Fracture (FAA Photo)**
