## RECORD OF CONVERSATION

**Samantha Link**  
**Aviation Accident Investigator**  
**Central Region**

**Date: October 15, 2022**  
**Person Contacted: Mr. Keenon Wood (FAA Inspector)**  
**NTSB Accident Number: WPR22LA008**

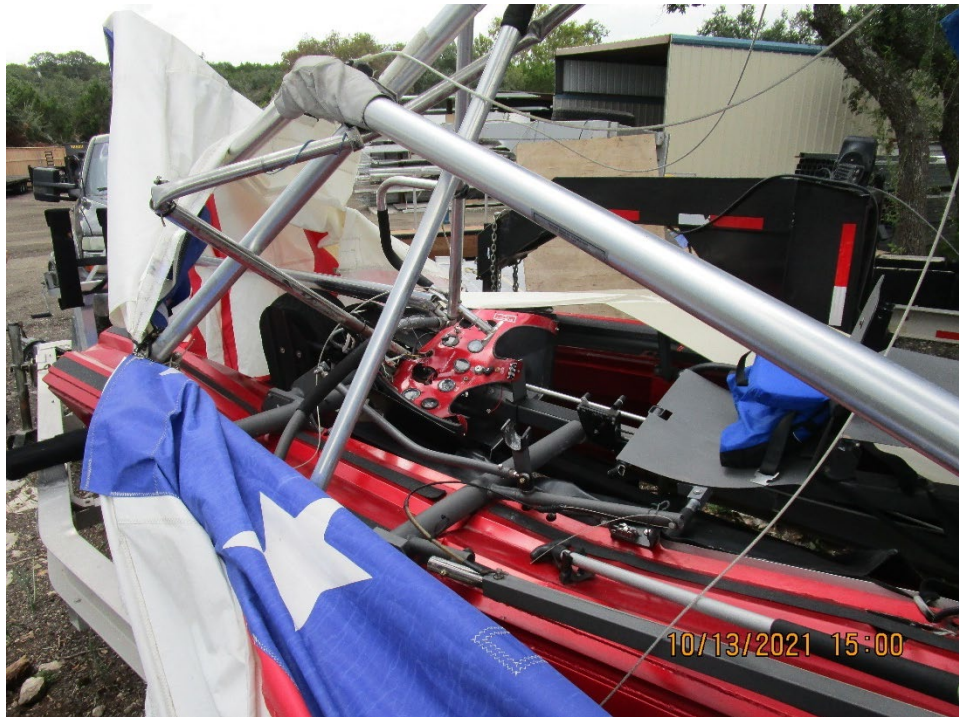
*Figure 1: Cockpit Area*

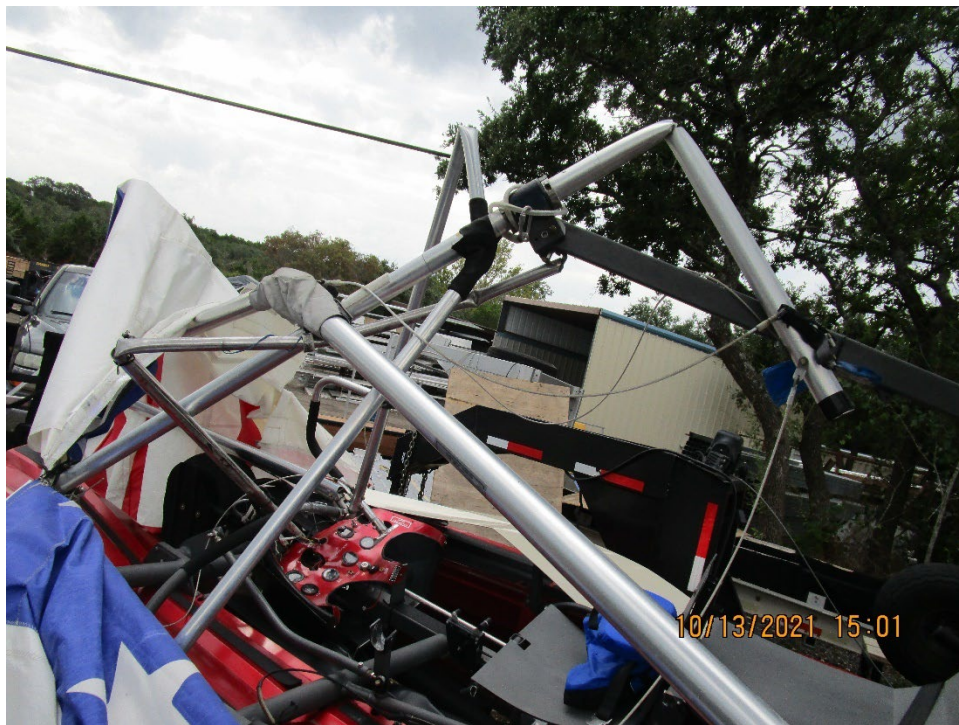
- The front tube was crushed downward and toward the left. It sustained several bends beneath the keel and crossbar.
- The keel remained attached to the carriage mast, however, the forward attachment point bolt was fractured. Which is consistent with impact damage. The forward portion of the keel extended downward, and the nose plate came to rest just above the outer left edge of the left float.

*Figure 2: An overview of the Keel.*

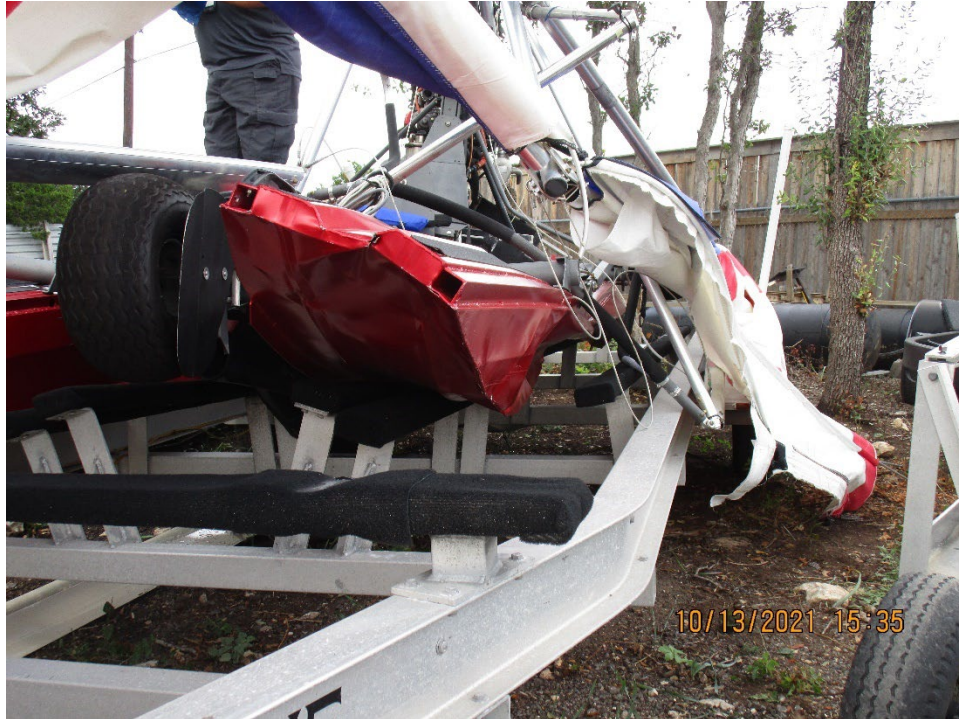
- It came to rest in front of the cockpit just over the nose landing gear tire.
  - The left side corner bracket came to rest outside of the left float.

- The two tubes that run between each float, and underneath the instrument panel, were bent upward on the left side.
- The forward portion of the left side float was bent upward, and the float leading edge was about a 40-degree angle.

Figure 3: Left side float and left side control corner bracket.

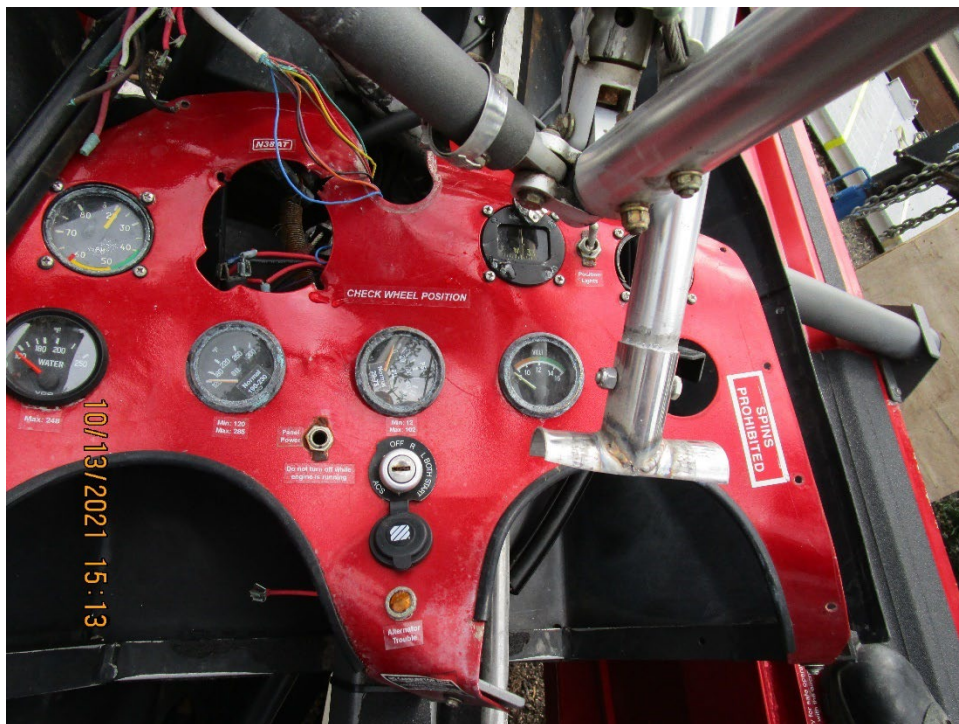
- The instrument panel was crushed downward and flattened.
  - The key was not present in the ignition; however, the ignition was found in the “both” position.

Figure 4: Instrument Panel

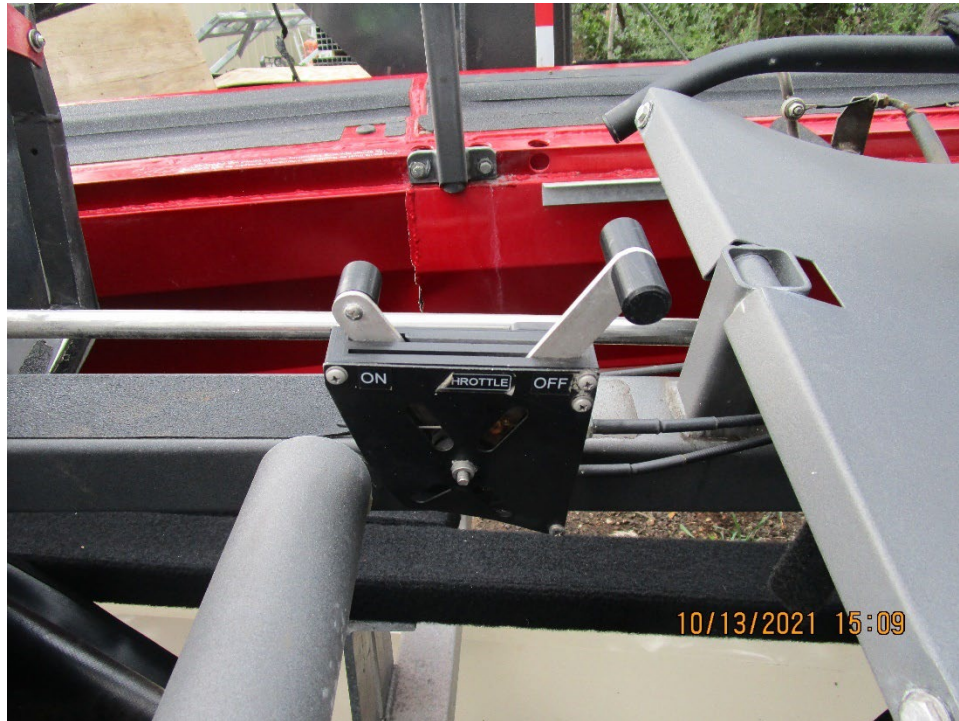
- The choke and throttle assemblies remained attached at the carriage keel directly in front of the front seat.
  - Both handles were found in the off position.

*Figure 5: Throttle and Choke Assembly*

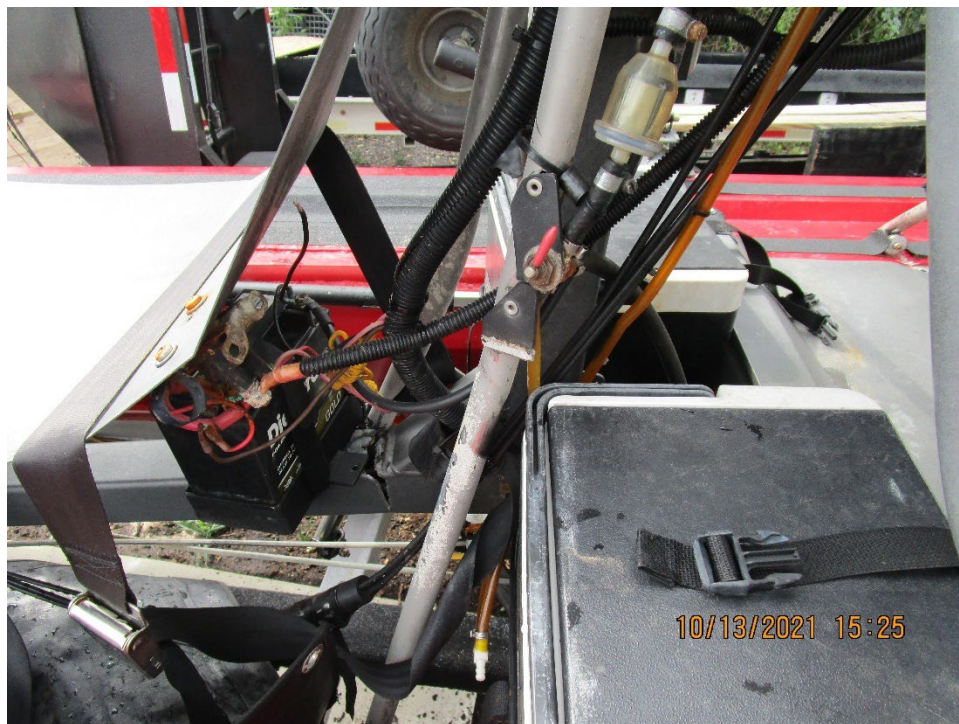
- A vertical crack was noted on the outside.
- The nose and main landing gear tires were found in the retracted position.
- The carriage keel was fractured just in front of where it meets the carriage mast.

*Figure 6: Fracture in the Aft Carriage Keel (just in front of the Carriage Mast)*

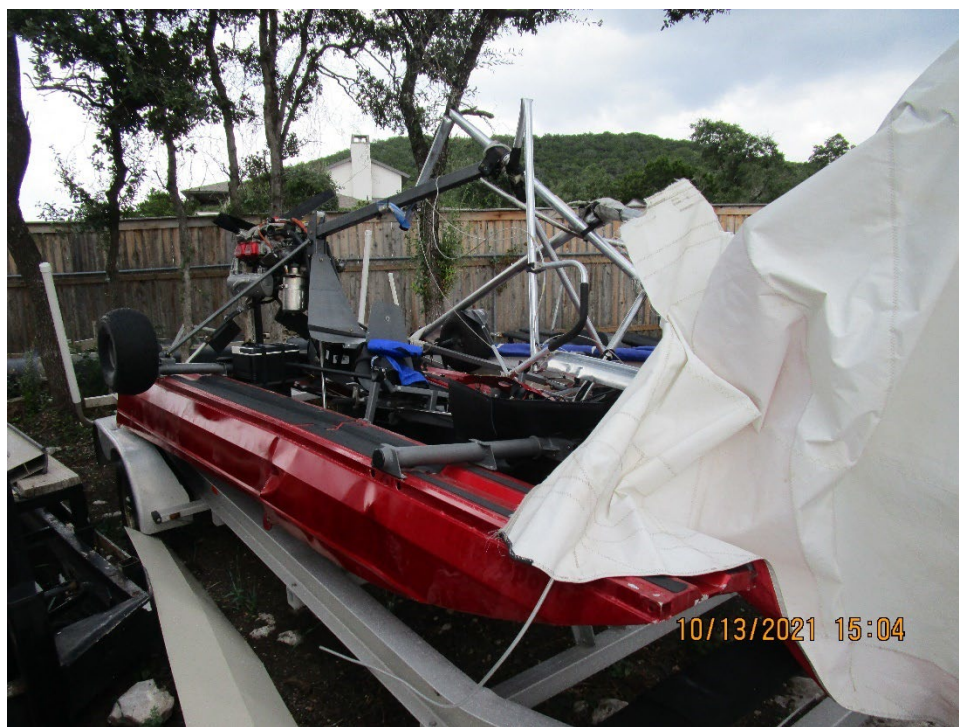
*Figure 7: Forward Right side of Airplane*

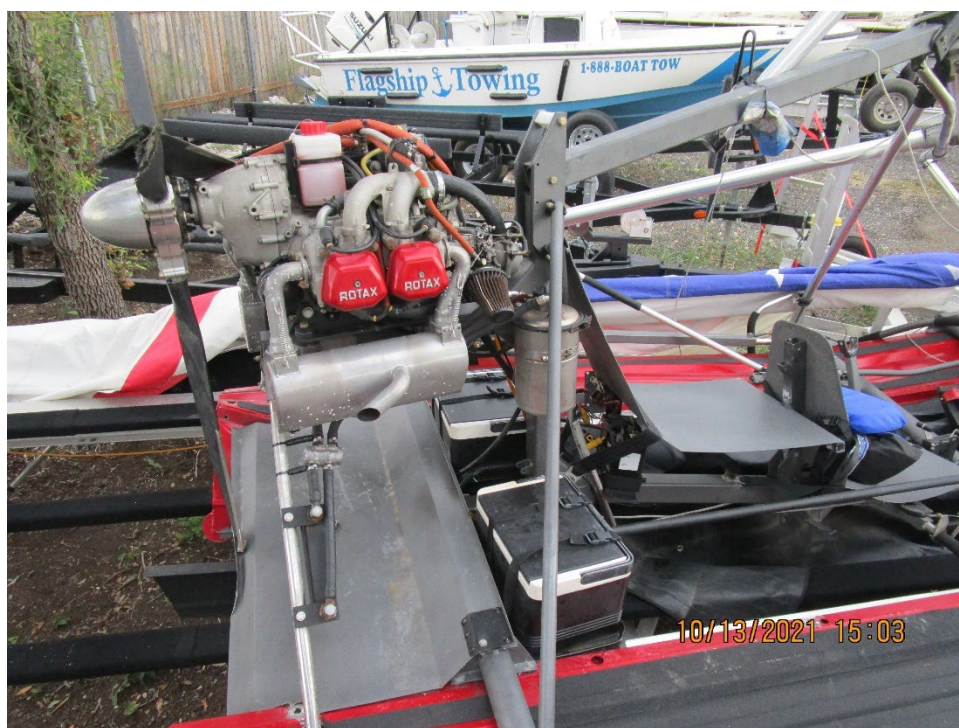
- The examination occurred with the airplane on a trailer at a salvage yard near Lake Travis.
- The carriage mast was bent forward from its lower attachment point just in front of the engine. The forward portion of the mast came to rest over the instrument panel and was slightly left of its centerline.

*Figure 8: The Side of the Engine and Carriage Mast Bend*

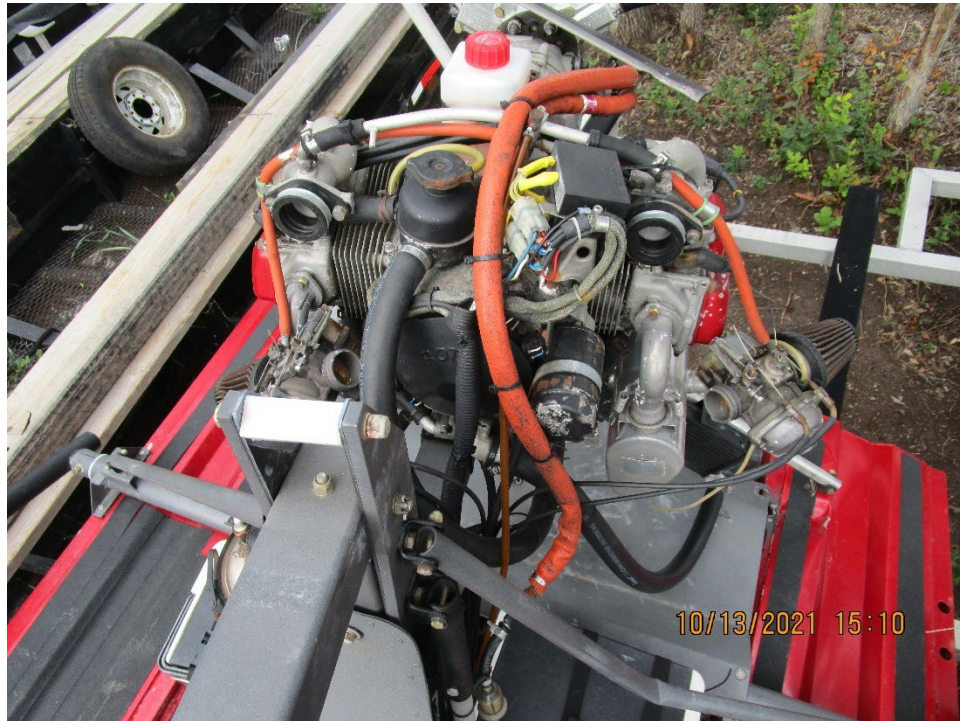
- The forward portion of the carriage keel appeared to be bent downward.
- The engine remained secured on its engine mount.
  - There were no visual signs of catastrophic anomalies with the engine.

*Figure 9: The Aft Side of the Pusher Configured Engine*

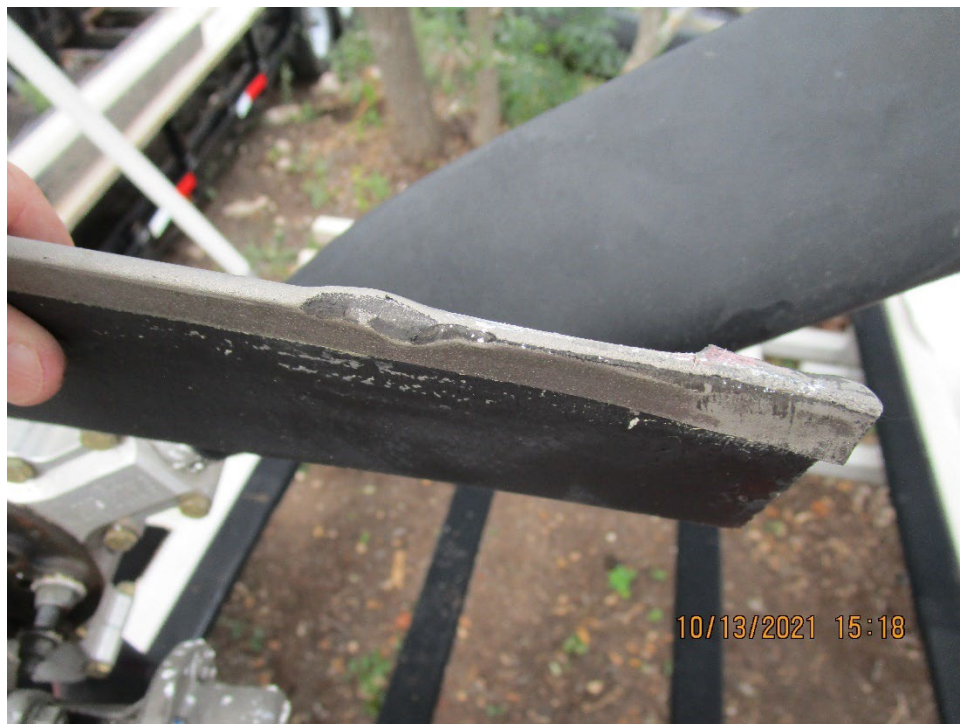
- The three composite propeller blades remained attached at the hub.
  - One blade was bent about 7 inches from the hub. It exhibited two leading edge dents with, what appeared to be, metal transfer marks.

*Figure 10: One blade was Bent about 7 Inches from the Hub*

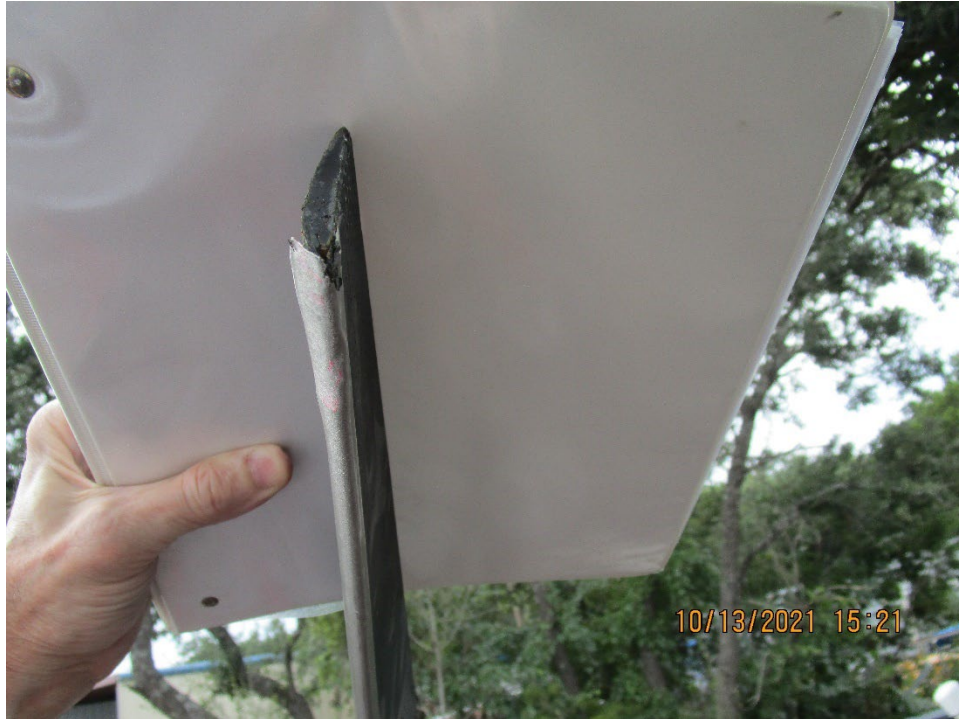
- The outer most dent also exhibited a red mark consistent with the color of the floats.
  - The tip of the second blade was fracture separated. The remaining outboard portion of the leading edge exhibited red transfer marks.

*Figure 11: The Tip of the Second Blade was Fracture Separated.*

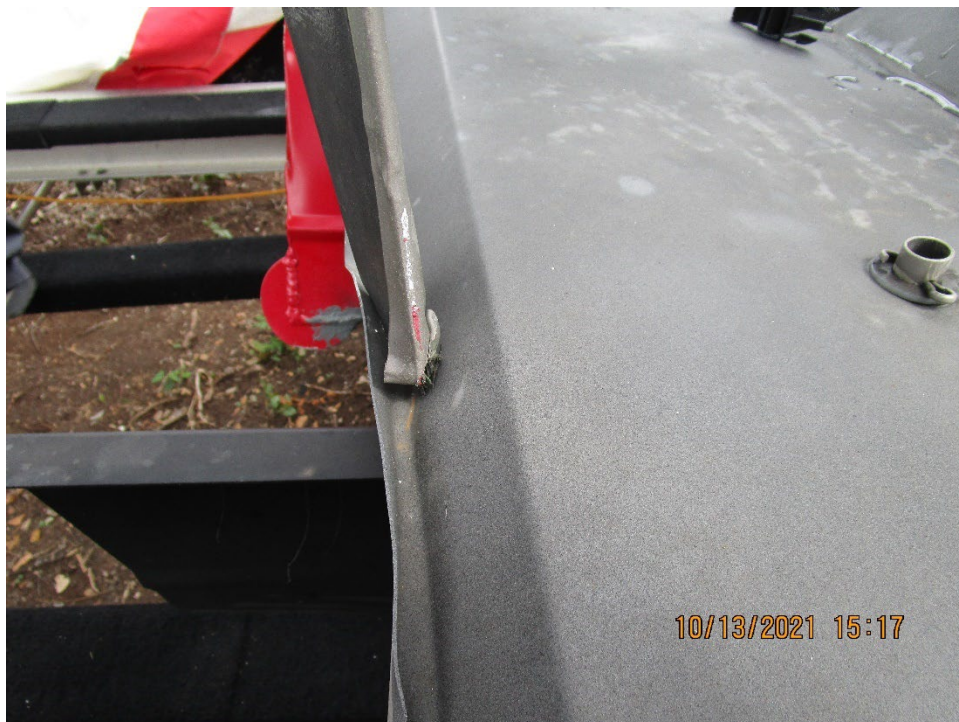
- The blade tip of the third blade was wedged on the metal plate below the engine (which extends between each float).
    - The leading edge of the blade was crushed aft, and the face side of the blade sustained chordwise scoring and fracturing.

*Figure 12: The Blade Tip of the Third Blade was Wedged on the Metal Plate Below the Engine*

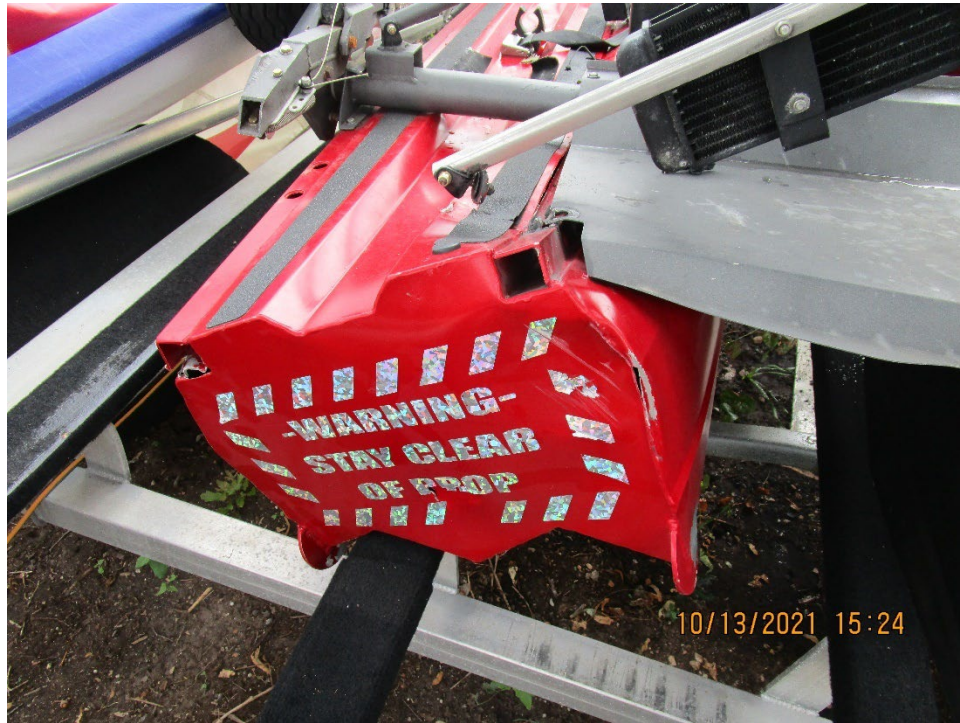
- Three scoring marks were noted on the aft side of the left float consistent with propeller blade strikes.
- The forward portion of the right-side float was bent slightly downward.

*Figure 13: Score Marks on the Aft Left Float*
