# Carburetor Icing Probability Graph – CEN22LA010

Airplane: Piper PA24

Accident Date: 10/7/2021

Accident Location: Fort Collins, CO

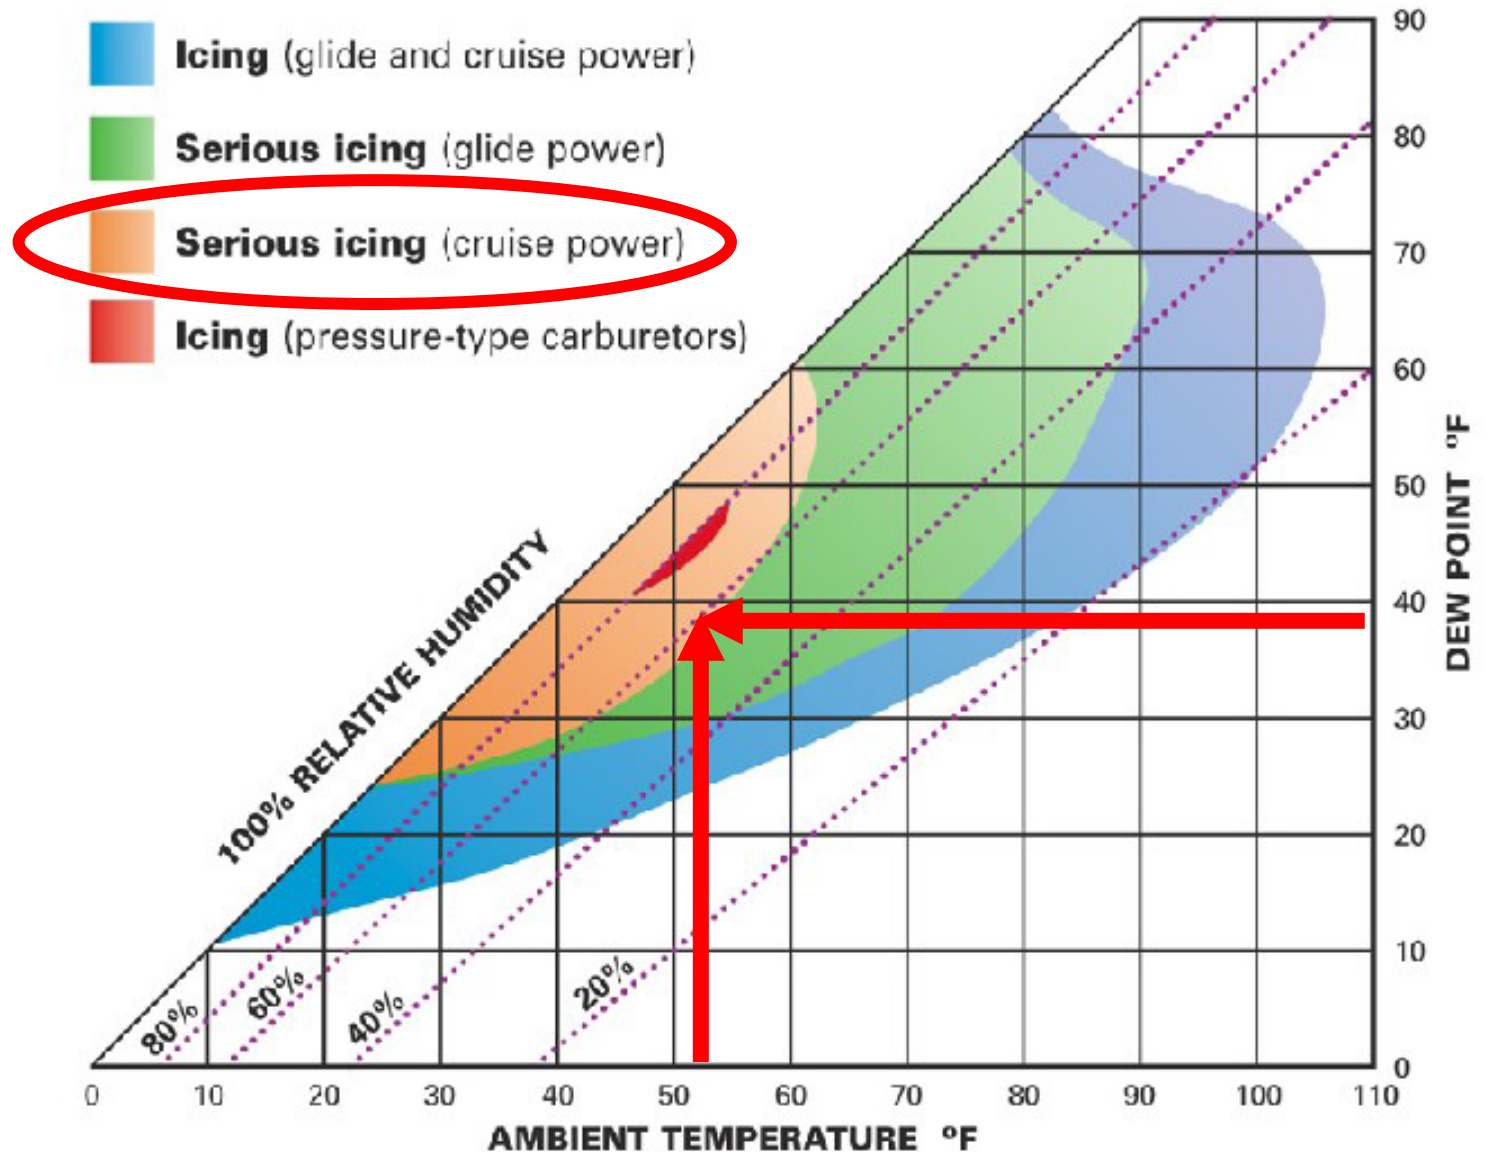
Weather: METAR KFNL 071256Z 13006KT 10SM CLR  
11/04 A3010

Temperature, 11° C = 51.8° F

Dew Point, 4° C = 39.2° F
