### NATIONAL TRANSPORTATION SAFETY BOARD Office of Aviation Safety Washington, DC 20594

#### SUMMARY OF AIRCRAFT EXAMINATIONS

-- CEN21FA360 --

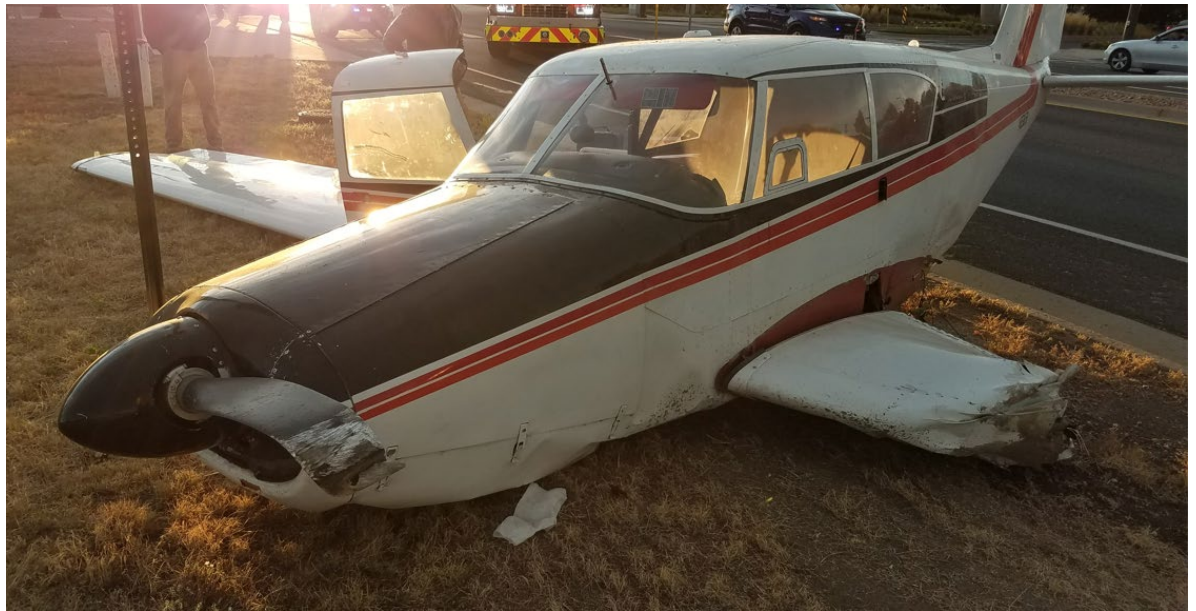
The pilot reported that after takeoff from Runway 15 at FNL, the airplane was not able to climb normally. The pilot executed a forced landing onto a road, during which the airplane impacted a pole and the left wing was damaged (see Photo 1).

Photo 1 – Airplane at Accident Site (Courtesy of FAA)

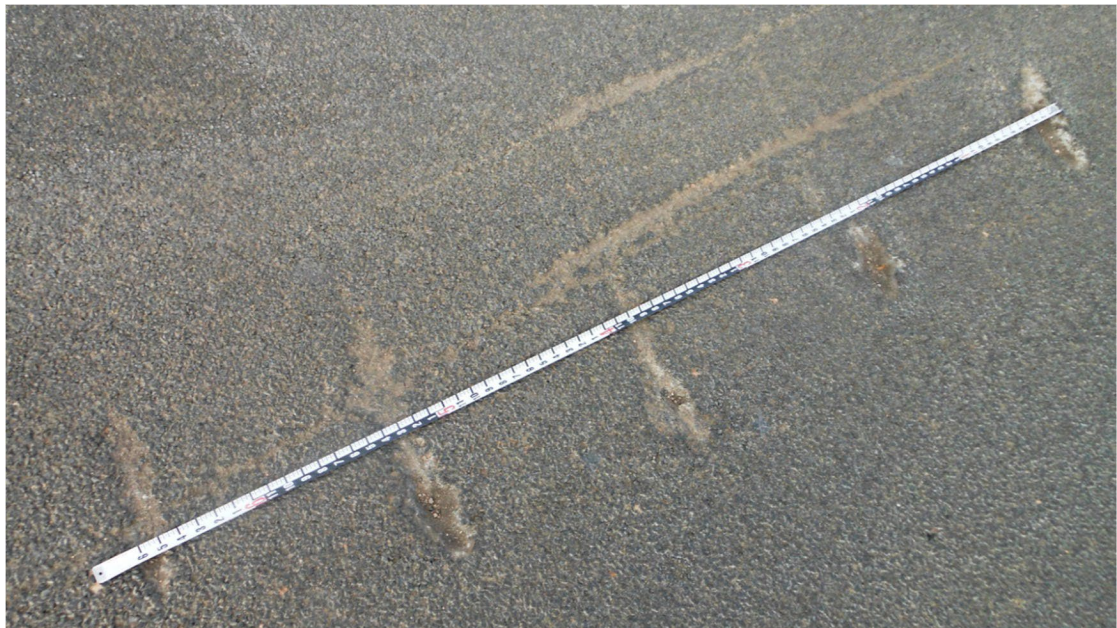
The propeller strike marks showed road wear since the day of the accident but were still discernable (see Photo 2). The distance between the first and second propeller strike marks was about 1.17 ft. Based on the strike marks and the last recorded ADS-B groundspeed of 59 knots, engine speed was estimated to be about 2,554 rpm when the blades contacted the road during the forced landing.

Photo 2 – Propeller Strike Marks on Road at Accident Site (Courtesy of Hartzell)
