## **Examination Summary**

NTSB ACCIDENT NUMBER: CEN22LA012

AIRCRAFT REGISTRATION/AIRCRAFT TYPE: N677JD, Stinson 108

### **Post-Accident Examination Summary**

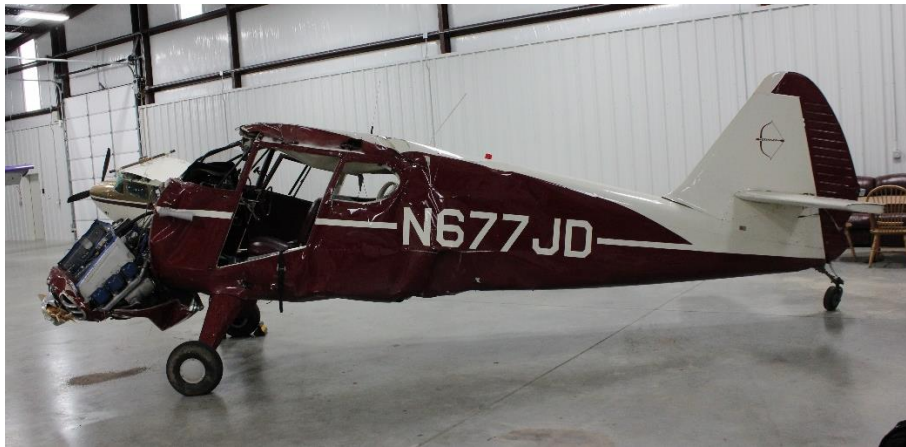
*Photo 1: Airplane*

The fuselage displayed impact related crushing on the left side about the location of the rear window. The right side of the fuselage exhibited a vertical crushing from under the "N" upwards about 1 ft. The rest of the fuselage was relatively free of impact damage.

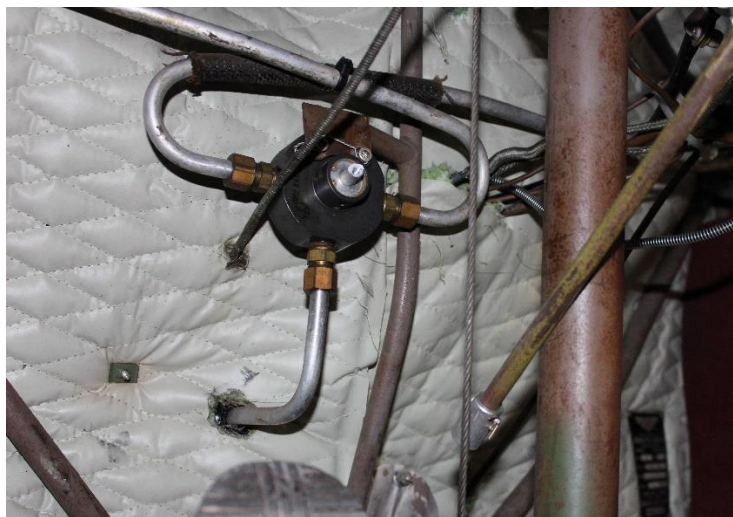
*Photo 2: Fuel Selector Valve*

The fuel selector handle was fractured from the fuel selector, consistent with impact damage. The fuel selector was removed from the airframe and inspected using a flashlight.

It was determined to be selected to the left fuel tank and was free of any debris or obstructions. The fuel strainer sustained damage consistent with impact damage. It was opened and found to be absent of any fuel, however, the damage sustained allowed for the possible evaporation of any fuel that may have remained. The screen was free of any debris.

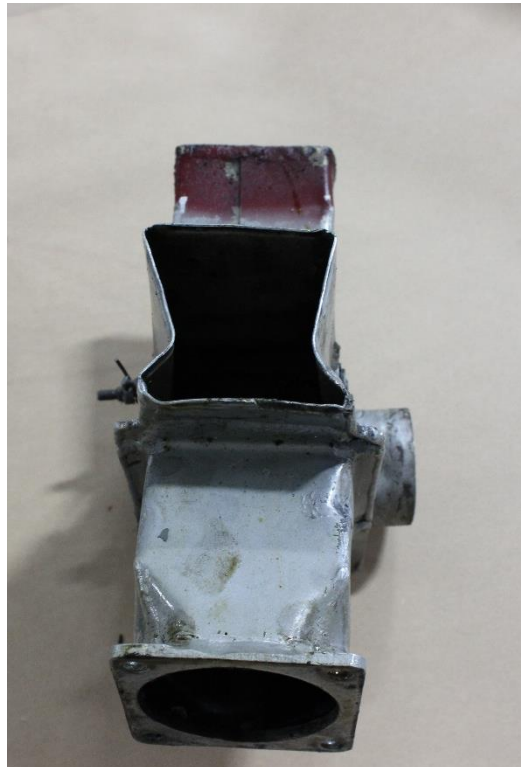
*Photo 3: Airbox*

The airbox sustained impact damage, but appeared to have been welded several times over it's lifespan on the corners. Once such weld failed and there was a fracture present. The surface of the fracture contained one area of shiny metal, consistent with a recent fracture as well as one area of darkened metal, consistent with a fracture that had been present for some time. The internal valve could not be manipulated due to crushing damage.

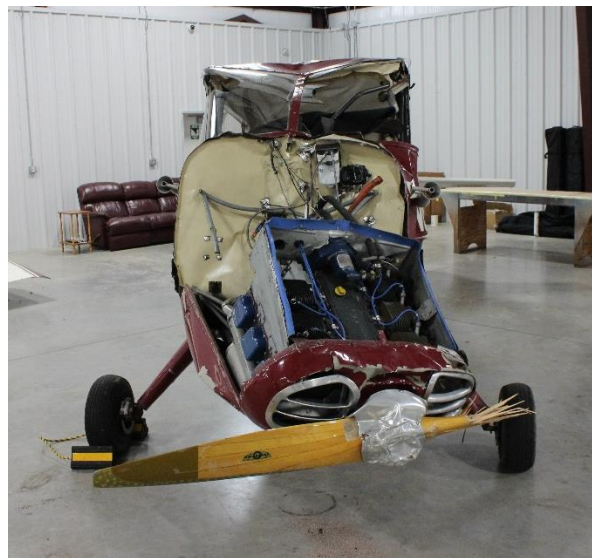
*Photo 5: Airplane*

The engine was displaced down and to the right with fractured engine mounts. The engine remained attached to the airframe by the oil lines and electrical wiring. The firewall was crumpled, consistent with impact damage. The spinner was crushed. One propeller blade was shattered and the other remained unremarkable.

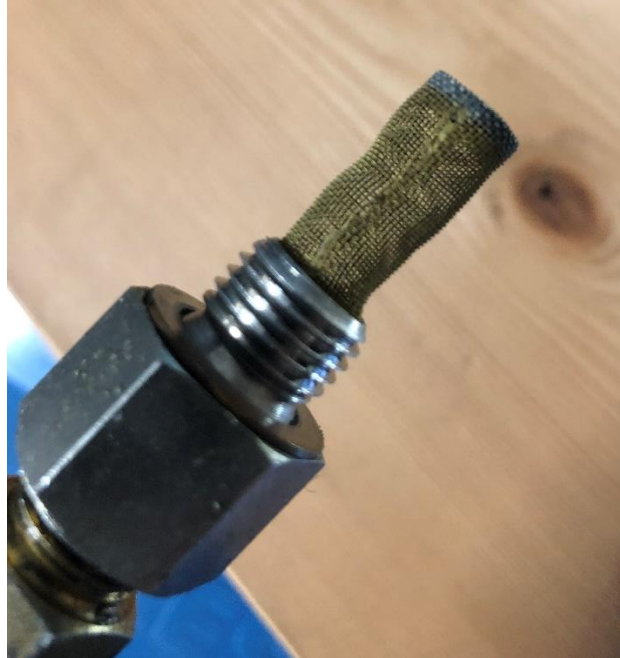
*Photo 6: Fuel Screen*

The carburetor was removed and when the throttle arm was manipulated, fuel was ejected from the nozzle, confirming that fuel had been present and the injector pump was functional. The carburetor was retained for further examination. Upon inspection, about a week later, the float bowl was absent of any fuel. The fuel screen was removed and was free of any debris.

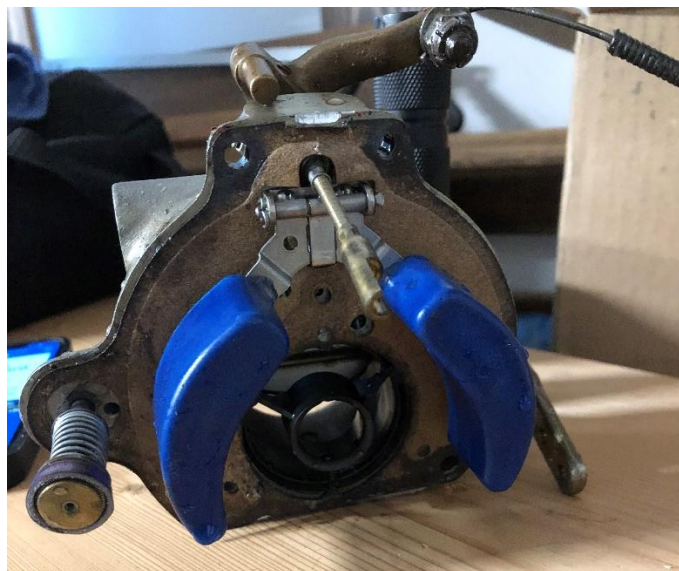
*Photo 7: Carburetor Floats*

The floats were inspected and found to be unremarkable. No defects or anomalies were noted with the carburetor.

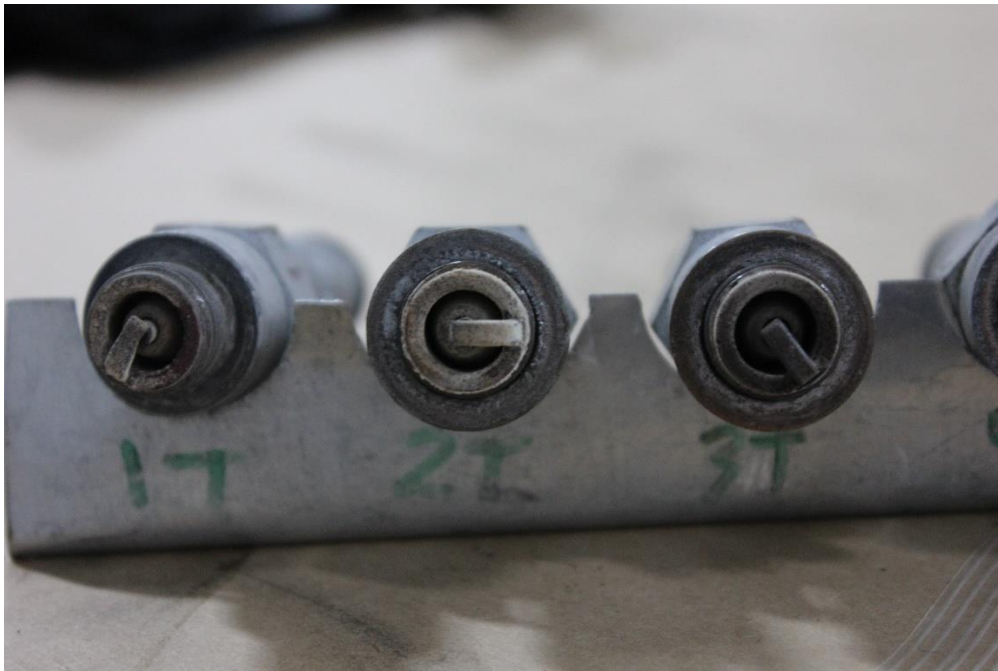
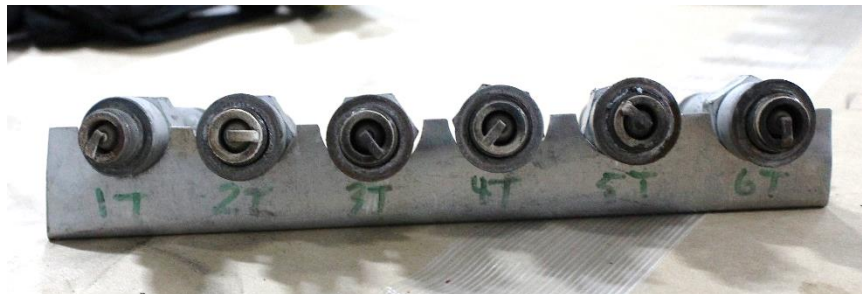
The spark plugs were removed for inspection and the insertion of a lighted borescope. The top spark plug from the No. 2 cylinder was a bright white, consistent with exposure to high heat. While the other top plugs displayed some white discoloration, it was not to the extent of the No.2.

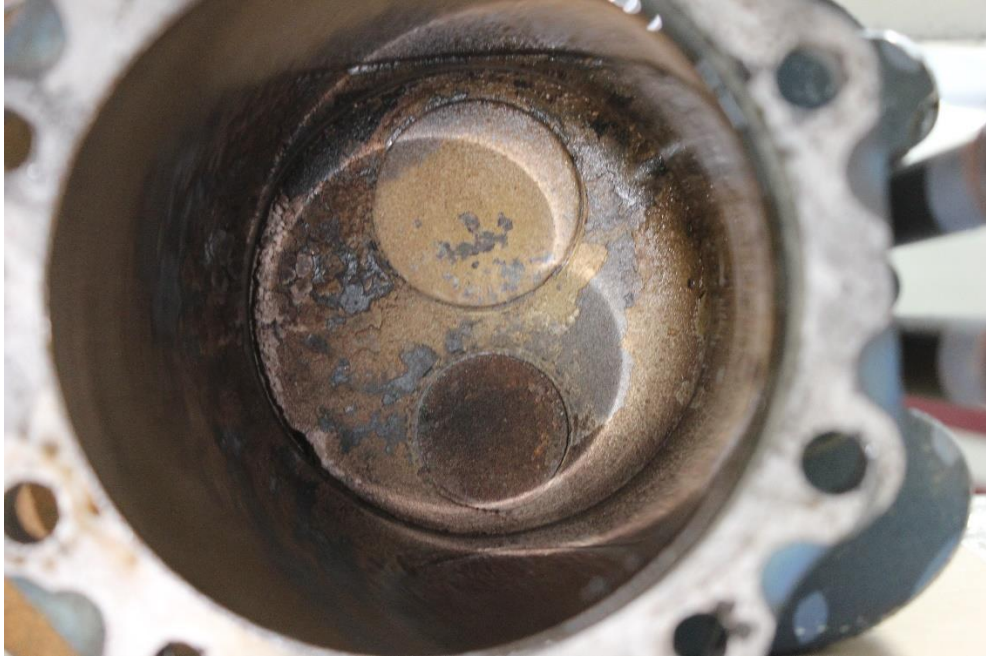
*Photo 10: Engine Cylinder*

The No. 5 cylinder was removed for further examination after anomalies were observed during a borescope of the cylinder. The edges of the piston had started to erode away and the piston head was in a poor condition. The inside of the cylinder
