**SUMMARY OF AIRPLANE EXAMINATION**

-- CEN22LA018 --

Aircraft: Cessna 210, N1235U

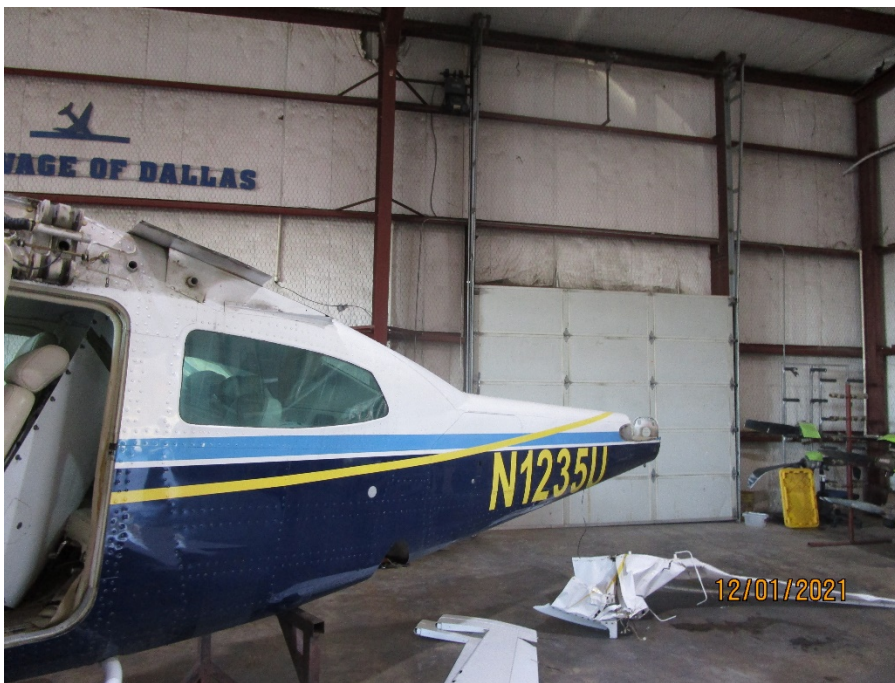
- The engine mounts were broken and there was heavy damage to the airplane. An engine test run was not able to be performed.
- The fuselage (with engine) was placed on stands; the wings which had been moved for transport, was aside the fuselage.
- The 3-bladed propeller remained attached to the engine crankshaft flange, the blades were absent indications of engine power.
- A visual inspection of the engine did not reveal a reason for a loss of engine power
- The engine driven fuel pump was removed; the pump turned freely, and the drive shaft was intact.
  - The pump was disassemble, gasket appeared hard, but otherwise the pump was clear of any debris or contaminates.

Figure 1: Accident airplane on stands

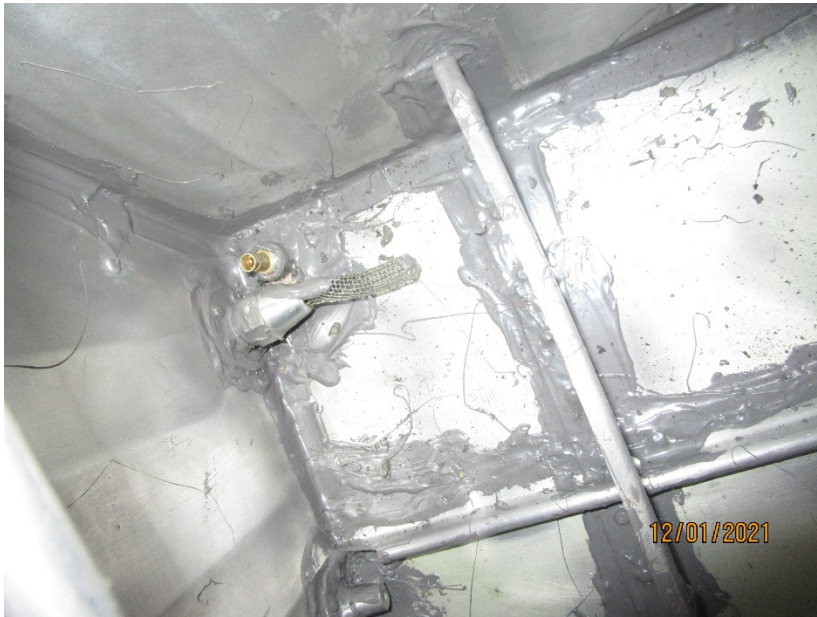
- Both left and right wing fuel tanks were opened. The tanks were dry and appeared free of contaminants.
- Shop air was blown in the fuel lines at the wing roots (left and right sides), fuel/air was observed at the engine.

Figure 2: Inside wing fuel tank

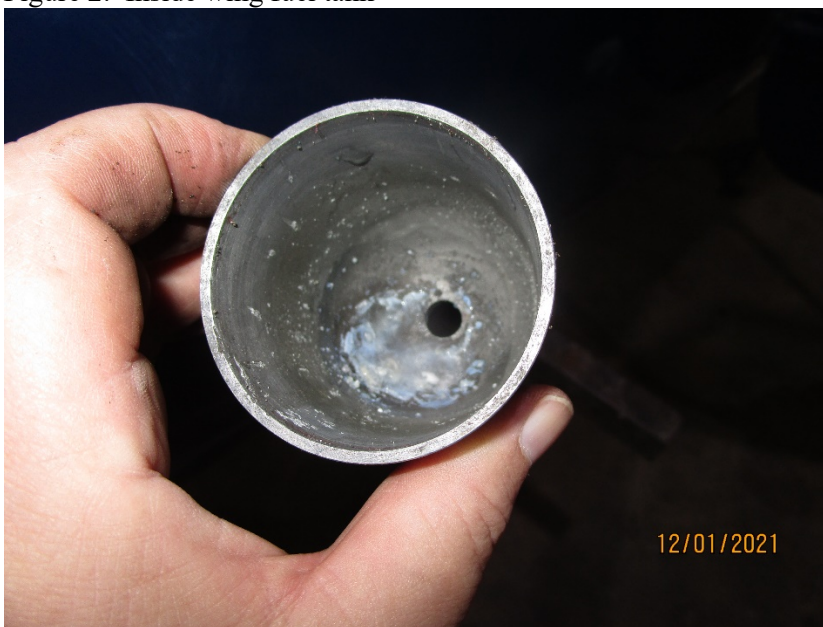
- Thumb compression and suction test on each cylinder was performed. Continuity thru the valve train and accessory drive was confirmed.
- The fuel strainer was opened: a milky-white substance was noted.

Figure 3: Unidentified contaminates in gascolator
