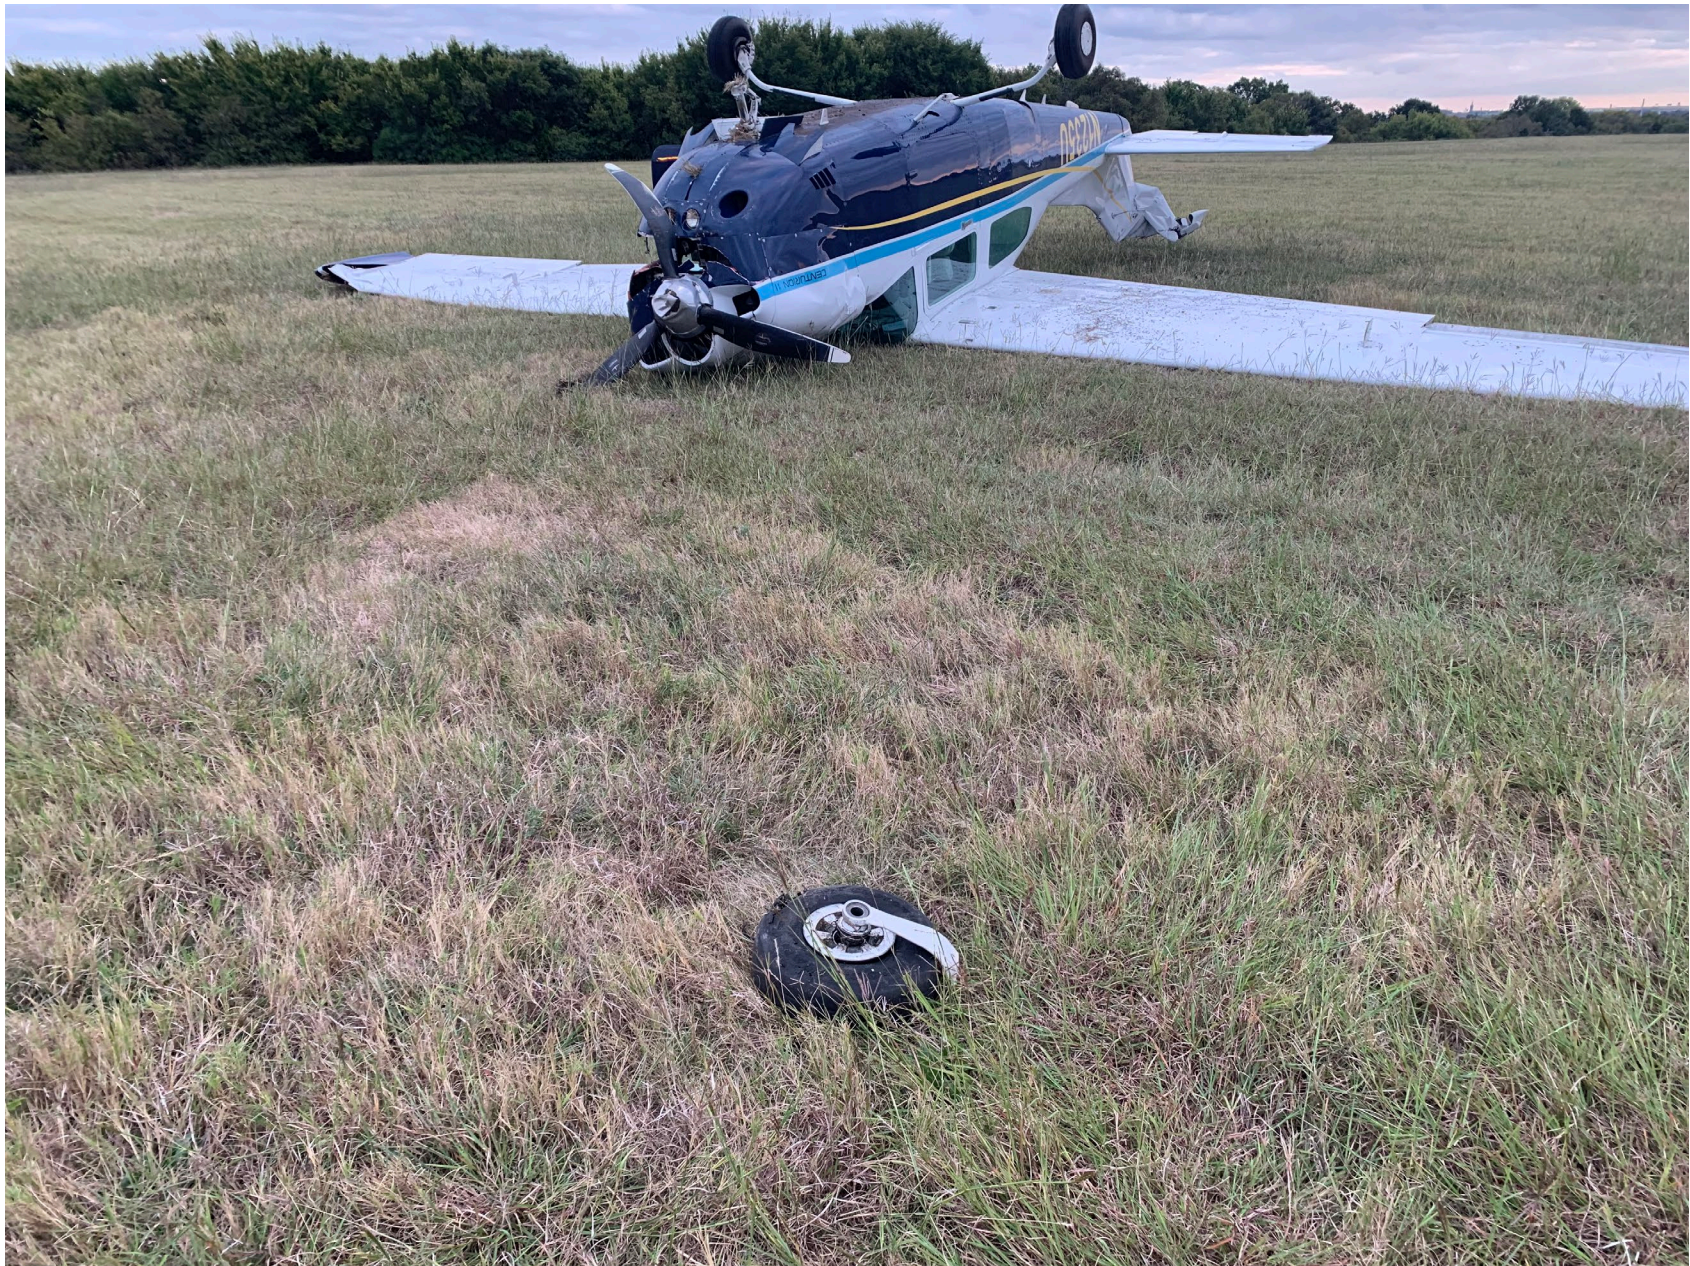
**Photo 1 – Front view of the inverted airplane (courtesy of the Federal Aviation Administration).**

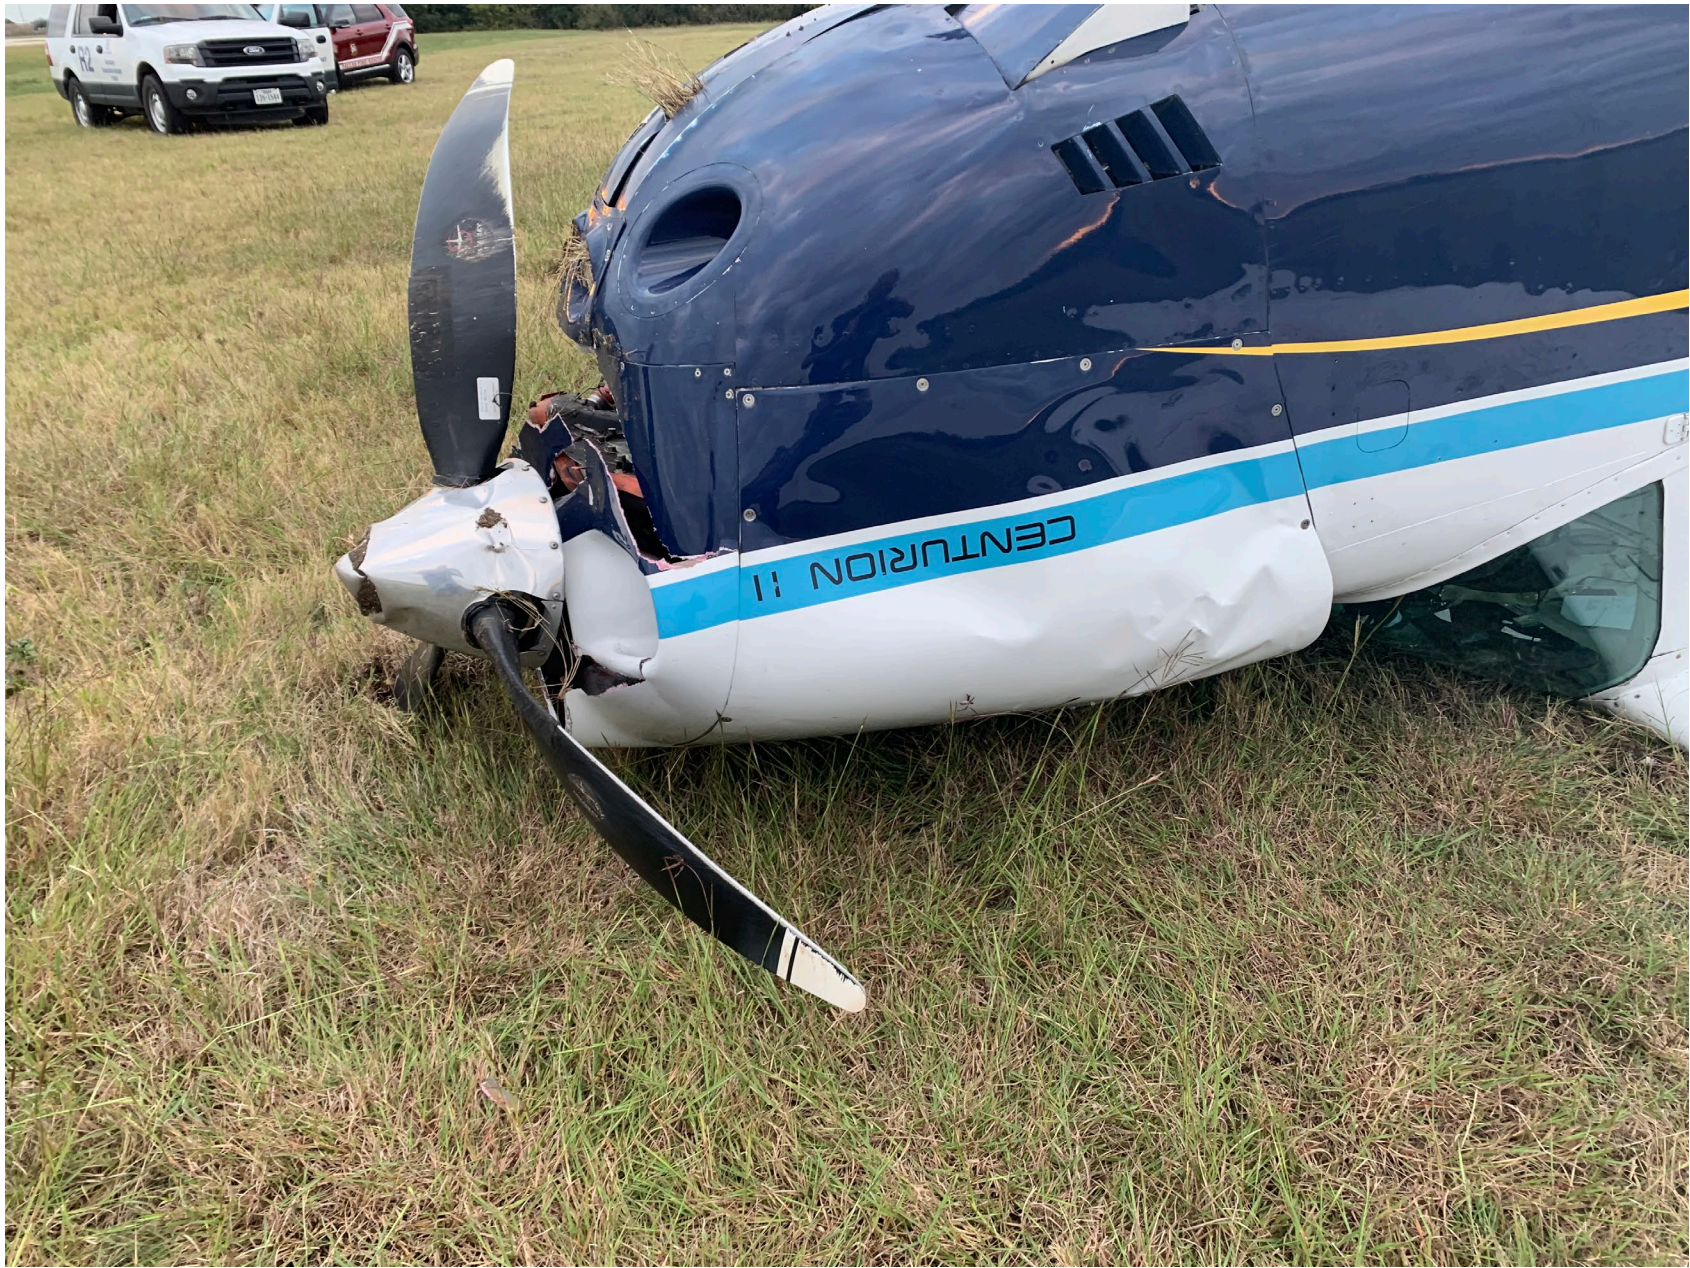
**Photo 2 – View of the right side engine area and propeller (courtesy of the Federal Aviation Administration).**

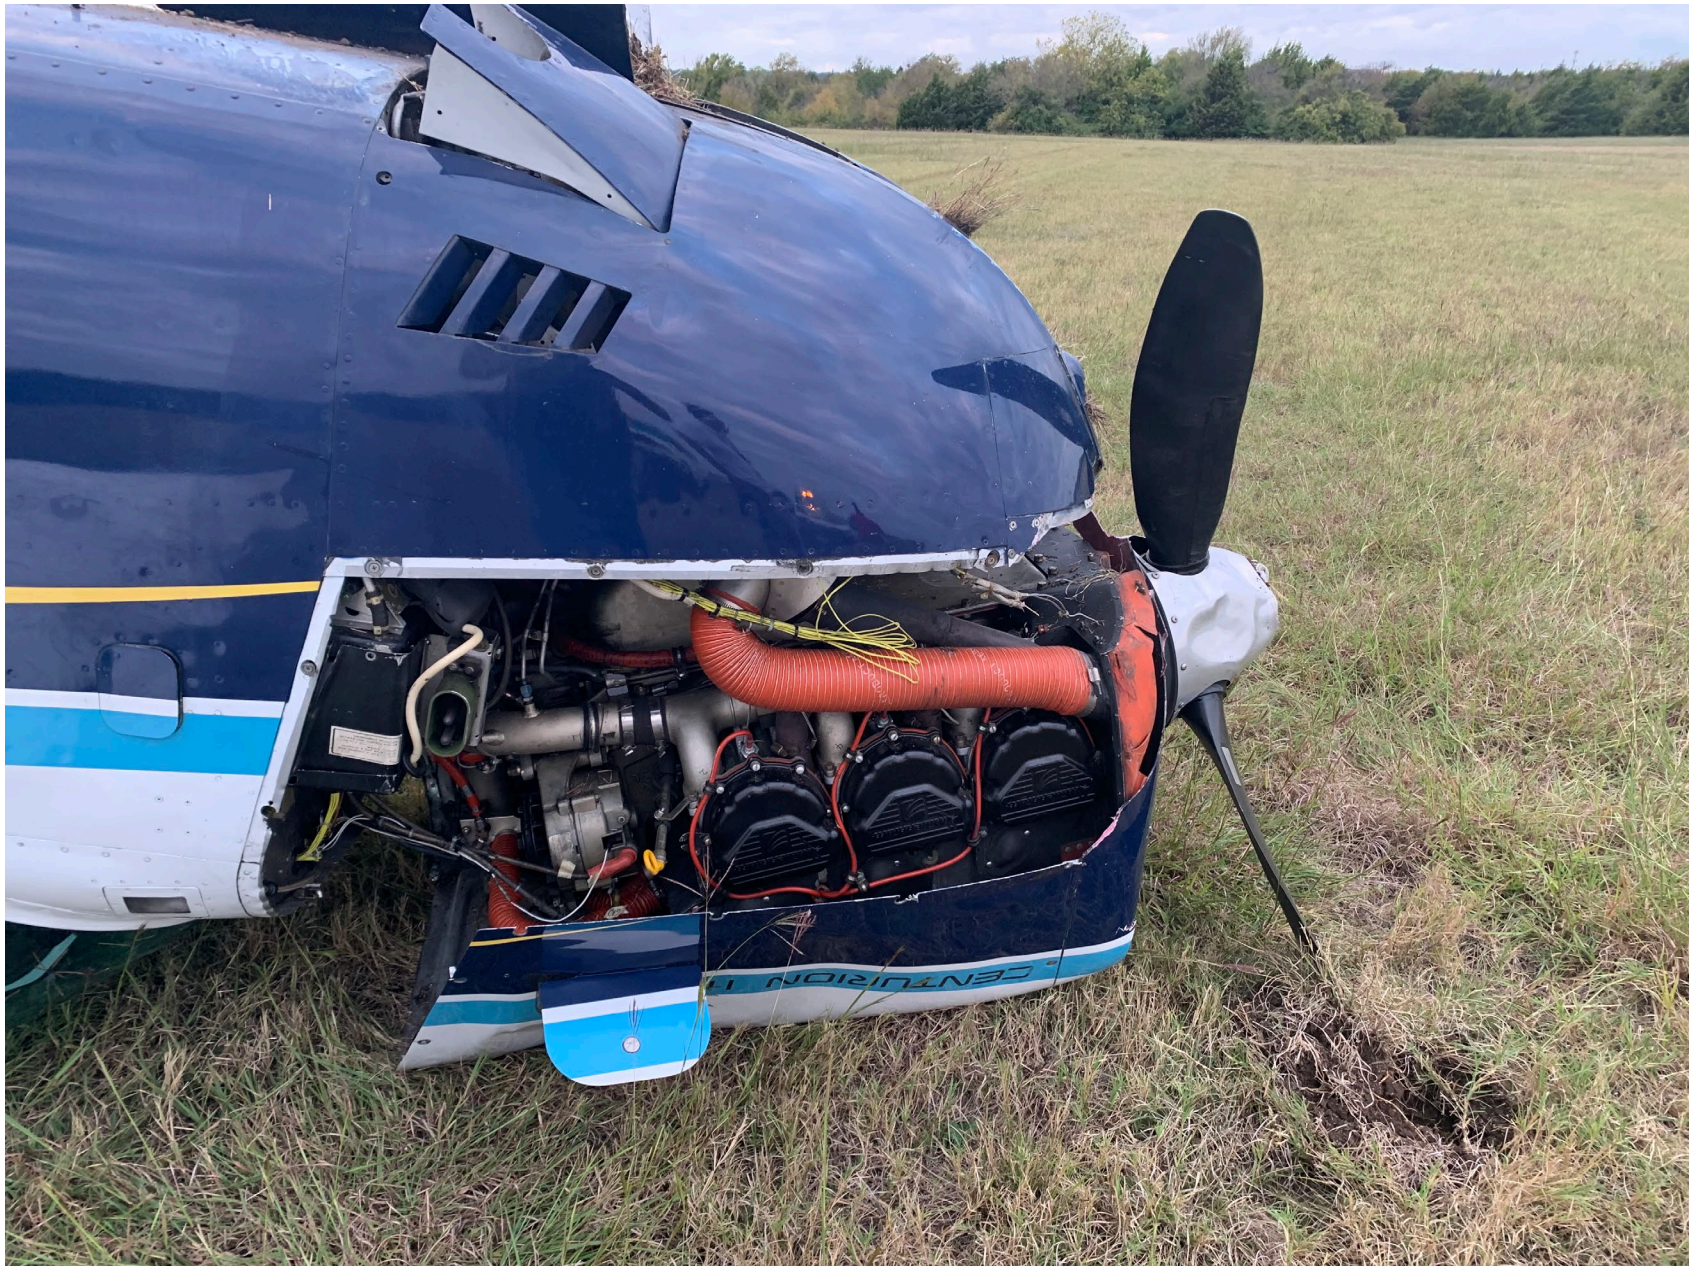
**Photo 3 – View of the left side engine area and propeller (courtesy of the Federal Aviation Administration).**

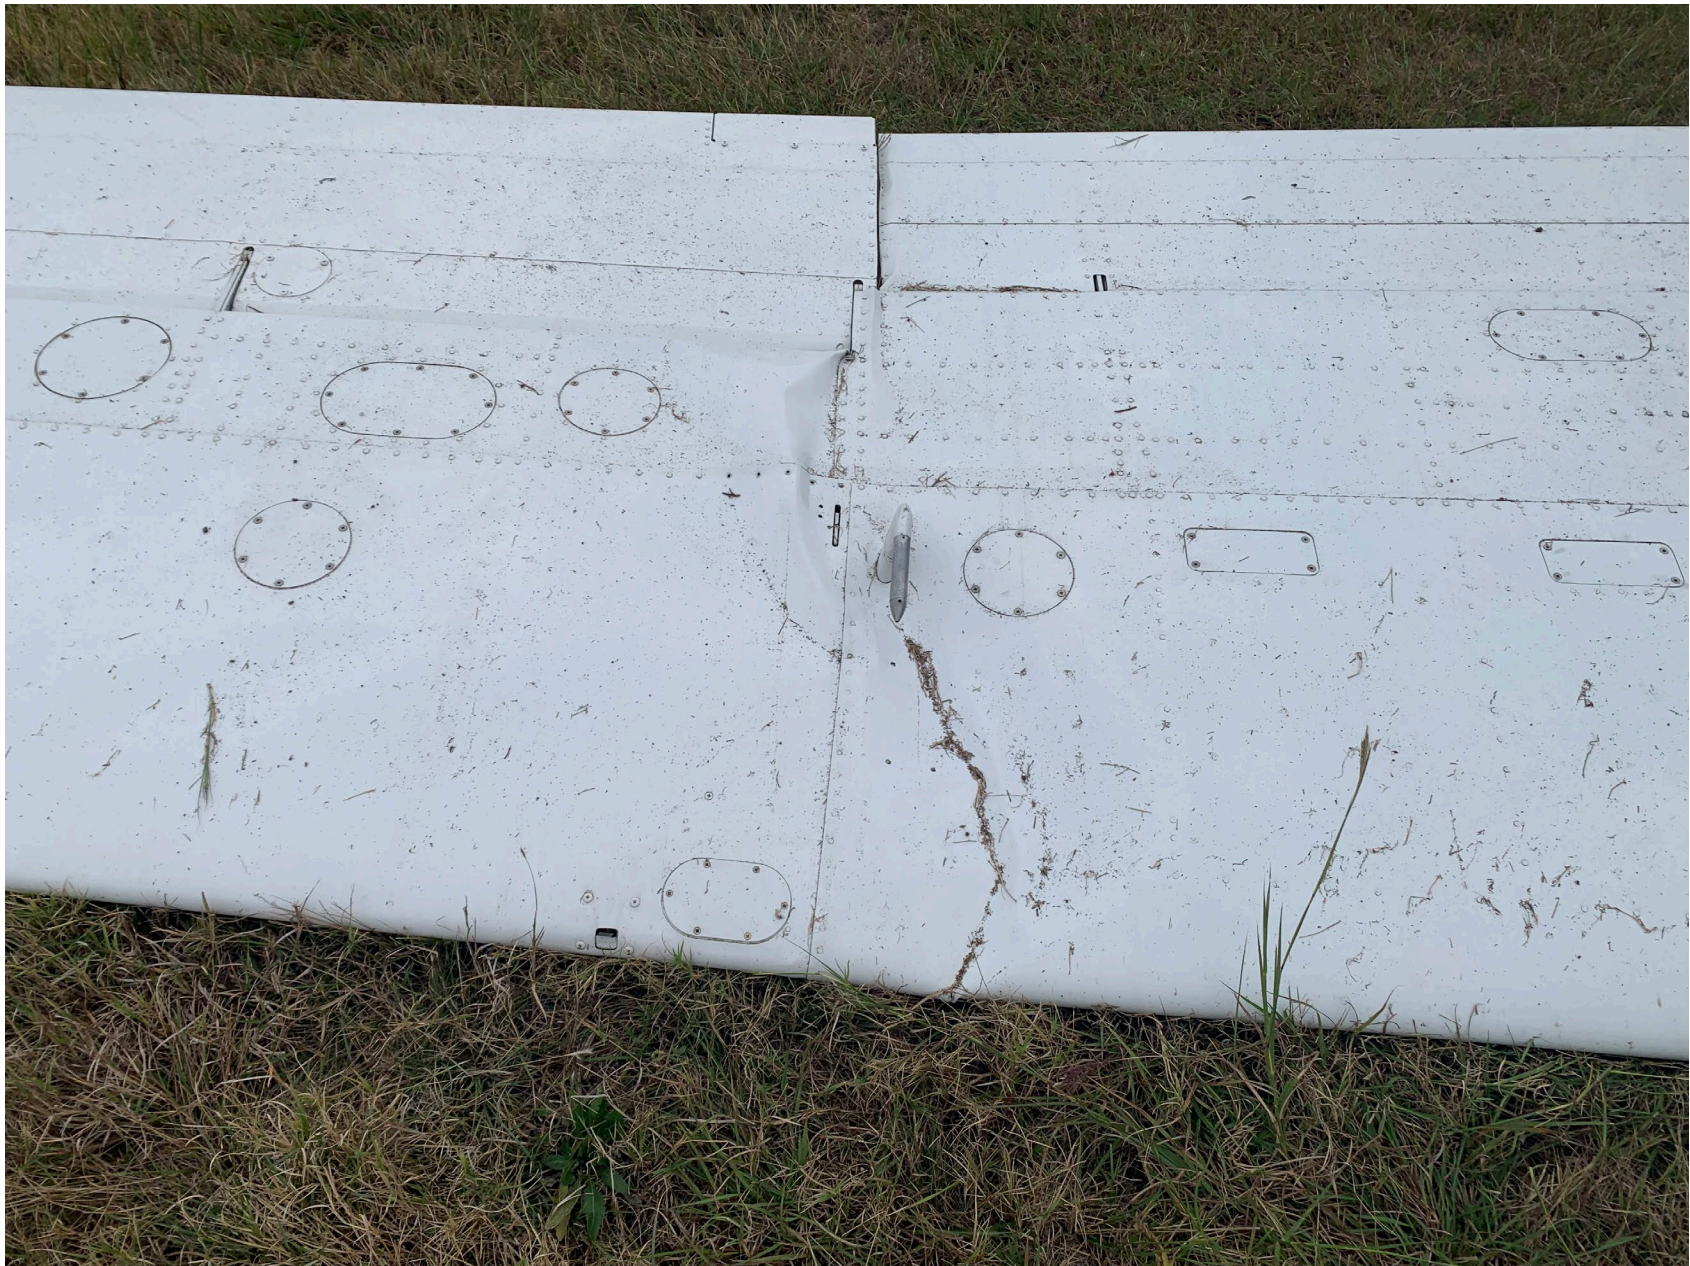
**Photo 4 – View of the substantial damage sustained to the left wing (courtesy of the Federal Aviation Administration).**

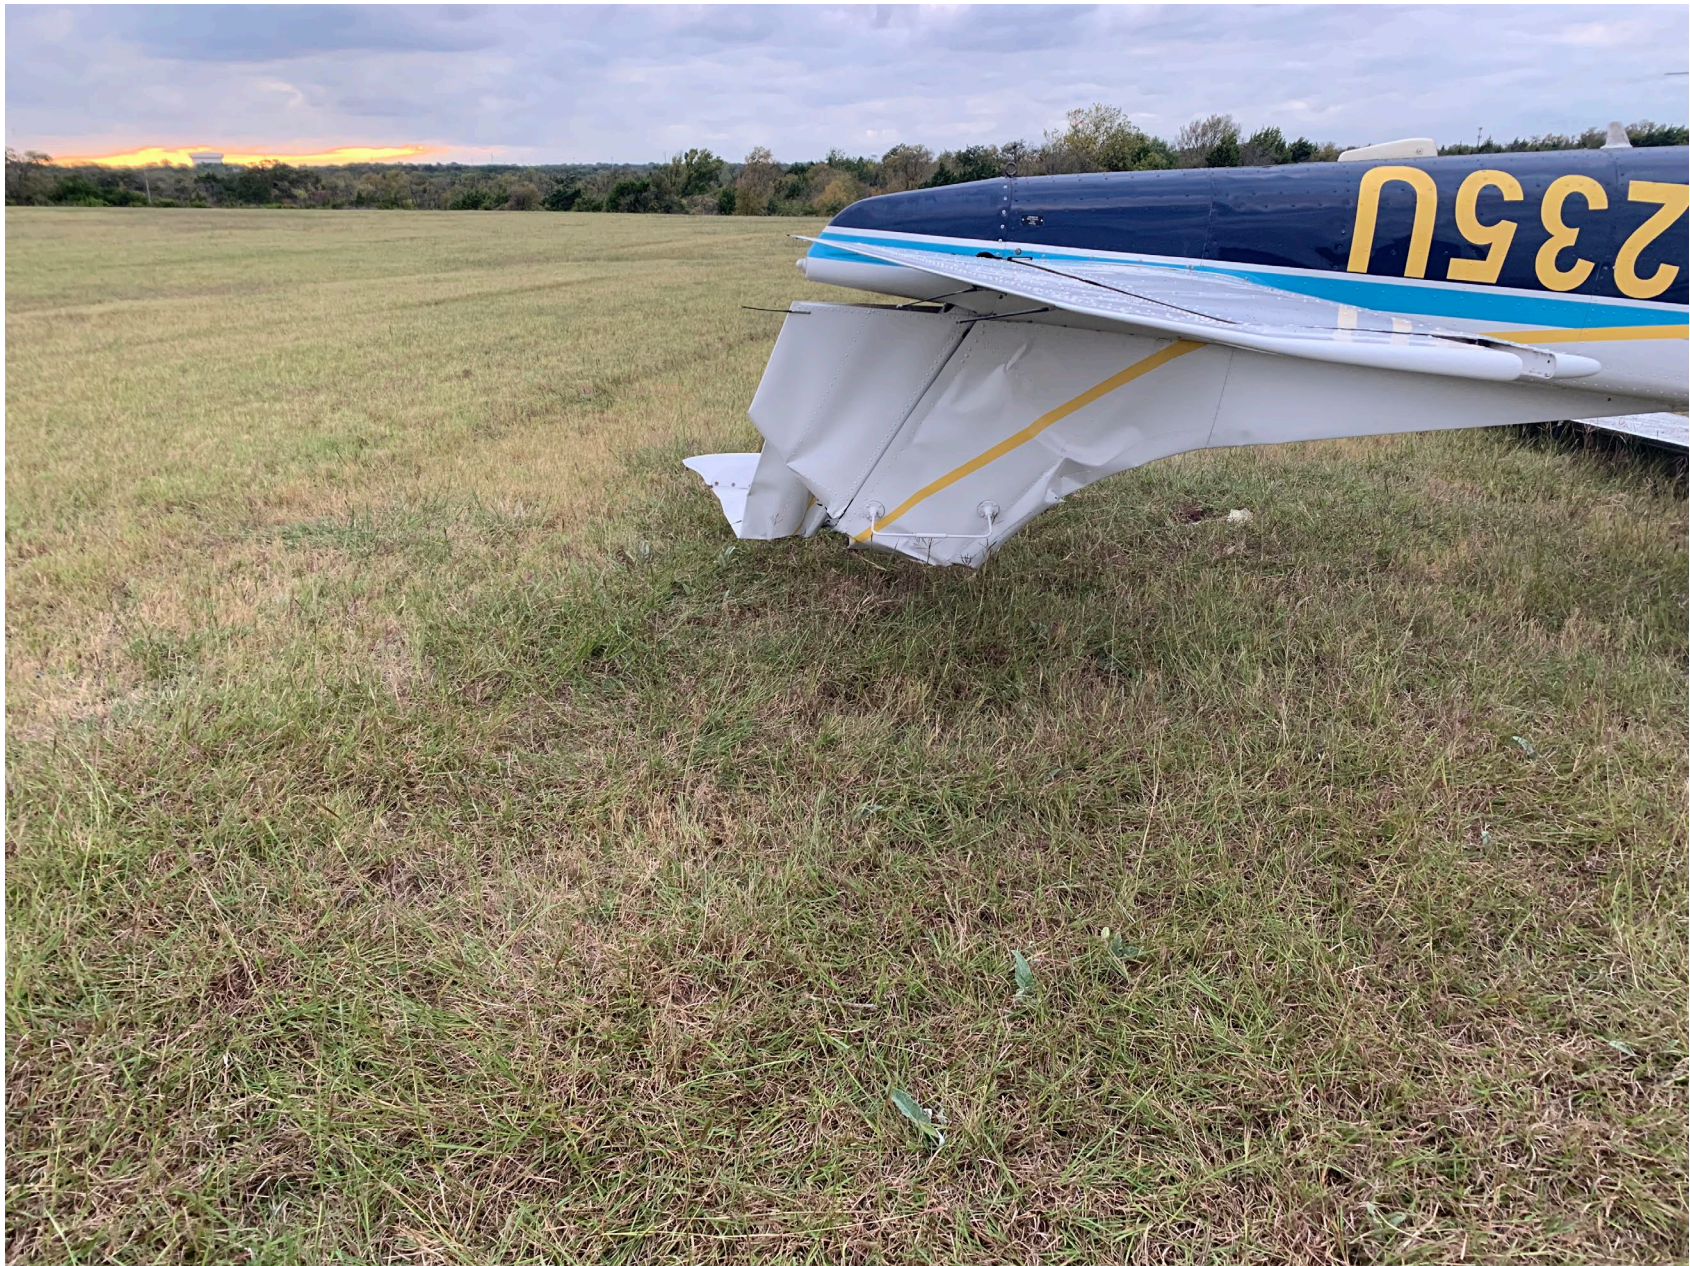
**Photo 5 – View of the substantial damage sustained to the empennage (courtesy of the Federal Aviation Administration).**

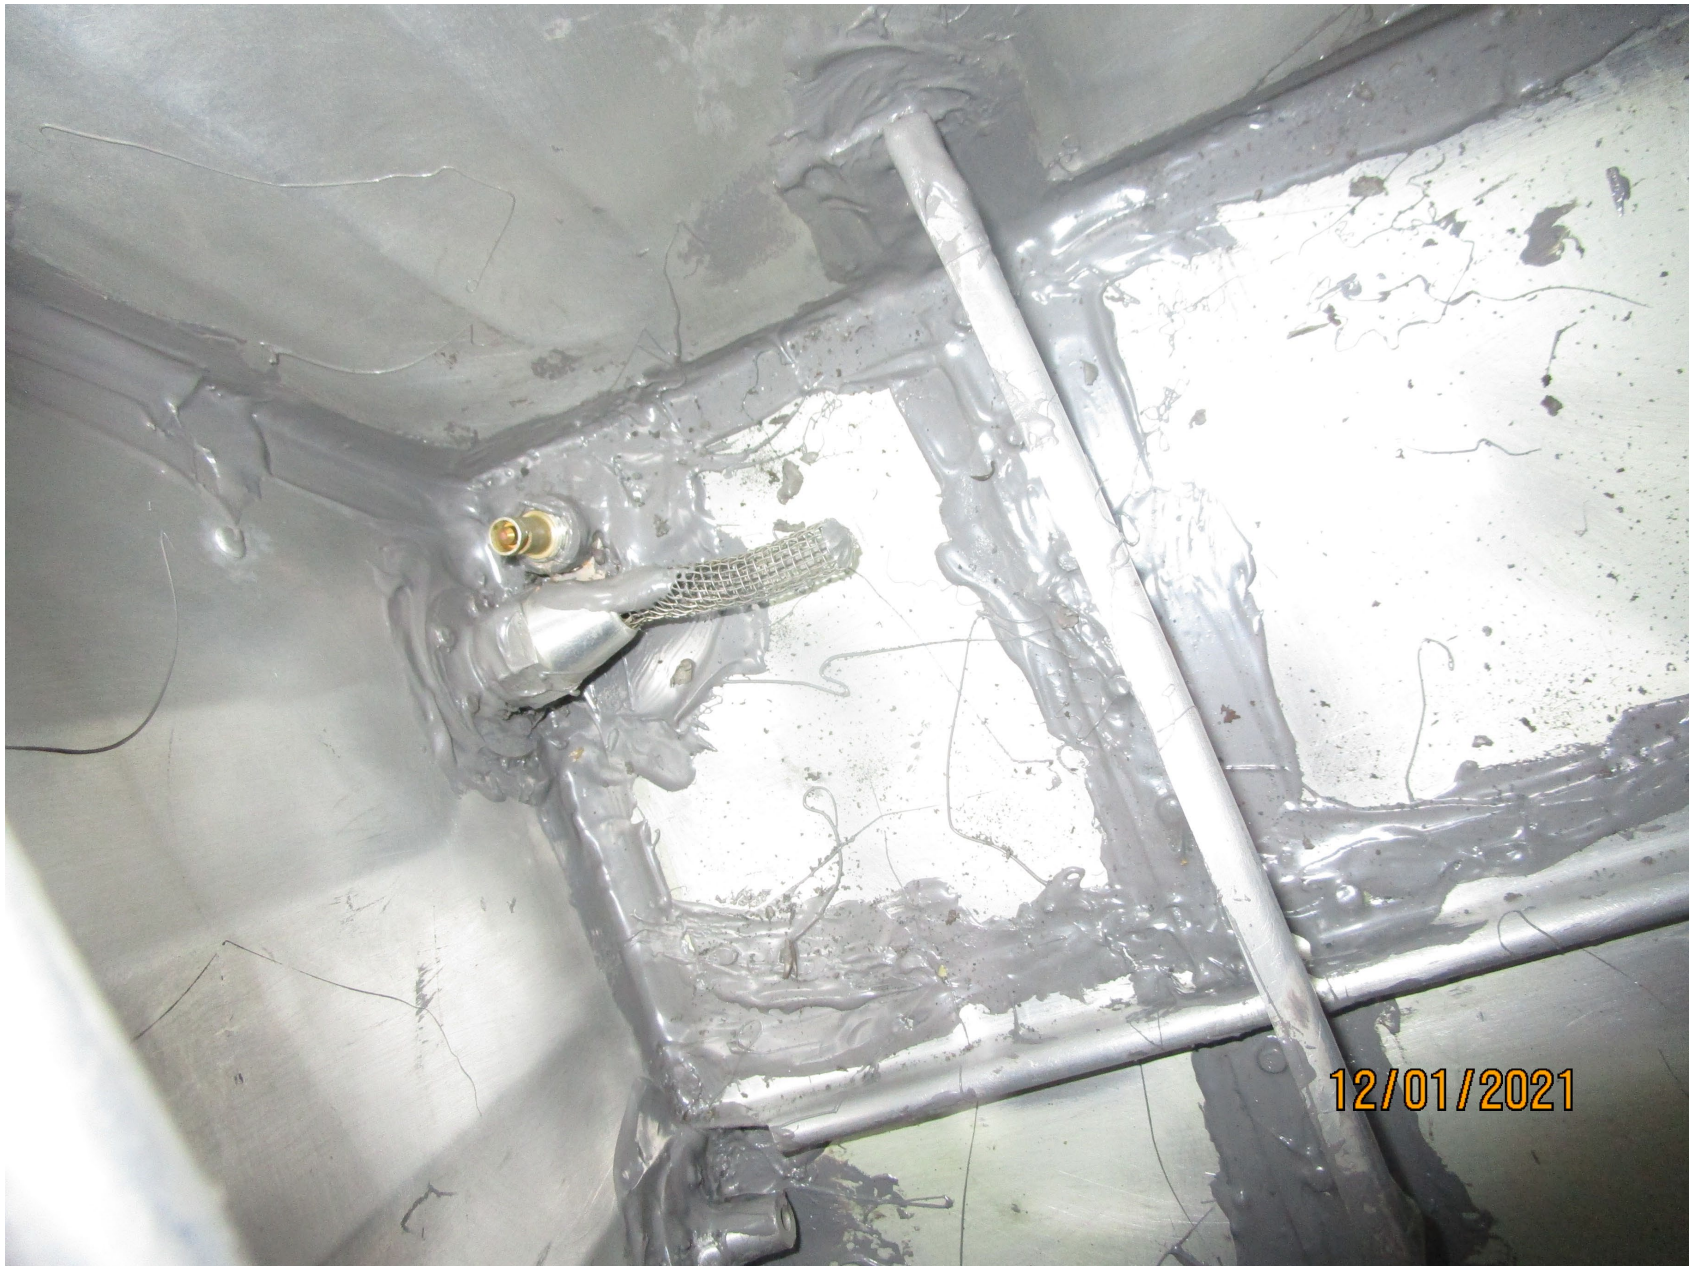
**Photo 6 – View of the interior of the left fuel tank.**

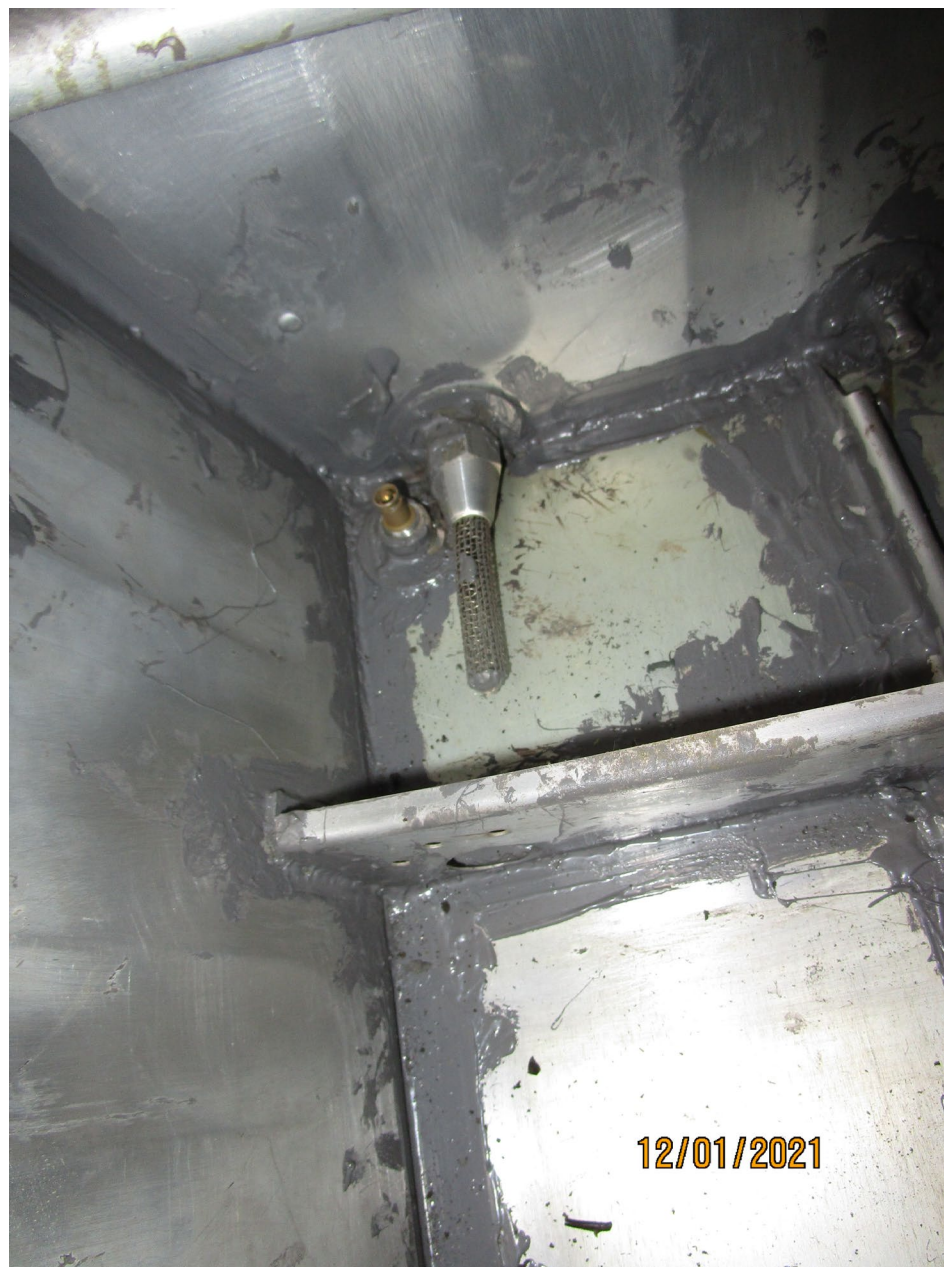
**Photo 7 – View of the interior of the right fuel tank.**

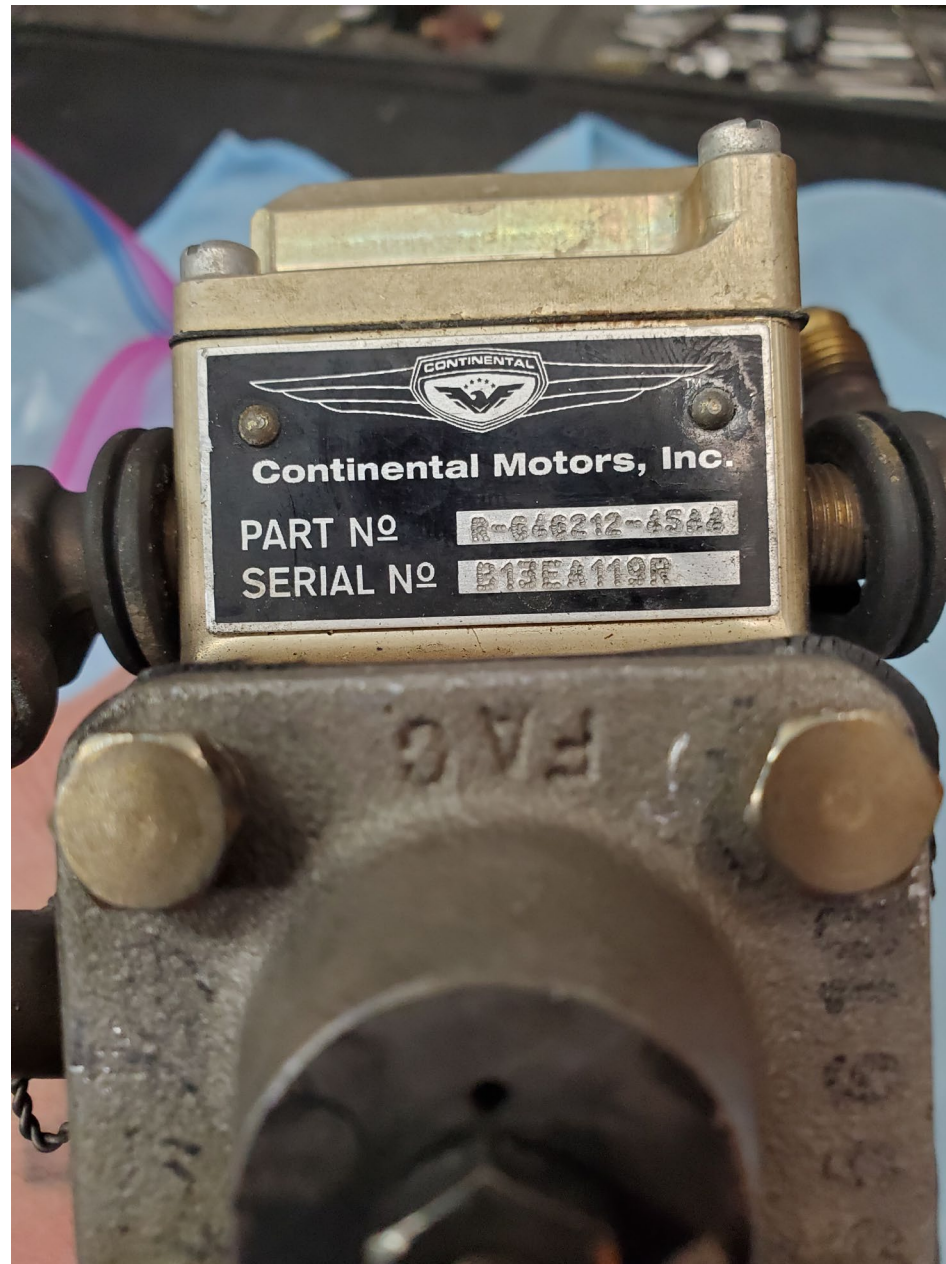
**Photo 8 – View of the fuel pump data plate (courtesy of Aircraft Accessories of Oklahoma).**

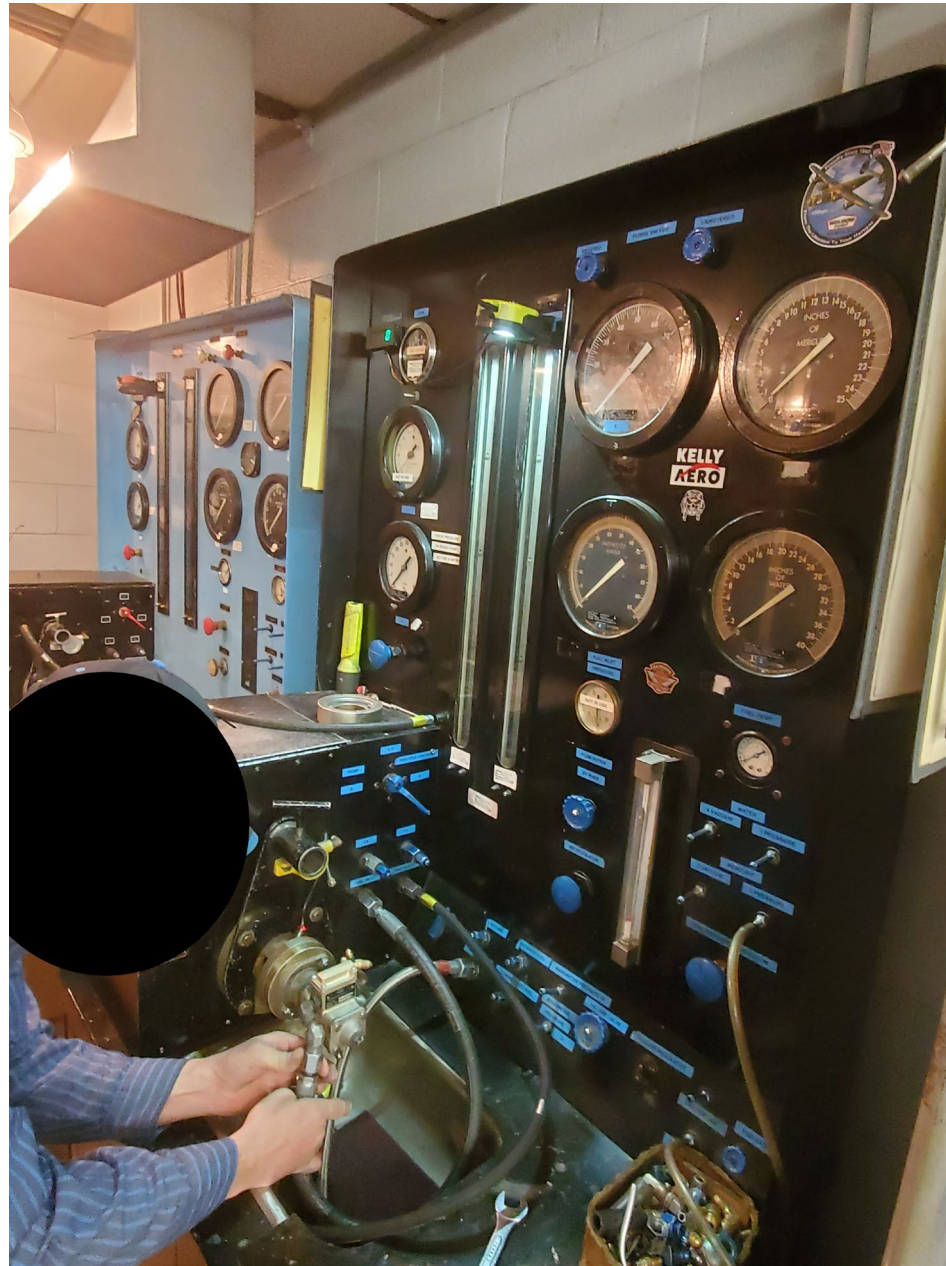
**Photo 9 – View of the fuel pump being tested (courtesy of Aircraft Accessories of Oklahoma).**

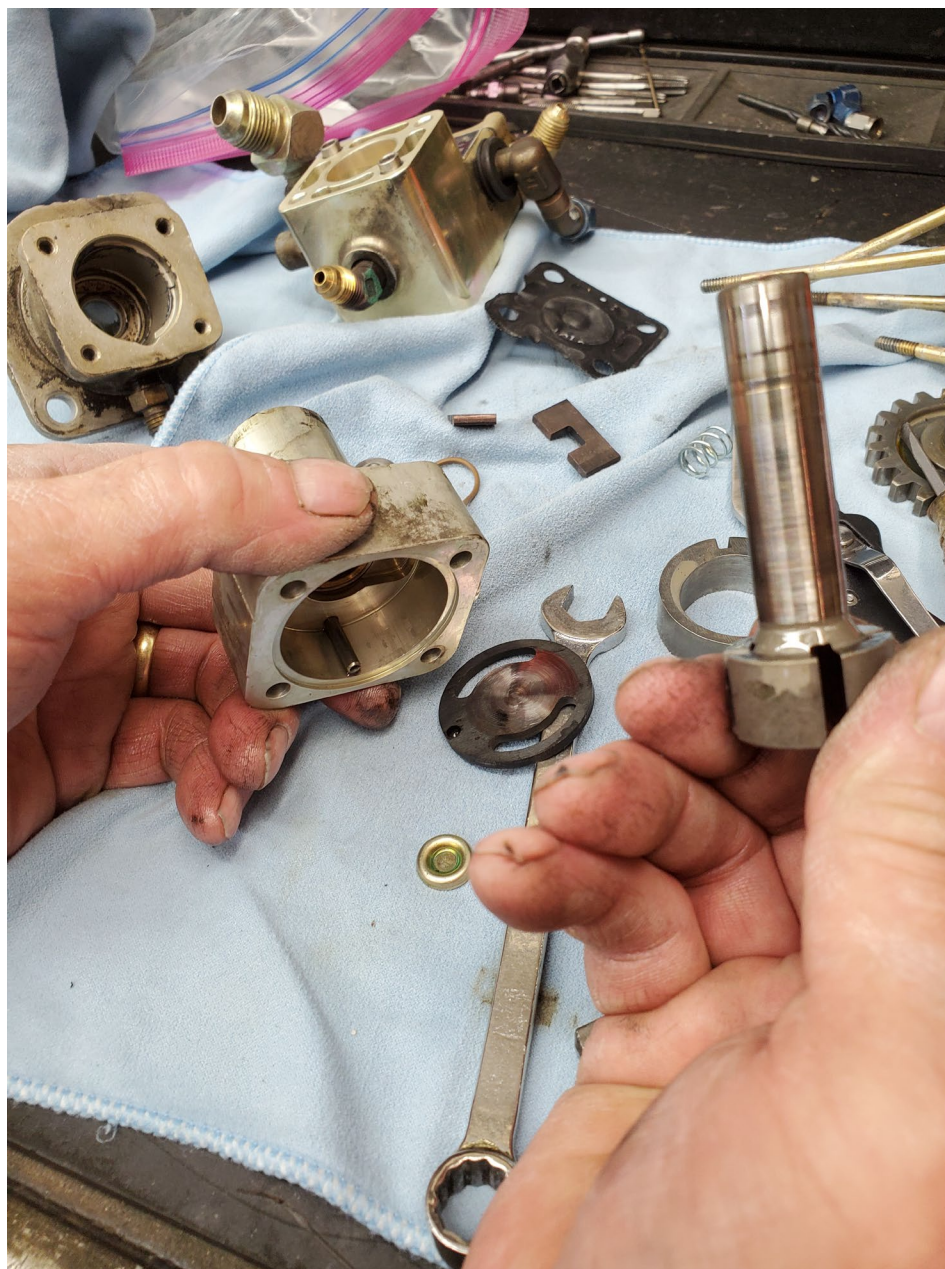
**Photo 10 – View of the fuel pump being disassembled (courtesy of Aircraft Accessories of Oklahoma).**
