# MANDATORY Service Bulletin Fuel Systems

Bulletin No.: MSA-13

**SUBJECT:    REPLACEMENT OF CARBURETOR FLOATS WITH  
NEW FOAM FLOATS**

### **SUBJECT – Required Replacement of Foam and Hollow Floats**

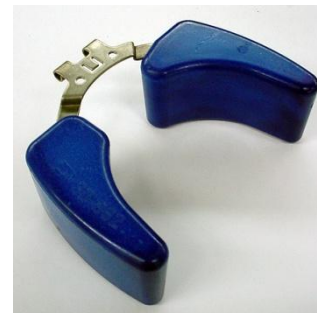
GOOD Large MA Float (BLUE)
