## Mike's Aircraft Fuel Metering Service

I have had a chance to tear down and visually inspect the condition of the Marvel Schebler carburetor that you sent to us from Accident Number CEN22LA027 (Model MA-3A, P/N 10-3103-1, S/N Y-41-3907). It was reported to us that this was involved in a loss of engine power in the traffic pattern. This was a teardown inspection only. I did not clean or do any additional inspection other than the visual teardown inspection. I will detail the various components below.

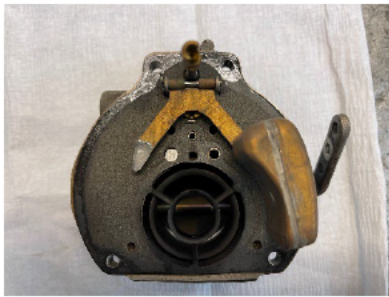
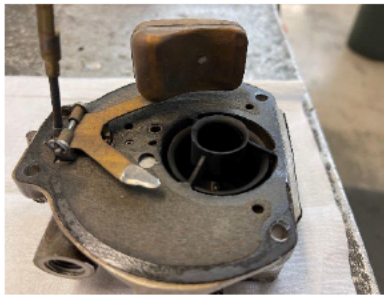
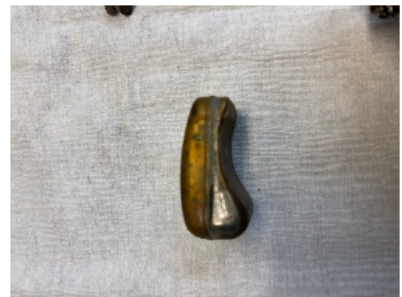
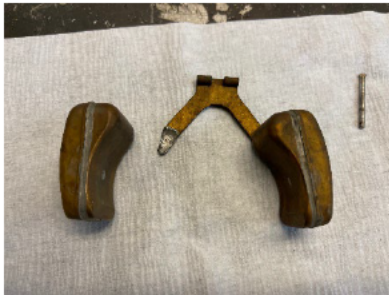
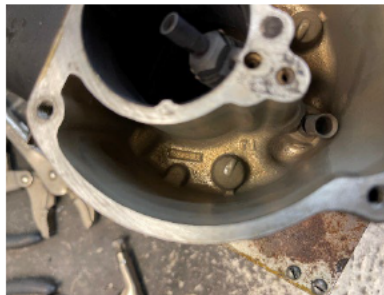
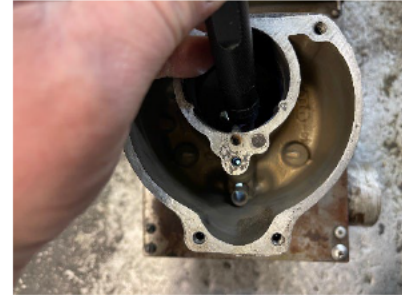
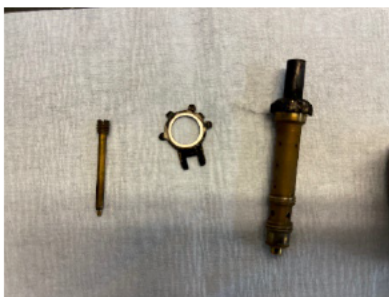
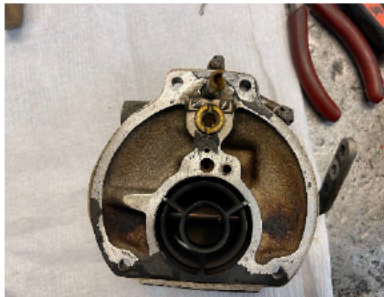
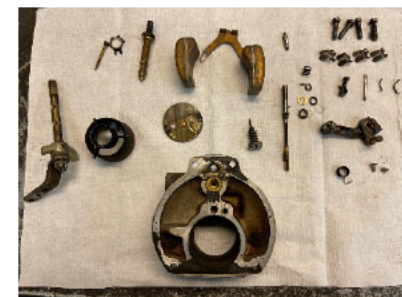
During disassembly, we found that the unit had a very old style of brass float. It does not use any type of clip or hanger to hold the needle. Also, one of the pontoons had detached from the float assembly arm. The rest of the carburetor appeared to be assembled correctly. The inside of the bowl was clean and did not show any signs of contamination. The throttle shaft, needle/seat assembly, mixture control shaft, nozzle, and idle tube, appeared to be in good condition and only have normal wear. The 4 screws that attach the throttle body and bowl were tight and no movement was observed between the halves. All lock washer appeared locked and undisturbed. The finger screen on the inlet adapter was missing.

In conclusion, I cannot rule out the pontoon that became detached from the float is a possible contributing factor to the issues that caused the loss of power. The pontoon most likely came detached due to the age of the float. The remainder of the carburetor appeared to be in working condition at the time of the inspection.
