## RECORD OF CONVERSATION

**Date: December 7, 2021**  
**Person Contacted: Mr. Tony Layton (Federal Aviation Administration Inspector)**  
**NTSB Accident Number: CEN22LA037**

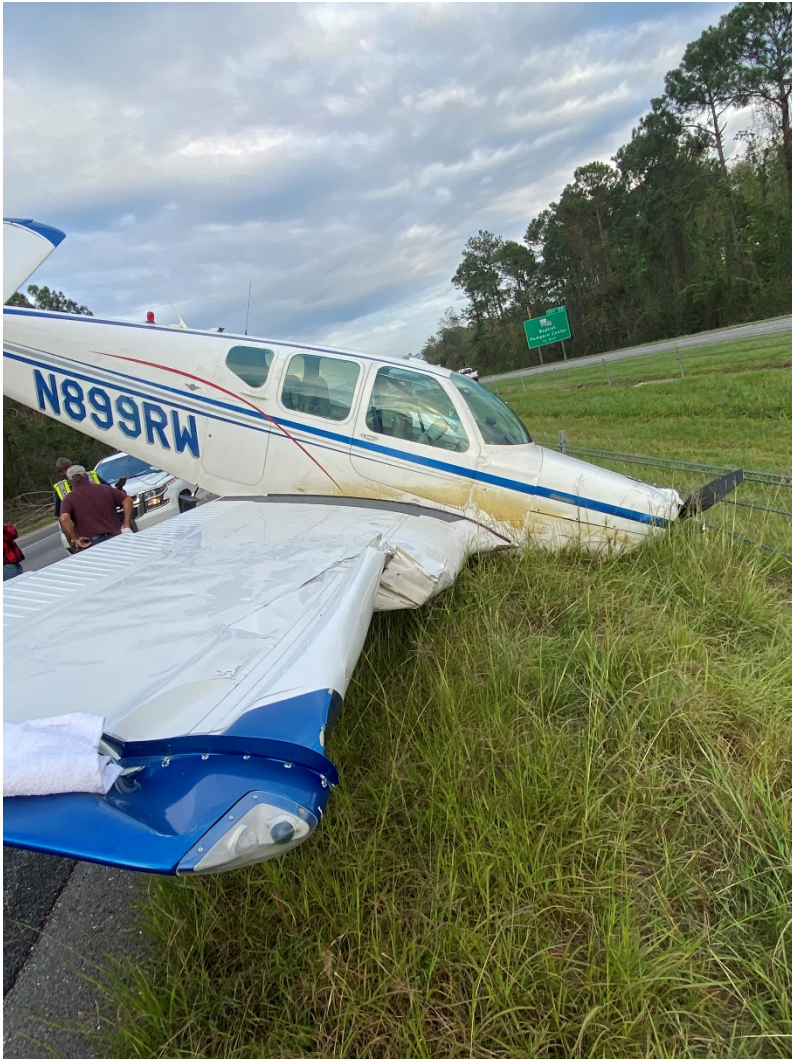
- On the day of the accident, he went on scene. He said the pilot/owner was very upset about what happened.
- Oil was noted along the bottom and right side of the airplane. Oil was also noted inside of the cowlings and on the engine components near the oil filter.

*Figure 1: Right side of Airplane*

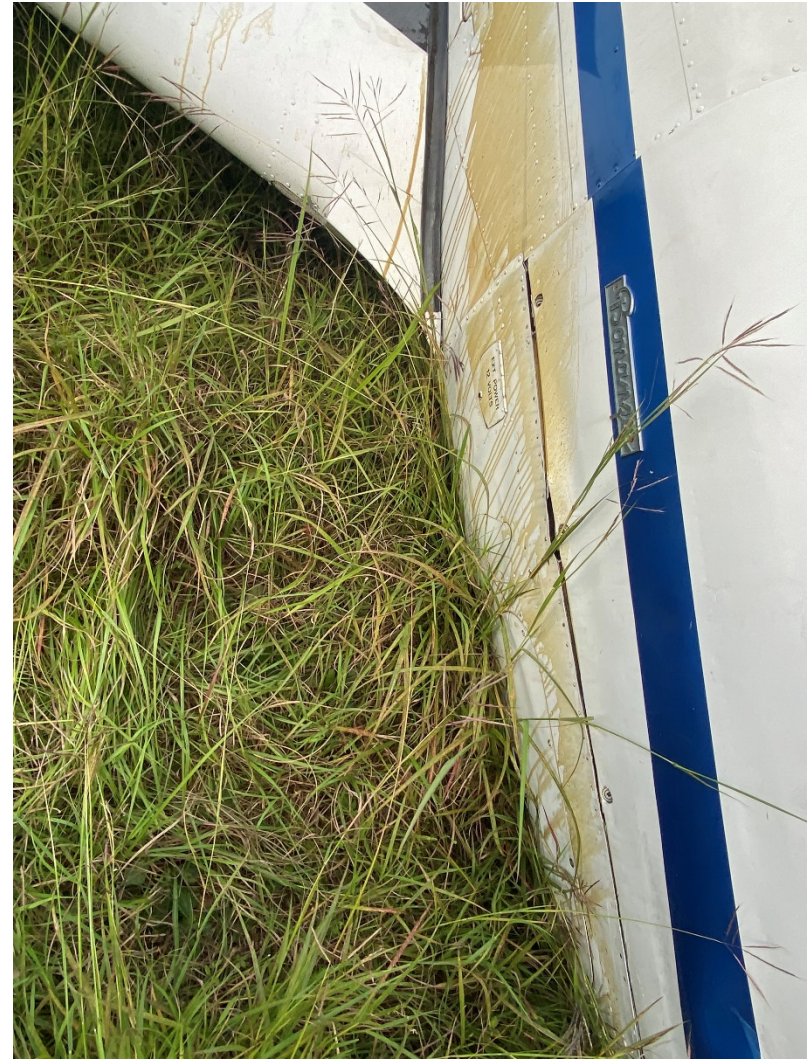
*Figure 2: Right Side Outside Cowling*

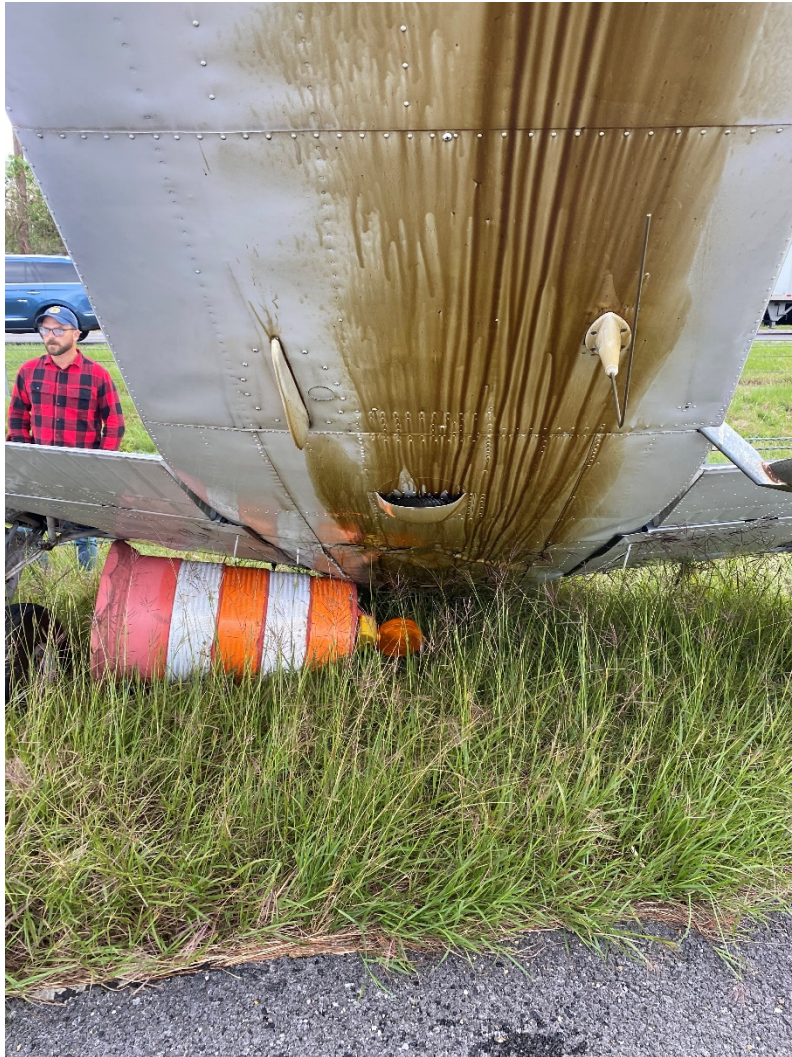
*Figure 3: Belly of Airplane*

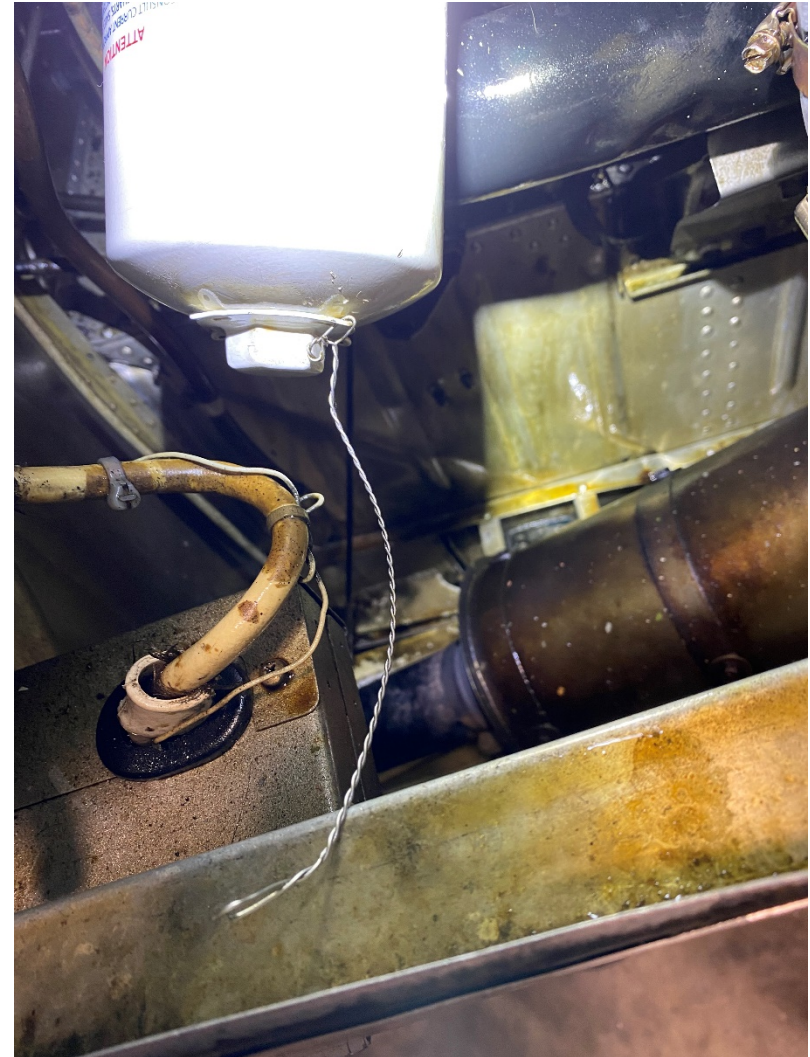
- The oil filter was loose and could be turned entire revolutions by hand.
- The pilot/owner mentioned he had recently changed the oil on the airplane but could not specify when. He further mentioned that he installed the safety wire onto the oil filter like he would a car.

*Figure 4: Inside Cowling Around Oil Filter*

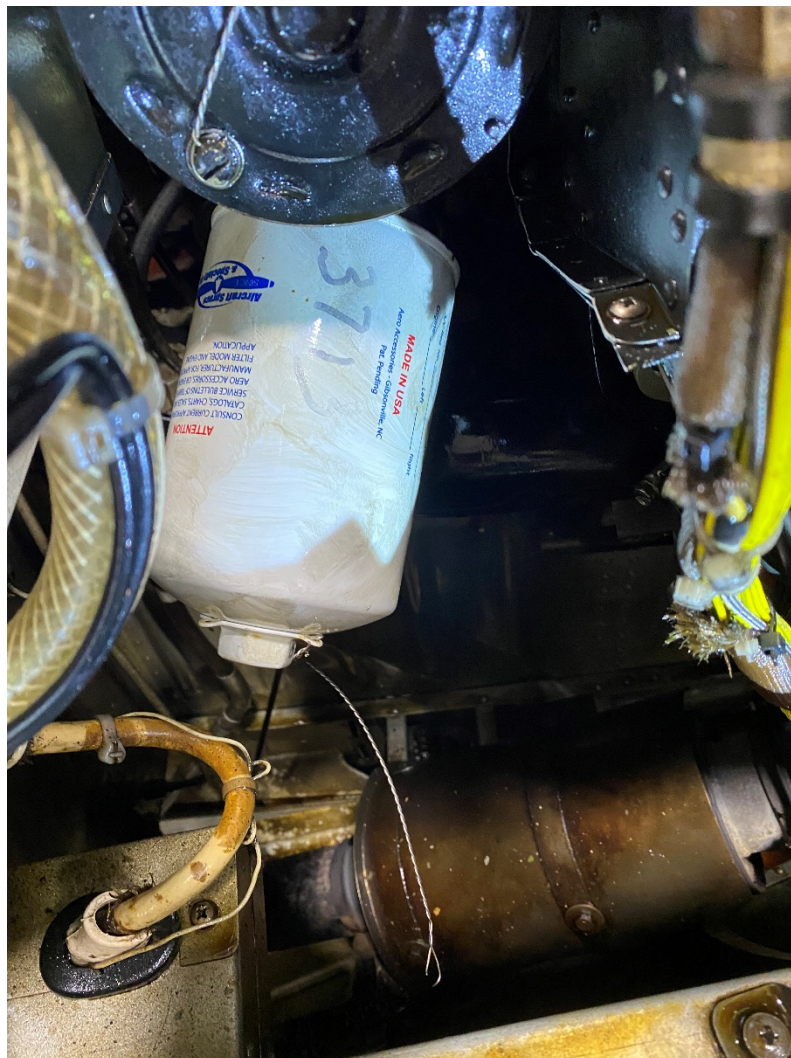
- The oil filter safety wire was observed fractured. One portion of the safety wire remained attached to the top of the oil filter. The other portion of the safety wire, which was described as “a small pig tail,” was found but the pilot/owner swiped it out of Mr. Layton’s hand before he could take a picture. After that, Mr. Layton was unable to find the piece of safety wire on the ground.

*Figure 5: Fracture Separated Safety Wire*
