**NATIONAL TRANSPORTATIONS SAFETY BOARD**  
**Office of Aviation Safety**  
**Washington, DC 20594**

**SUMMARY OF AIRPLANE EXAMINATION**

-- CEN22LA039 --

Aircraft: Beech A36TC, N1805D

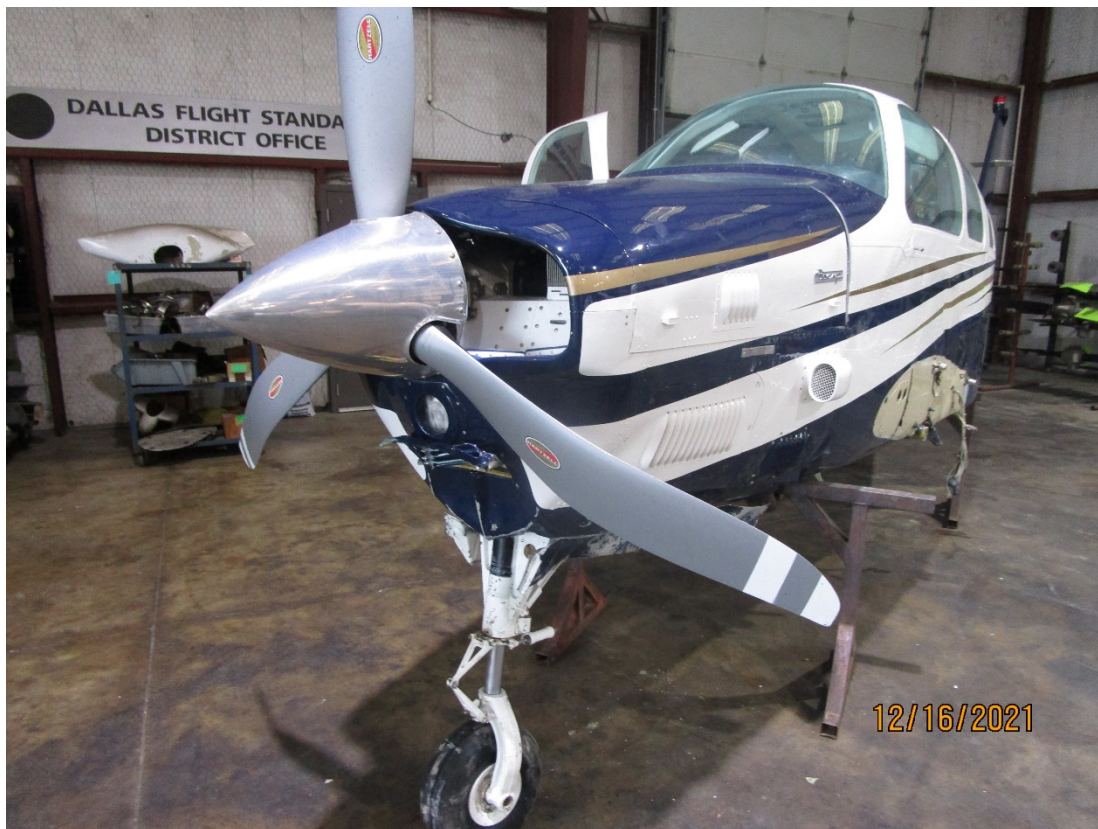
Airframe on stands, ready for exam

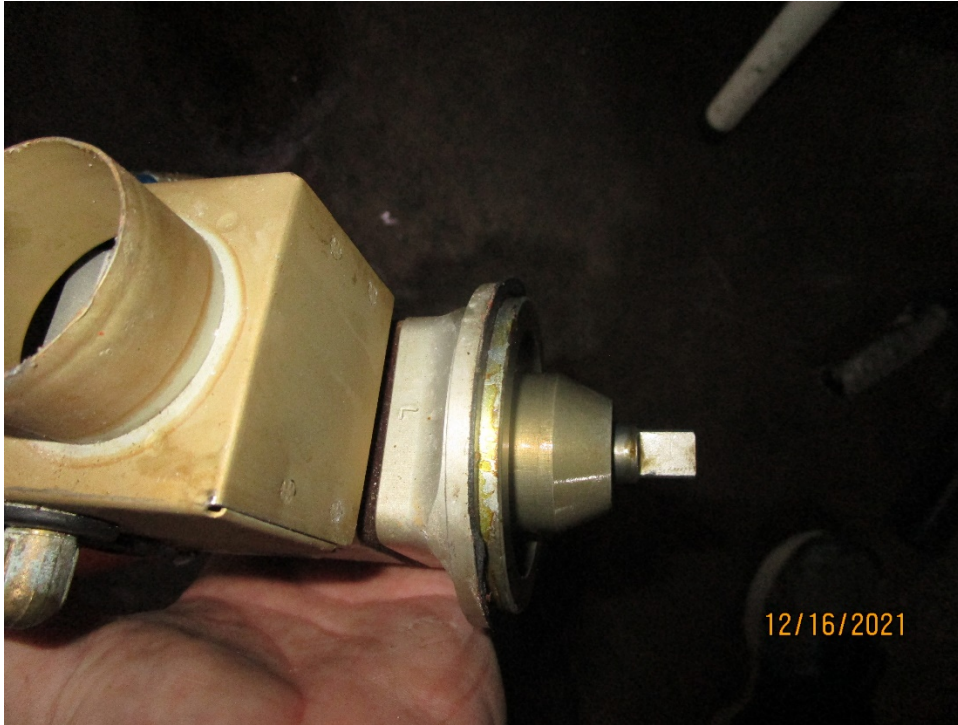
Fuel pump – drive spline intact

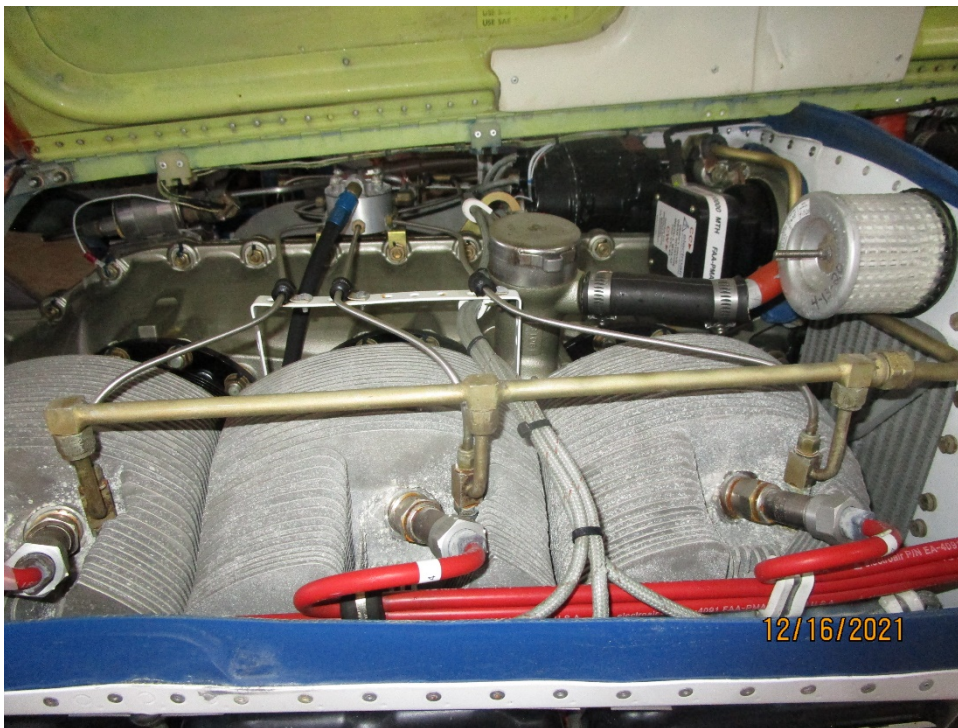
- The engine was equipped with one electric ignition and one traditional magneto. The P-lead were disconnected from the magnetos. The magneto was turned, and spark was not observed on the top set of ignition leads. It was noted that the magneto showed evidence of corrosion due to water immersion.

Right magneto and left electronic ignition

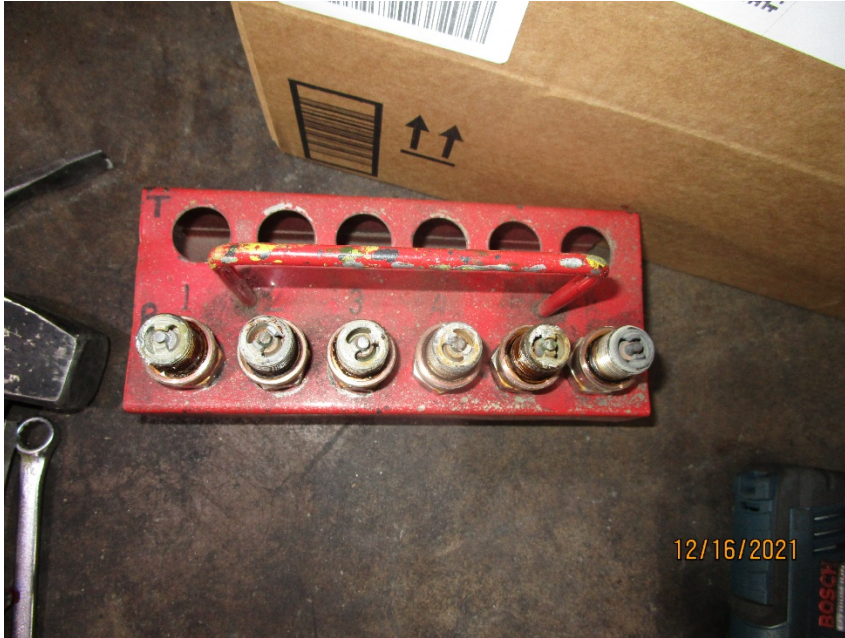
- During the accident the aircraft had been submerged in water: An engine test run was not able to be performed.
  - The fuselage (with engine) was placed on stands; the wings which had been moved for transport, were set next to the fuselage.
- The 3-bladed propeller remained attached to the engine crankshaft flange. All three blades had similar appearance: gentle/slight bent aft.
- An initial inspection of the engine did not reveal any obvious pre-impact abnormalities.
- The engine driven fuel pump was removed; Residual liquid consistent with avgas was drained from the pump. The drive spline was intact, and the pump rotated freely by hand
- The top set of sparkplugs were removed; normal wear was observed,

Top set of sparkplugs

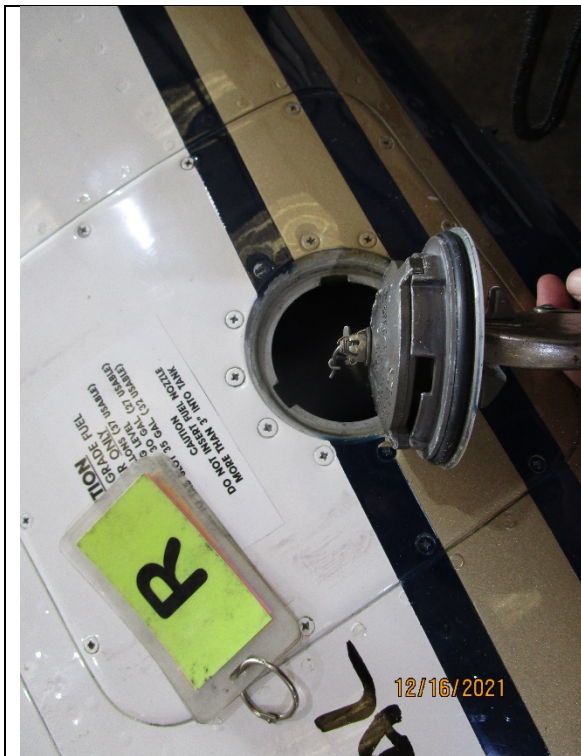
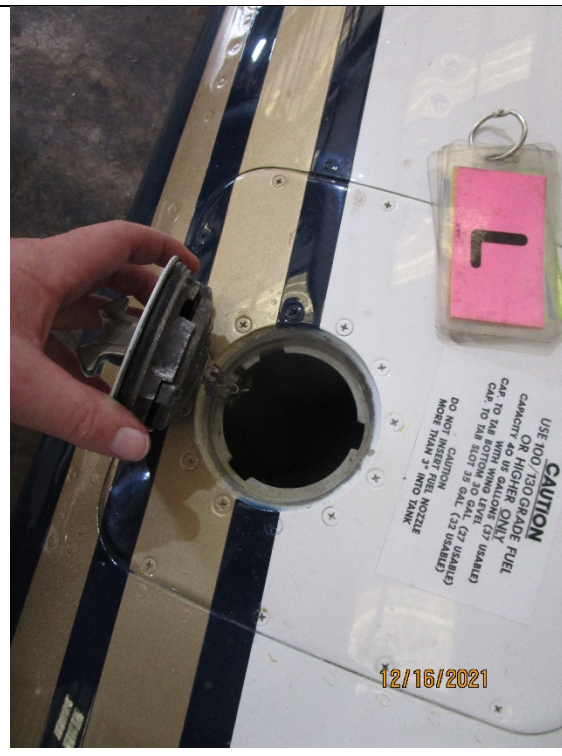
Fuel caps

- Both left and right fuel caps had similar appearance; evidence of water corrosion/the large O-rings appeared dry and pliable.
- No preimpact anomalies were noted during the airplane examination.
