# National Transportation Safety Board

CEN22LA059

## **ENGINE EXAMINATION**

Location: Cleveland, TX  
Date: December 2, 2021  
Time: 1415 (Local)  
2015 (UTC)  
Airplane: Beech A36

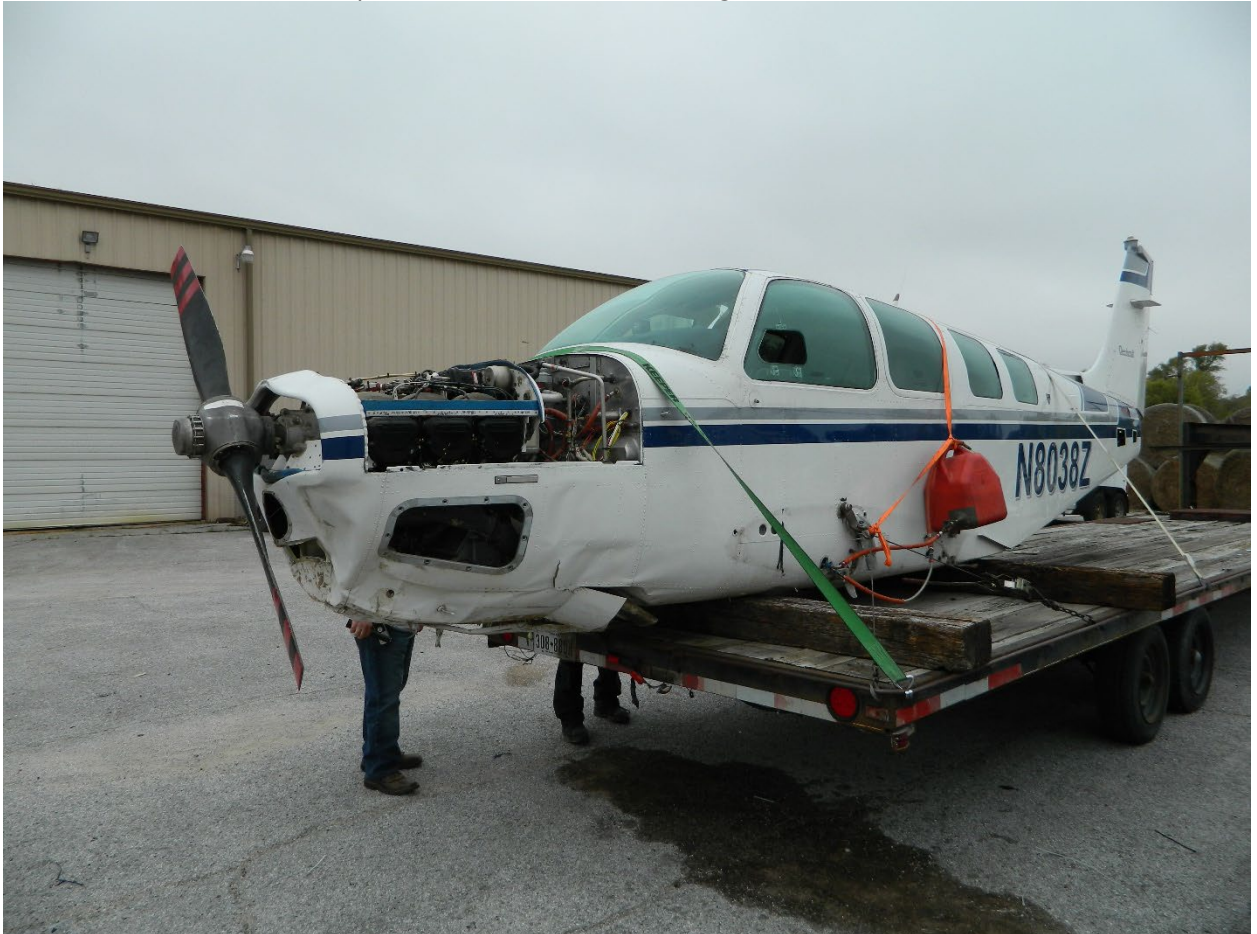
**Figure 1 Airplane Setup for Engine Run**

With the assistance of an A&P mechanic, the airplane was mounted on a trailer with a modified fuel can which provided fuel via the wing fuel line.

The engine was primed and started on the first attempt. Power was set at various RPM settings and the engine ran without any problems or malfunctions.
