## RECORD OF CONVERSATION

**NTSB Case Number: CEN22LA103**

# Racine County Sheriffs Office (RASO) Incident Report

**Radne County Sheriff's Office**  
Scale Diagram

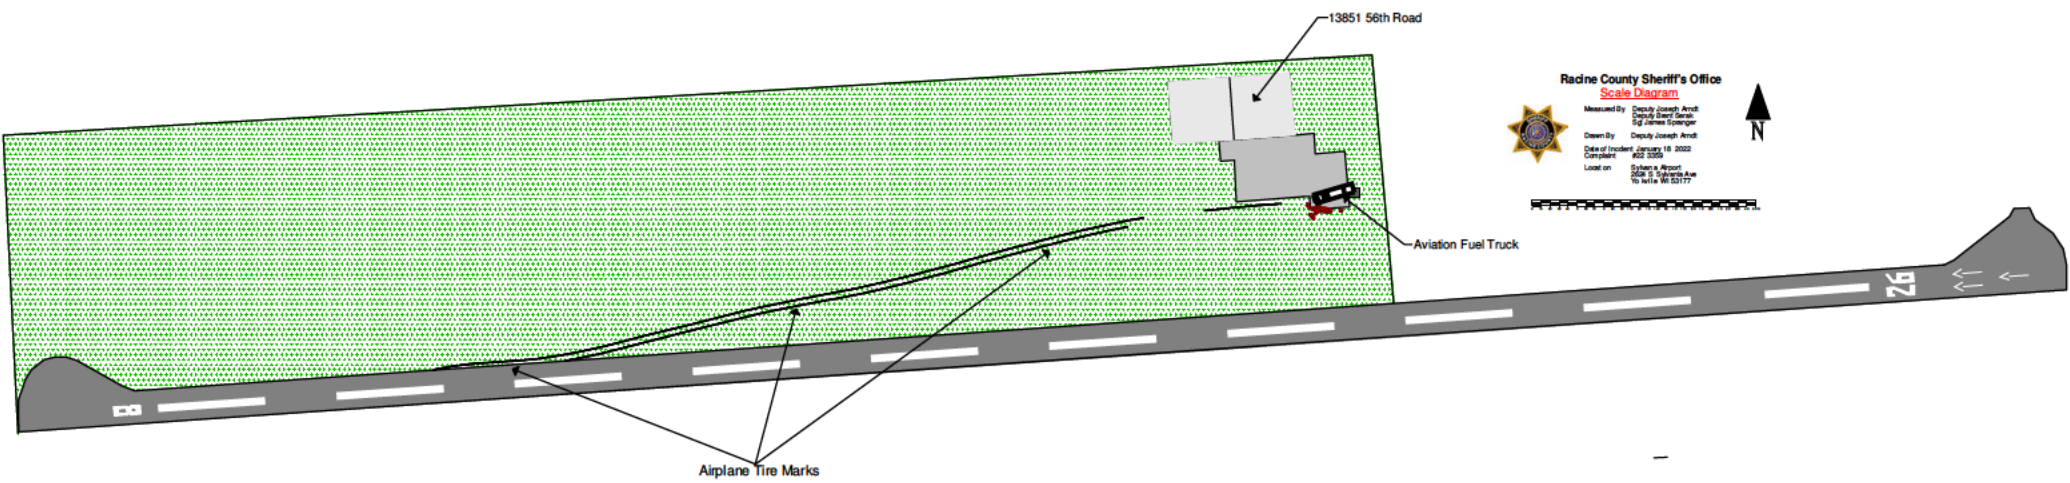
To create a scaled diagram of the scene, Deputy SERAK, Sgt SPRANGER and I completed a forensic mapping of the scene using a Trimble S3 robotic total station. The total station is an electronic survey instrument that is composed of a theodolite (angle measuring system), an EDM (electronic distance measuring) system, a data collector and a prism. The Trimble S3 also has prismless capabilities, known as direct reflect technology. The S3 has a data collector that communicates with total station via radio frequency. The theodolite and EDM systems measure the angle and distance to points of interest. The measurements are stored electronically by the data collector and are later downloaded for processing into computer aided drawing software in order to create a scaled drawing of the crash scene. This instrument allows for data points to be measured in three dimensions, thereby mapping roadways, evidence locations, and contiguous terrain with a high degree of accuracy. A scaled diagram of the scene was produced using CrashZone version 10.6 software.

The mapping of the scene included locating and documenting the runway and adjacent grass field, the airplane and its final rest location, fuel truck, and airplane tire marks.

Approximately 1006 feet of airplane tire marks were located from the area where the airplane left the runway to the area of impact with the fuel truck.
