CEN22LA130

## **AUTOMATIC DEPENDENT SURVEILLANCE- BROADCAST (ADS-B) STUDY**

Airplane Performance Study

Location: Aspen, Colorado  
Date: February 21, 2022  
Time: 11:33 mountain daylight time (MDT)  
18:33 UTC  
Aircraft: RAYTHEON AIRCRAFT COMPANY HAWKER 800XP

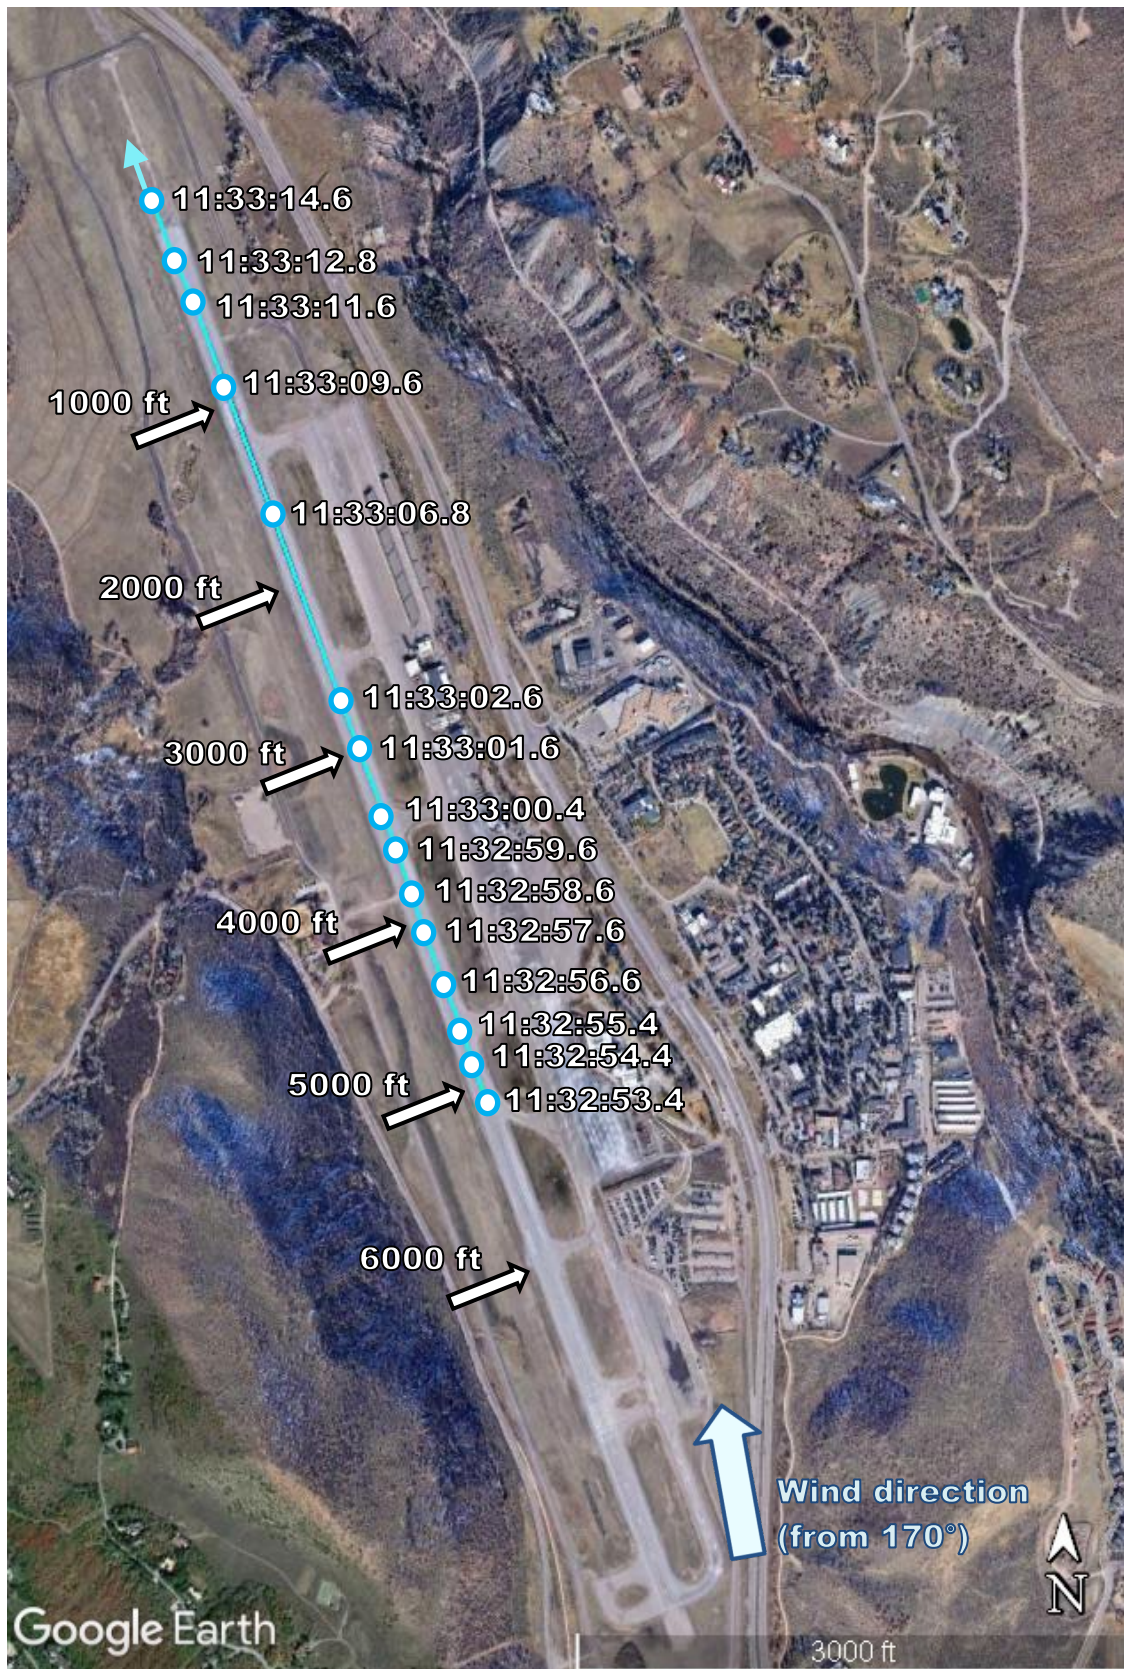
Figure 2 shows a map of the take-off roll and Figure 3 shows the groundspeeds calculated from the position data. ADS-B coverage of the take-off roll did not start until 11:32:53, when the airplane was already at a groundspeed of 135 kts. The beginning point of the take-off roll is therefore unknown. The airplane accelerated to 165 kts by 11:33:01.6 when it was about 3,300 ft from the end of the runway. It then decelerated but left the paved surface at a groundspeed of 120 kts.

**Figure 2.** Aircraft take-off roll with selected times and distance to end of runway annotated.

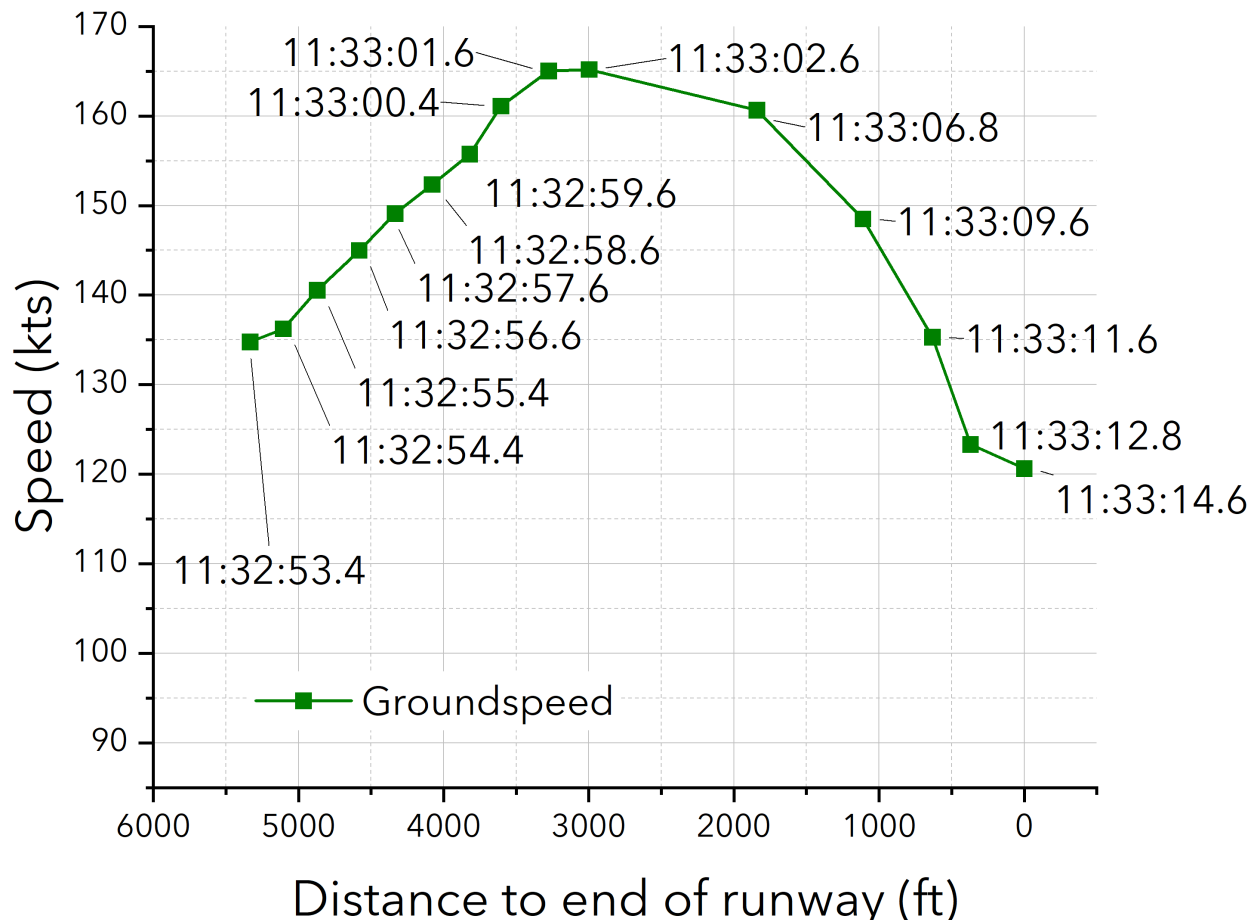
**Figure 3.** Calculated groundspeed versus distance to end of runway. Times are noted at each point.

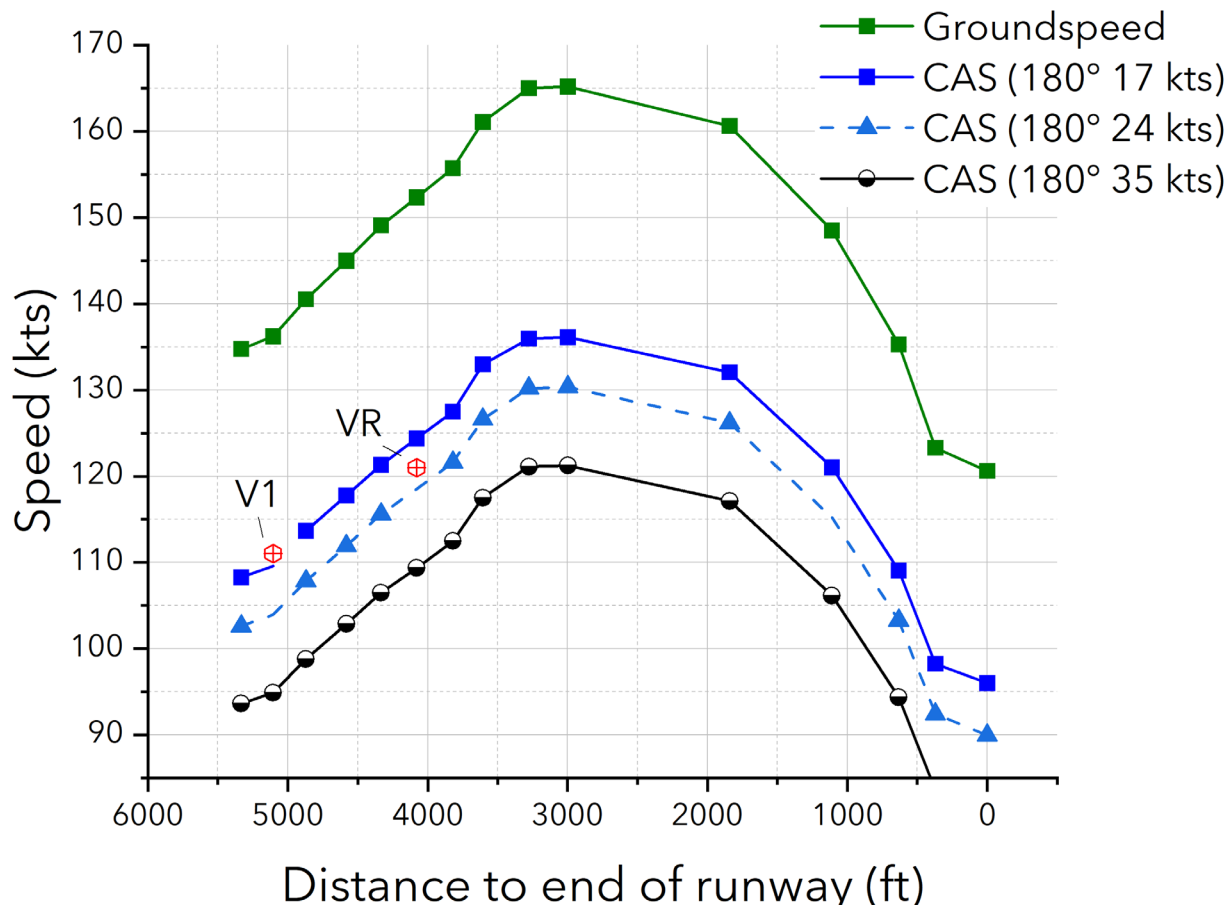
data recorder, these call outs can be assumed to reflect the indicated airspeed at two points during the takeoff roll. The crew reported that the airplane did not rotate after  $V_R$ . Figure 4 shows the groundspeed and three calculated calibrated airspeeds based on three wind conditions. The 111 kts  $V_1$  speed was in line with what calibrated airspeed would be for a 17 kts wind from  $180^\circ$ , which was the automated wind report for 11:30 (Table 1). The  $V_R$  callout falls between the CAS for 17 kts and 24 kts (the gusting condition), suggesting a possibility that the wind increased between the  $V_1$  and  $V_R$  callouts.

**Figure 4.** Calculated calibrated airspeeds for three different wind conditions.

The wreckage examination found no abnormalities in the control surfaces. This would imply that when the pilot pulled back on the yoke, there was an insufficient airload on the elevators to induce rotation. Figure 4 also shows the calculated CAS for 35 kts winds from 180°. Winds of this magnitude or greater would keep the airplane's airspeed just below rotation speed such that the airplane would be unable to rotate or lift-off. The necessary winds would therefore had to have been significantly more than those ATC reported to the pilots and actively gusting higher as the airplane went down the runway.

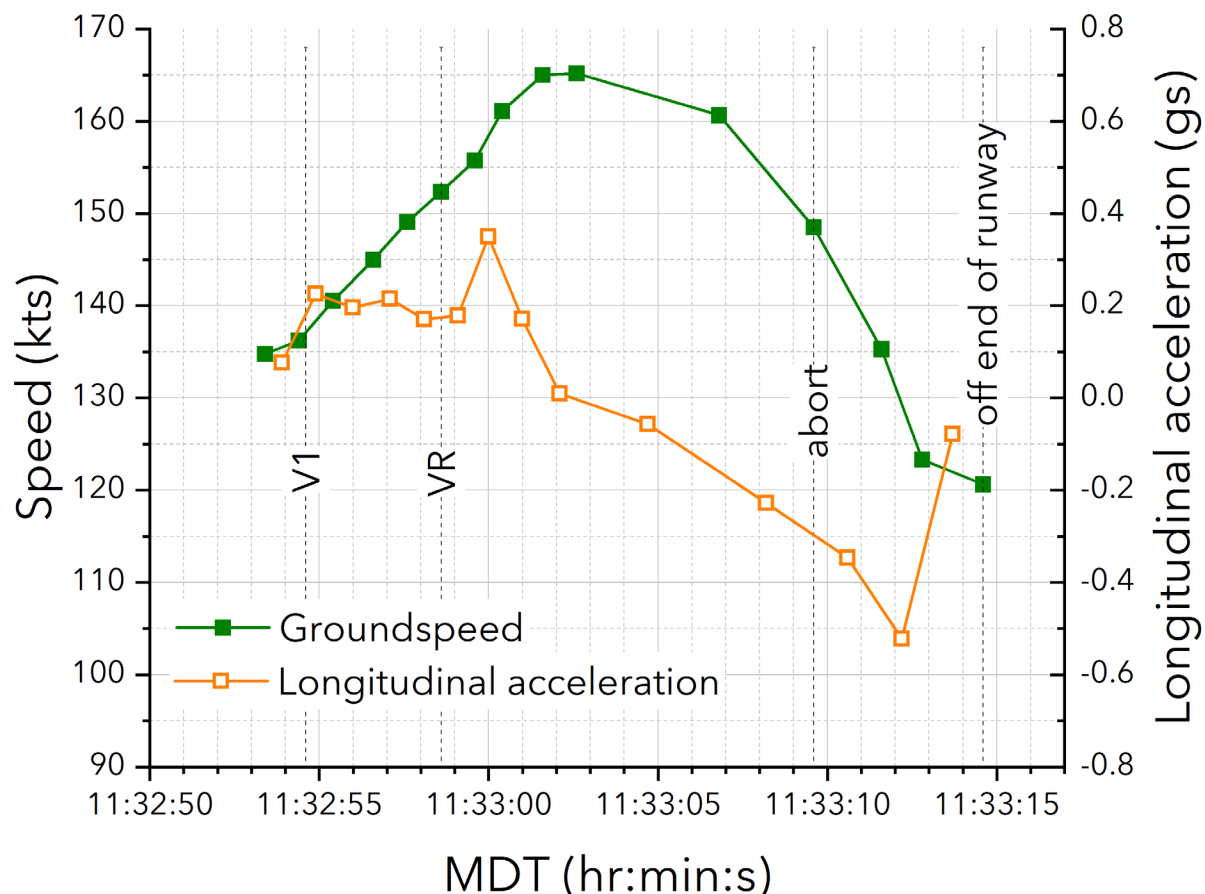
The airplane reached a maximum groundspeed of 165 kts at 11:33:02, three seconds after the  $V_R$  callout (Figure 5). Between 11:33:02 and 11:33:06 the airplane decelerated to 160 kts. The CVR recorded the crew announcing that the take-off was aborted at 11:33:10 when the groundspeed was 148 kts and the airplane was about 1,000 ft from the end of the runway. Security video showed braking smoke towards the end of the runway. At the final ADS-B point at the end of the paved surface, the airplane had decelerated to a groundspeed of 121 kts.

**Figure 5.** Calculated groundspeed and longitudinal acceleration versus time.
