**SPECIALIST'S FACTUAL REPORT OF INVESTIGATION**

**CEN22LA130**

## **Cockpit Voice Recorder**

Location: Aspen, Colorado  
Date: February 21, 2022  
Aircraft: Raytheon Aircraft Company, Hawker 800XP  
Registration: N99AP  
Operator: Private  
NTSB Number: CEN22LA130

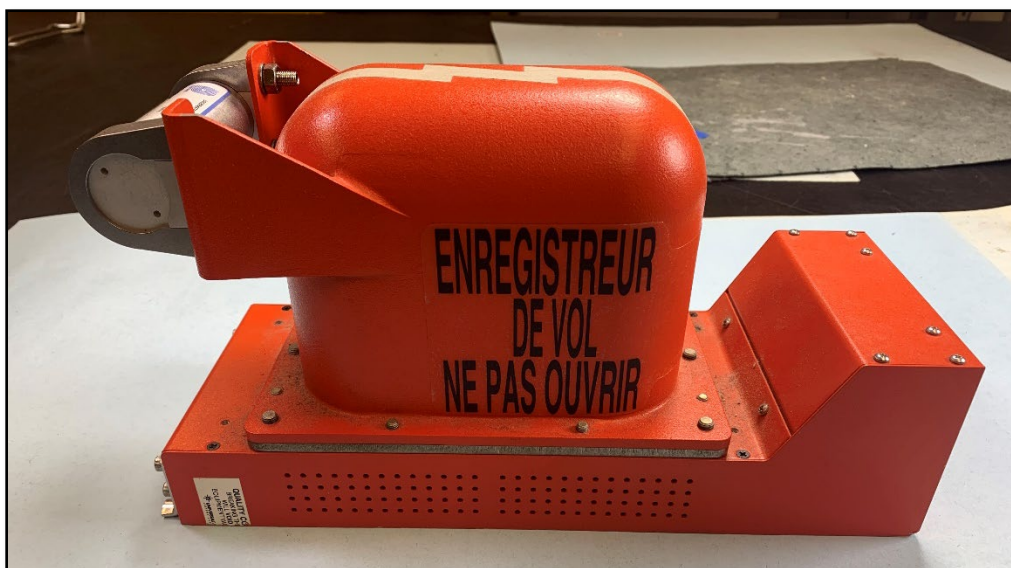
Upon arrival at the laboratory, it was evident that the CVR had not sustained any heat or structural damage, and the audio information was extracted from the recorder normally, without difficulty. The CVR, as received, is shown in Figure 1.

**Figure 1.** Universal CVR-30B, as received.
