# Aviation Investigation Final Report

| <b>Location:</b> | Aspen, Colorado | <b>Accident Number:</b> | CEN22LA130 |
| <b>Date &amp; Time:</b> | February 21, 2022 11:33 Local | <b>Registration:</b> | N99AP |
| <b>Aircraft:</b> | Raytheon Aircraft Company Hawker 800Xp | <b>Aircraft Damage:</b> | Substantial |

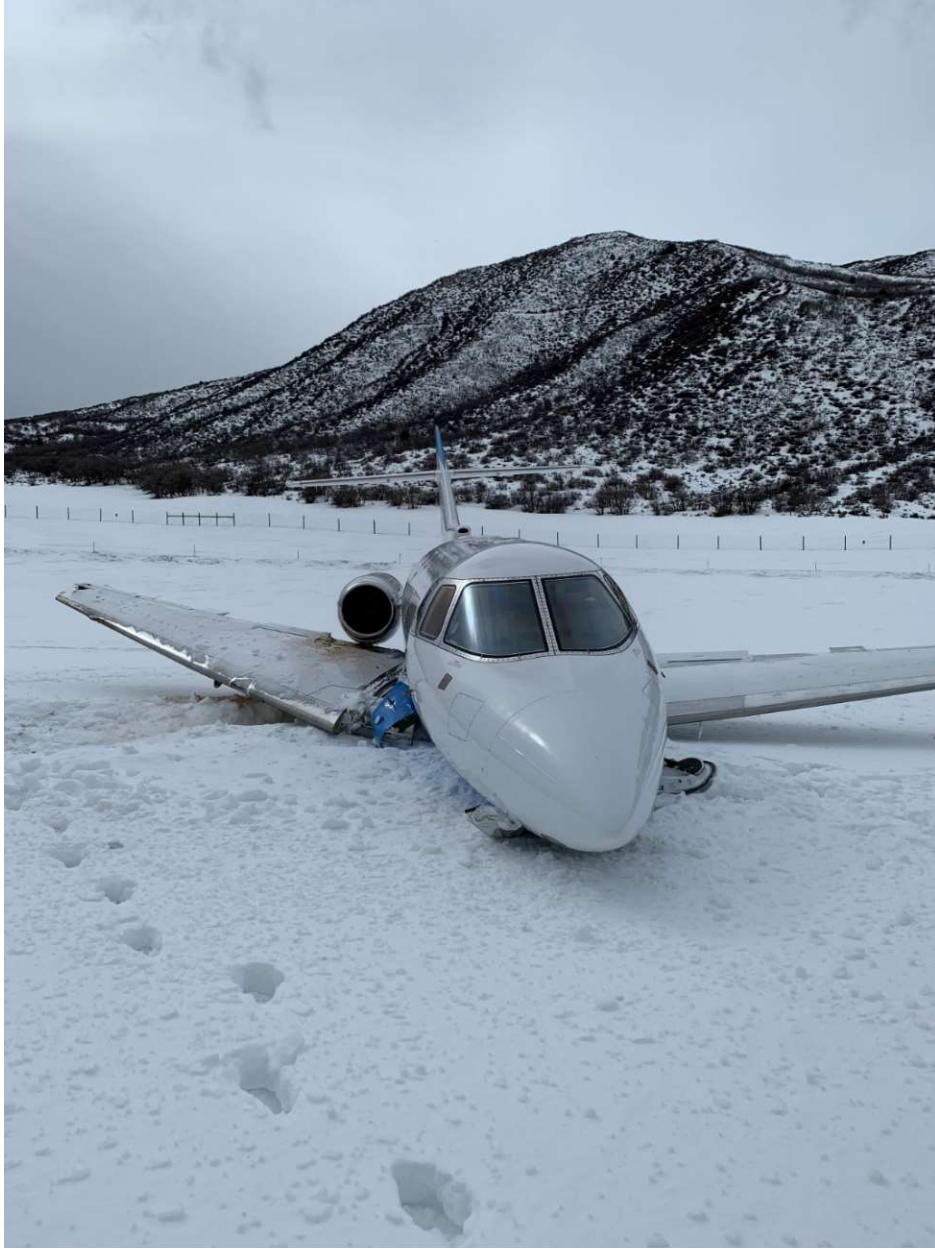
After a few seconds without any indication the airplane would take off, the captain called for and performed an aborted takeoff by reducing the engines to idle, deploying the thrust reversers, and applying the brakes. The airplane subsequently departed the end of the runway into the snow (see figure 1). The captain secured the airplane and assisted in the evacuation of the passengers.

Figure 1. Accident airplane following runway excursion (Source: ASE airport operations)

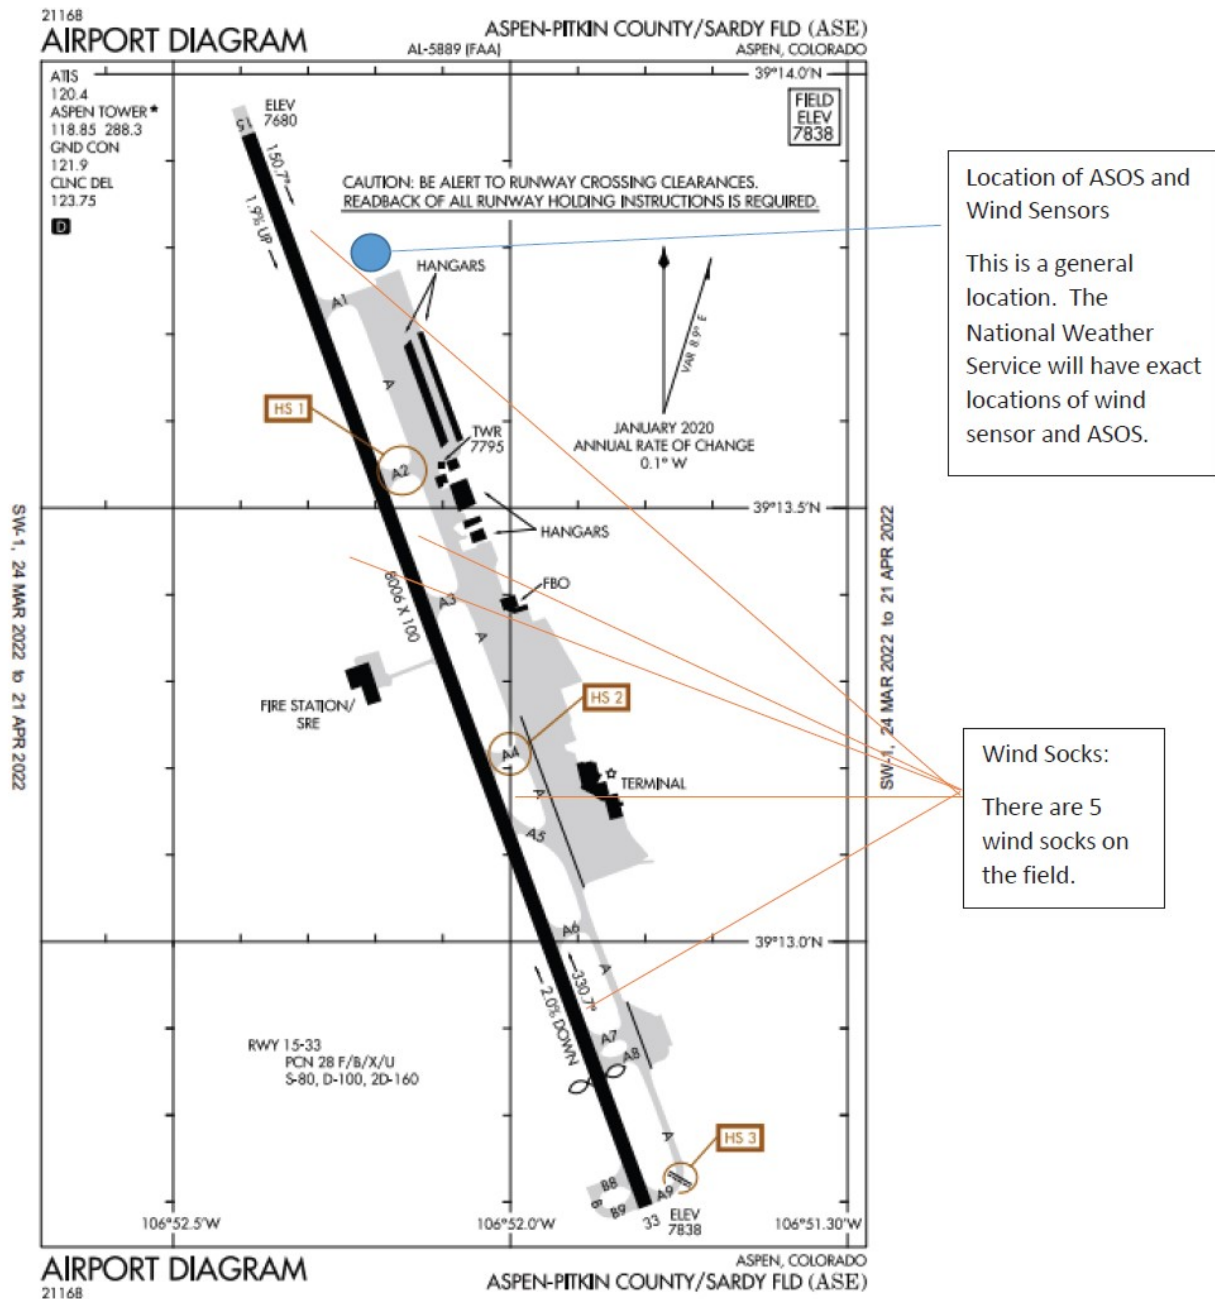
ASE is equipped with multiple windsocks, an automated surface observing system (ASOS) (maintained by the National Weather Service) and a standalone weather sensor (SAWS) (maintained by the Federal Aviation Administration (FAA) Technical Operations), which are located about 20 ft from each other on the north side of taxiway A1 (see figure 2).

Figure 2. Annotated ASE airport diagram

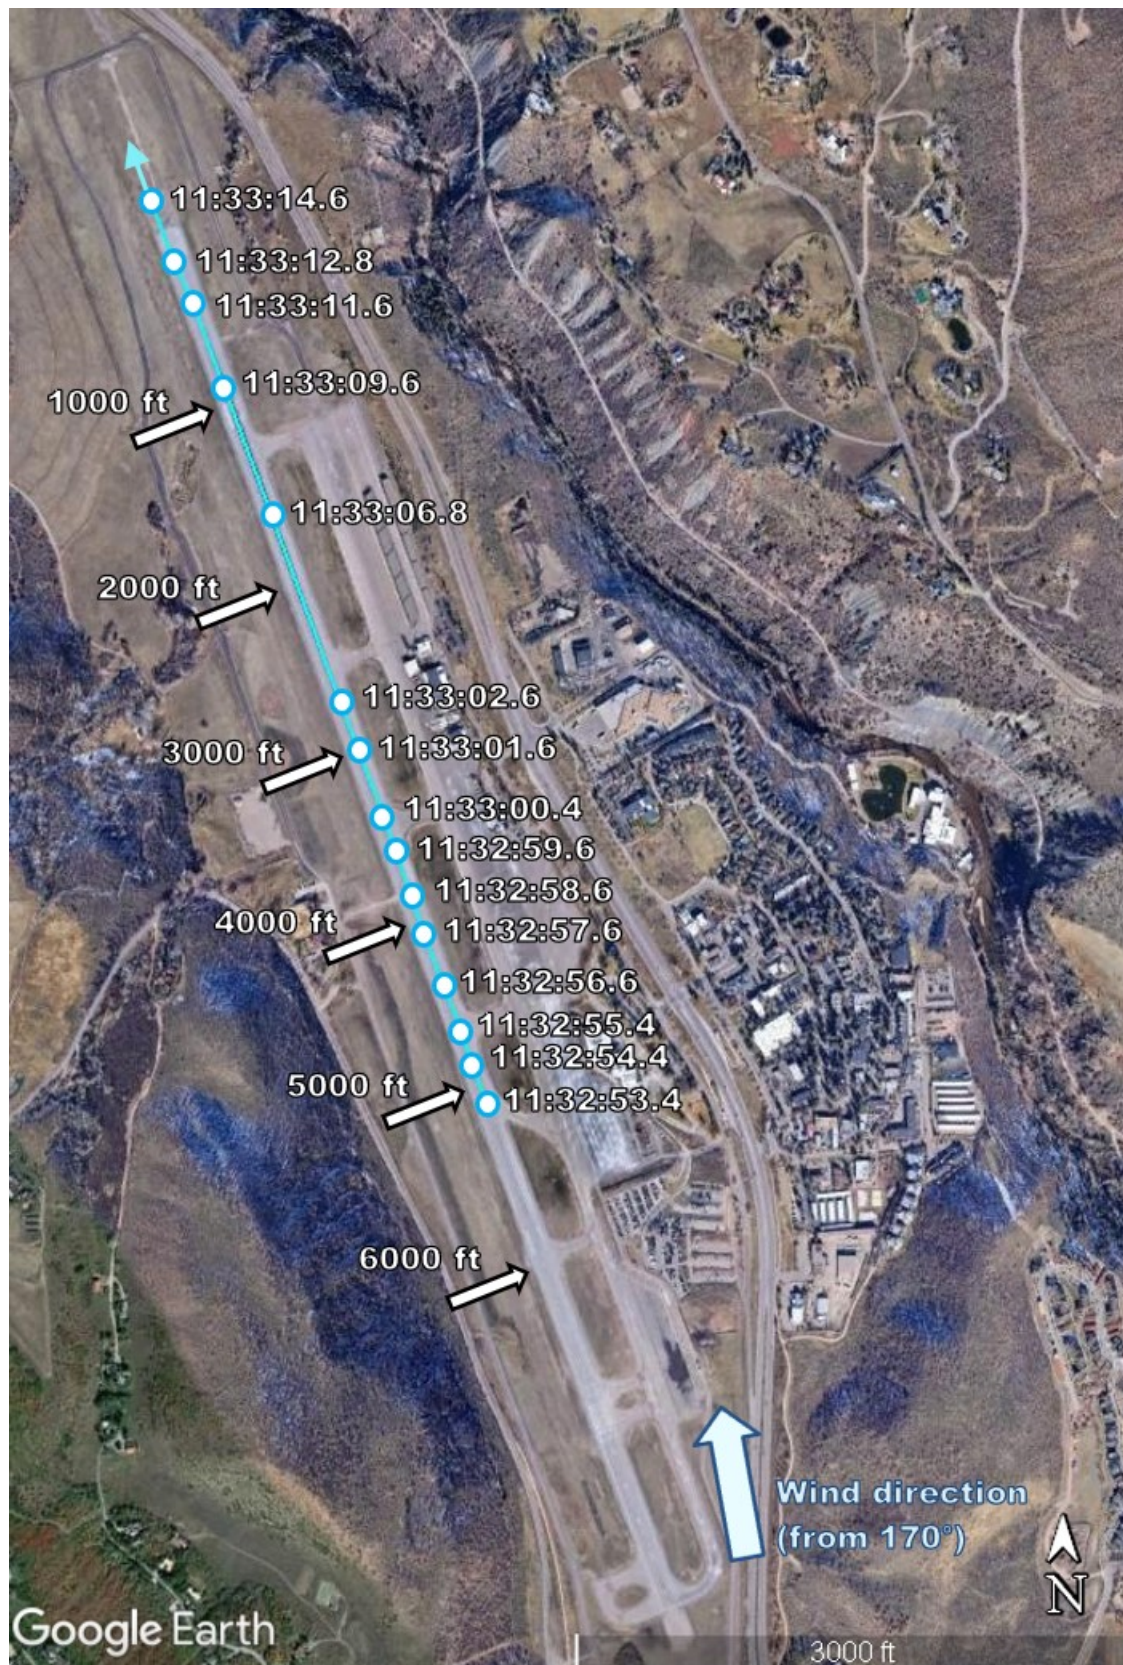
ADS-B coverage of the takeoff roll (see figure 3) did not start until 1132:53, when the airplane was already at a groundspeed of 135 kts. The airplane accelerated to 165 kts by 1133:01.6 when it was about 3,300 ft from the end of the runway, it then decelerated and left the paved surface at a groundspeed of 120 kts (see figure 4).

Figure 3. Aircraft takeoff roll with times and distance to end of runway

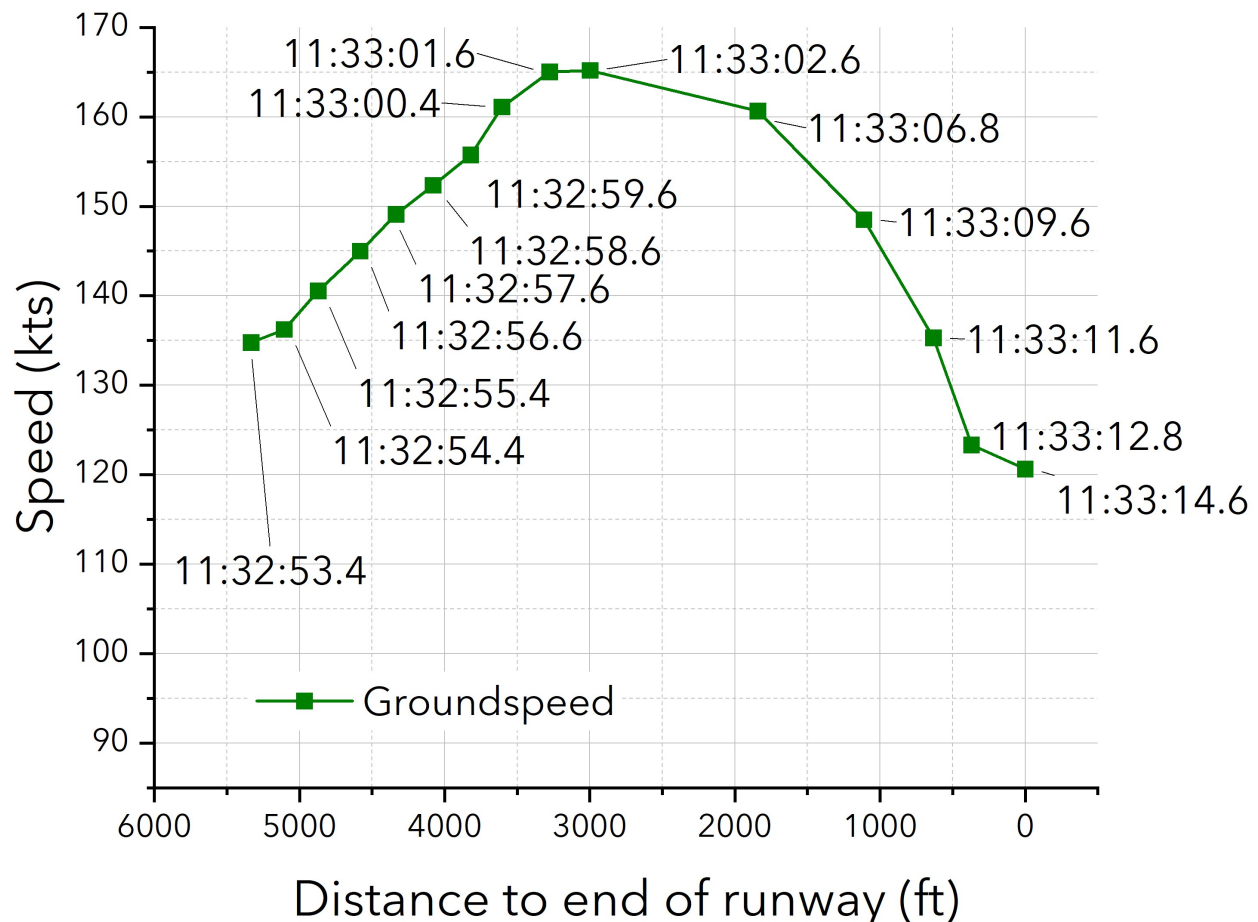
Figure 4. Calculated groundspeed versus distance to end of runway.

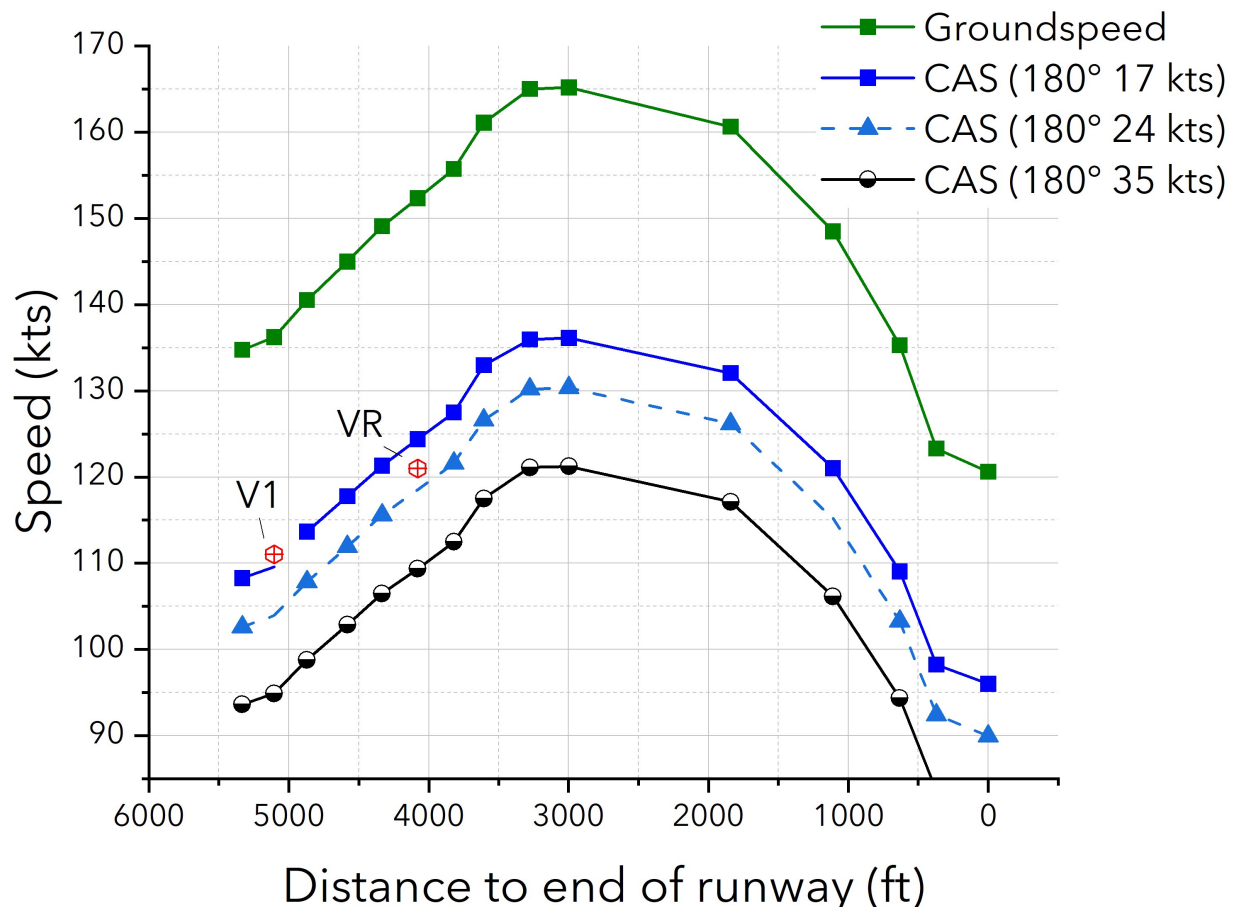
Figure 54. Calculated CAS for three different wind conditions

The black line in Figure 5Figure 4 also shows the calculated CAS for 35 kt wind from 180°. ~~At the maximum achieved ground speed of 165 kts, a Wwind of this magnitude or greater would lowerkeep the airplane's indicated airspeed to just below  $V_R$  rotation speed.~~ Title 14 Code of Federal Regulations Part 25.107, Takeoff Speeds, requires that the  $V_R$  be at least 10% greater than the minimum calibrated airspeed at which the airplane can safely rotate and lift off. ~~such that the airplane would not be able to rotate or liftoff. The wind speed would therefore had to have been significantly higher than that reported to the flight crew and actively gusting higher as the airplane went down the runway.~~
