# National Transportation Safety Board

CEN22LA138

## INVESTIGATION SUMMARY

Location: Gulfport, Mississippi  
Date: March 6, 2022  
Time: 2130 central standard time  
Airplane: N8170J, Beech 200

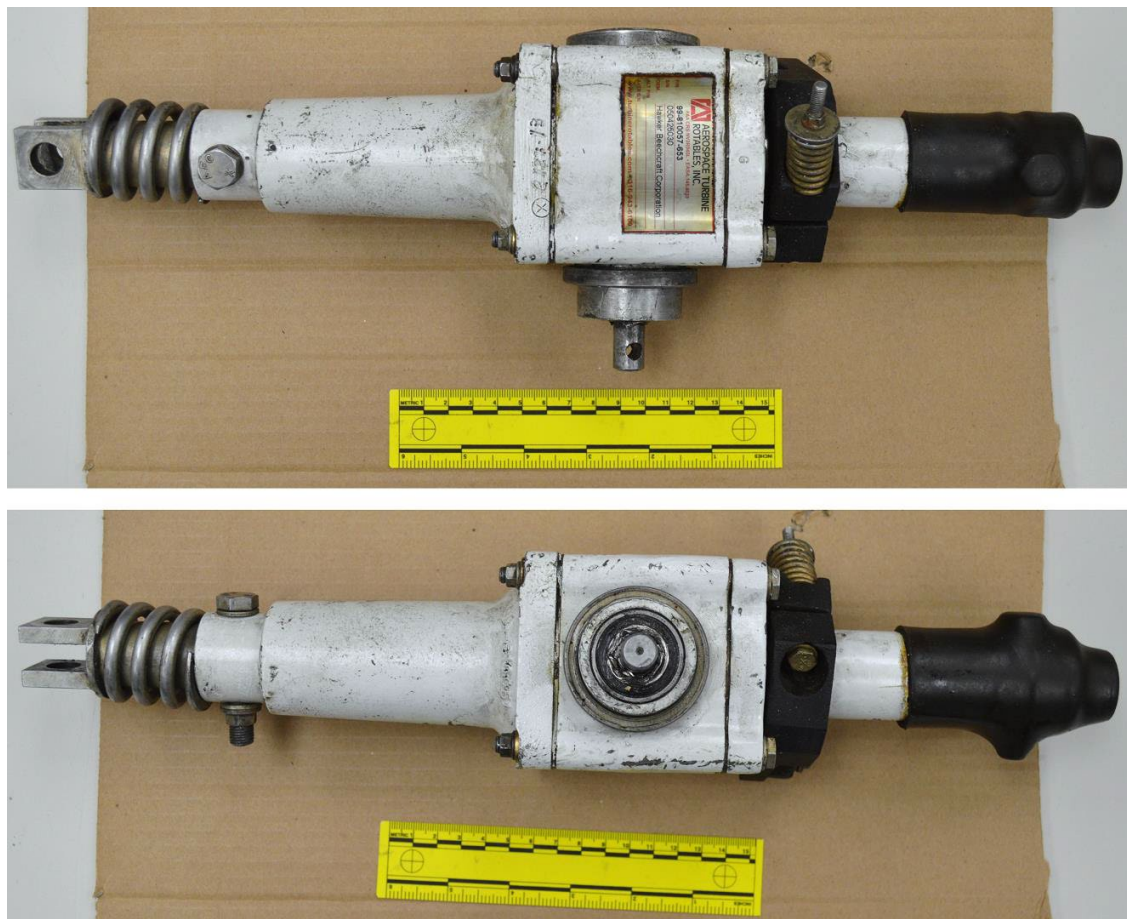
The actuator assembly exterior was documented along with any visible damage, reference Figure 2. Before beginning the teardown of the assembly, a functional test was performed. The pinion gear shaft could only be turned about a quarter of a rotation and did not extend or retract the gear assembly. However, the actuator nut was able to rotate freely, indicating that the thread interface between the actuator nut and actuator screw remained functional.

Figure 2. Overview images of exterior of gear actuator assembly as received.

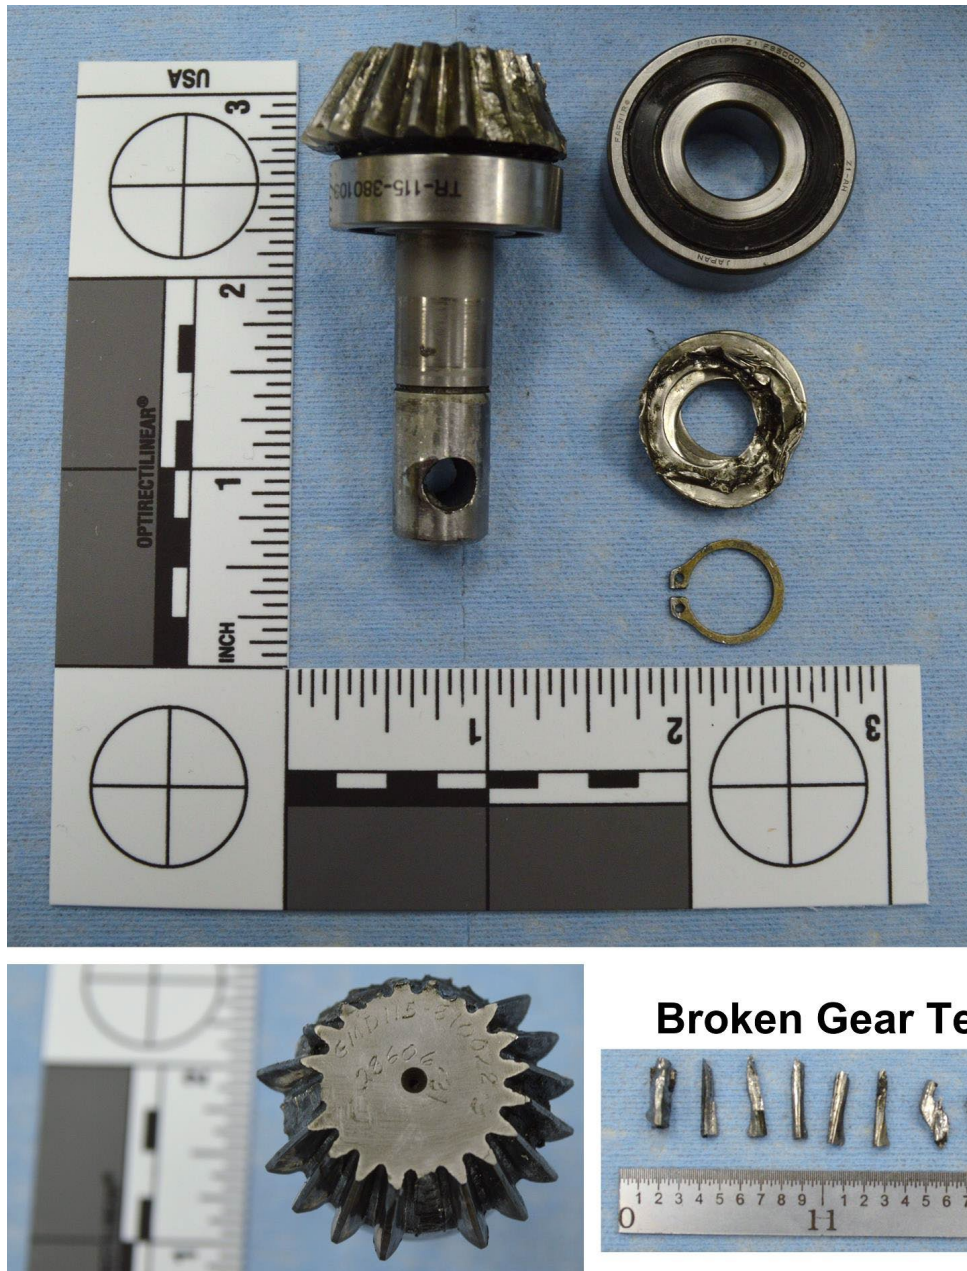
Once the grease was removed from both gears, the part markings became visible. Both gears have similar scribed markings paired with their part number, 28606-31, indicating they are a matched set. As shown in Figure 4, the pinion gear had 8 broken teeth, with the majority of the failures being localized to the root/fillet area of the teeth.

Figure 4. 115-810028-3 Pinion/Drive Gear and Broken Gear Teeth.

1. The initial component failure originated between the straight bevel gear set.
2. Breakage of the teeth from the pinion varied in fracture surface and location. The individual teeth that broke off have different features in comparison to the 6 adjacent teeth that were broken.

- a. The individual broken teeth show cracking features that would have developed progressively before failure.
  - b. The group of adjacent broken teeth have evidence of shear overload and tensile overload indicating the failure was abrupt and possibly related to shock overloading.

7. The pinion gear has effective case hardening to the appropriate depth but does not meet the drawing requirements for minimum case hardness.
8. The driven gear did not have evidence of case hardening and does not meet the drawing requirements for both effective case depth and minimum case hardness.

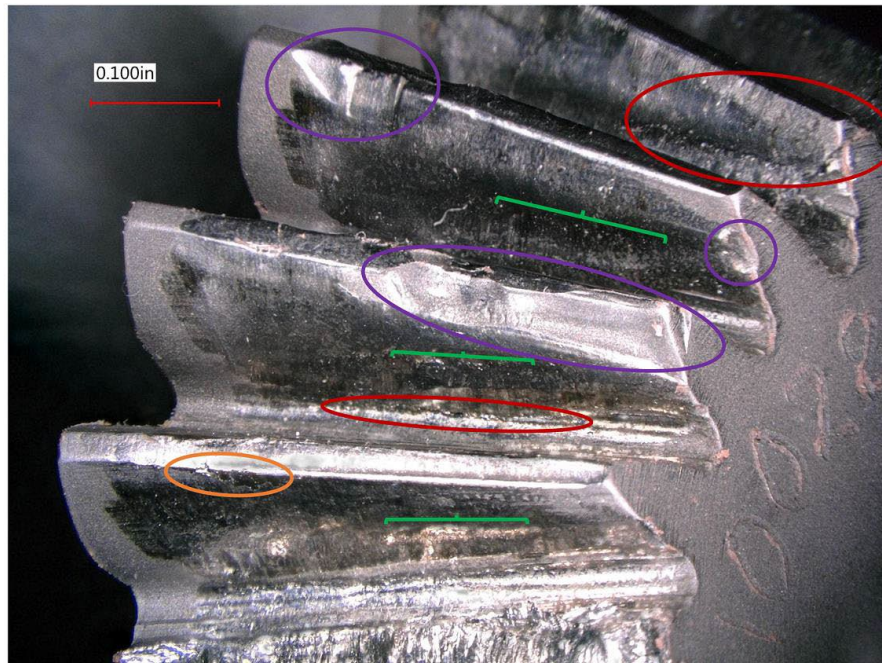
Figure 5 helps illustrate the wear and breakage visible on the pinion gear. There were cracks present near the dedendum of the teeth still attached. The pinion gear had evidence of pitting along the pitch line of the teeth. Plastic flow was present along the addendum of the teeth. No discoloration was present on the surfaces of the teeth. A few of the broken teeth that had interior secondary fractures within the teeth. The different types of wear observed on the broken sections of the gear teeth are shown in Figure 6.

Figure 5. Different Types of Wear Visible on Teeth attached to Pinion/Drive Gear.

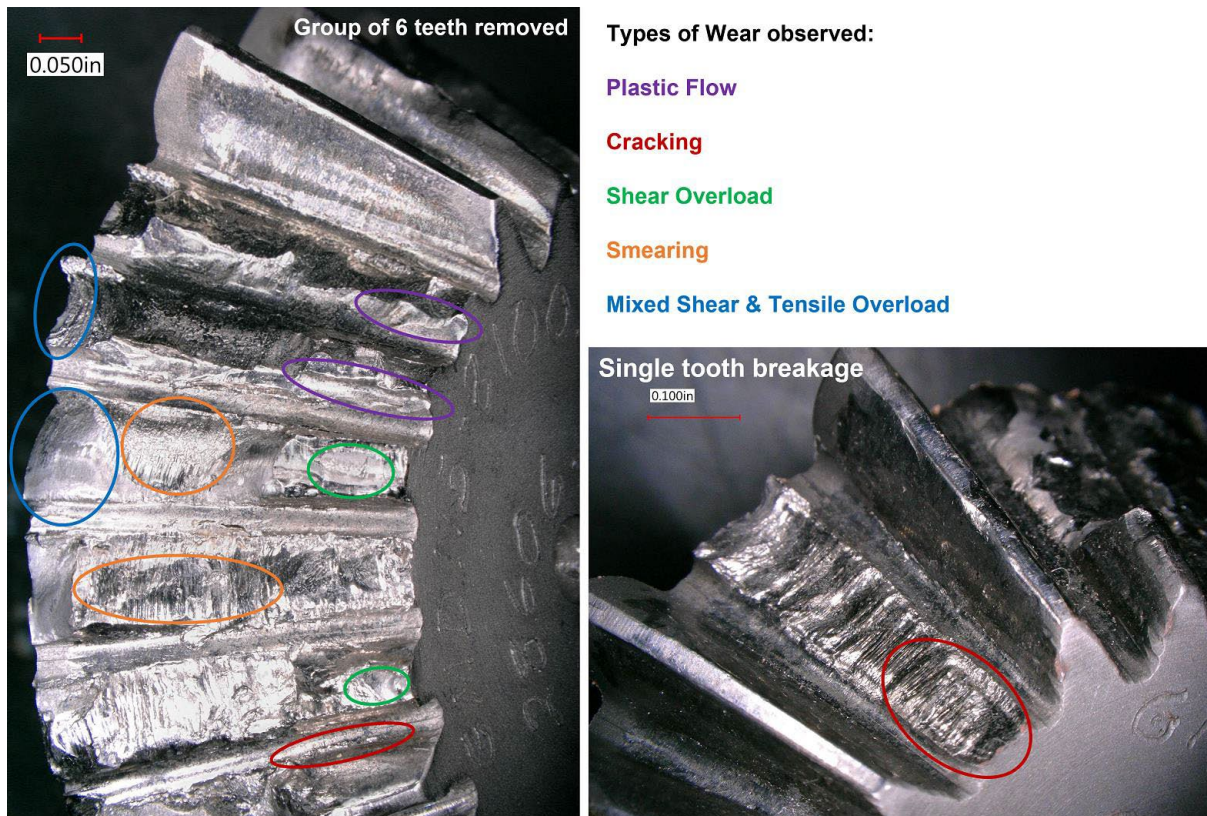
Figure 6. Different Types of Wear Visible on Pinion/Drive Gear Where Teeth are Missing.

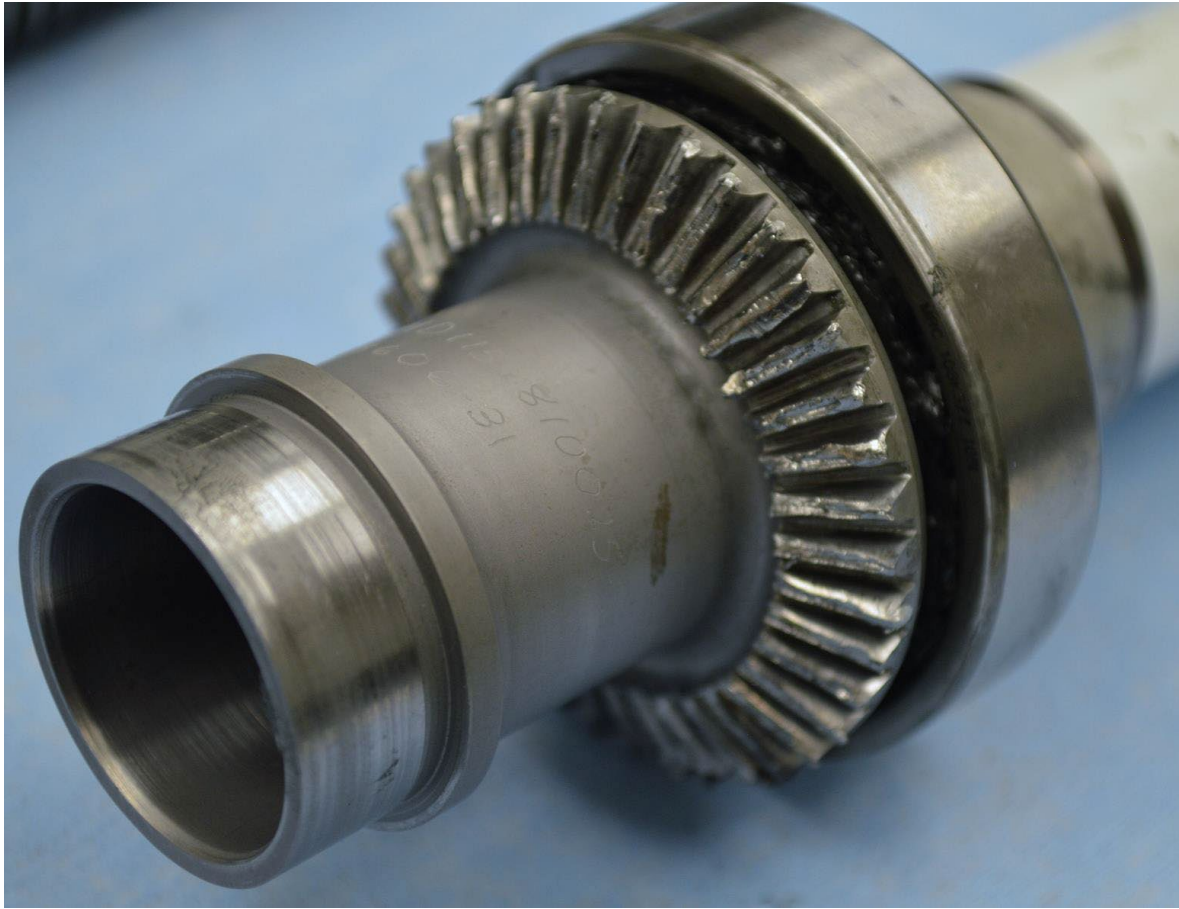
The damaged driven gear retained most of its teeth, as shown in Figure 7. A combination of partial tooth breakage/cracks and plastic flow were the primary wear patterns on the driven gear, reference Figure 8. No discoloration was present on the surfaces of the teeth. The plastic flow was localized to the addendum of the gear teeth, but cracks were found in regions near or below the pitch line of the teeth.

Figure 7. 115-810025-1 Driven Gear with damaged Gear Teeth.

4. The driven gear teeth were plastically deformed and cracked along the tip of the addendum as it smeared against the broken section of pinion teeth. Additional cracks were observed near the root of the driven gear but cannot be confirmed as either a result of fatigue or overload cracking.

Submitted by:

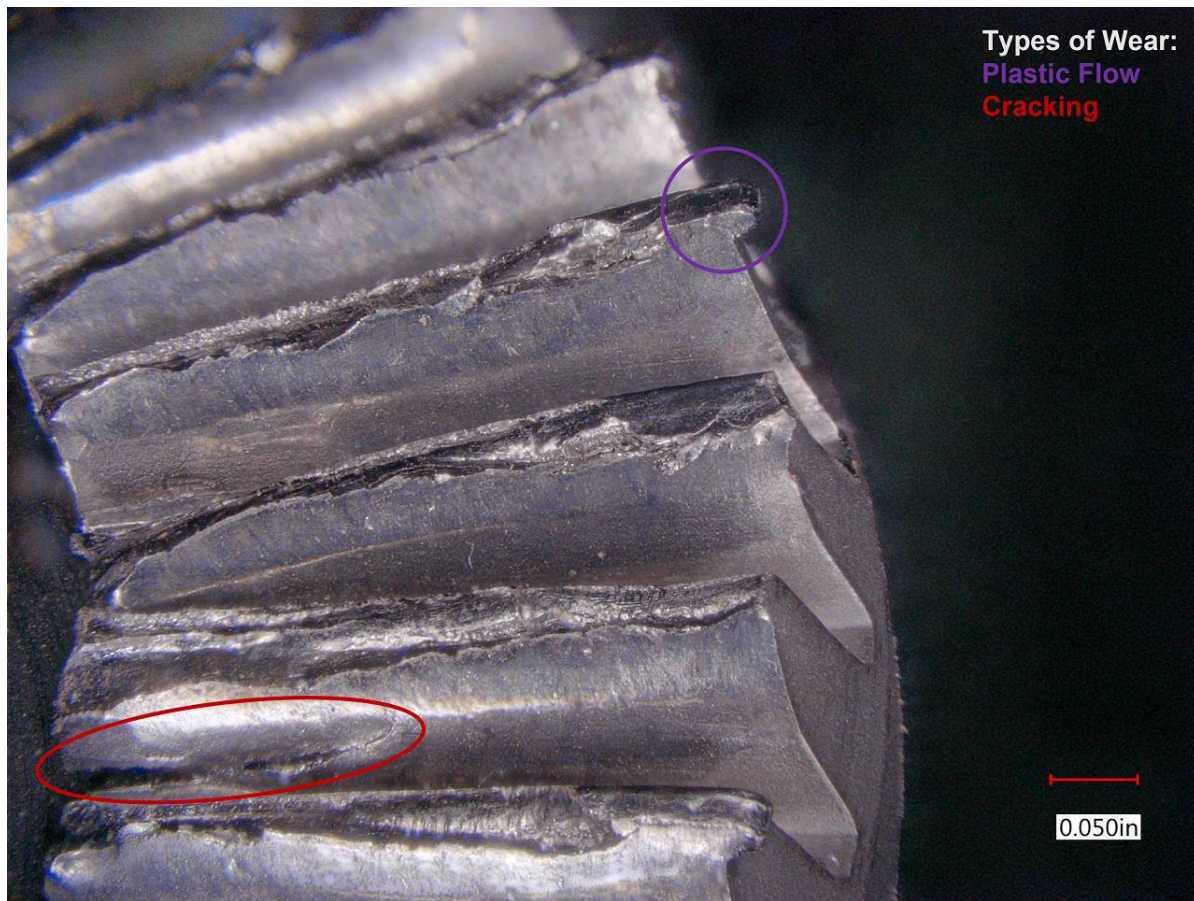
Figure 8. Different types of wear present on damaged teeth from the Driven Gear.

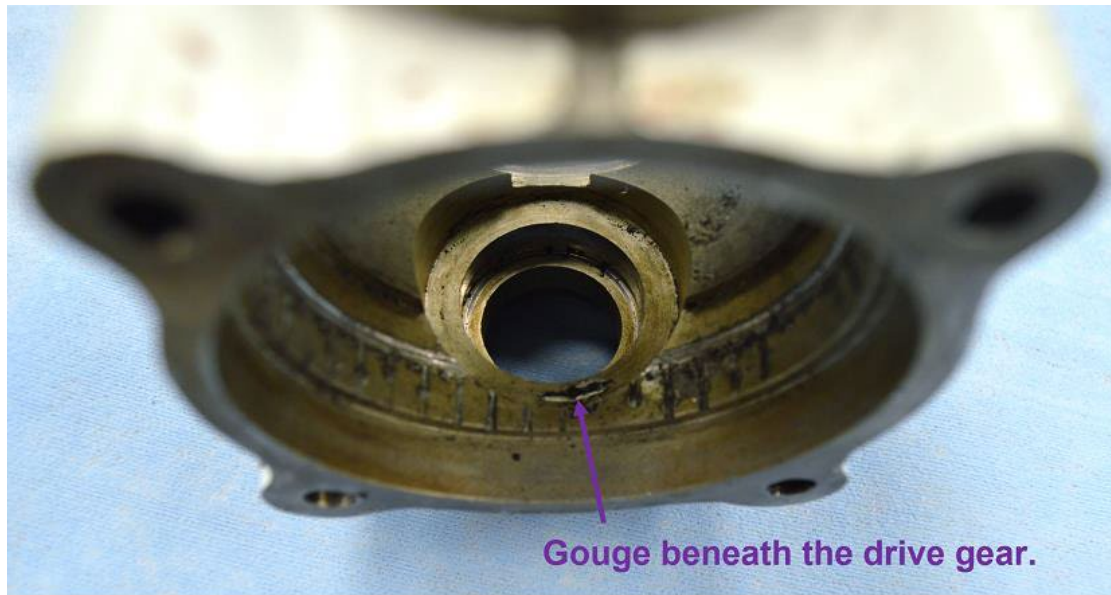
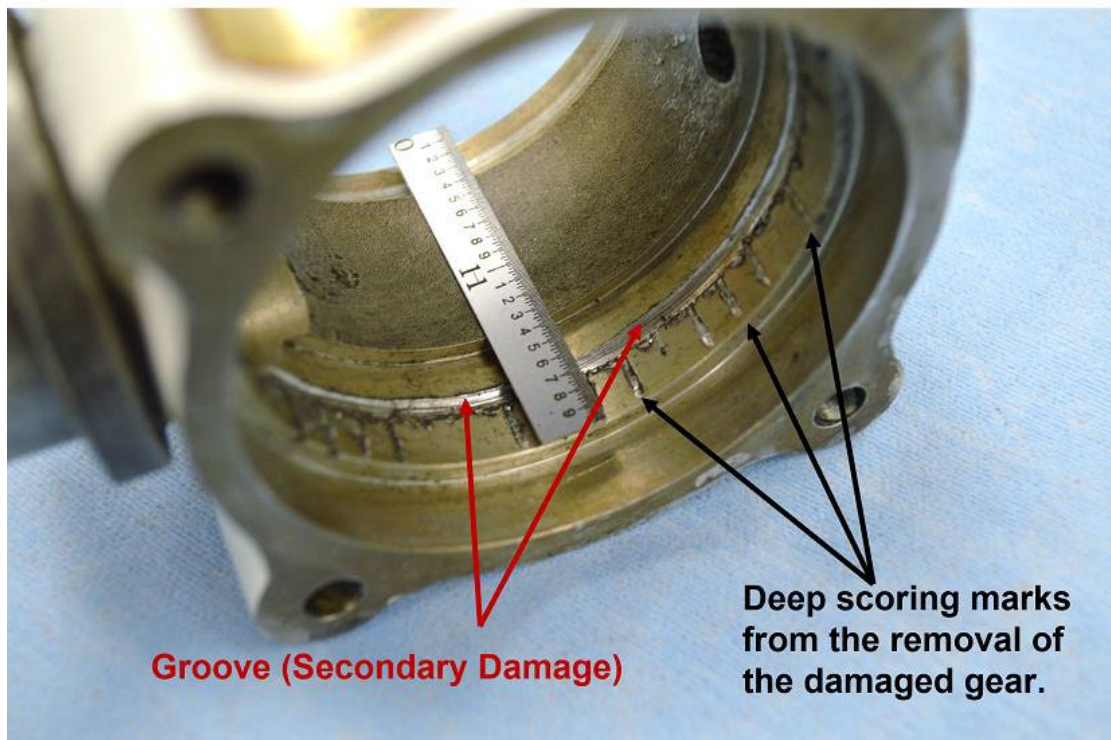
The vertical scoring/grooves in the inner bore, as shown in Figure 9, were made during the removal of the damaged driven gear. The secondary damage within the case is likely a result of the gear mesh fracturing/deforming resulting in secondary damage.

Figure 9. Visible damage inside the actuator housing.
