TEXTRON AVIATION, INC.  
P.O. Box 7704  
WICHITA, KANSAS 67277

Model No.: B200  
Report No.: 23-359-005

Examination of B200 Super King Air N8170J Main Landing Gear Actuator, P/N 99-810057-653

Report Date: 05/05/2023

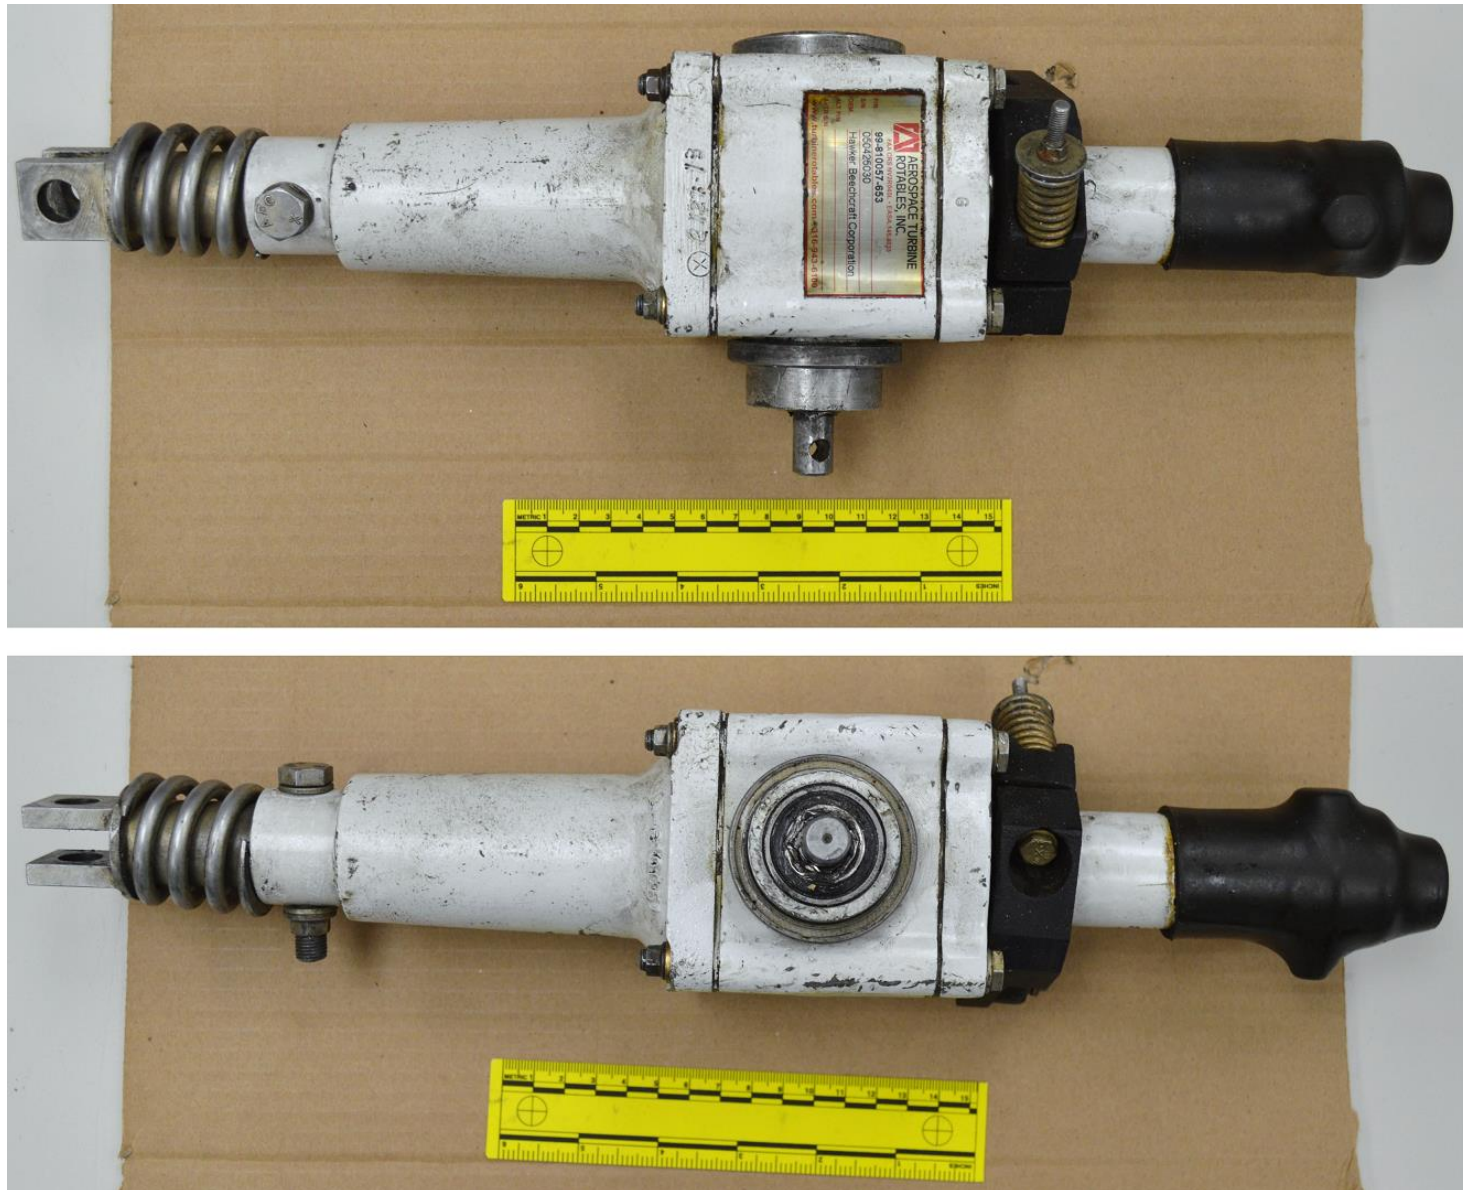
The assembly arrived packaged as shown in Figure 2. The assembly was carefully removed, and the exterior was documented along with any visible damage, reference Figure 3 and Figure 4. Before beginning the teardown of the assembly, a functional test was performed. The pinion gear shaft could only be turned about a quarter of a rotation and did not extend or retract the gear assembly. However, the actuator nut was able to rotate freely, indicating that the thread interface between the actuator nut and actuator screw remained functional.

Figure 3: Overview images of exterior of gear actuator assembly as-received (Mag x0.4)

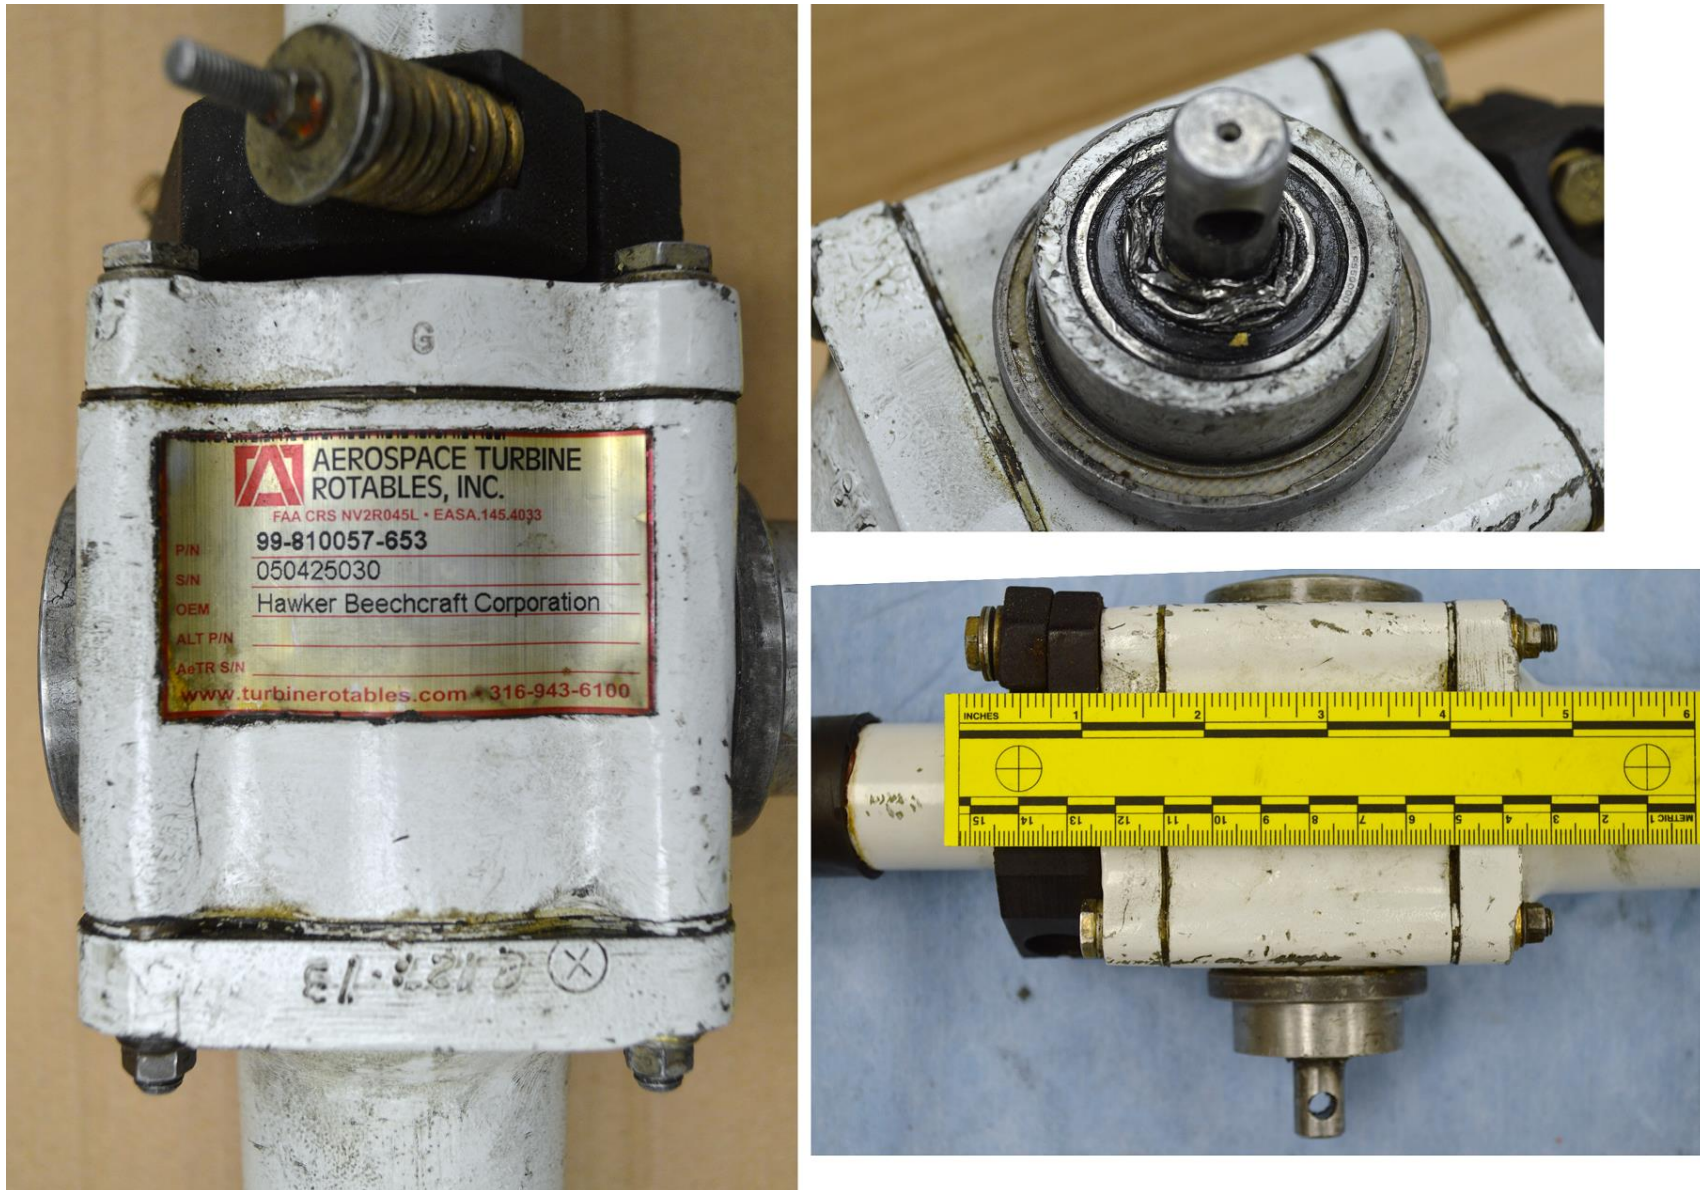
Figure 4: Additional Images of gear actuator assembly as-received

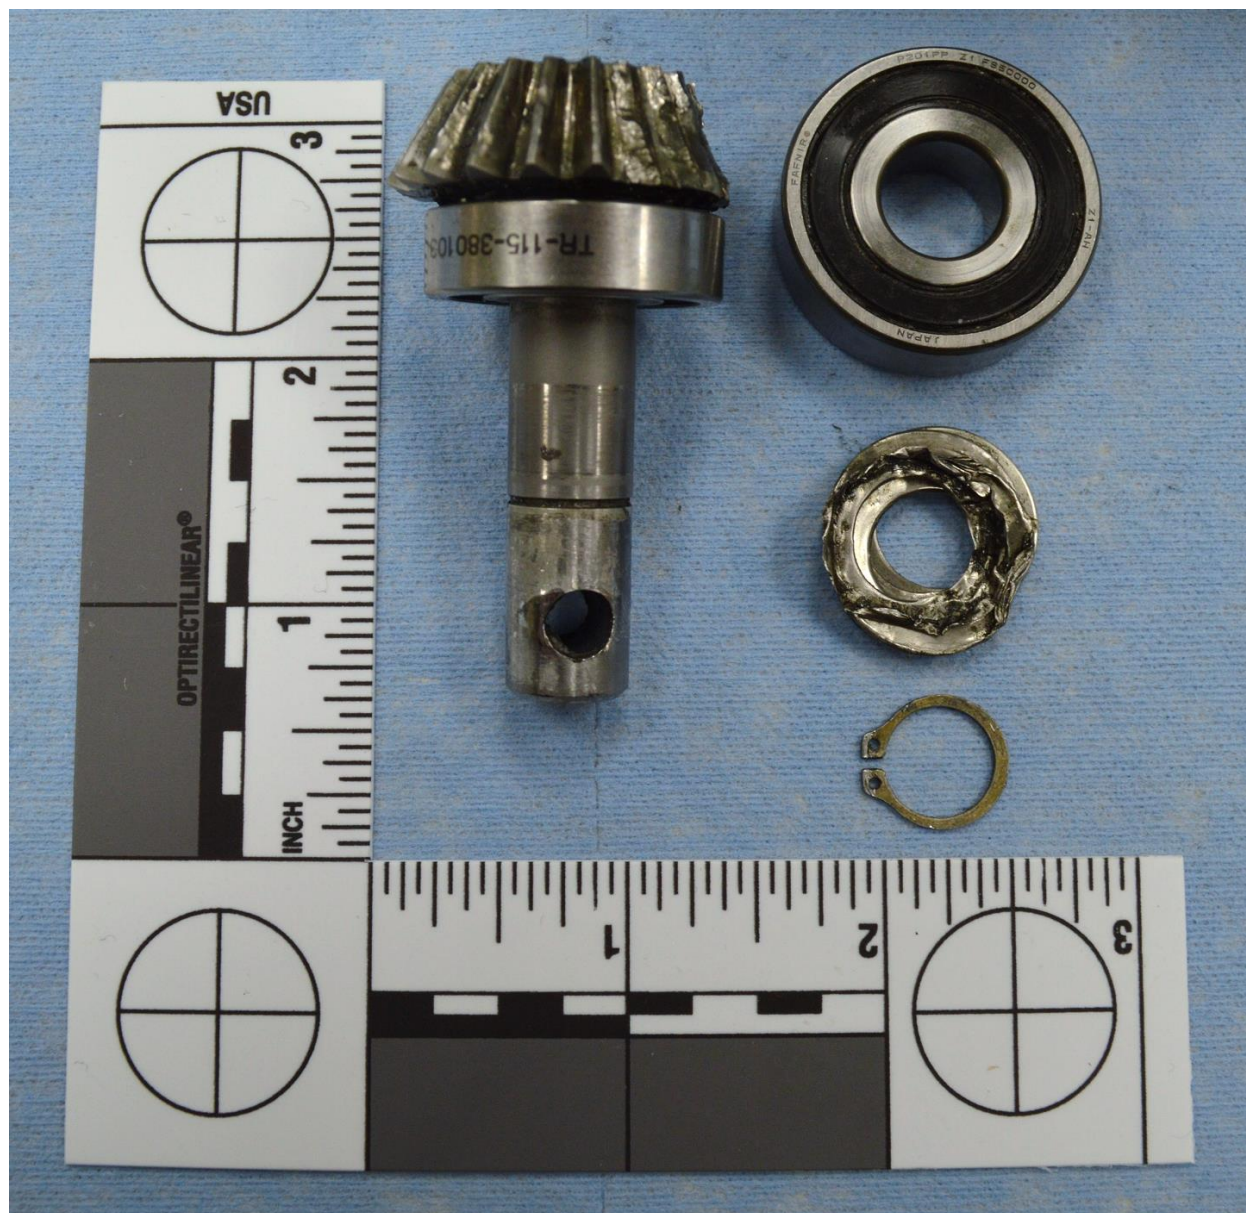
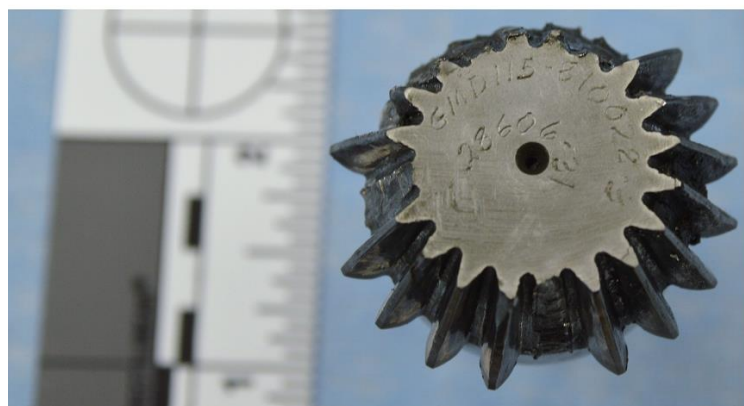
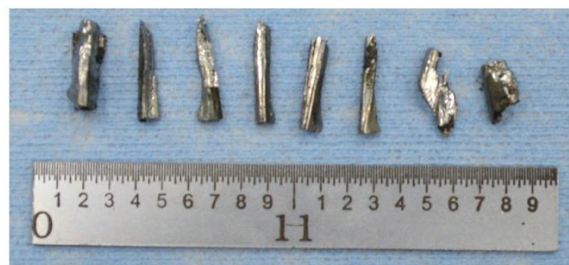
As shown in Figure 12, the pinion gear had 8 broken teeth, with the majority of the failures being localized to the root/fillet area of the teeth. Figure 13 and Figure 14 help illustrate the wear and breakage visible on the pinion gear. There were cracks present near the dedendum of the teeth still attached. The pinion gear had evidence of pitting along the pitch line of the teeth. Plastic flow was present along the addendum of the teeth. No discoloration was present on the surfaces of the teeth. Figure 15 contains a few of the broken teeth that have interior secondary fractures within the teeth. The different types of wear observed on the broken sections of the gear teeth are shown in Figure 16. Both Figure 17 and Figure 18 include SEM Images of the different types of wear observed.

- The initial component failure originated between the straight bevel gear set.
- Breakage of the teeth from the pinion varied in fracture surface and location. The individual teeth that broke off have different features in comparison to the 6 adjacent teeth that were broken.

- The individual broken teeth show cracking features that would have developed progressively before failure.
  - The group of adjacent broken teeth have evidence of shear overload and tensile overload indicating the failure was abrupt and possibly related to shock overloading.

Figure 12: 115-810028-3 Drive Gear and Broken Gear Teeth

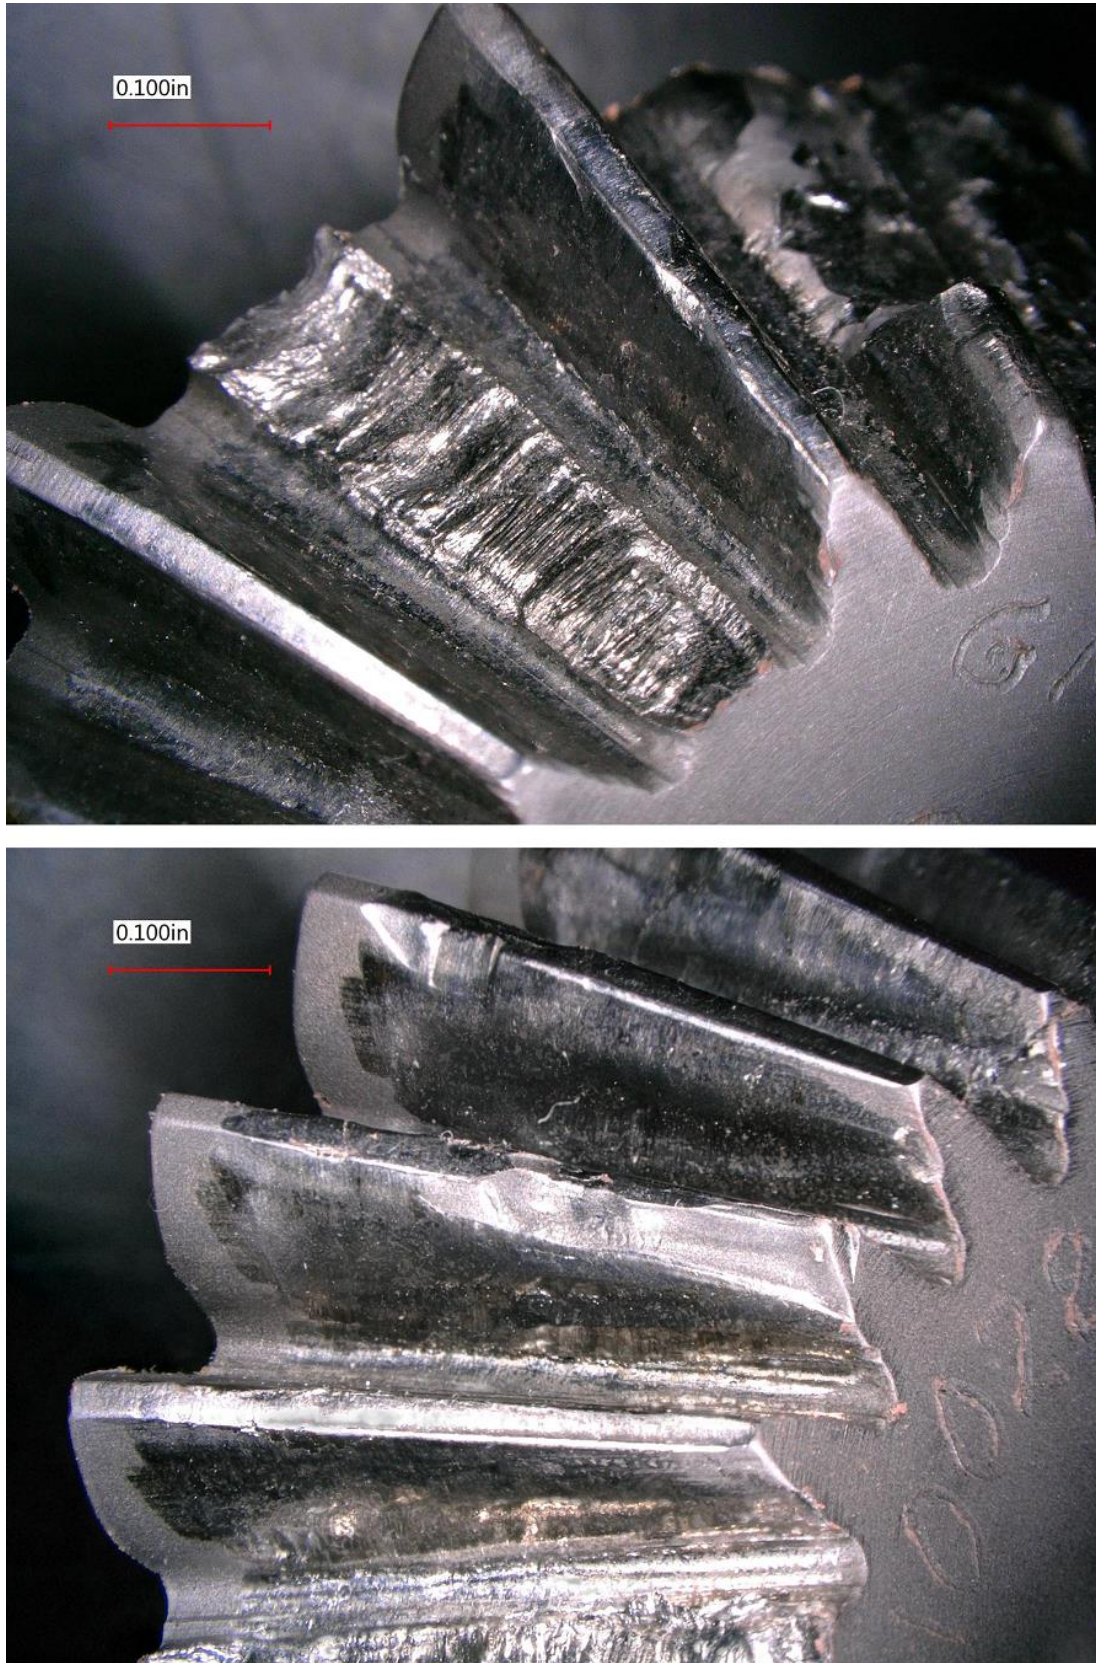
Figure 13: Visible Wear on Drive Gear Teeth. (Mag x8)

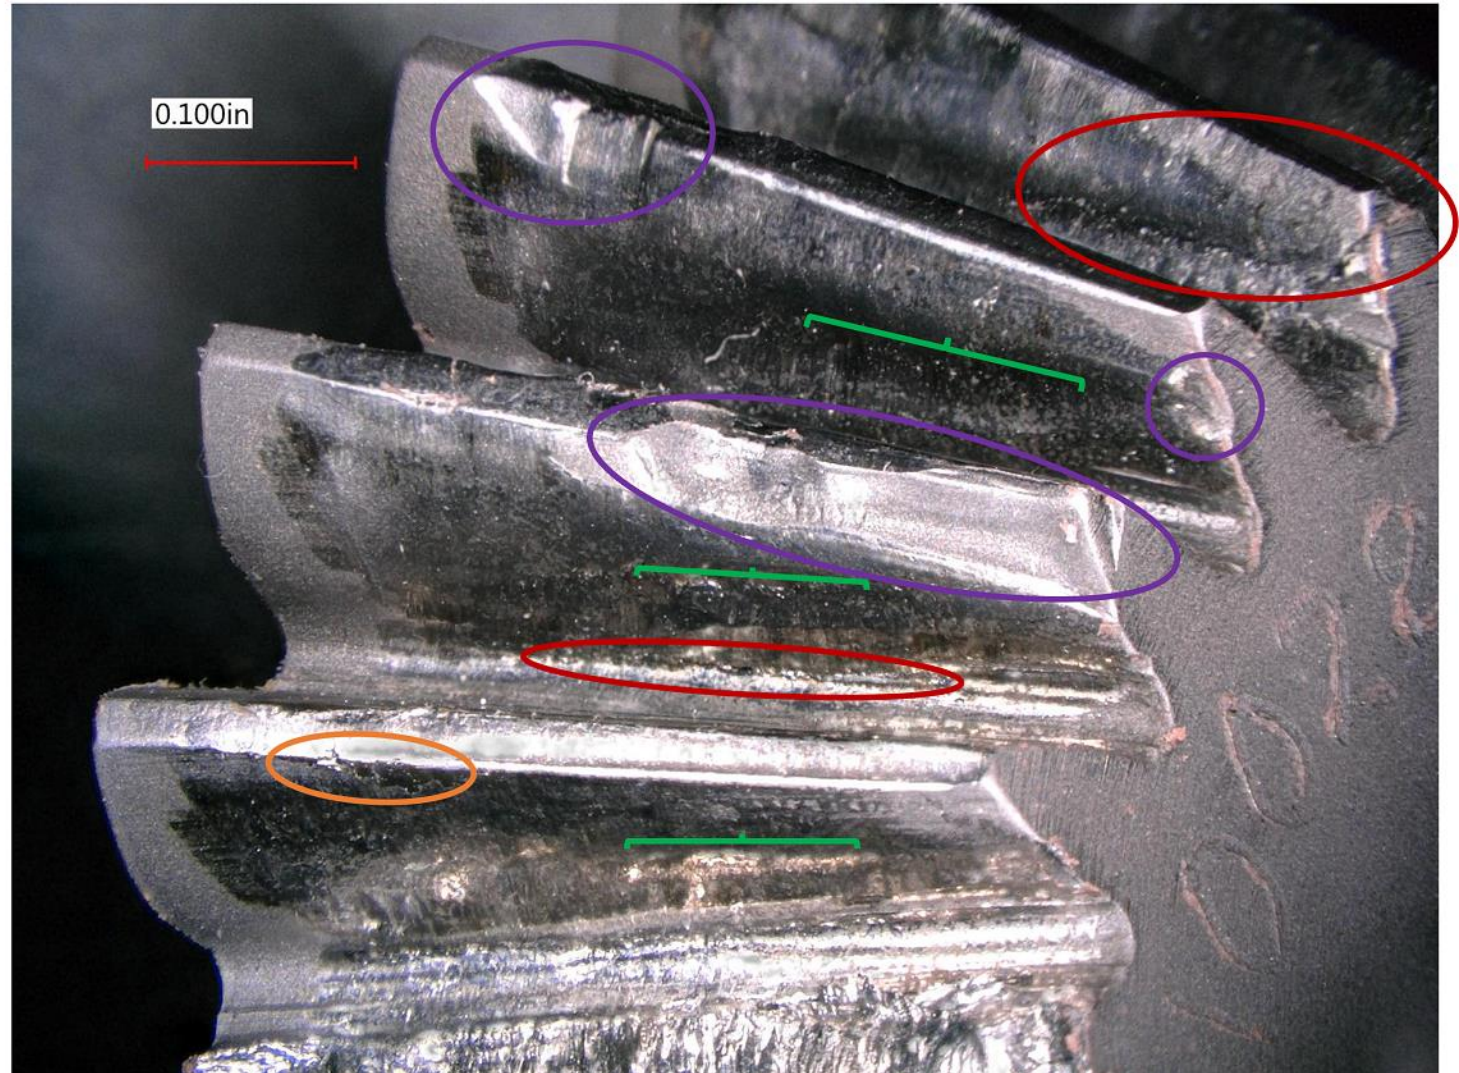
## Types of Wear:

Plastic Flow

Cracking

Pitch Line Pitting

Flaking

Figure 14: Different Types of Wear Visible on Teeth attached to Drive Gear. (Mag x10)

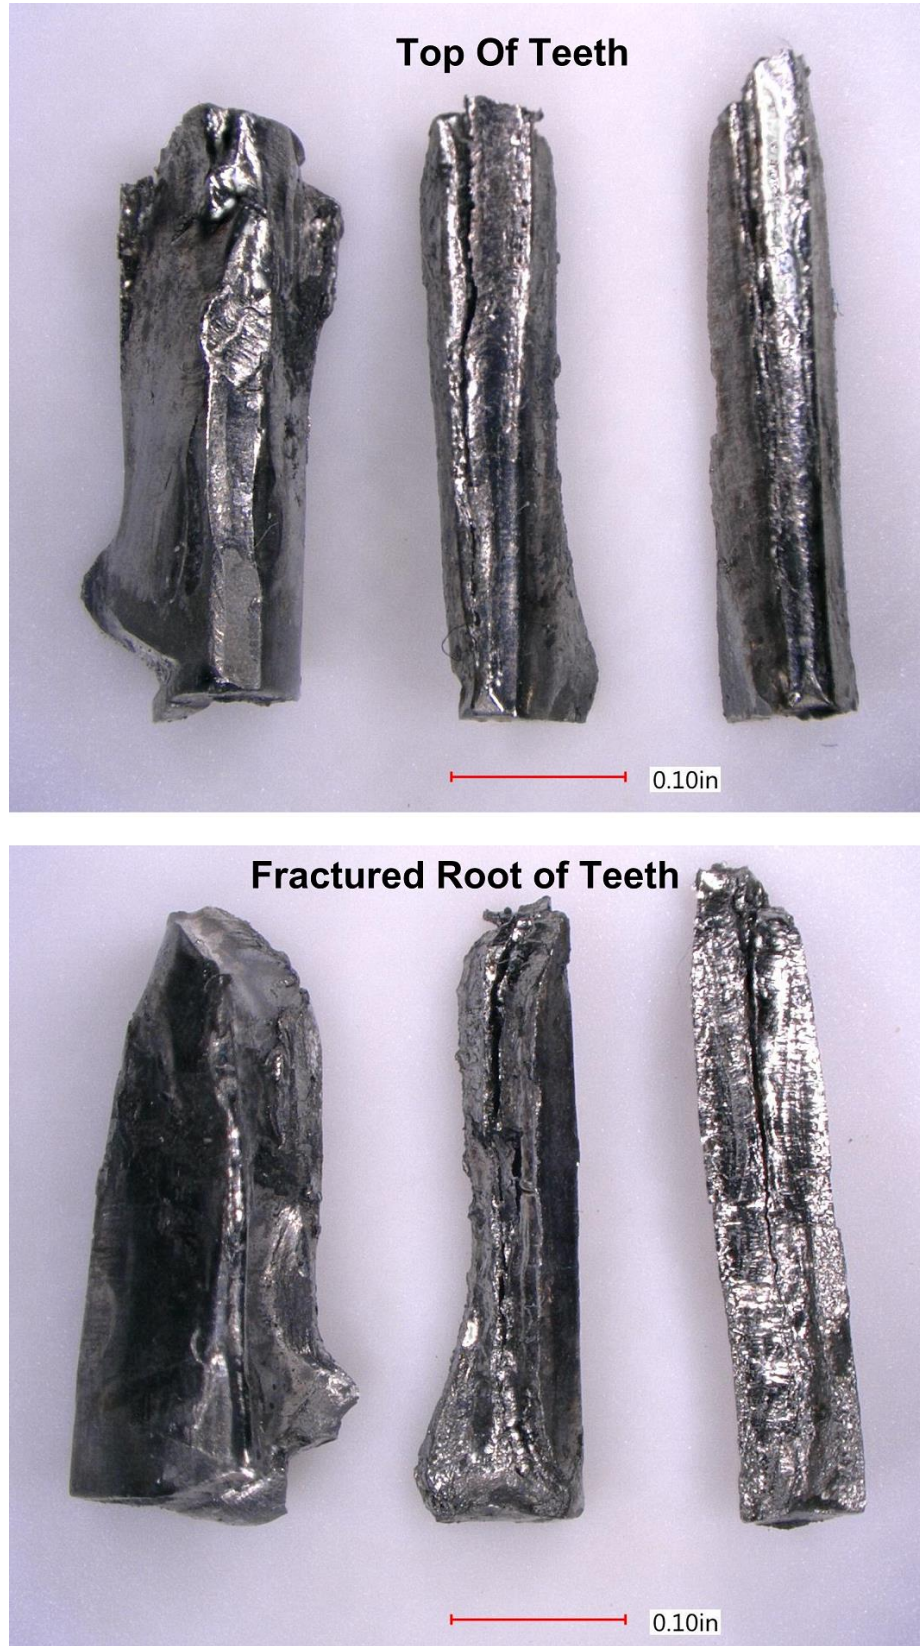
- Due to smearing that occurred during the final stages of mechanical failure it obscures additional evidence to the failure modes present.
- The broken teeth recovered from the pinion gear have internal secondary cracks.

Figure 15: Different Types of Wear Visible on Fractured Teeth from the Drive Gear. (Mag x8)

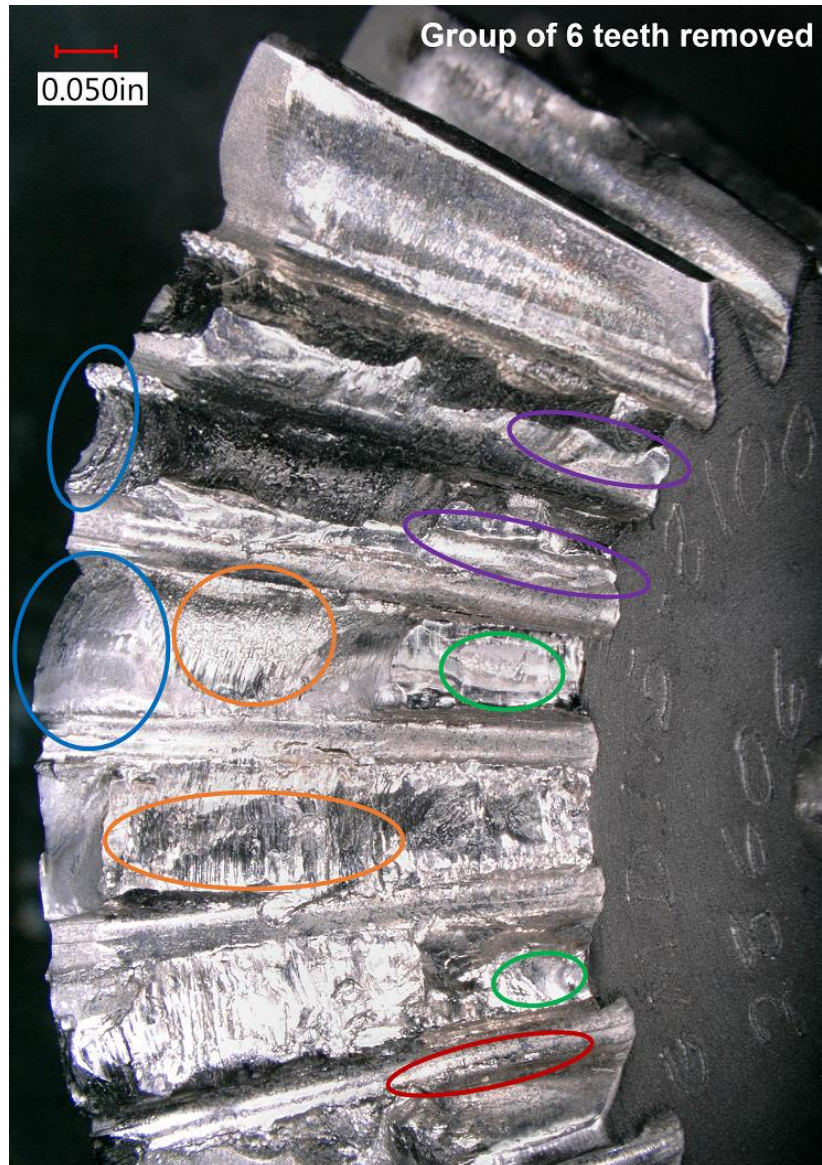
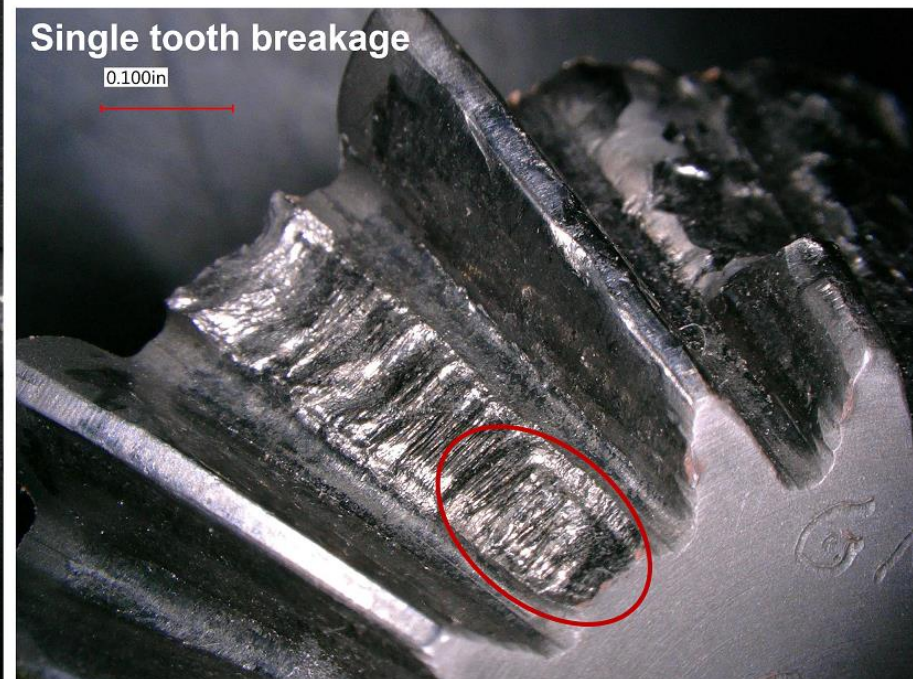
#### Types of Wear observed:

Plastic Flow

Cracking

Shear Overload

Smearing

Mixed Shear & Tensile Overload

Figure 16: Different Types of Wear Visible on Drive Gear Where Teeth are Missing.

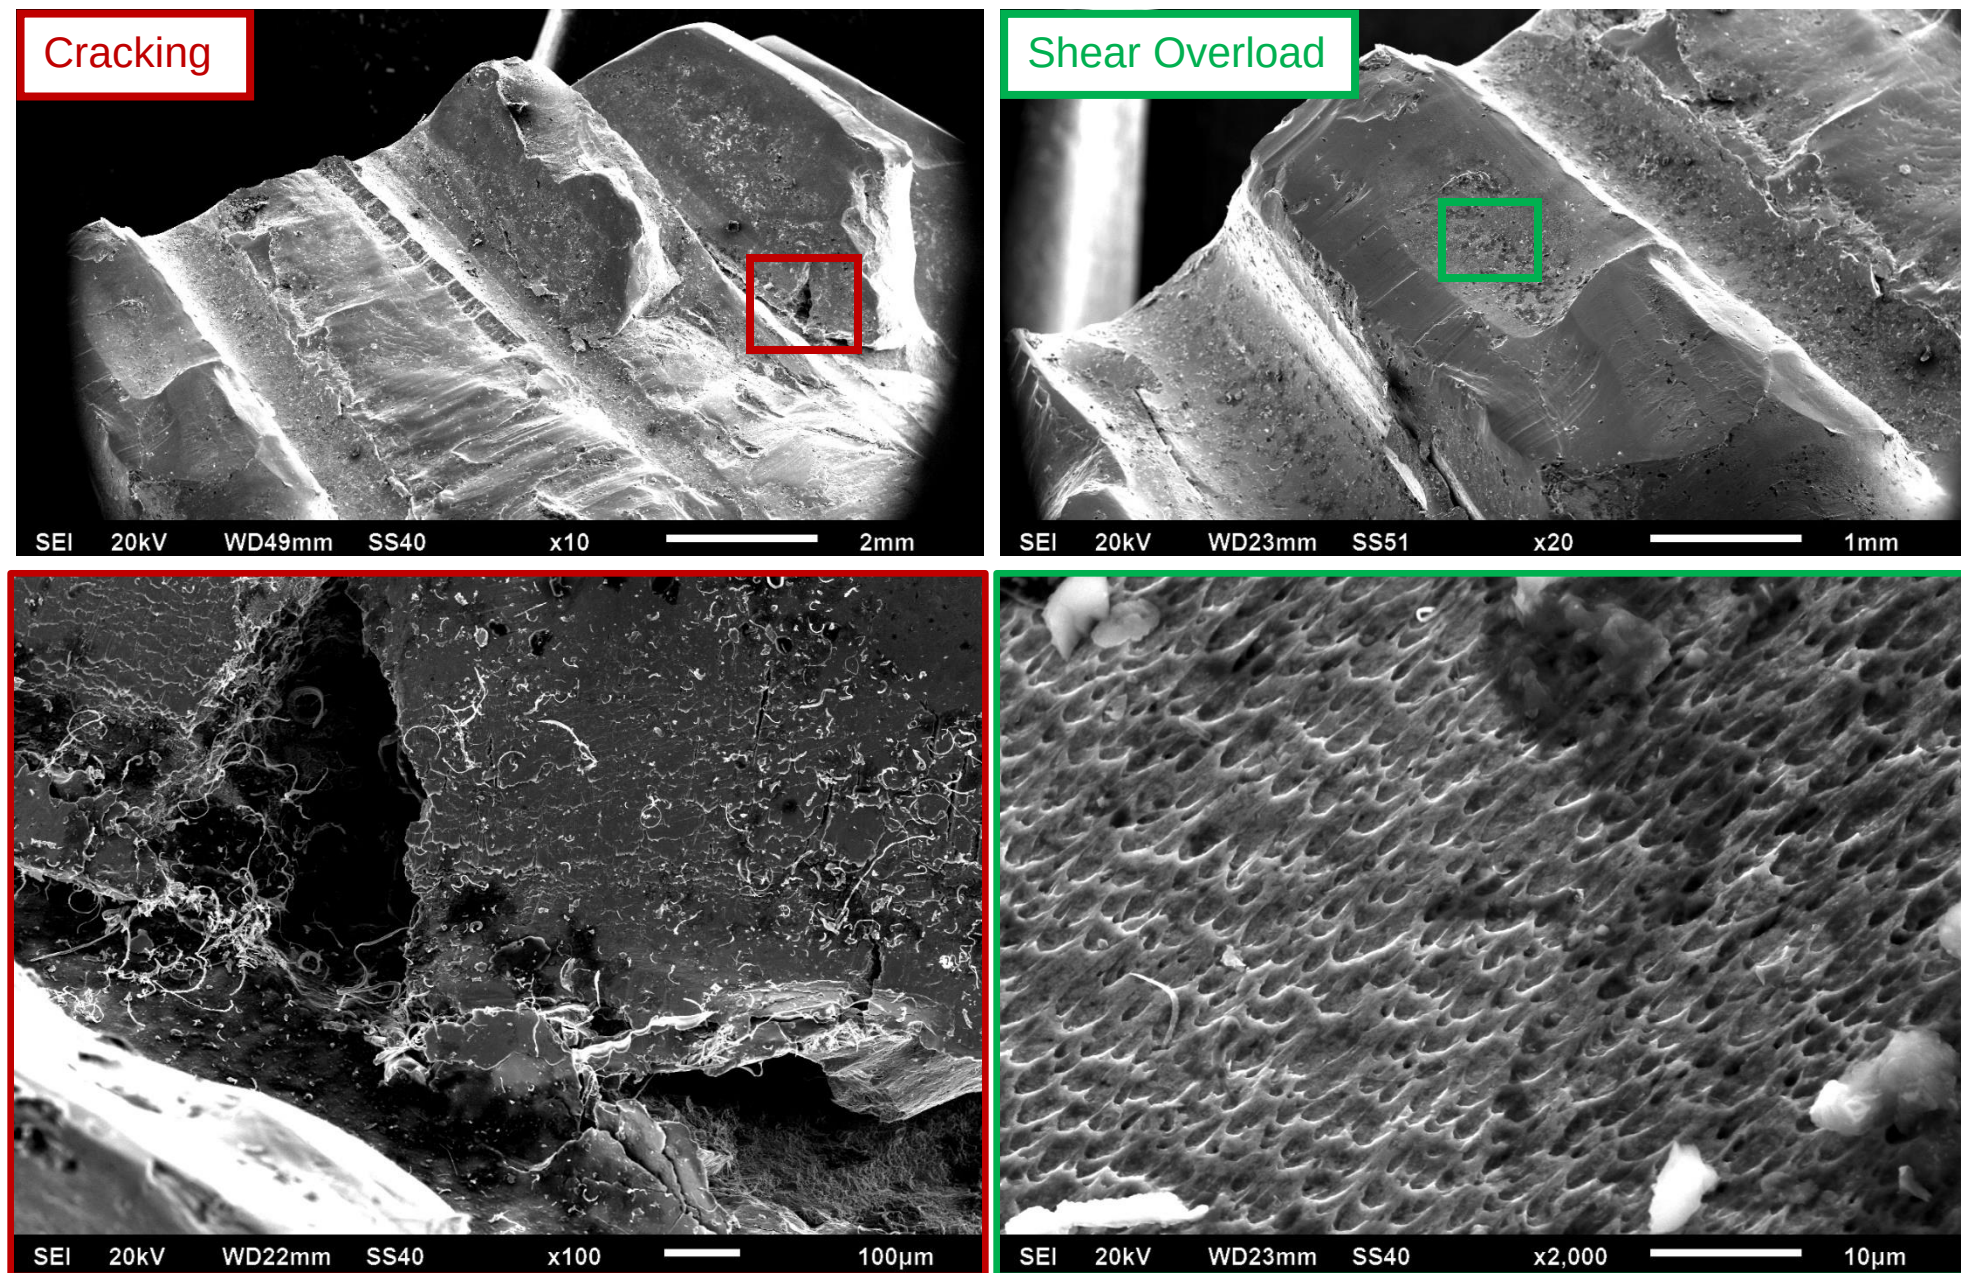
Figure 17: SEM Images of Different Types of Wear Visible on Drive Gear Where Teeth are Missing - Part 1

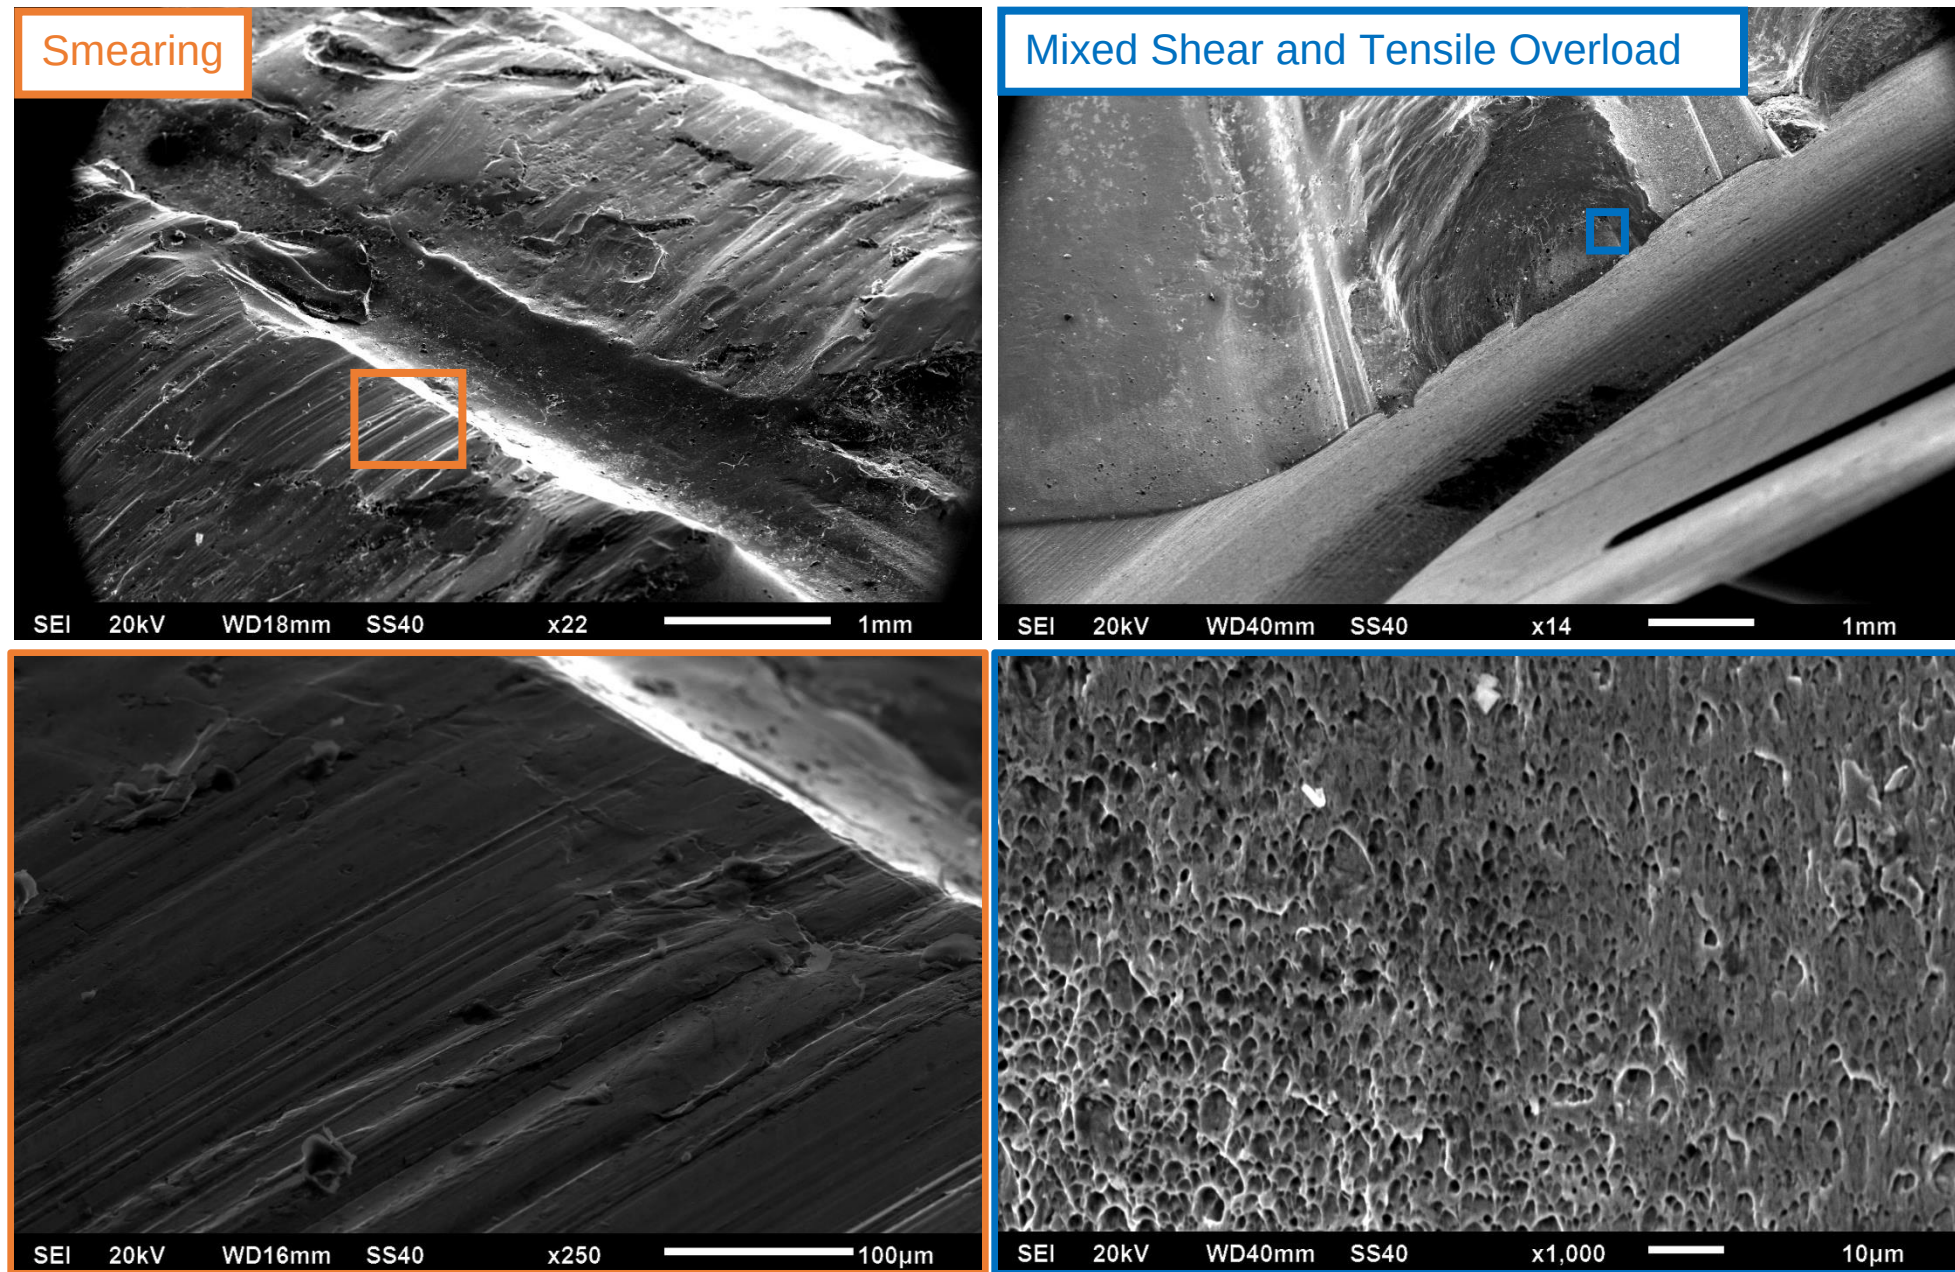
Figure 18: SEM Images of Different Types of Wear Visible on Drive Gear Where Teeth are Missing - Part 2

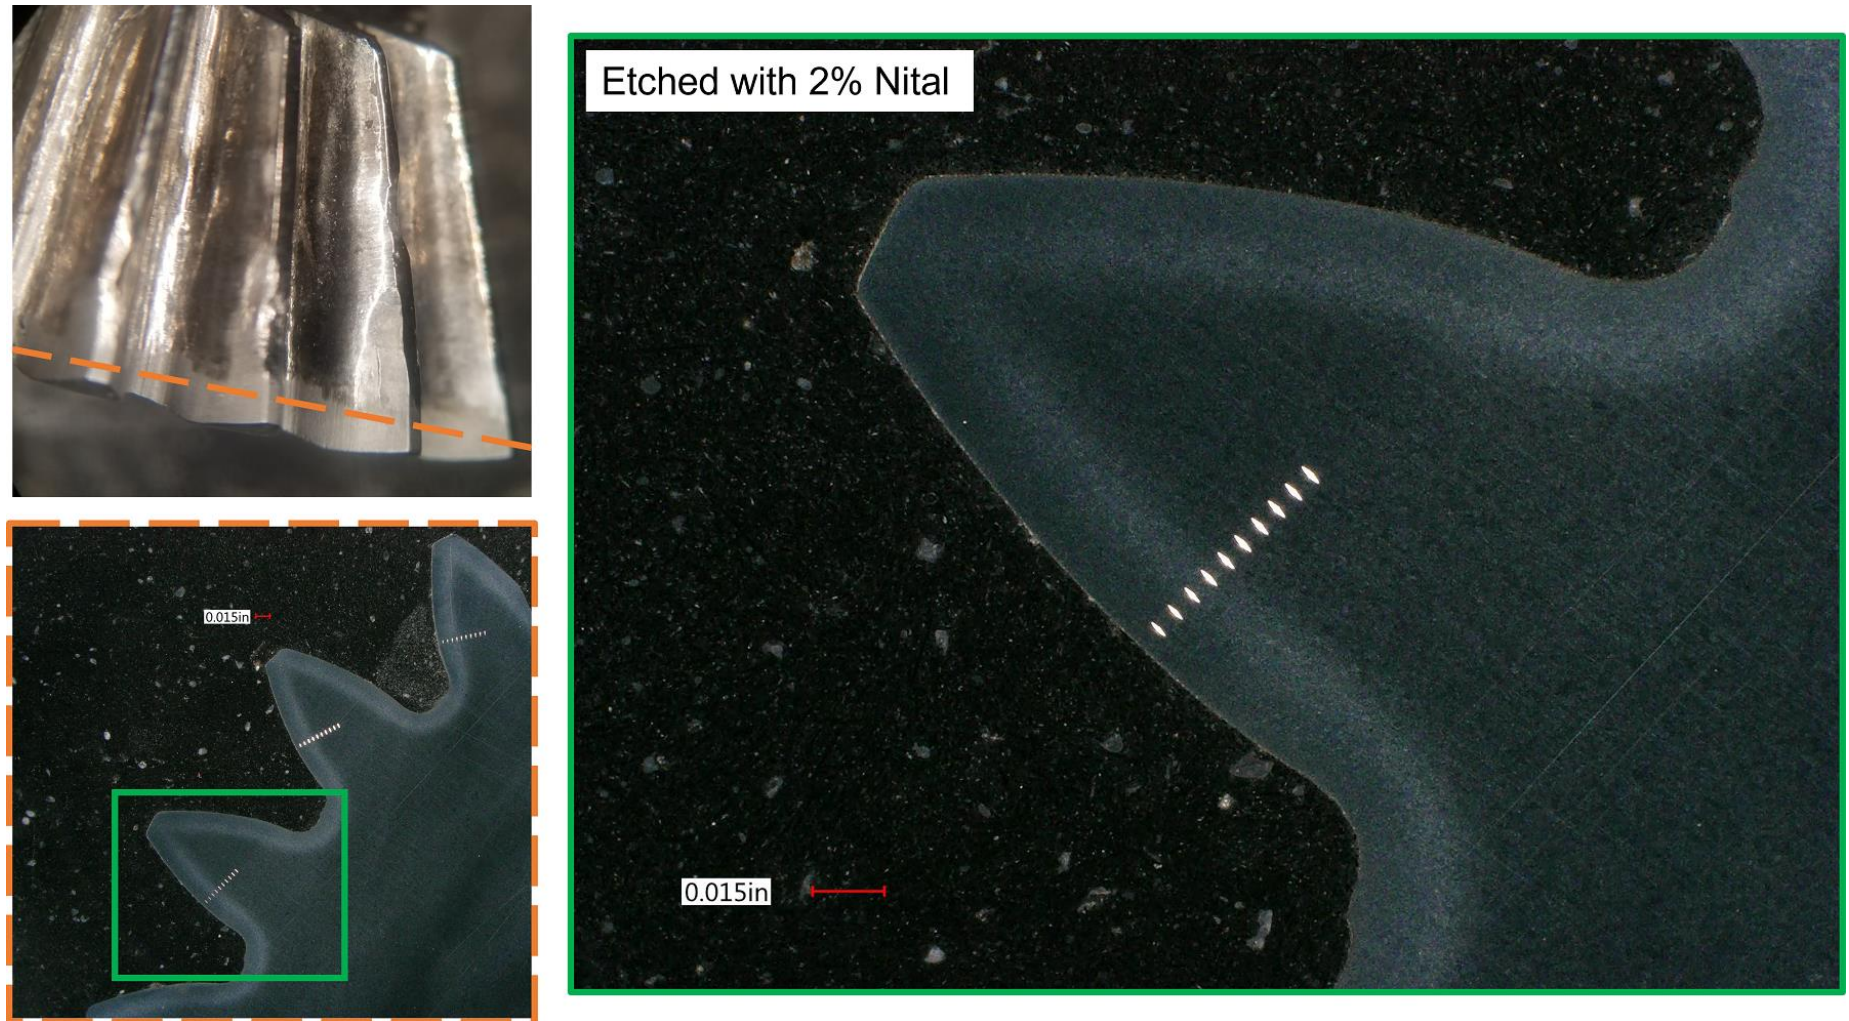
To verify the case hardening of the gear, microhardness measurements were collected on an undamaged portion of several gear teeth. No wear was present near the wider end of the bevel gear teeth, as shown in Figure 19. A cross section was taken through the region defined by the dotted orange line in Figure 19 to obtain the microhardness measurements reported in the table below. The measured case hardness did not conform to the drawing requirements but the case depth did meet the drawing requirements. After hardness testing, the cross-section was etched with 2% Nital to reveal the case within the microstructure.

- The pinion gear has effective case hardening to the appropriate depth but does not meet the drawing requirements for minimum case hardness.
- The driven gear did not have evidence of case hardening and does not meet the drawing requirements for both effective case depth and minimum case hardness.

Figure 19: Drive Gear Cross-section and Microhardness Testing (115-810028-3)

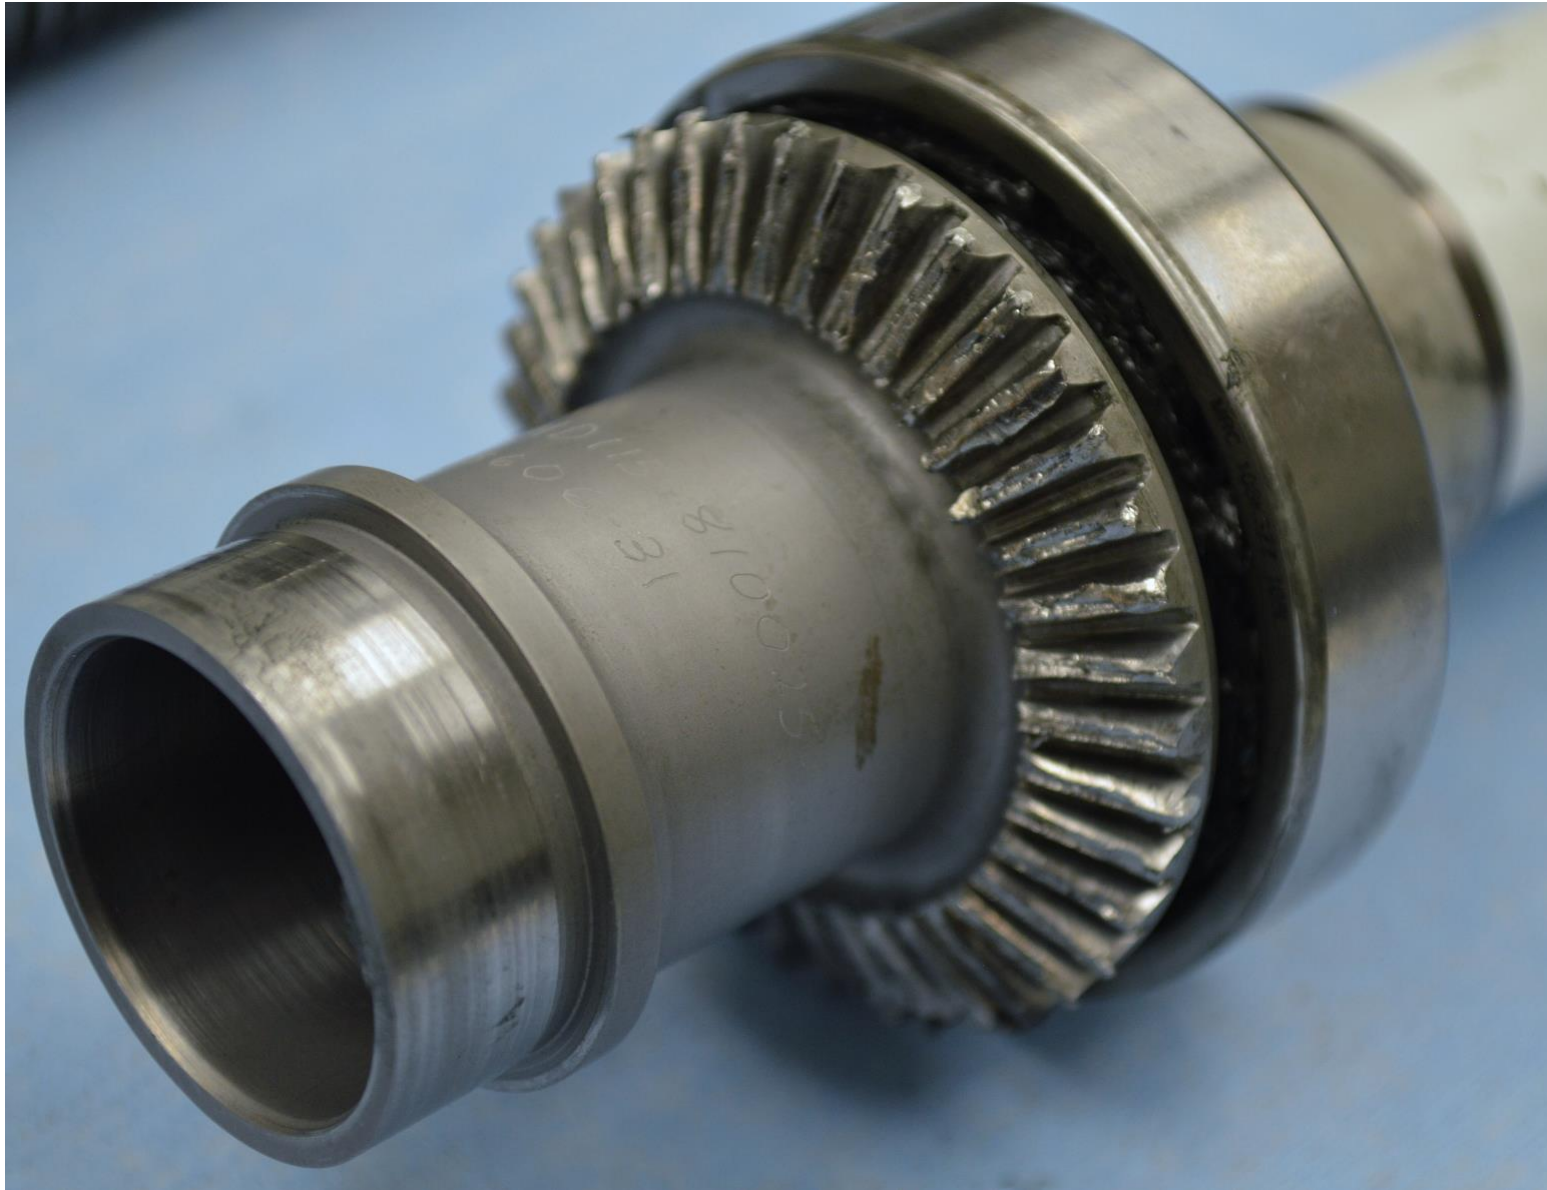
The damaged driven gear retained most of its teeth, as shown in Figure 20. A combination of partial tooth breakage/cracks and plastic flow were the primary wear patterns on the driven gear, reference Figure 21. No discoloration was present on the surfaces of the teeth. The plastic flow was localized to the addendum of the gear teeth, but cracks were found in regions near or below the pitch line of the teeth.

Figure 20: 115-810025-1 Driven Gear with damaged Gear Teeth. (Mag x2)
