TEXTRON AVIATION, INC.  
P.O. Box 7704  
WICHITA, KANSAS 67277

Model No.: B200  
Report No.: 23-359-005

Examination of B200 Super King Air N8170J Main Landing Gear Actuator, P/N 99-810057-653

Report Date: 05/05/2023

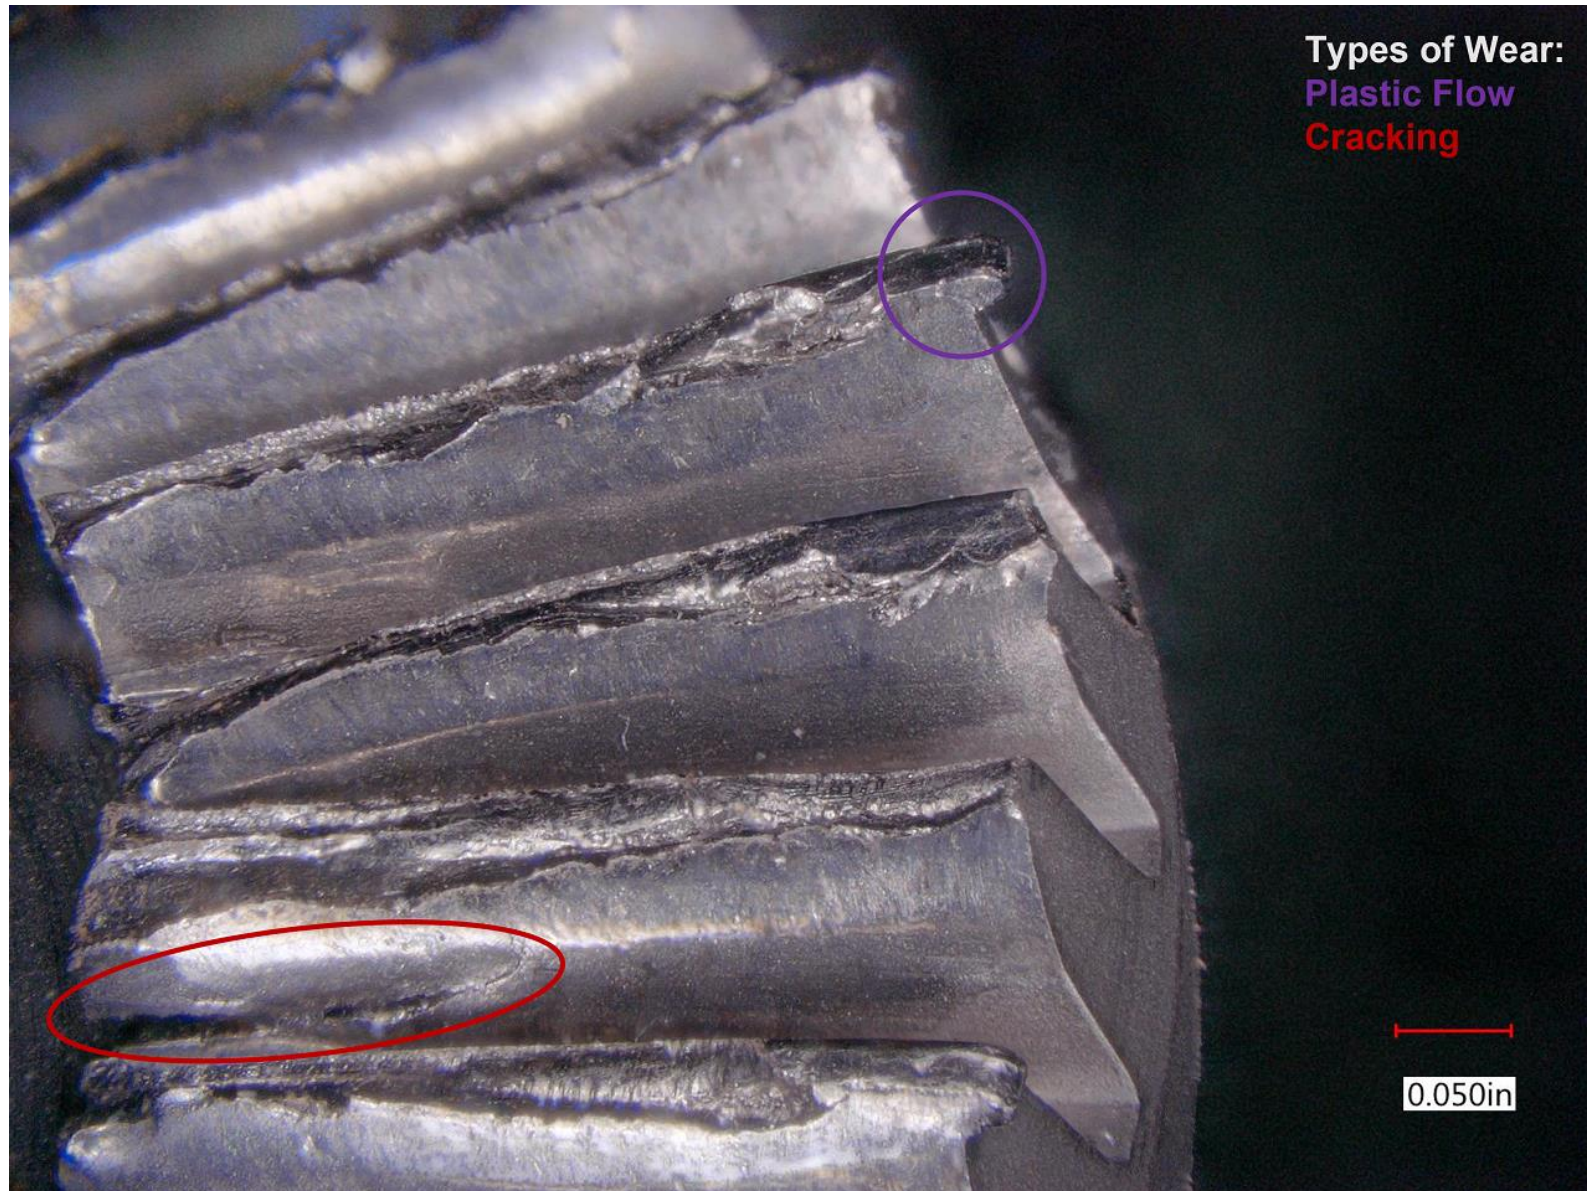
The damaged driven gear retained most of its teeth, as shown in Figure 20. A combination of partial tooth breakage/cracks and plastic flow were the primary wear patterns on the driven gear, reference Figure 21. No discoloration was present on the surfaces of the teeth. The plastic flow was localized to the addendum of the gear teeth, but cracks were found in regions near or below the pitch line of the teeth.

- The driven gear teeth were plastically deformed and cracked along the tip of the addendum as it smeared against the broken section of pinion teeth. Additional cracks were observed near the root of the driven gear but cannot be confirmed as either a result of fatigue or overload cracking.

Figure 21: Different types of wear present on damaged teeth from the Driven Gear. (Mag x12)

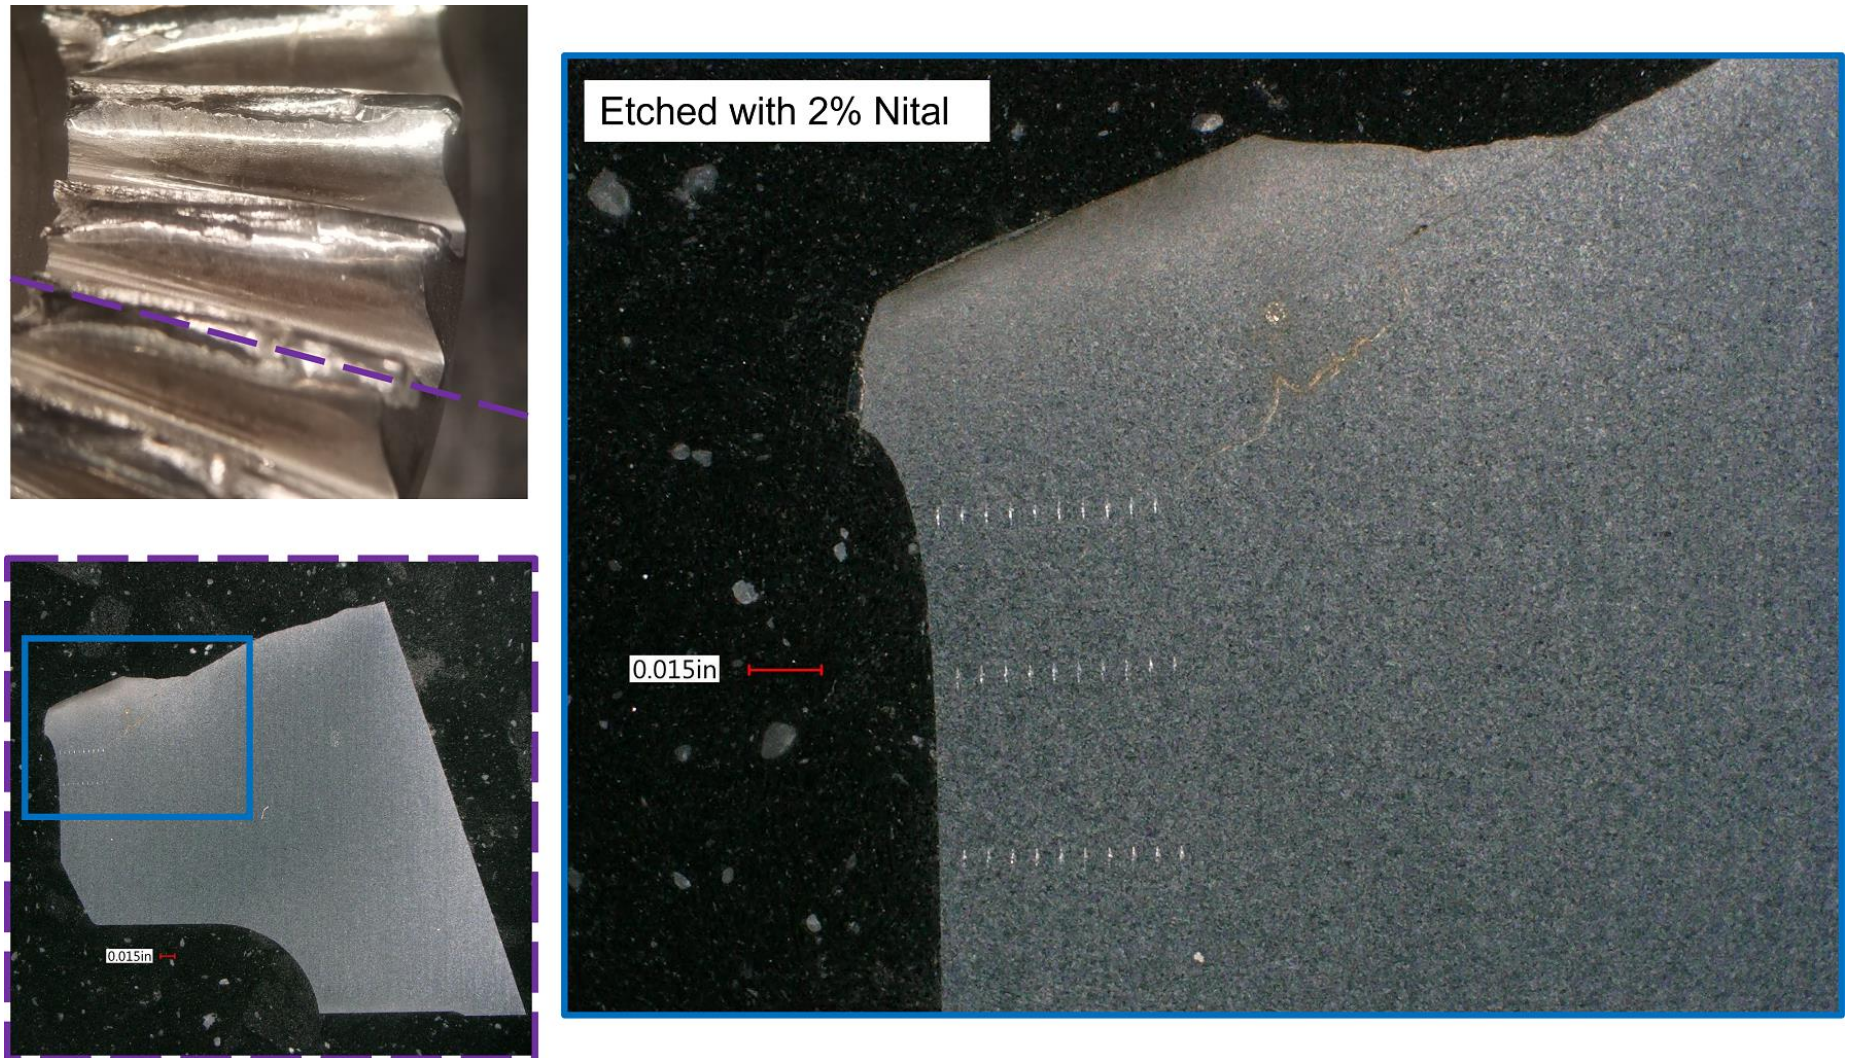
To verify the case hardening of the gear, microhardness measurements were collected on an undamaged portion of a gear tooth. No wear was present near the base of the outside surface of the teeth, as shown in Figure 22. A cross section was taken through the region defined by the dotted purple line in Figure 22 to obtain the microhardness measurements reported in the table below. The measured case hardness and depth did not meet the drawing requirements. The hardness tests did not indicate the presence of a case layer. Etching with 2% Nital, after hardness testing, did not reveal a case layer.

- The pinion gear has effective case hardening to the appropriate depth but does not meet the drawing requirements for minimum case hardness.
- The driven gear did not have evidence of case hardening and does not meet the drawing requirements for both effective case depth and minimum case hardness.

Figure 22: Driven Gear Cross-section and Microhardness Testing (115-810025-1).

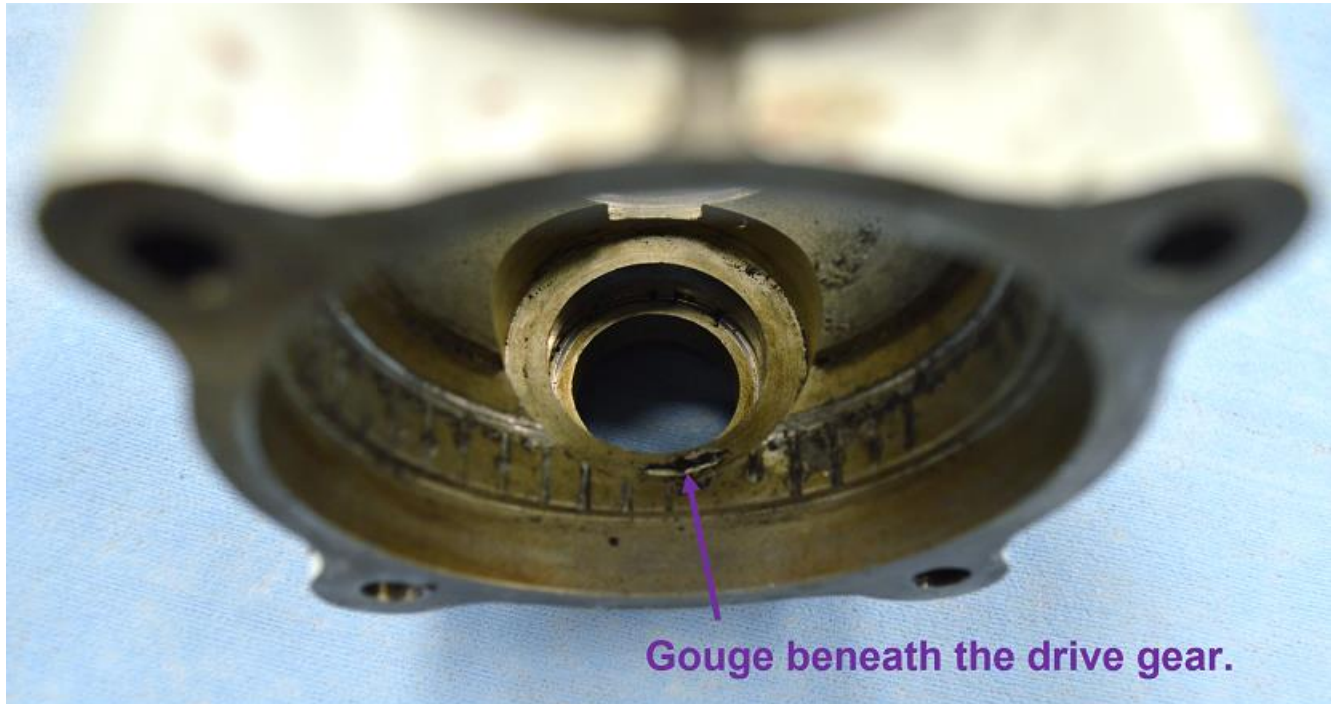
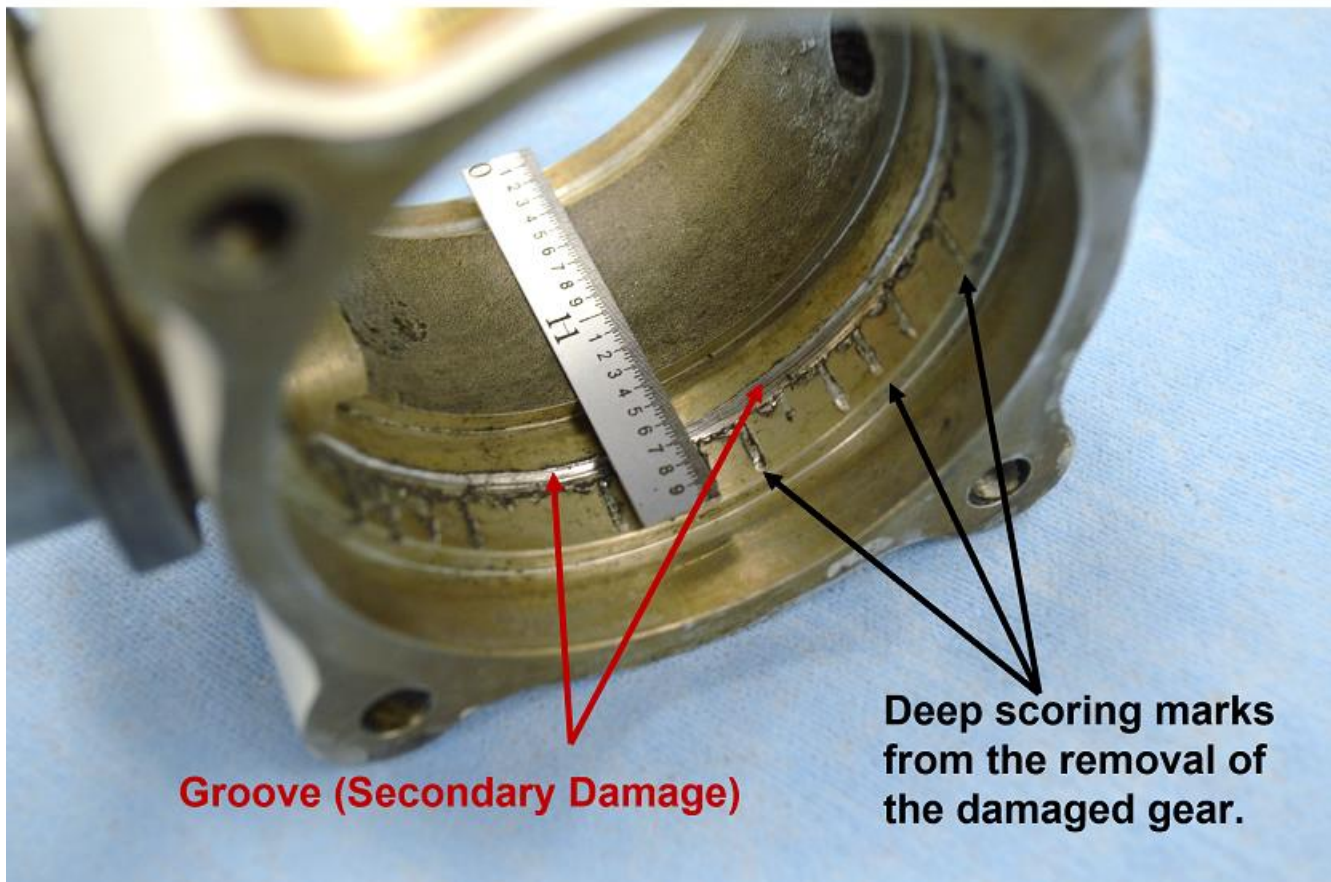
The vertical scoring/grooves in the inner bore, as shown in Figure 23, were made during the removal of the damaged driven gear. The secondary damage within the case is likely a result of the gear mesh fracturing/deforming resulting in secondary damage.

Figure 23: Visible damage inside the actuator housing.

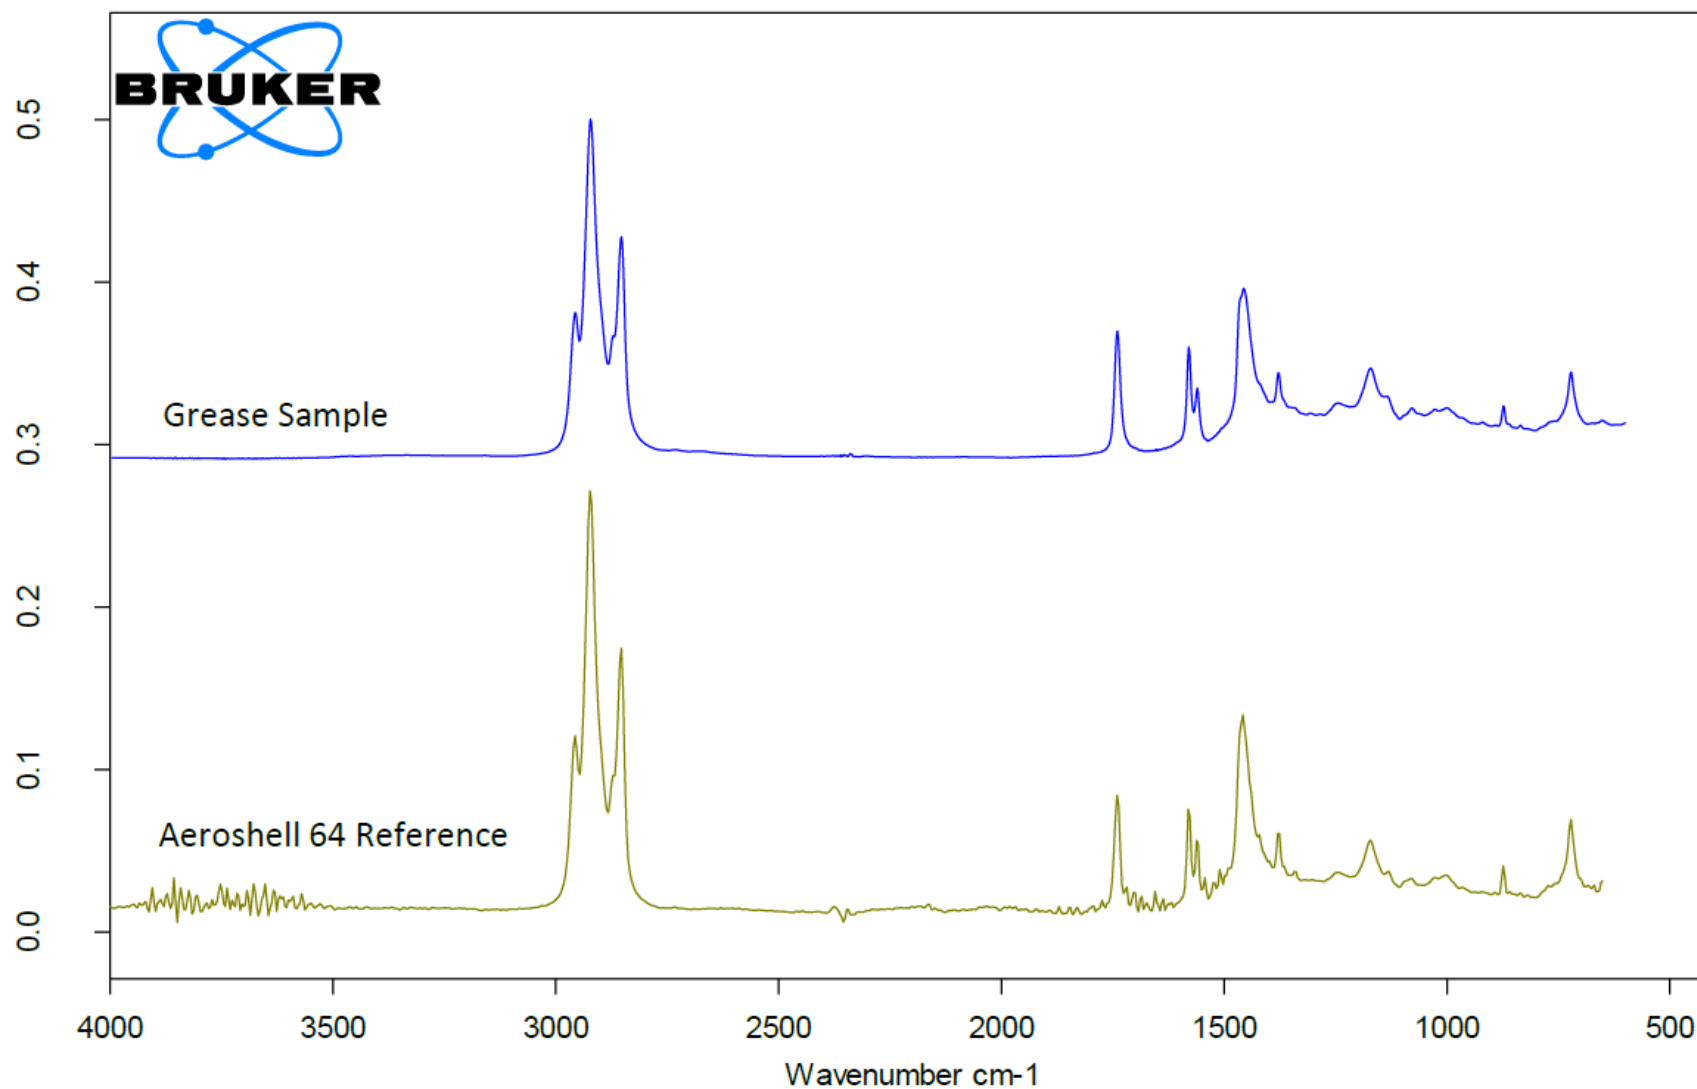
During the teardown, a sample of the grease was collected from the interior of the actuator after removing the screw housing from the actuator housing. The grease was evaluated using FTIR, and it was identified as Aeroshell 64. Figure 24 illustrates how the grease sample obtained from the actuator closely matched the Aeroshell 64 reference. Based on the peaks present within the Spectrum collected from the sample, the grease did not appear to be degraded.

Figure 24: FTIR Analysis of Grease Sample

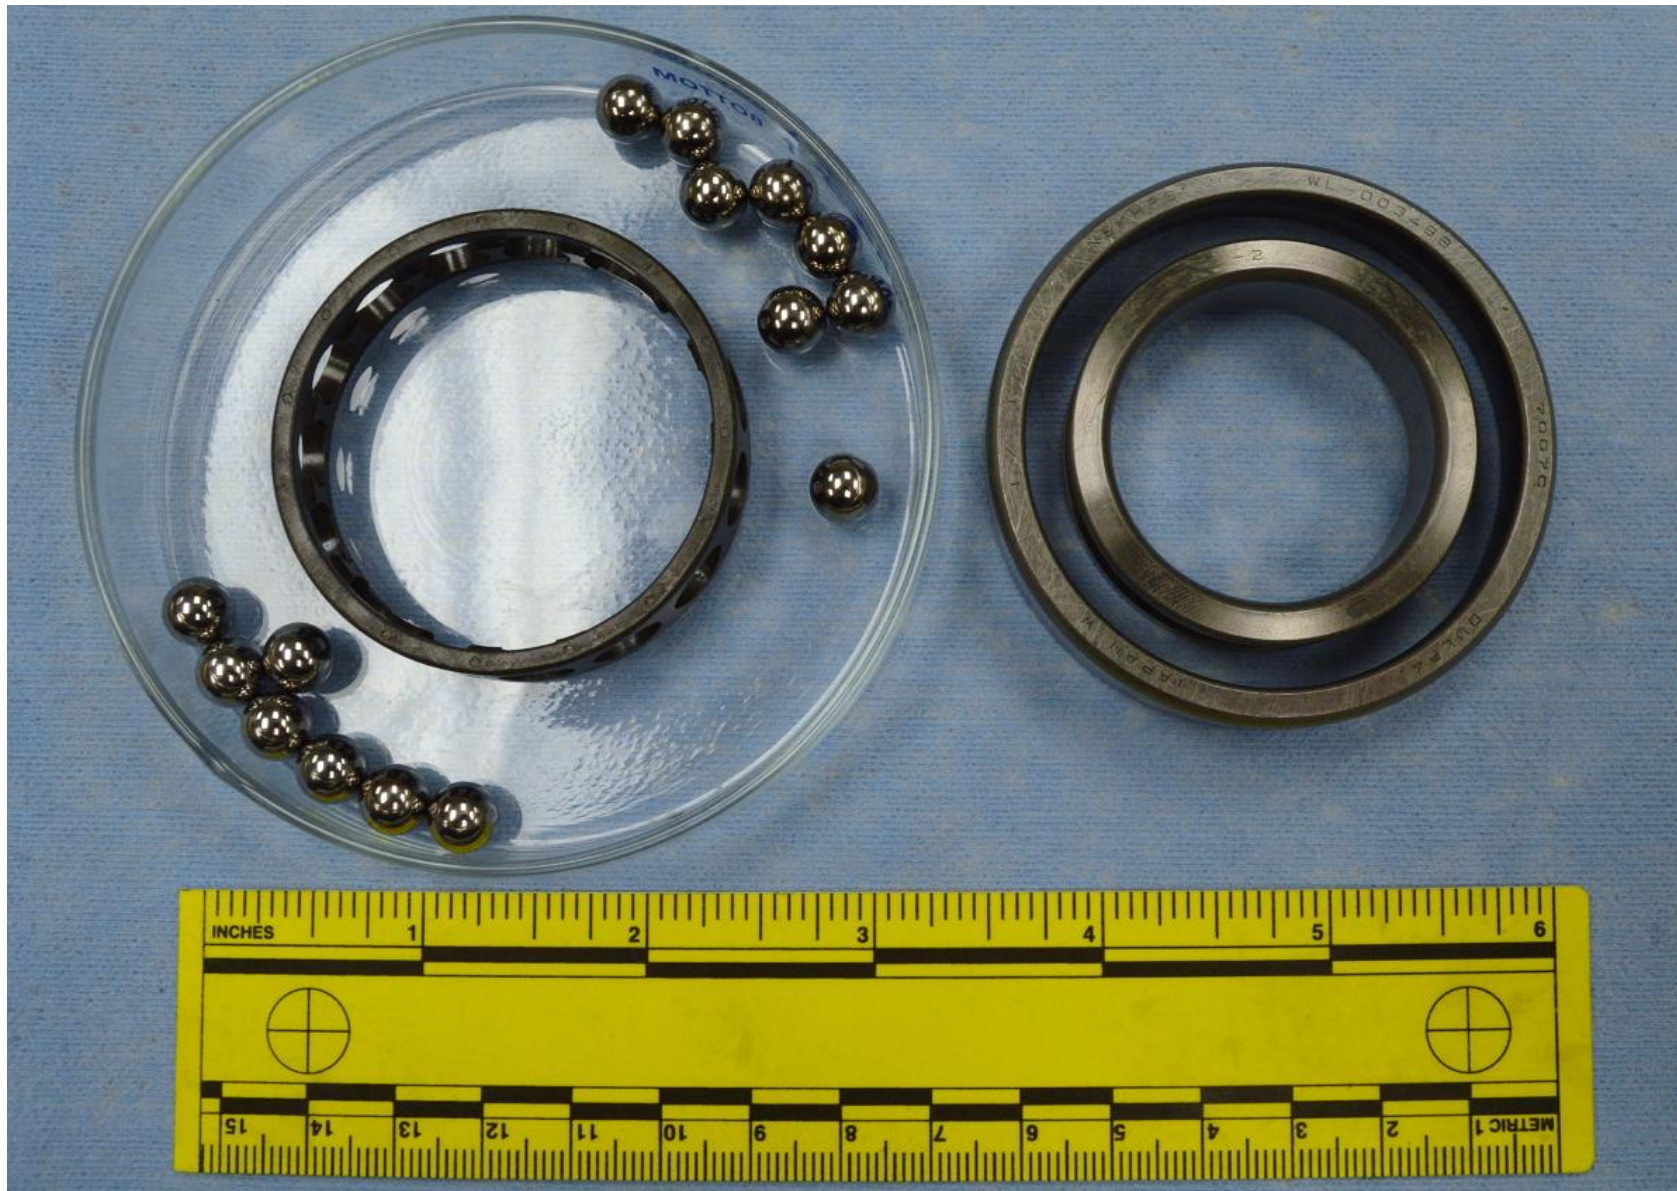
The Lower bearing was removed in pieces due to its design utilizing a floating bearing cage. The components were cleaned of grease and visually inspected for damage, reference Figure 25. The Upper Bearing was pressed from the screw housing and then inspected. The bearing cage prevented any non-destructive teardown of the bearing. Visual inspection of the assembled bearing was done after cleaning, and no immediate indicators of wear or damage were present, reference Figure 26.

Figure 25: Lower Bearing removed from housing. (Mag x0.6)

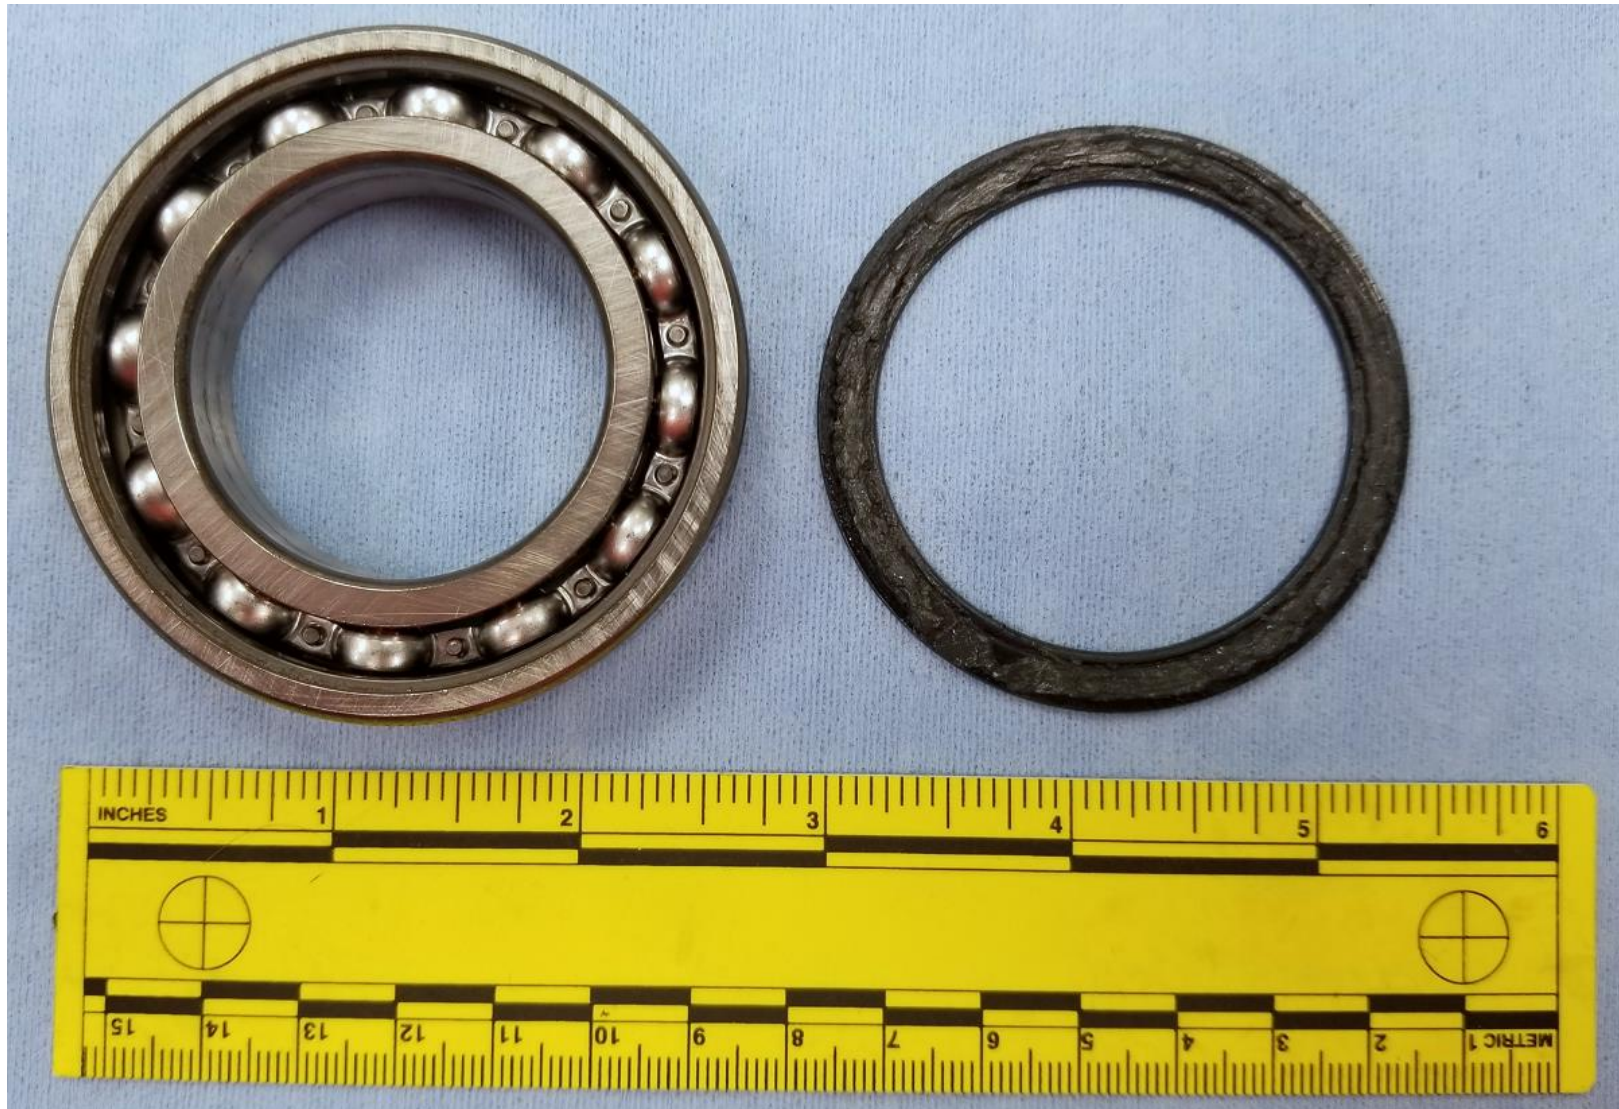
Figure 26: Upper Bearing removed from housing. (Mag x0.6)
